EVALUATION OF HASTELLOY N ALLOYS
AFTER NINE YEARS EXPOSURE TO BOTH
A MOLTEN FLUORIDE SALT AND AIR AT
TEMPERATURES FROM 700 TO 560°C

J. W. Koger

DECEMBER 1972

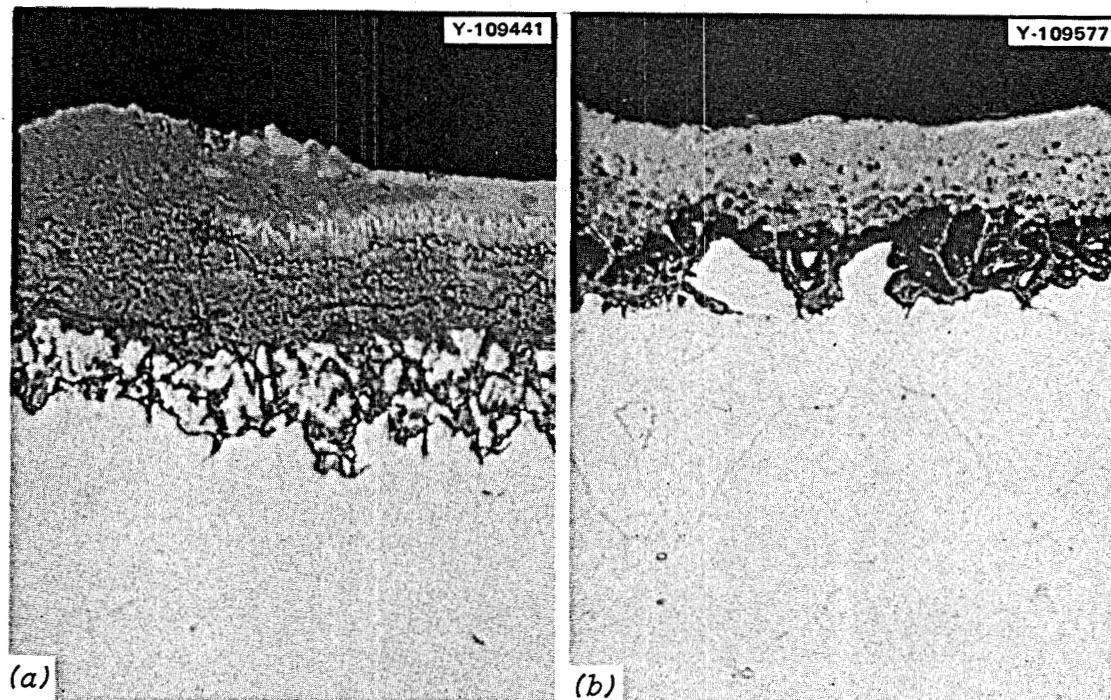
Fig. 24. Outside surface of standard Hastelloy N tubing, exposed to air underneath a heater at temperatures above 605–620°C. Location B, Fig. 22. (a) As polished, (b) etched with glyceria regia. 500X.

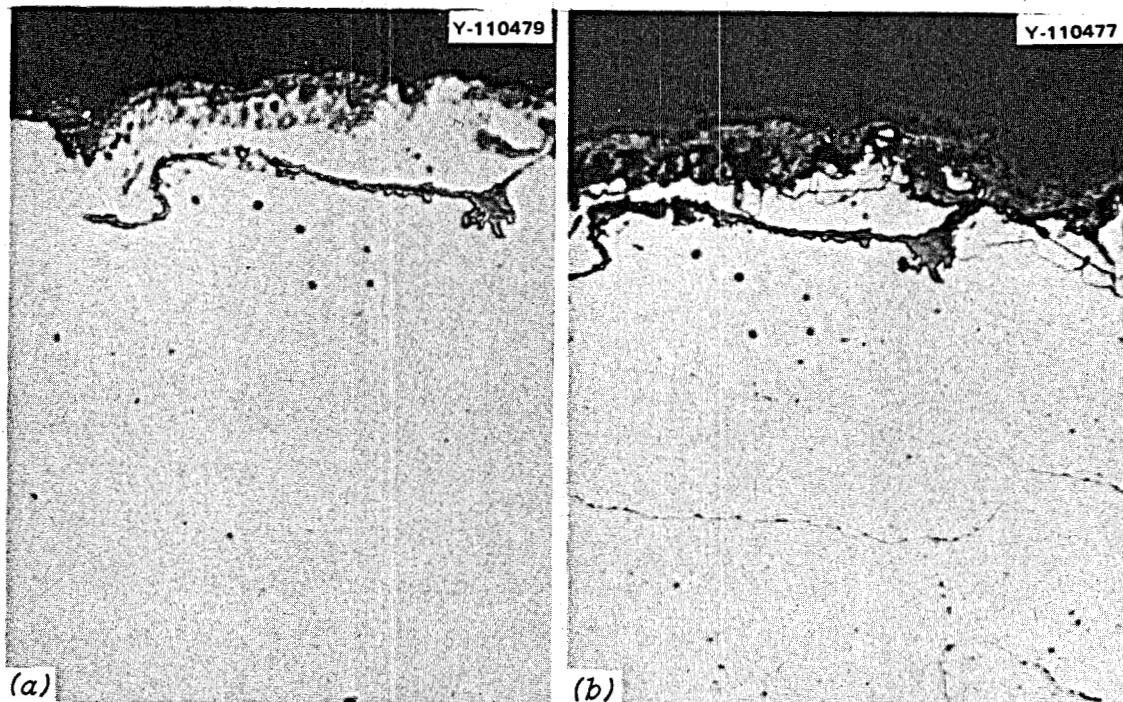
Fig. 25. Outside surface of standard Hastelloy N tubing, exposed to air underneath a heater at temperatures above 580°C. Location C, Fig. 22. (a) As polished, (b) etched with glyceria regia. 500X.

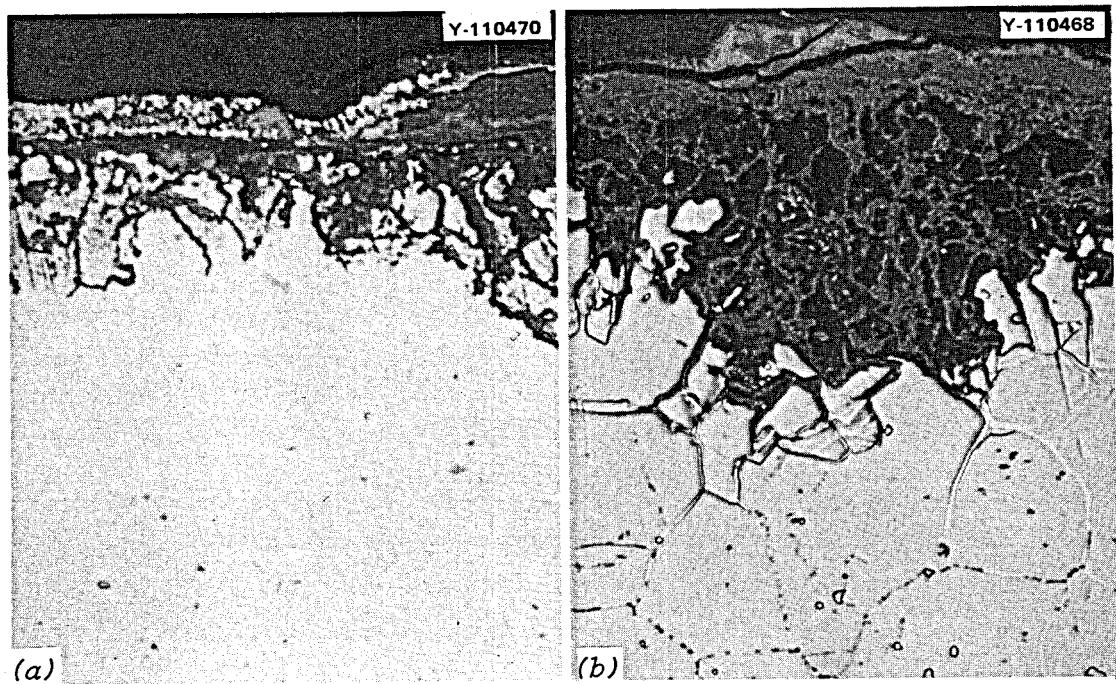
Fig. 26. Outside surface of standard Hastelloy N tubing, exposed to air at 660°C. Location F, Fig. 22. (a) As polished, (b) etched with glyceria regia. 500X.

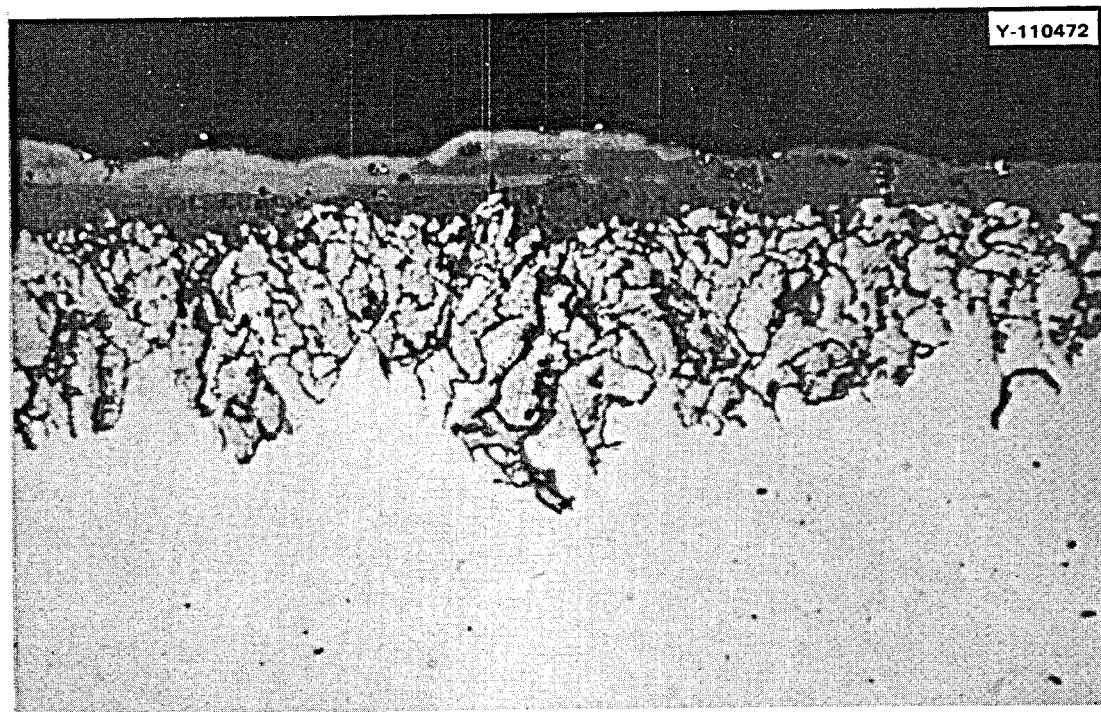
Fig. 27. Outside surface of standard Hastelloy N tubing, exposed to air at 593°C. Location E, Fig. 22. As polished, 500X.

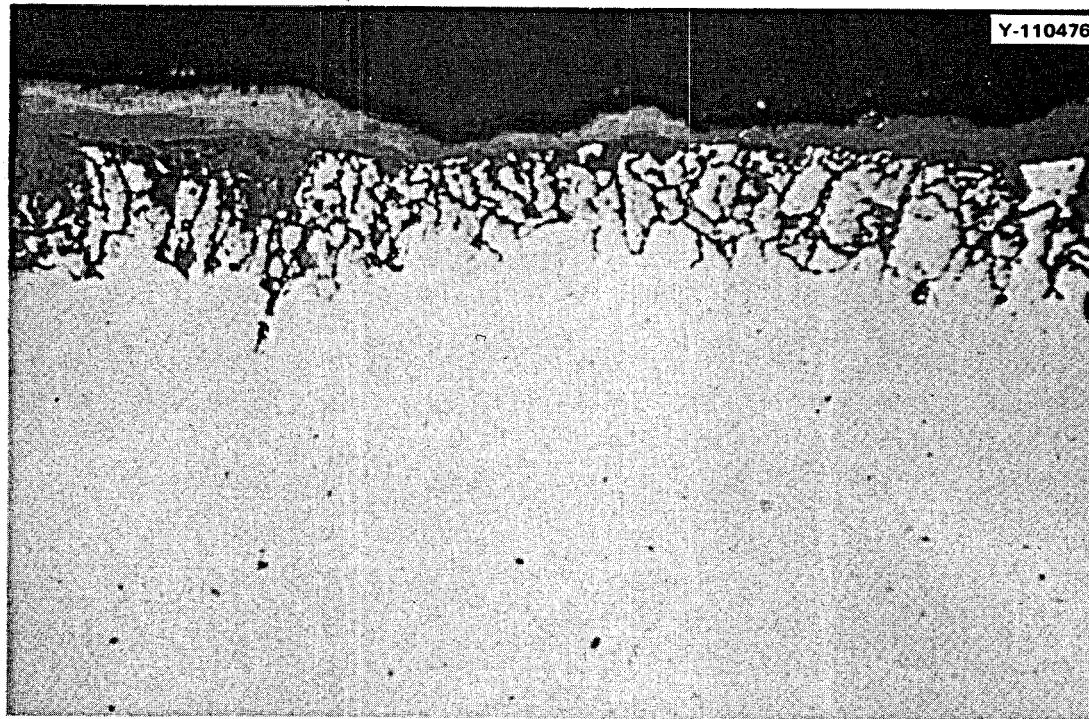
Fig. 28. Outside surface of standard Hastelloy N tubing, exposed to air at 560°C. Location D, Fig. 22. As polished, 500X.

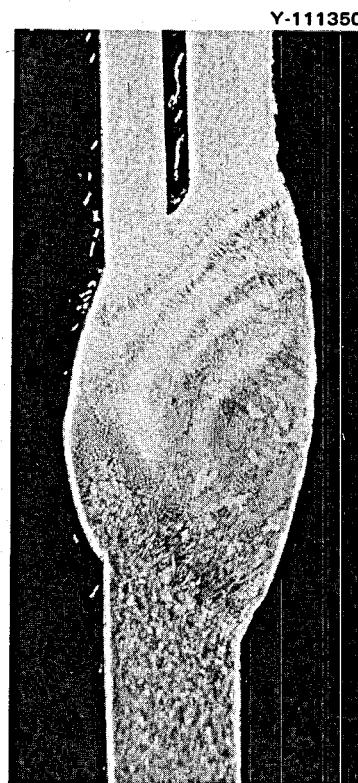
Fig. 29. Weld joining standard Hastelloy N tubing (top, right) and spacer (top, left) to modified Hastelloy N-2% Nb tubing (below). Left side exposed to salt at 665°C; right side exposed to air. Etched with glyceria regia. 12X.

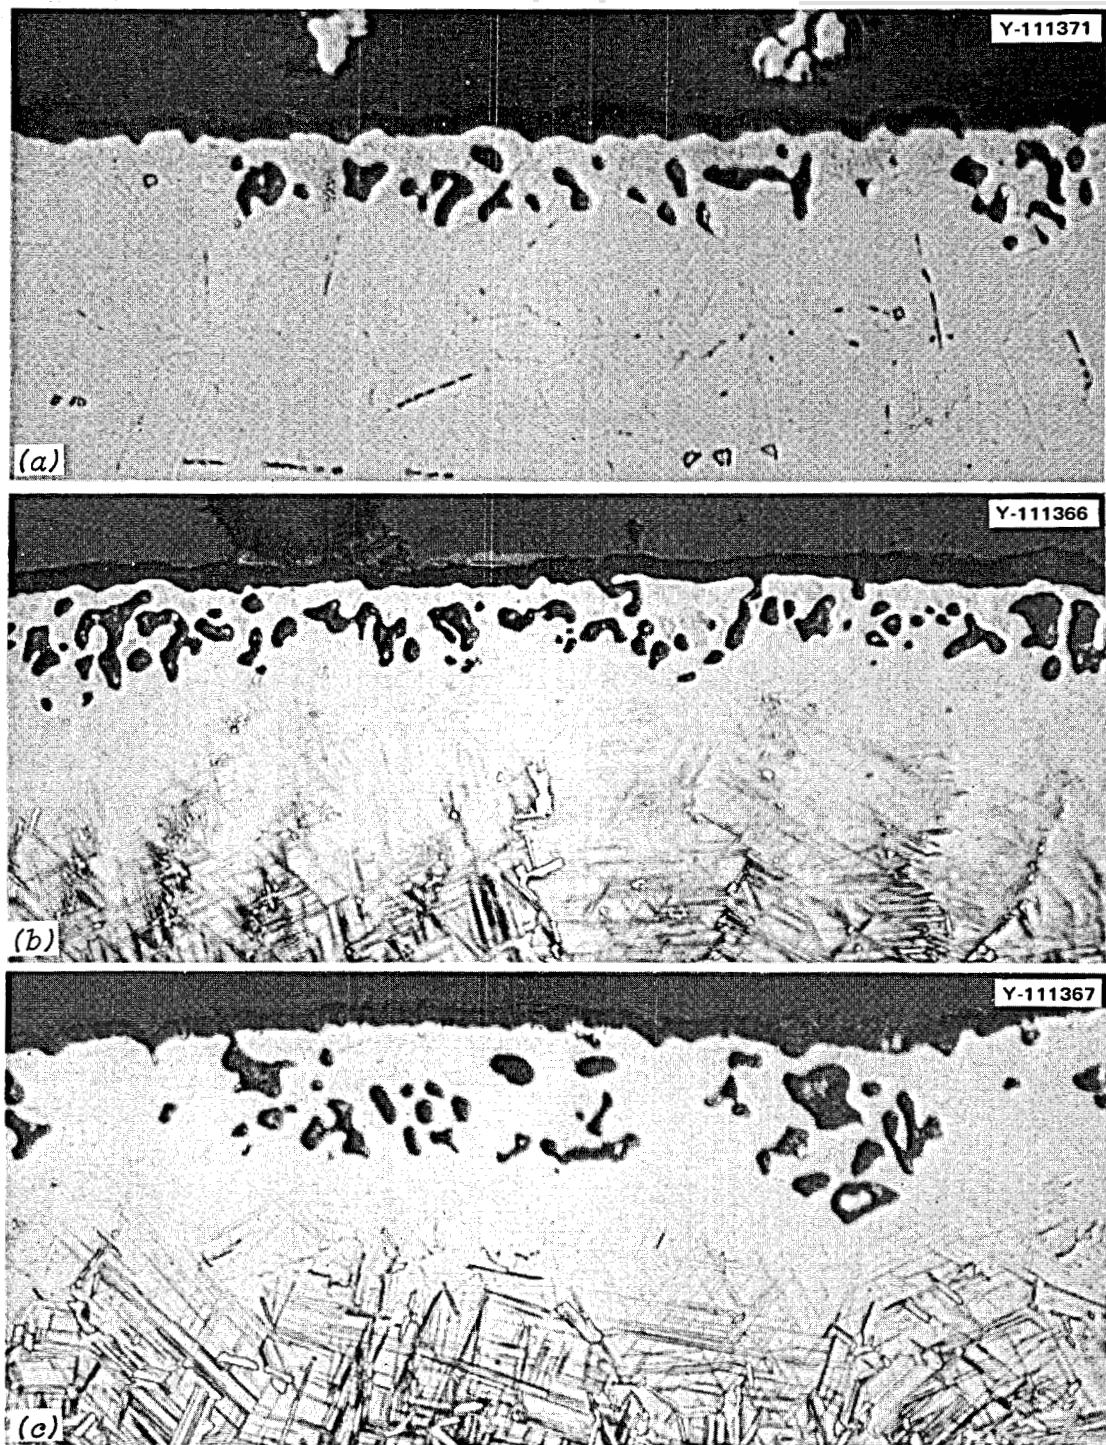
Fig. 30. Inside surface, exposed to salt, of weld joining Hastelloy N tubing and spacer to modified Hastelloy N. Higher magnification of left side of Fig. 29. (a) Hastelloy N spacer; (b) weld; (c) Hastelloy N-2% Nb tubing. Etched with glyceria regia. 500X.

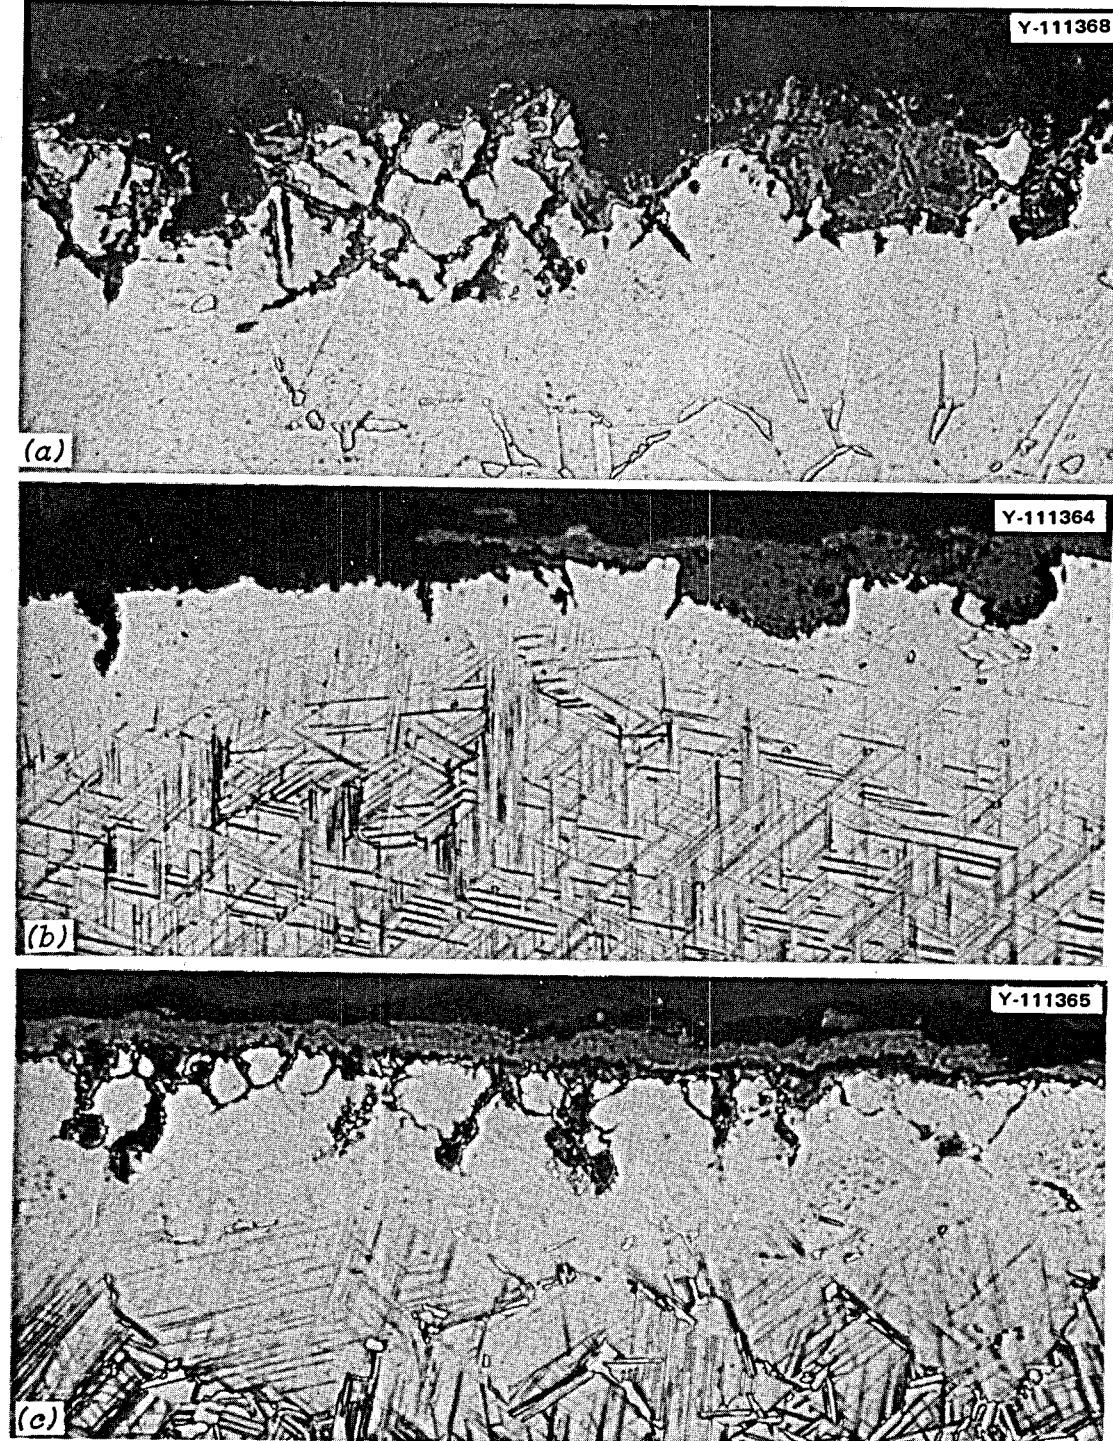
Fig. 31. Outside surface, exposed to air, of weld joining Hastelloy N tubing and spacer to modified Hastelloy N. Higher magnification of right side of Fig. 29. (a) Hastelloy N tubing; (b) weld; (c) Hastelloy N-2% Nb tubing. Etched with glyceria regia. 500X.

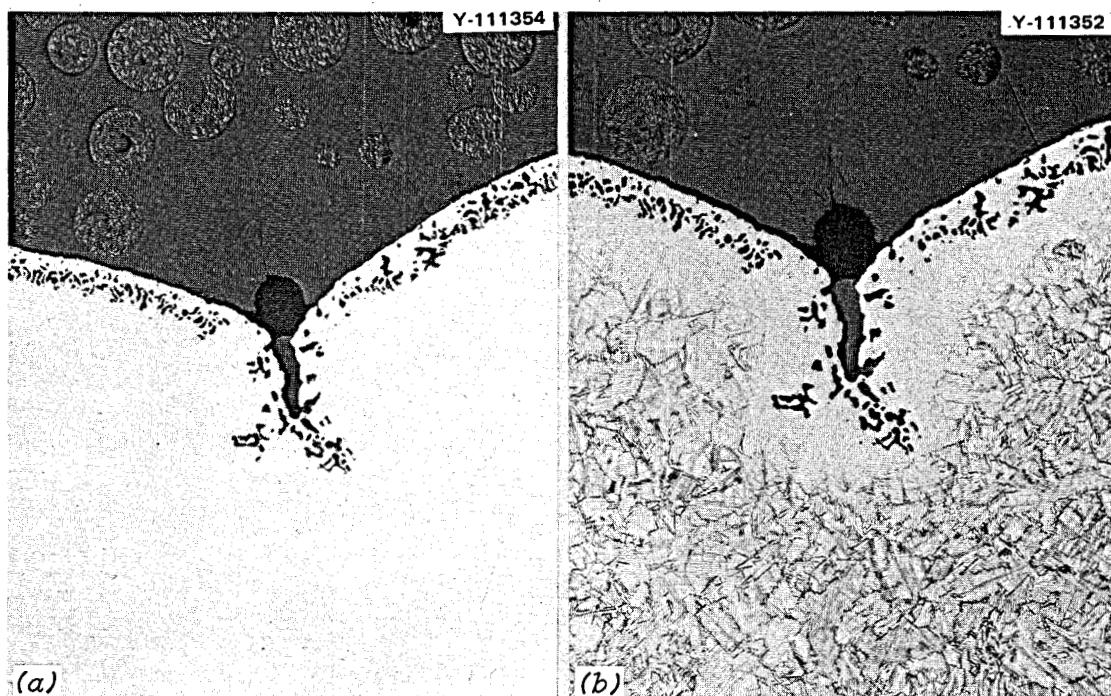
Fig. 32. Inside surface, exposed to salt at 650°C, of welded Hastelloy N-2% Nb tubing, showing the weld. (a) As polished, (b) etched with glyceria regia. 100X.

The modified Hastelloy N-2% Nb tubing was formed from sheet and welded. Figure 32 shows the inside surface of the tubing, at the weld. The temperature of the salt at this position was about 650°C. Note the increased void formation at the tip of the closure.

We found no difference in the corrosion (either in air or salt) of the weld and the adjacent alloy. The corrosion that occurred at the base of the Hastelloy N-2% Nb tubing weld (Fig. 32) was interesting as it showed much greater corrosion at the tip; the voids extended much deeper into the alloy at this point. The weld corrosion resistance was as good as that of the alloys.

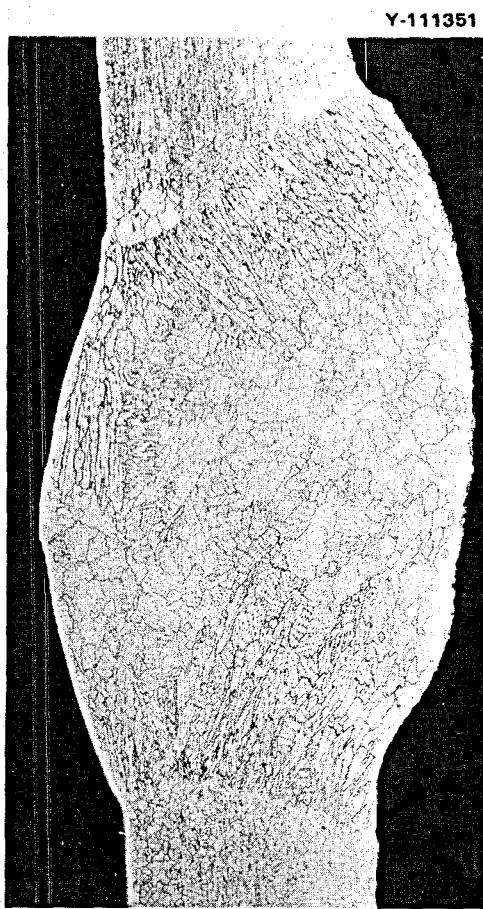
Figure 33 is one side of Hastelloy N tubing welded to Hastelloy N tubing at the lower crossover portion of the loop. The temperature of the salt at this position was 580°C. Figure 34 is the inside surface of the tubing, which was exposed to the salt. Very little change in the microstructure was seen or expected in this region.

Fig. 33. Weld joining two pieces of Hastelloy N tubing. Left side exposed to salt at 580°C; right side exposed to air. Etched with glyceria regia. 20X.

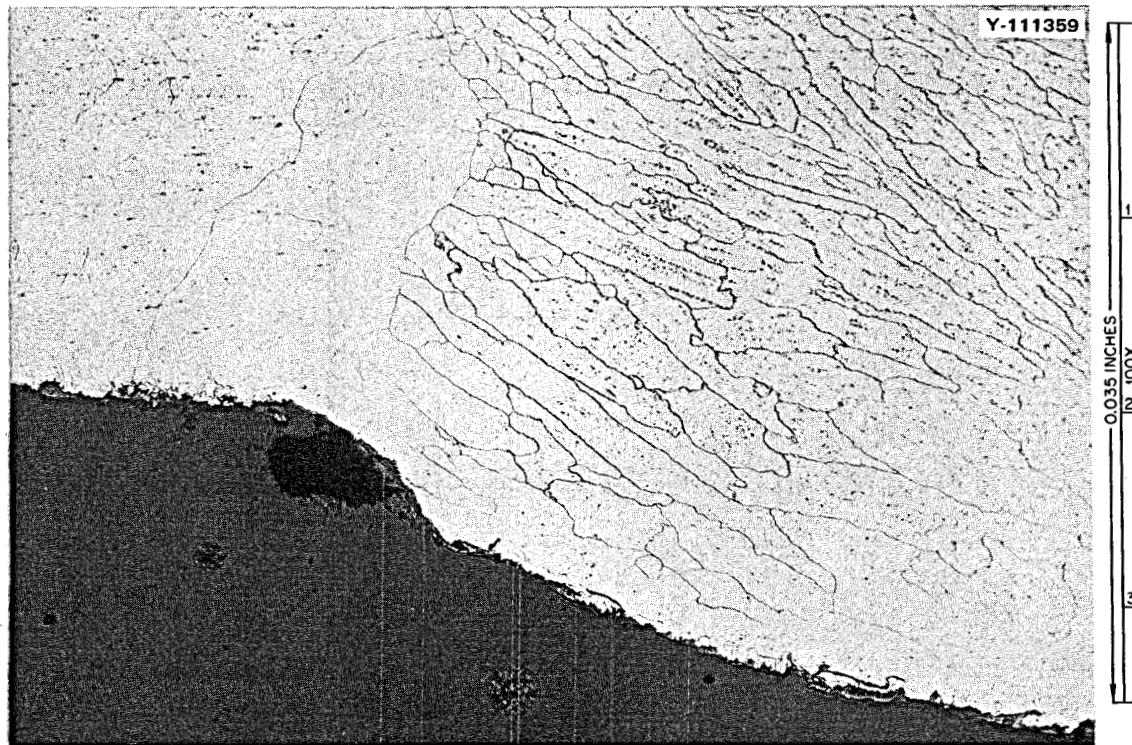
Fig. 34. Microstructure of weld joining two pieces of Hastelloy N tubing, exposed to salt at 580°C. Etched with glyceria regia.

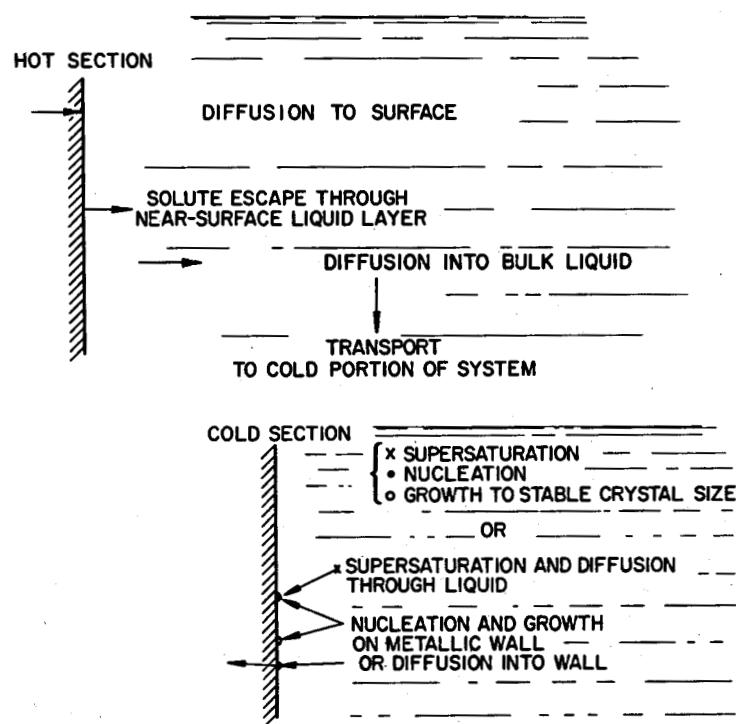
ORNL-DWG 67-6800R

Fig. 35. Temperature-gradient mass transfer.

corrosion-product concentration in the circulating salt continues until the amount of chromium returning to the walls exactly balances the amount of chromium entering the system in the hot-leg regions. Under these conditions, the two positions of the loop at equilibrium with the salt, termed the "balance point," do not shift measurably with time. Thus, a quasi-steady-state situation is eventually achieved whereby chromium is transported at very low rates and under conditions of a fixed chromium surface concentration at any given loop position. A schematic of this mass transfer process is shown in Fig. 35. Our results in this experiment show material loss in the hot portions of the loop and material deposition in the cold portion.

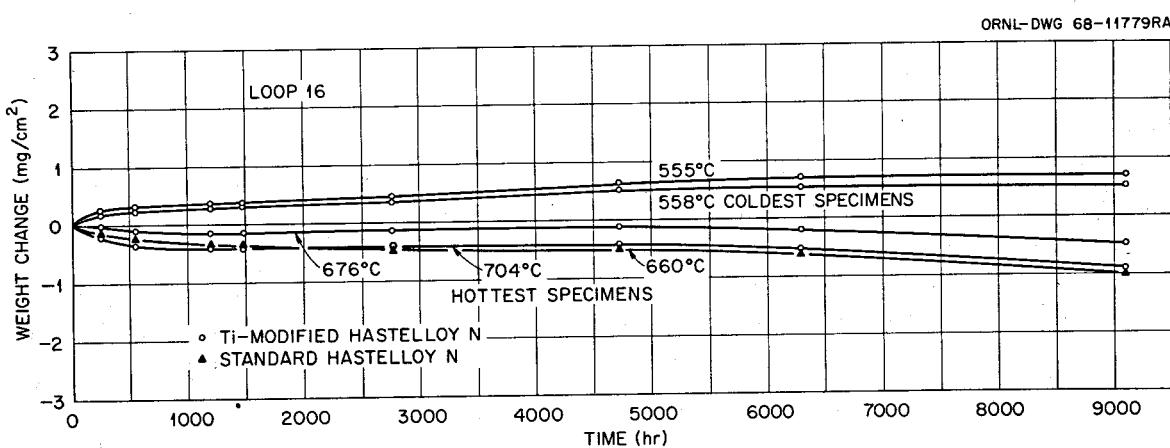
Figure 37 shows quantitative mass transfer data during 9000 hr of operation for a standard Hastelloy N-LiF-34.0 mole % BeF₂-0.5 mole % UF₄ thermal convection loop system (NCL-16) which operated at a maximum temperature of 700°C and a minimum temperature of 540°C. This loop operated an additional

Fig. 37. Weight change vs time for standard and titanium-modified specimens in loop NCL-16, exposed to fuel salt (LiF-34.0 mole % BeF_2 -0.5 mole % UF_4) at various temperatures.

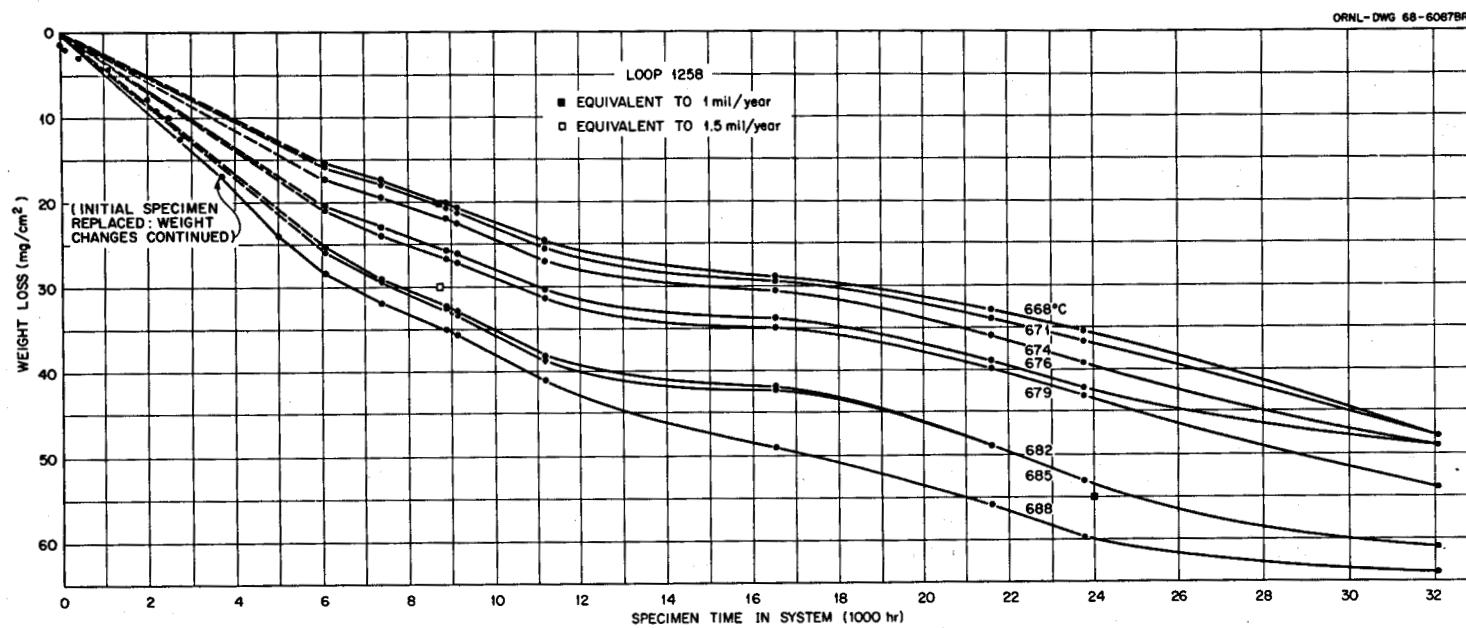
A thermal convection loop of type 304L stainless steel has contained salt from the same batch as loop 1255 for over eight years at a maximum temperature of 688°C and a minimum temperature of 588°C. A plot of the weight change of specimens in the loop as a function of time and temperature is given in Fig. 38. These specimens were placed in the loop after the loop had operated three years. Figure 39 shows the voids formed in the specimen exposed at 688°C for 5700 hr. Microprobe analyses of this specimen disclosed an appreciable chromium gradient for 1.2 mils.

Fig. 38. Weight loss of type 304L stainless steel specimens as a function of operation time at various temperatures in LiF-23 mole % BeF₂-5 mole % ZrF₄-1 mole % ThF₄-1 mole % UF₄ salt.

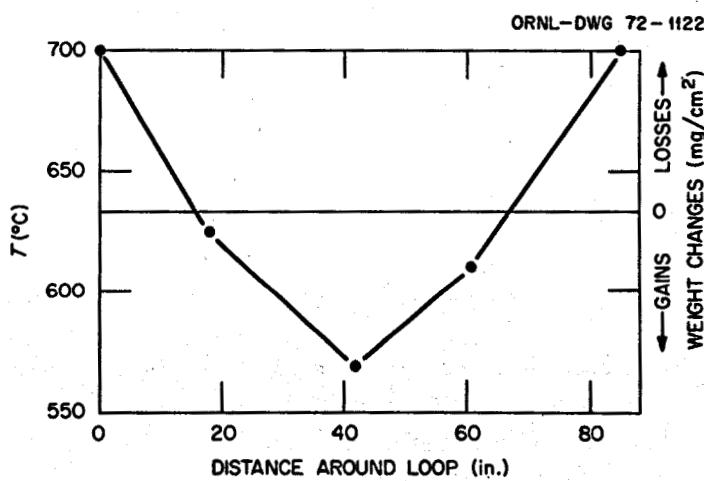
The schematic temperature profile of loop 1255 as a function of loop position is shown in Fig. 40. The points are actual measured temperatures at certain positions. On the right-hand ordinate scale the probable regions of weight loss and weight gain based on mass transfer theory and quantitative data from loops such

Fig. 40. Temperature profile and mass transfer schematic.

as those discussed previously are noted. Positions (temperatures) above the zero line will probably lose material, while those below will gain material.

and results schematically represented in Fig. 40, this means we could expect a maximum depletion of 4.4 mils at the hottest position at the top of the hot leg, 700°C, decreasing to zero at 630°C. We have assumed that all positions at temperatures below 630°C gain weight.

Micrographs of the inside surfaces of insert specimens and loop tubing that were exposed to the salt disclose regions of both material loss and gain. In most cases the micrographs agree with the calculations and with Fig. 40. Fewer voids were seen in the regular Hastelloy N than the Hastelloy N modified with 2% Nb; however, the temperatures were different, so no definite statement can be made comparing the compatibility of these two alloys. The concentration of chromium corrosion product in the salt was never large enough to cause precipitation in the cold leg, so no plugging trends were ever noted.
