Report Date:2024-04-15 00:00:00Source Room:2nd Floor Bed 3Test Date:2024-04-04 00:00:00Receiver Room:1st Floor Bed 2DLAA Test No1.3.1Test Assembly:Floor-ceiling

ASTM E336-20 Standard Test Method for Measurement of Airborne Sound Attenuation between Rooms in Buildin

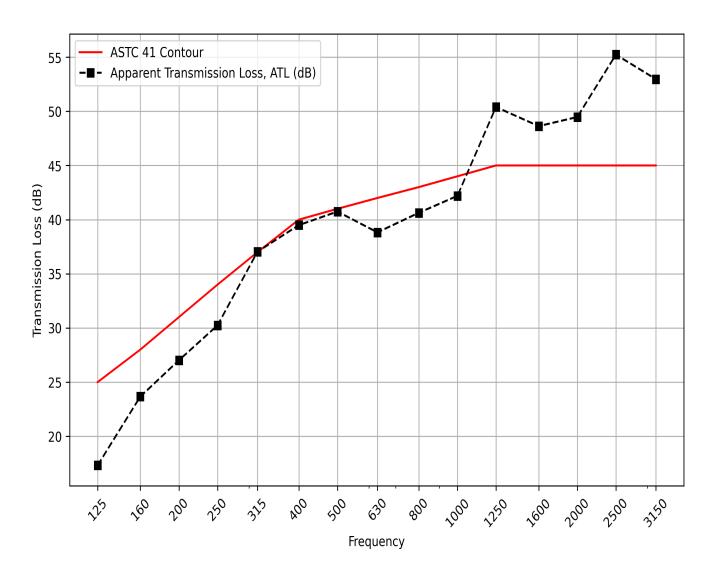
The Apparent Sound Transmission Class (ASTC) of 41 was calculated. The ASTC rating is based on Apparent Transmission Loss (ATL), and includes the effects of noise flanking. The ASTC reference contour is shown on the next page, and has been "fit" to the Apparent Transmission Loss values, in accordance with the procedure of ASTC Test Procedure ASTM E336-16
