Report Date:2024-04-15 00:00:00Source Room:2nd Floor Bed 1Test Date:2024-04-04 00:00:00Receiver Room:1st Floor Bed 1DLAA Test No1.4.1Test Assembly:Floor-ceiling

STATEMENT OF TEST RESULTS:

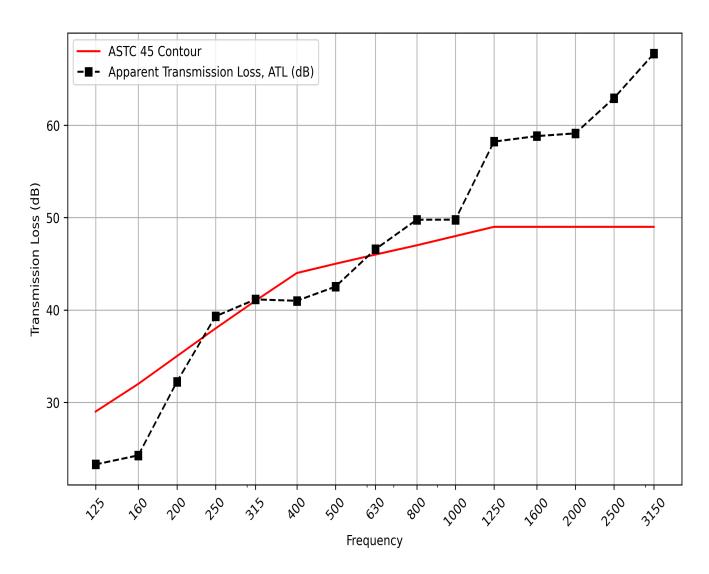
The Apparent Sound Transmission Class (ASTC) of 45 was calculated. The ASTC rating is based on Apparent Transmission Loss (ATL), and includes the effects of noise flanking. The ASTC reference contour is shown on the next page, and has been "fit" to the Apparent Transmission Loss values, in accordance with the procedure of ASTC Test Procedure ASTM E336-16
