Report Date: 2024-04-15 00:00:00 Source Room: 2nd Floor Kitchen

Test Date: 2024-04-04 00:00:00 **Receiver Room:** 1st Floor Great Room/Kitchen

DLAA Test No 1.2.1 Test Assembly: Floor-ceiling

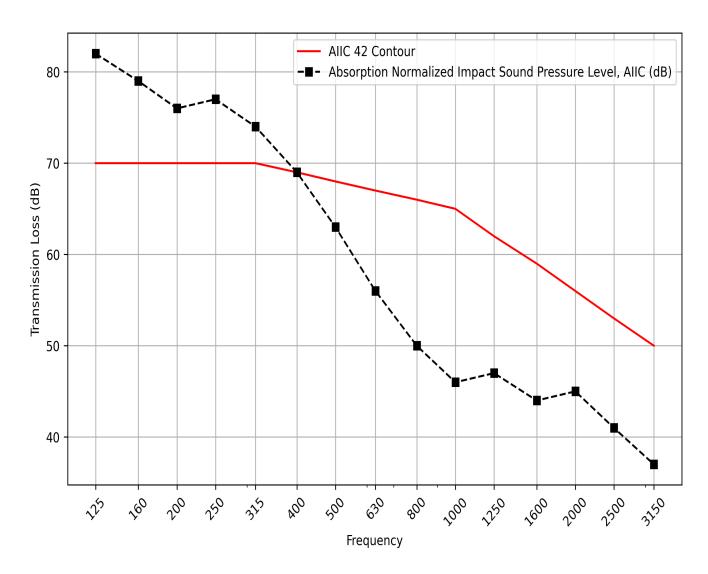
The Apparent Impact Insulation Class (AIIC) was calculated. The AIIC rating is based on Absorption Normalized Impact Sound Pressure Level (ANISPL), and includes the effects of noise flanking. The AIIC reference contour is shown on the next page, and has been "fit" to the Absorption Normalized Impact Sound Pressure Level values, in accordance with the procedure of ASTC Test Procedure ASTM E336-16 The results stated in this report represent only the specific construction and acoustical conditions present at the time of the test. Measurements performed in accordance with this test method on nominally identical constructions and acoustical conditions may produce different results.
