Report Date:2024-04-15 00:00:00Source Room:2nd Floor Bed 3Test Date:2024-04-04 00:00:00Receiver Room:1st Floor Bed 2DLAA Test No1.3.1Test Assembly:Floor-ceiling

### **STATEMENT OF TEST RESULTS:**

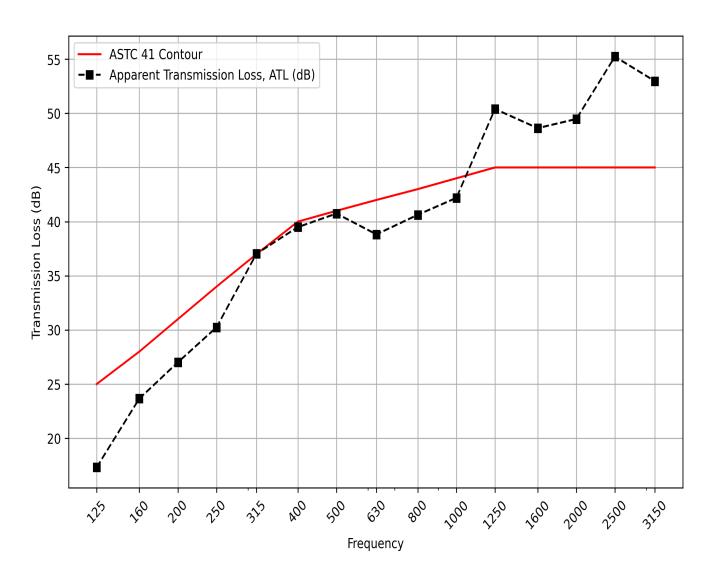
The Apparent Sound Transmission Class (ASTC) of 41 was calculated. The ASTC rating is based on Apparent Transmission Loss (ATL), and includes the effects of noise flanking. The ASTC reference contour is shown on the next page, and has been "fit" to the Apparent Transmission Loss values, in accordance with the procedure of ASTC Test Procedure ASTM E336-16
