# Reverse Engineering a High-Temperature Heat Shield for Interstellar Propulsion Using Blue Light Scanning: Applications of 3D Scanning in Polygonal Geometry

Philip Wang, Atholton High School  
Mentored by Mr. Michael Boyle (REDD/R1H)

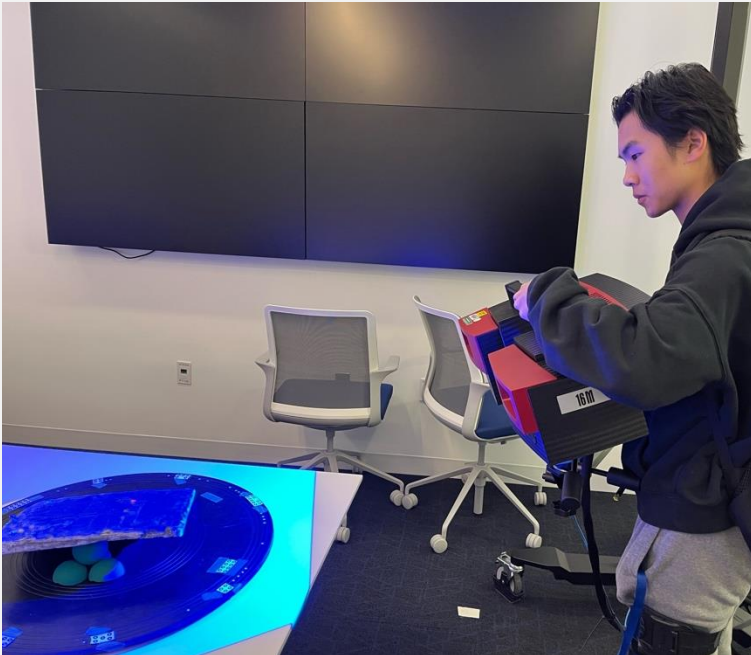
Using the ATOS camera to scan the heat shield in the ideal setup.
