PetroChem

**INTERNAL / EXTERNAL AND ULTRASONIC
POST REPAIR TANK INSPECTION REPORT
FOR
BENGAL PIPELINE COMPANY
TANK 125
JACKSON, LOUISIANA
JUNE 13, 2013
DECEMBER 2, 2013 (POST REPAIR)
AND
APRIL 21, 2014 (FINAL INSPECTIOn)**

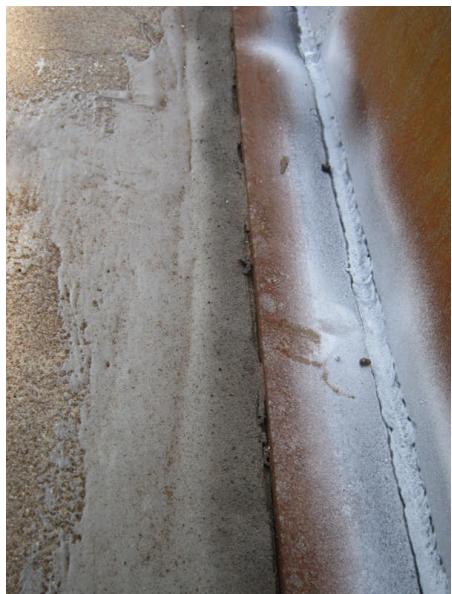
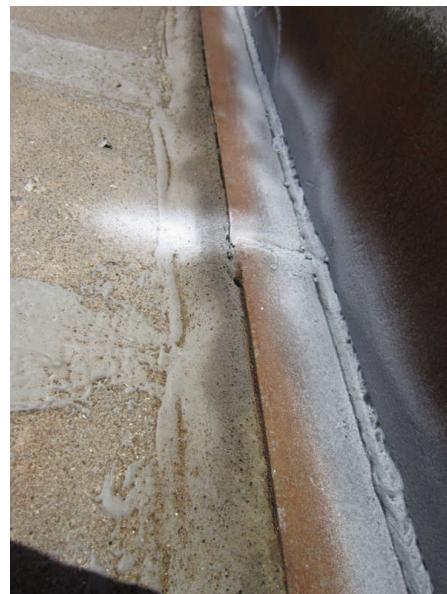
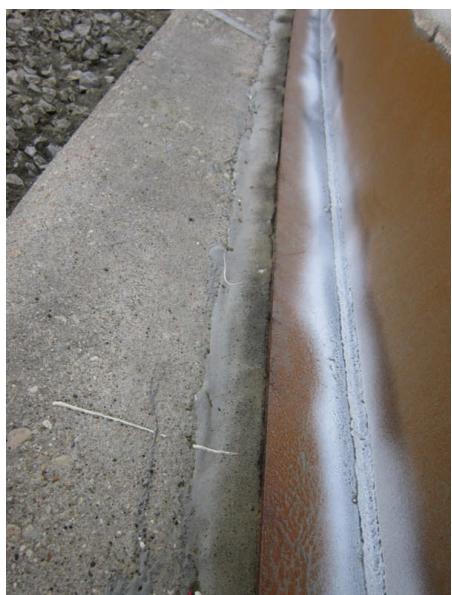
ITEM 11 / COND. CODE 3 (Initial Inspection June 13, 2013) / ITEM 11 / COND. CODE 3 (Post Repair Inspection December 2, 2013) / ITEM 11 / COND. CODE 4 (Final Inspection April 21, 2014): The moisture barrier was deteriorated (disbonding). Consideration should be given to installing an appropriate moisture barrier to seal against water intrusion under the tank bottom.

001 Deteriorated Moisture Barrier

002 Deteriorated Moisture Barrier

003 Deteriorated Moisture Barrier

POST REPAIR: A new moisture barrier was installed and found to be acceptable.
--

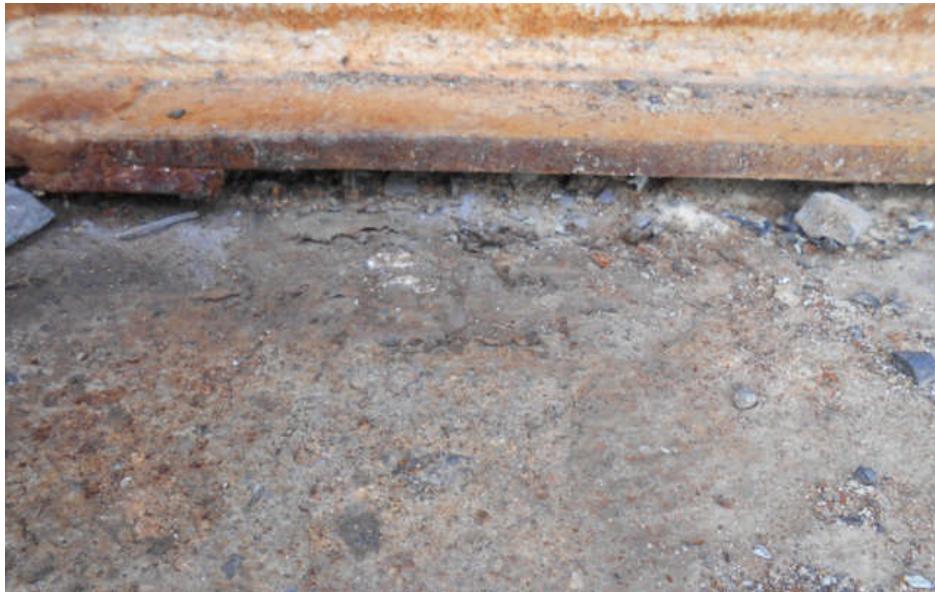
001 Deteriorated Moisture Barrier

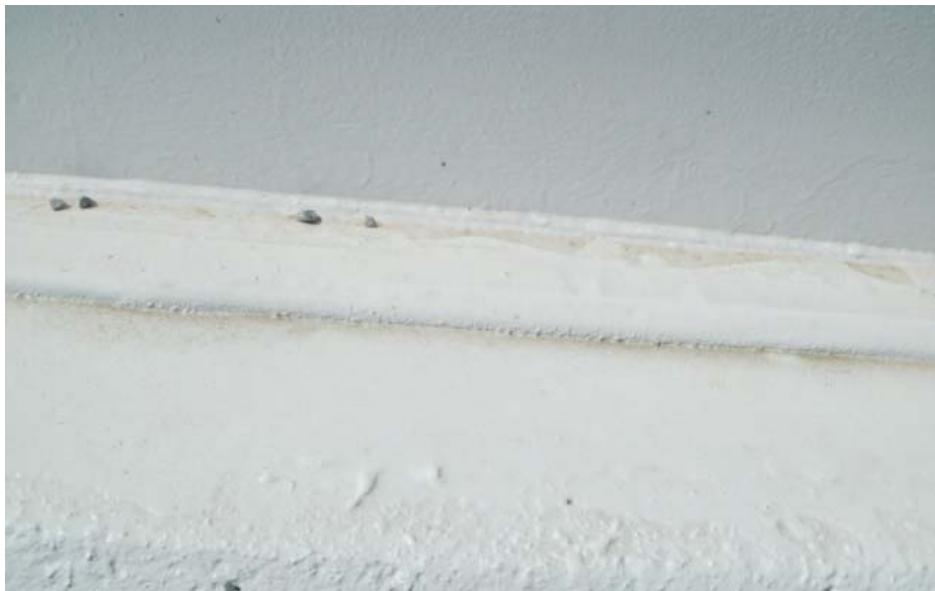
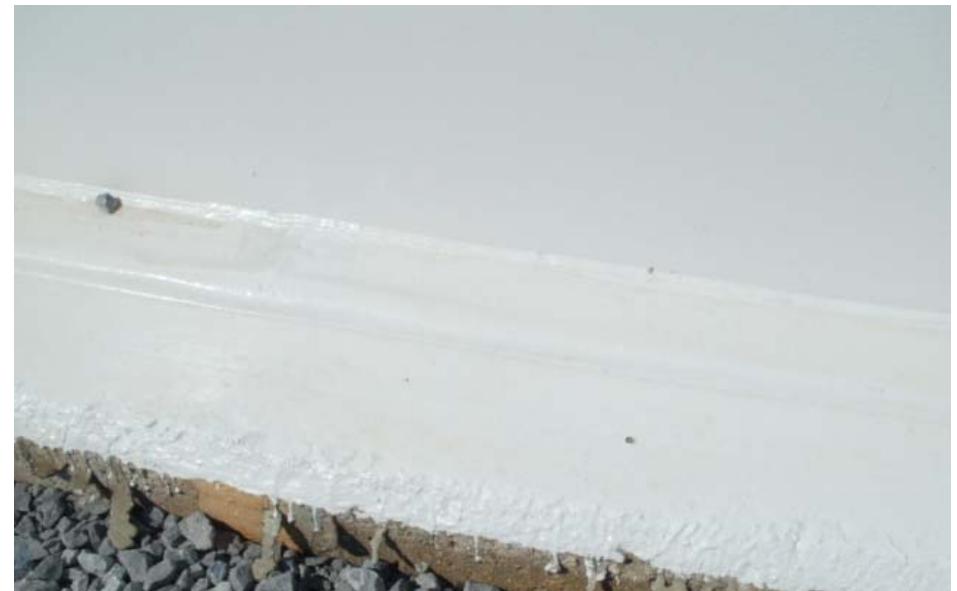
001 New Moisture Barrier

002 New Moisture Barrier

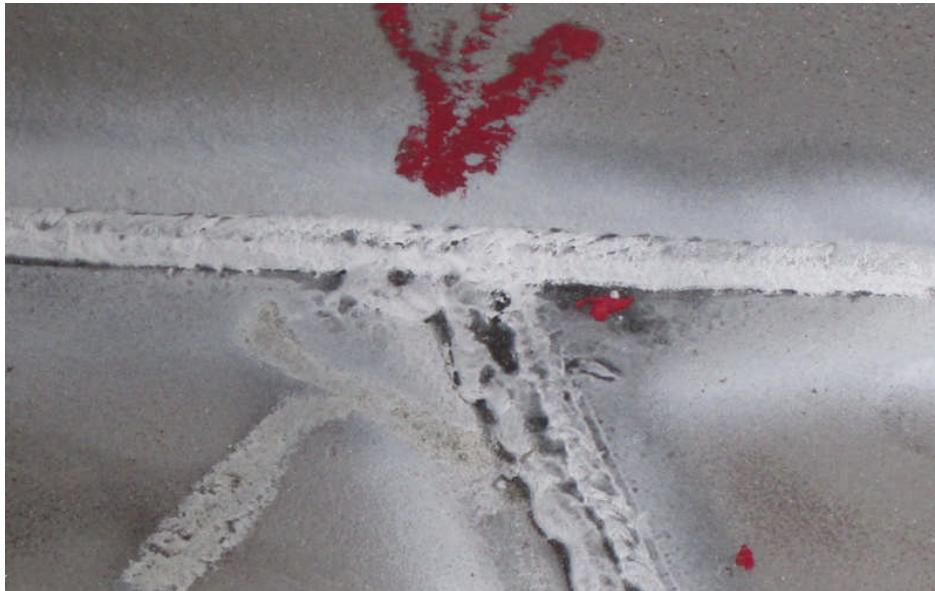
ITEM 118 / COND. CODE 3 (Initial Inspection June 13, 2013) / ITEM 118 / COND. CODE 4 (Post Repair Inspection December 2, 2013): Magnetic Particle (MT) inspection was performed on the internal shell-to-bottom weld and sump weld and revealed two (2) weld defects (pinholes) in the internal shell-to-bottom weld. One (1) weld defect is located between Bottom Plates 156 and 158 and the other is located on the lap weld adjacent to the internal shell-to-bottom weld between Bottom Plates 81 and 114. Consideration should be given to repairing these areas using approved welding and NDE procedures per API 653 guidelines.

005 Weld Defect in Internal Shell-to-Bottom Weld

POST REPAIR: A new bottom and annular ring were installed and found to be acceptable. All required NDE was performed by Capitol Ultrasonics & CAPE.
--

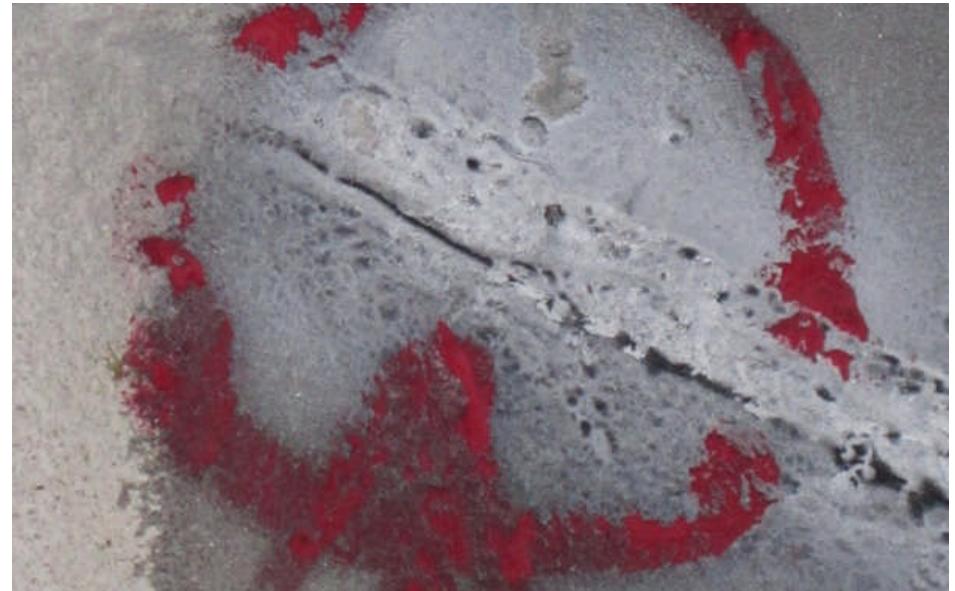
006 Weld Defect in Lap Weld

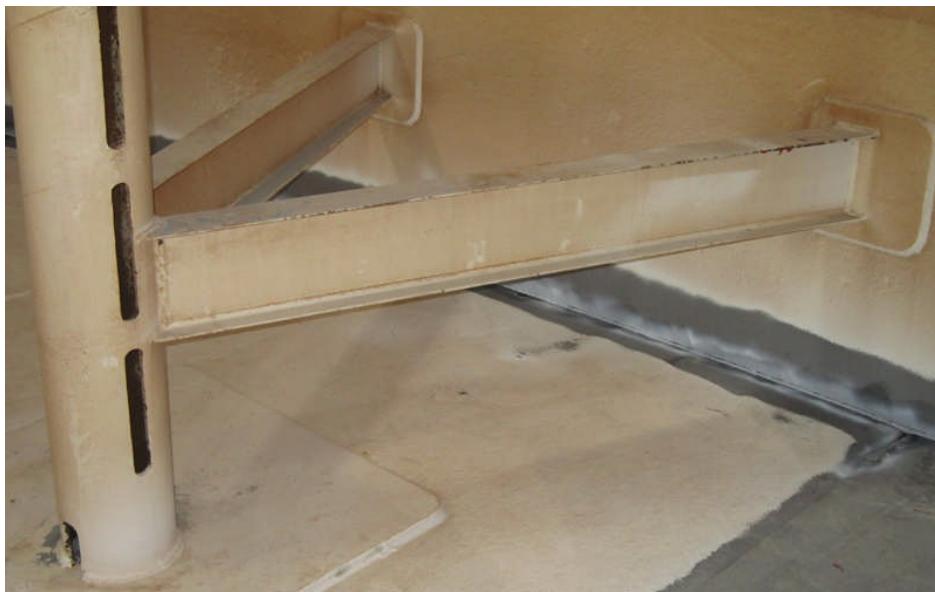
ITEM 141 / COND. CODE 2 (Initial Inspection June 13, 2013) / ITEM 141 / COND. CODE 4 (Post Repair Inspection December 2, 2013): The gauge pole is welded to reinforcing plates that are welded to the shell and to a bearing plate that is welded to the tank bottom. This results in the gauge pole being rigidly connected to the bottom. Consideration should be given to modifying these details to prevent stress on the bottom plates.

007 Gauge Pole Rigidly Supported

POST REPAIR: The gauge pole was removed at the time of the post repair inspection.

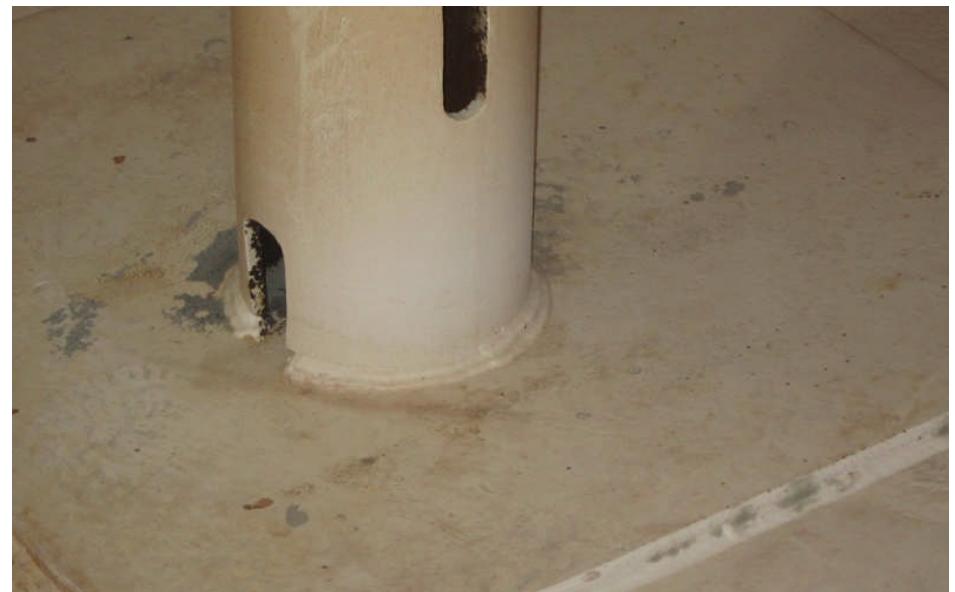
008 Gauge Pole Welded to Bottom

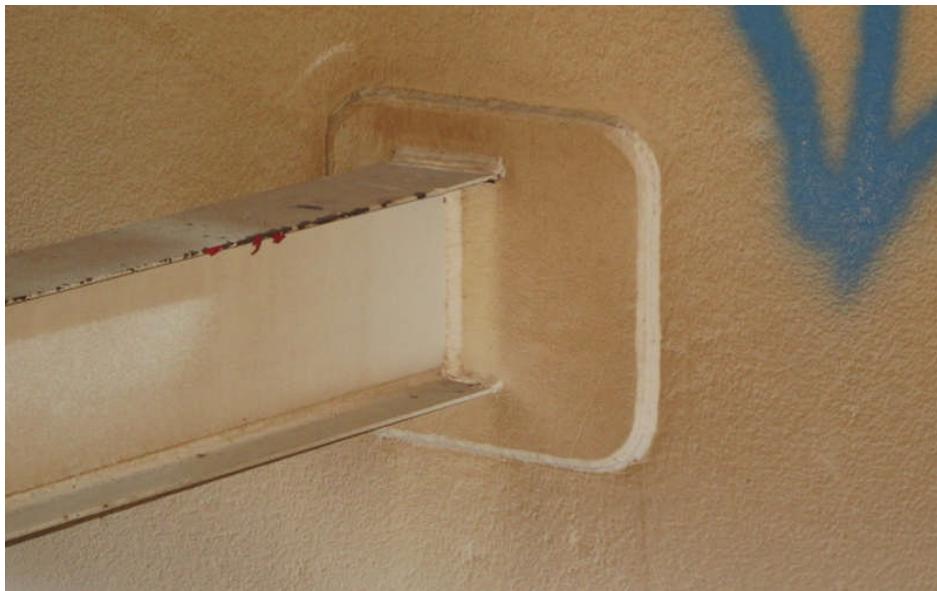
009 Gauge Pole Welded to Shell

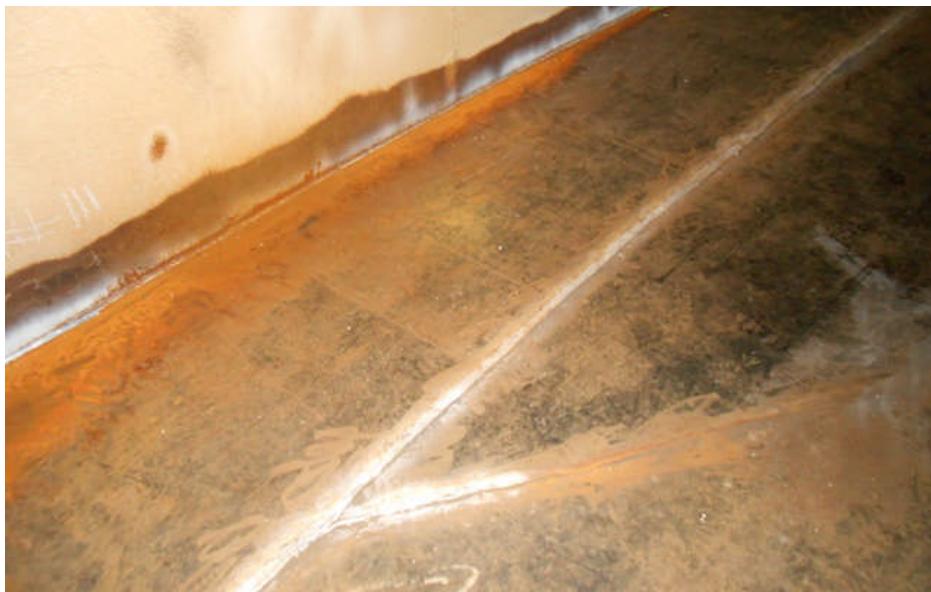
001 New Annular Ring

POST REPAIR: A new bottom and annular ring were installed and found to be acceptable. All required NDE was performed by Capitol Ultrasonics & CAPE.
--

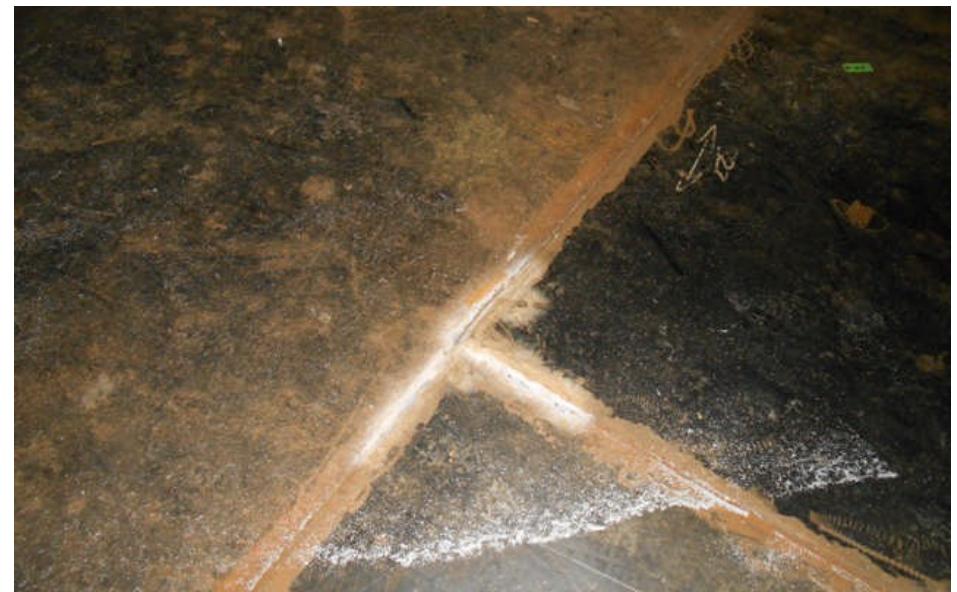
002 New Annular Ring

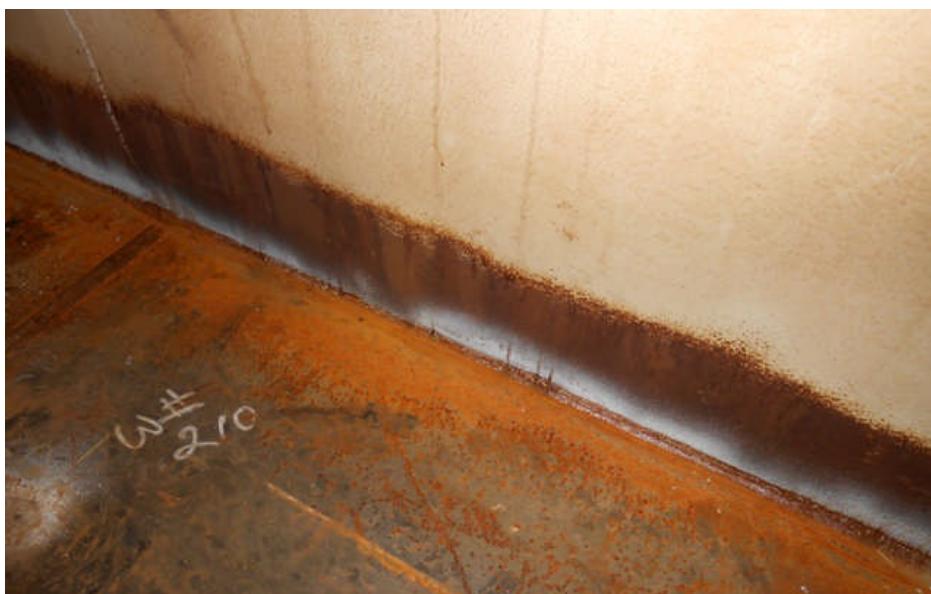
003 New Annular Ring

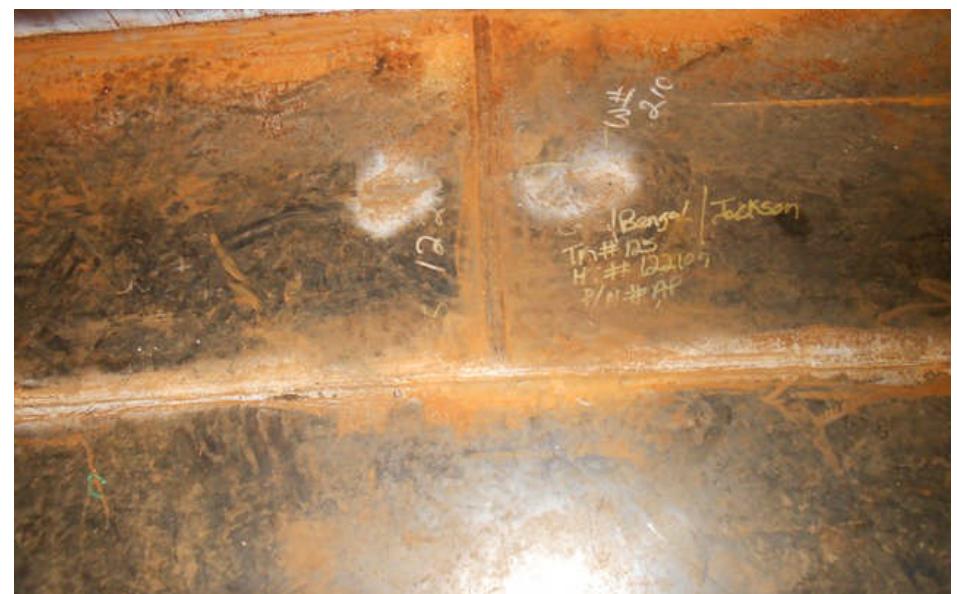
004 New Annular Ring

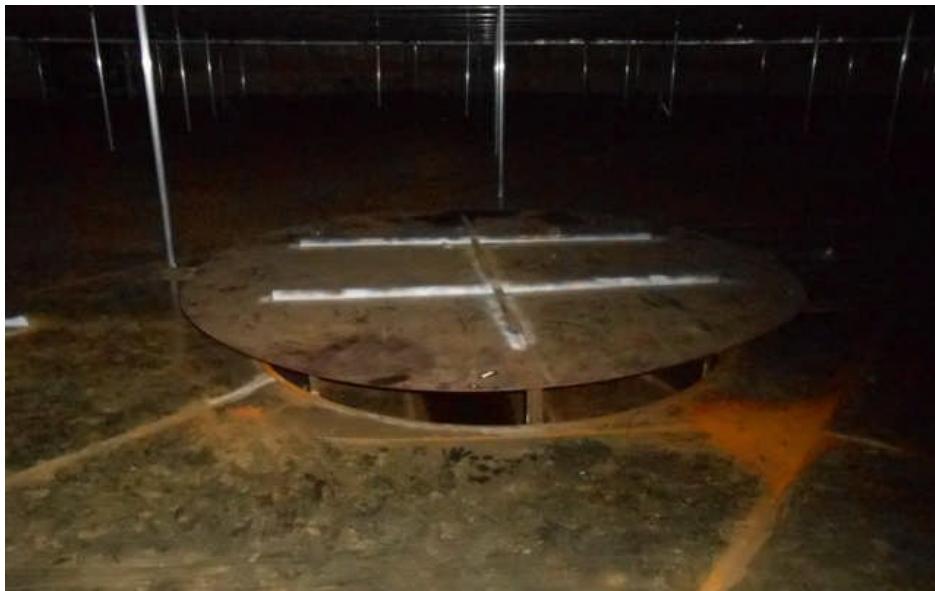
005 New Sump

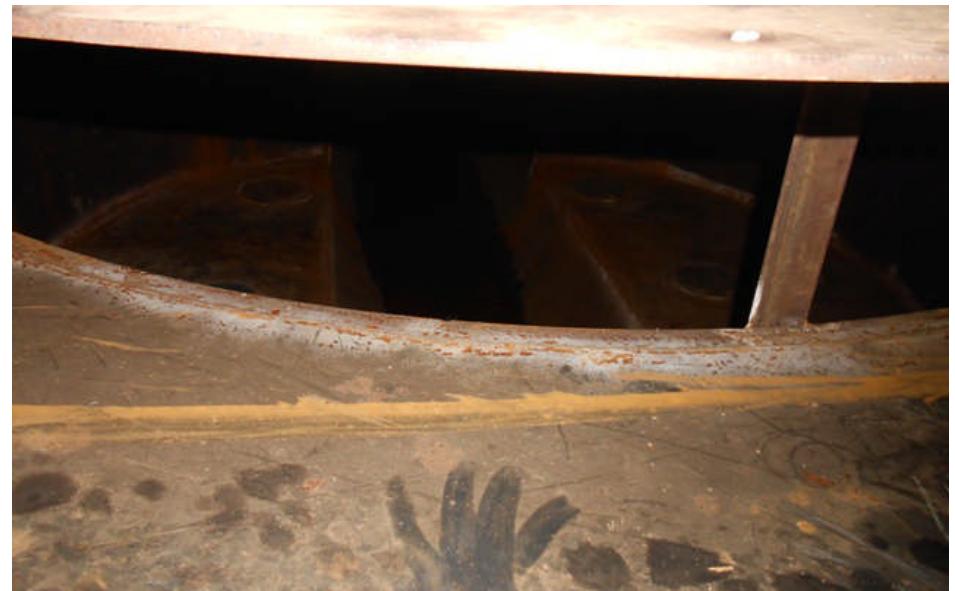
006 New Sump

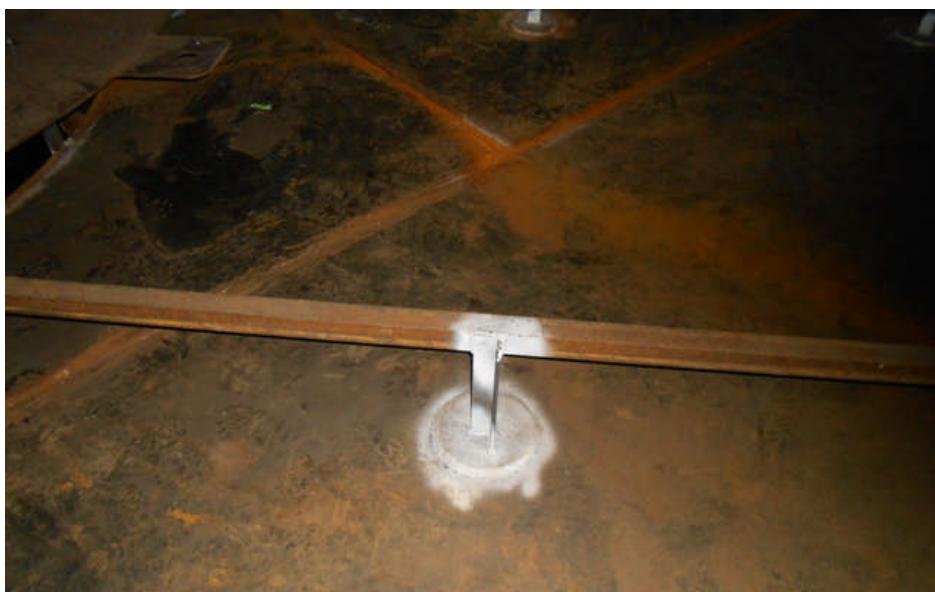
007 New Piping Support

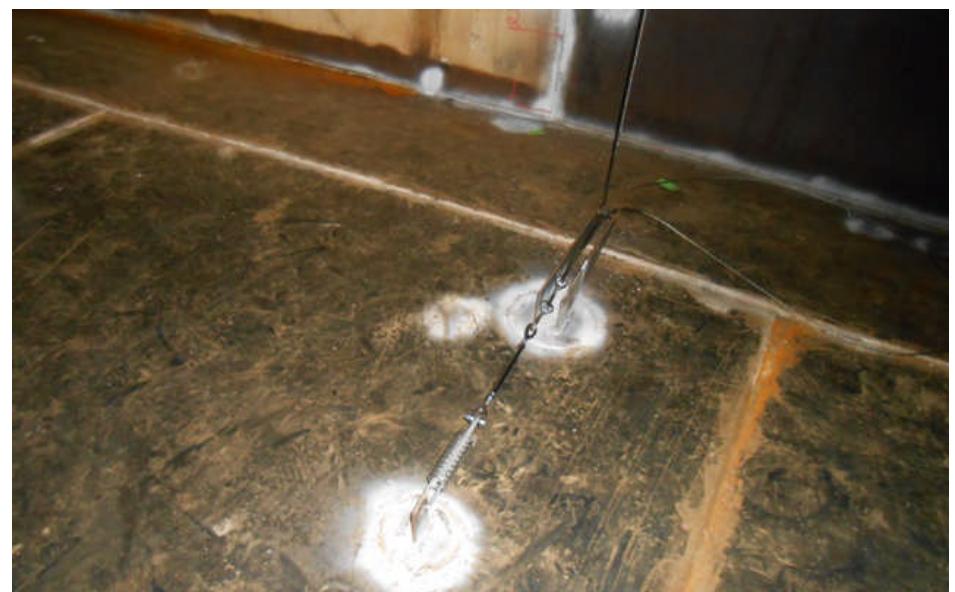
008 New Anti-Rotation

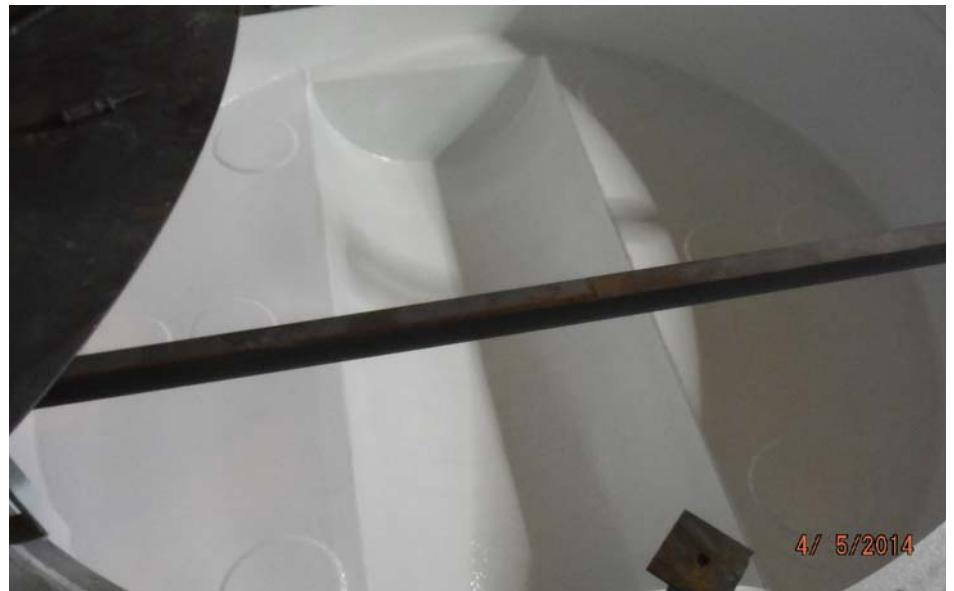
006 New Sump

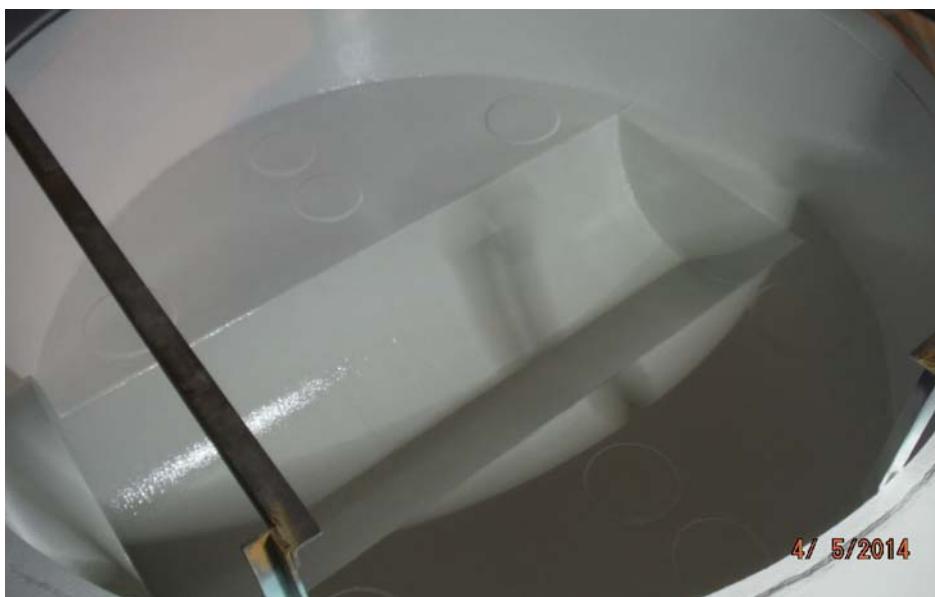
007 New Sump

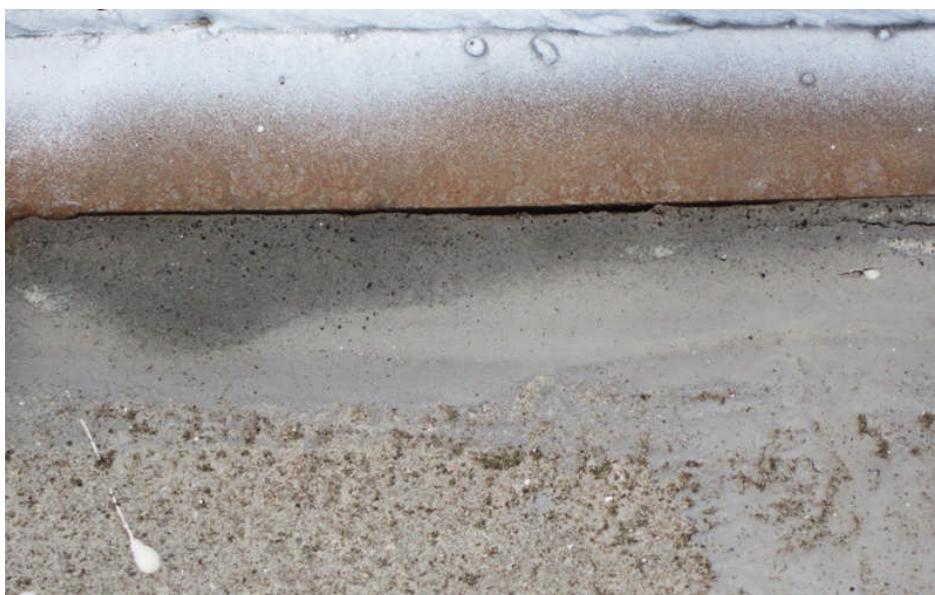
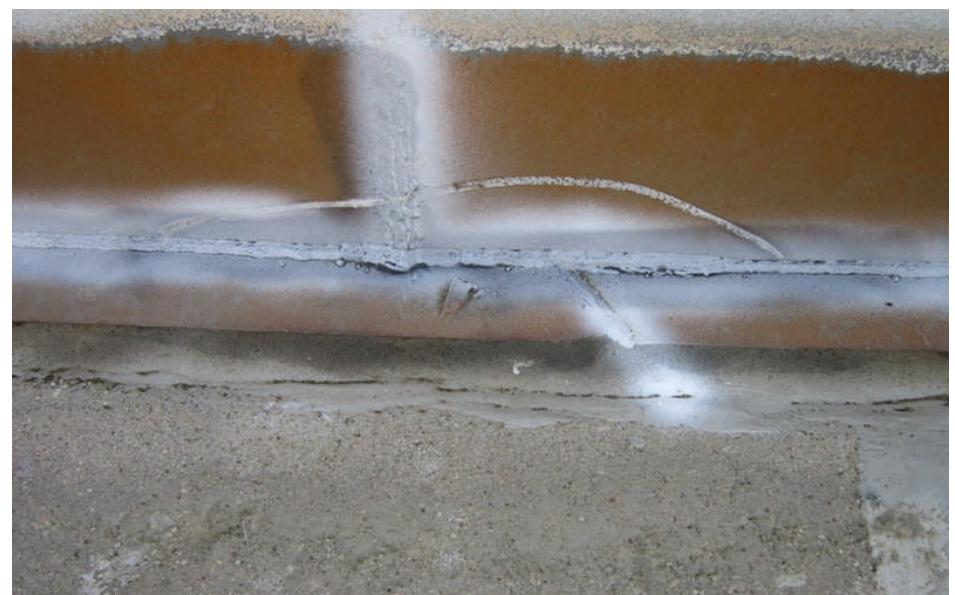
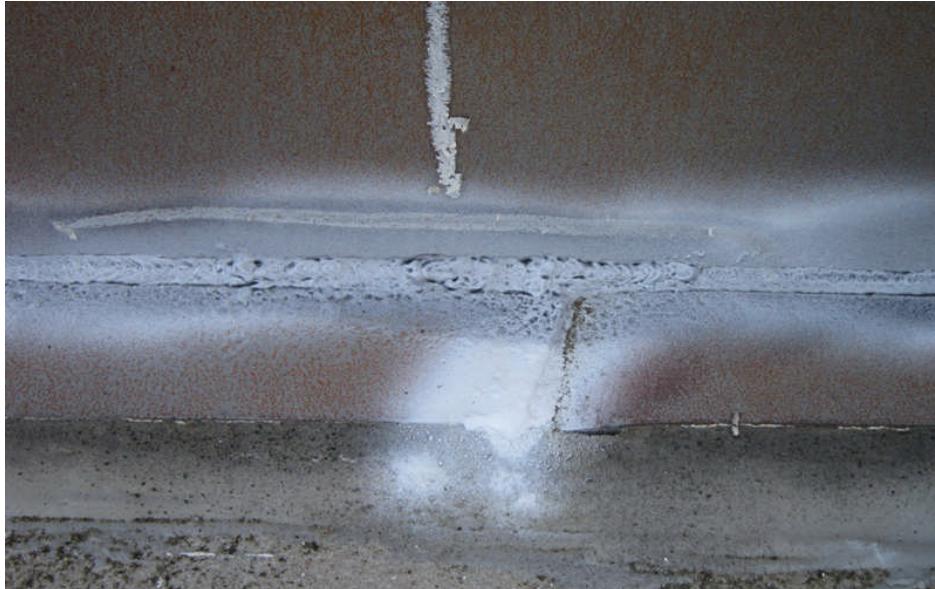
ITEMS 17 & 19 / COND. CODE 3 (Initial Inspection June 13, 2013) / ITEMS 17 & 19 / COND. CODE 4 (Post Repair Inspection December 2, 2013): Magnetic Particle (MT) inspection was performed on the external shell-to-bottom weld and wind girder-to-shell weld. There are fifty plus (50+) weld defects (undercut, pinholes and porosity) in the external shell-to-bottom weld and seventy plus (70+) weld defects (corrosion and pinholes) in the wind girder-to-shell weld. These areas have been marked on the tank. Consideration should be given to repairing these areas using approved welding and NDE procedures per API 653 guidelines.

007 Weld Defect in External Shell-to-Bottom Weld

008 Weld Defect in External Shell-to-Bottom Weld

009 Weld Defect in External Shell-to-Bottom Weld

POST REPAIR: A new bottom was installed and found to be acceptable. The wind girder-to-shell weld defects were repaired and found to be acceptable. All required NDE was performed by Capitol Ultrasonics & CAPE.
--

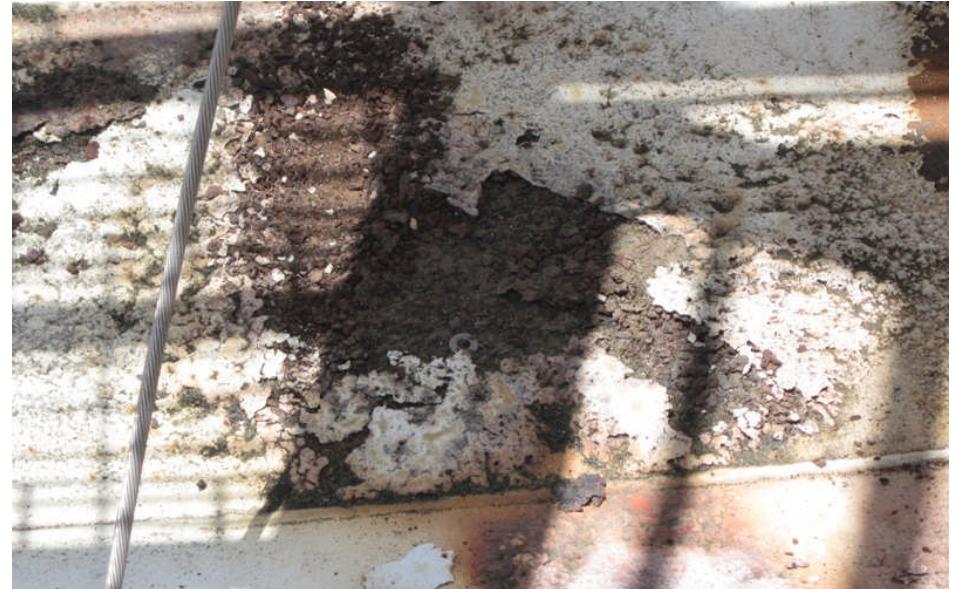
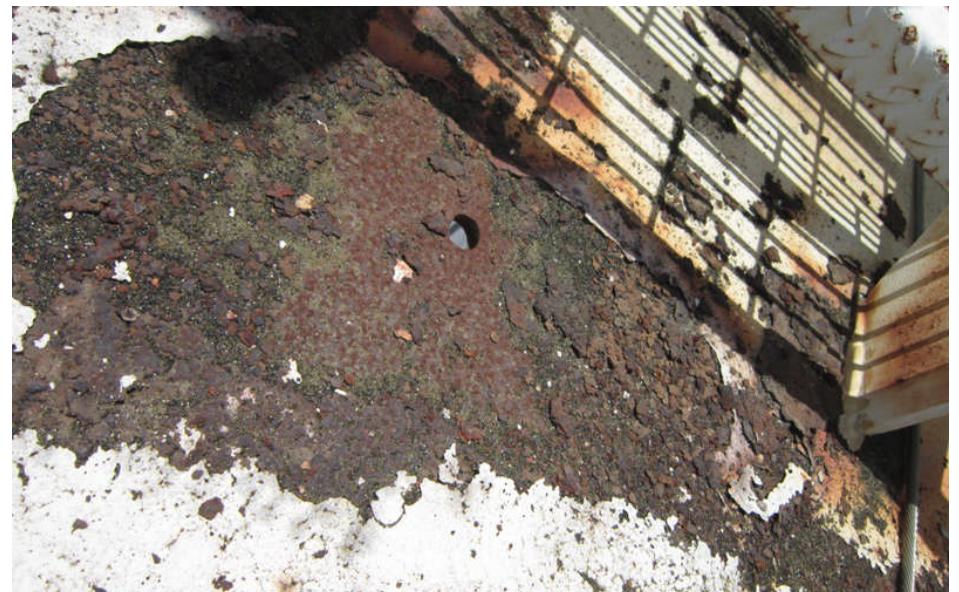
ITEMS 20, 31 & 50 / COND. CODE 3 (Initial Inspection June 13, 2013) / ITEMS 20, 31 & 50 / COND. CODE 3 (Post Repair Inspection December 2, 2013) / ITEMS 20, 31 & 50 / COND. CODE 4 (Final Inspection April 21, 2014): The external shell has coating failure (chalky) and mildew. The top side of the wind girder has coating failure with surface rust and corrosion. The underside of the wind girder has coating failure and mildew. The coating beneath the stair treads was sandblasted. Consideration should be given to properly cleaning and re-coating the entire shell.

010 Coating Failure and Corrosion on Wind Girder

011 Coating Failure and Corrosion on Wind Girder

012 Corrosion on Wind Girder

POST REPAIR: The wind girder was cleaned and re-coated. Additional drainage holes were installed in areas that were needed.
--

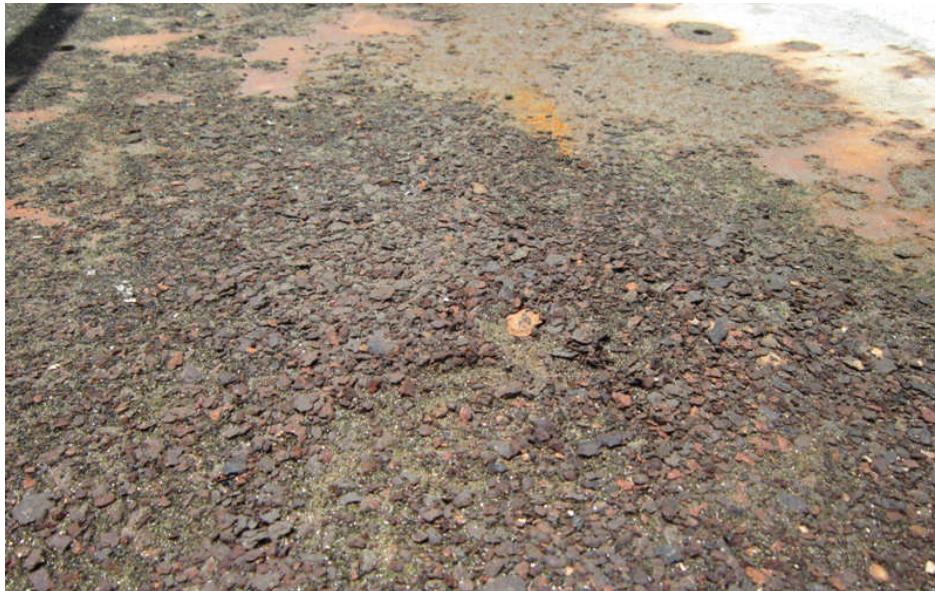
013 Scale on Wind Girder

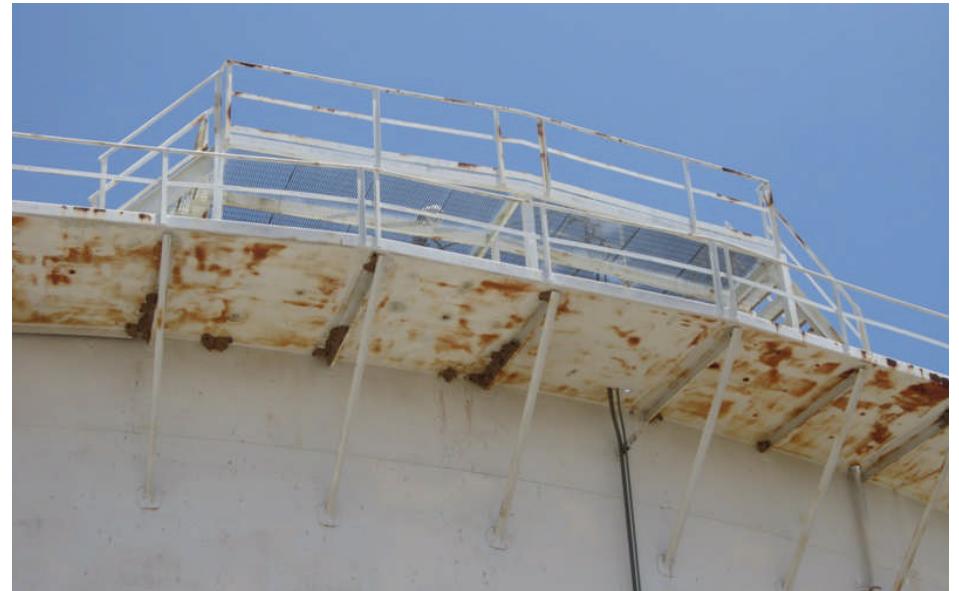
014 Coating Failure and Corrosion on Underside of Wind Girder

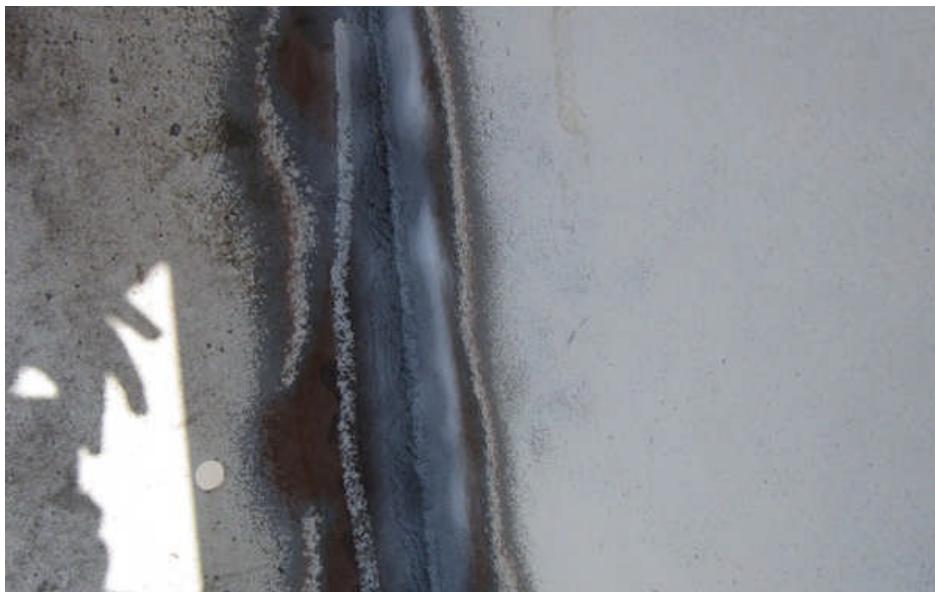
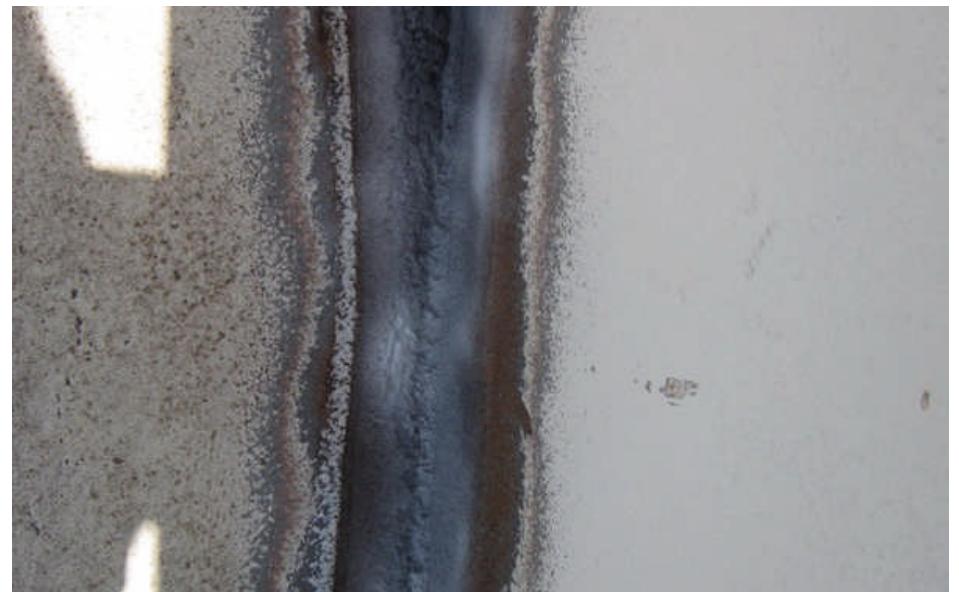
015 Weld Defects on Wind Girder-to-Shell Weld

016 Weld Defects on Wind Girder-to-Shell Weld

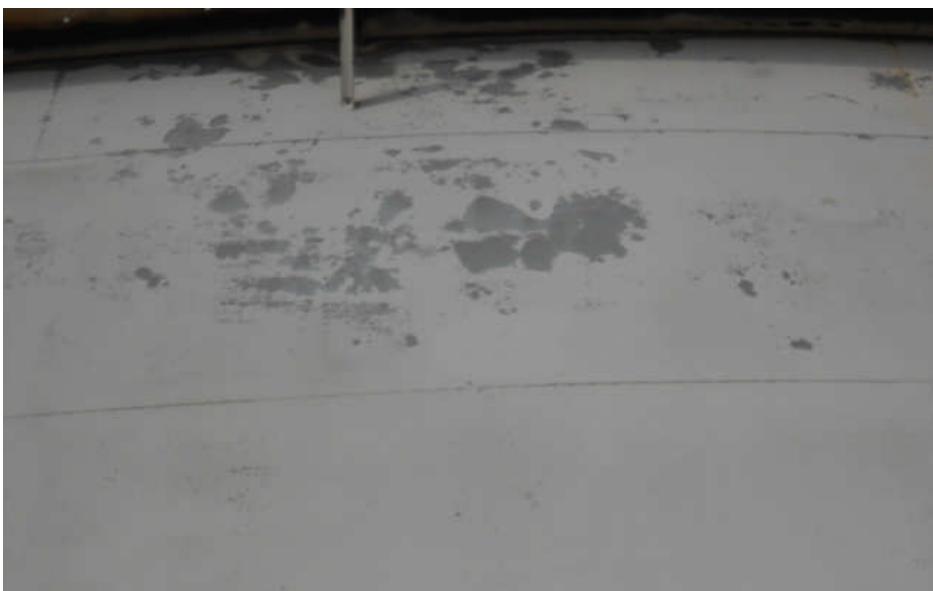
003 Coating Failure on Shell

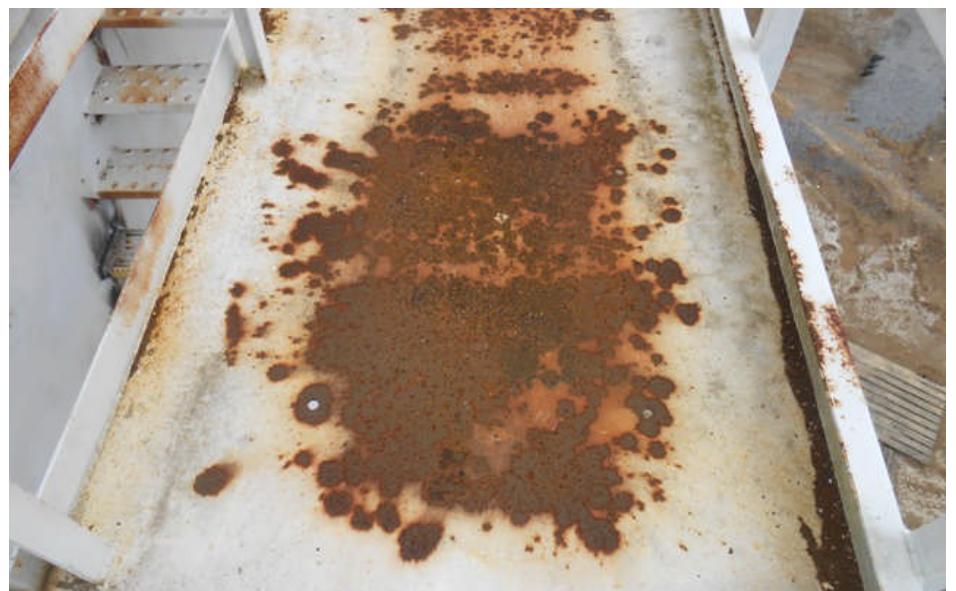
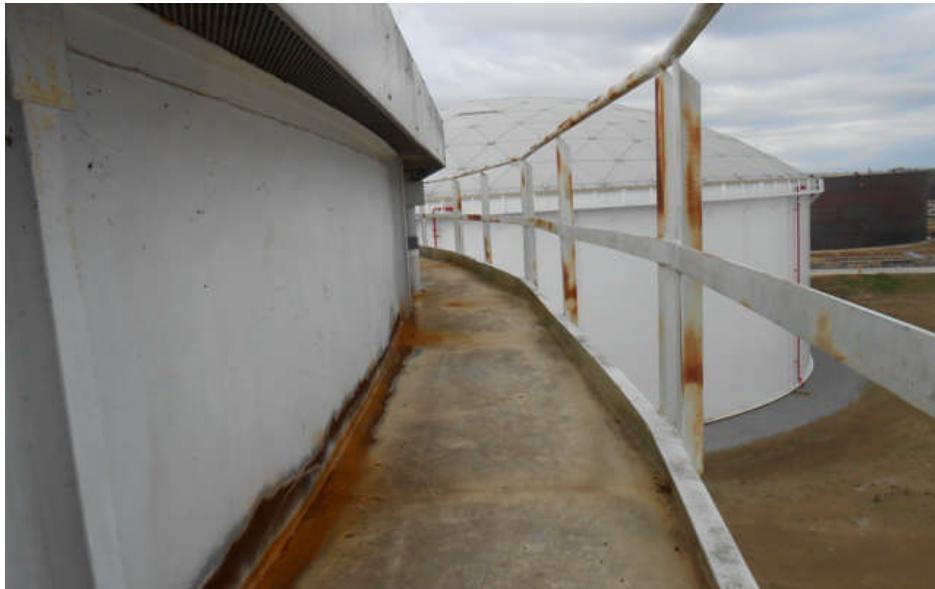
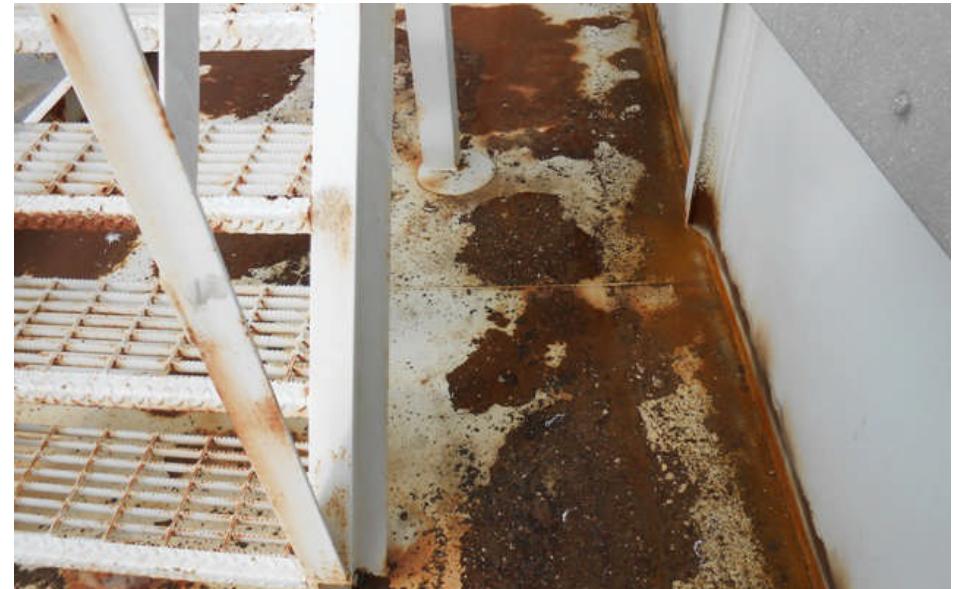
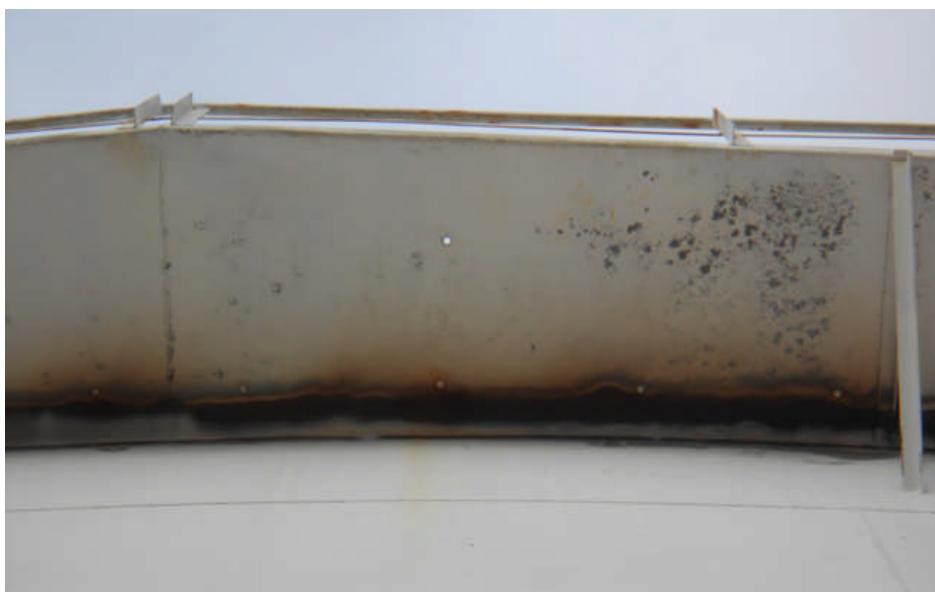
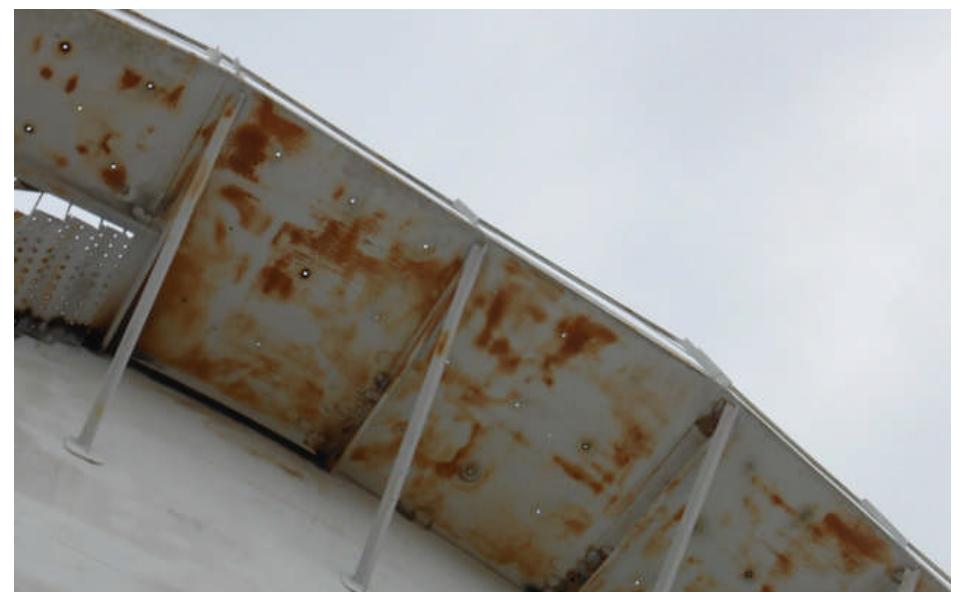
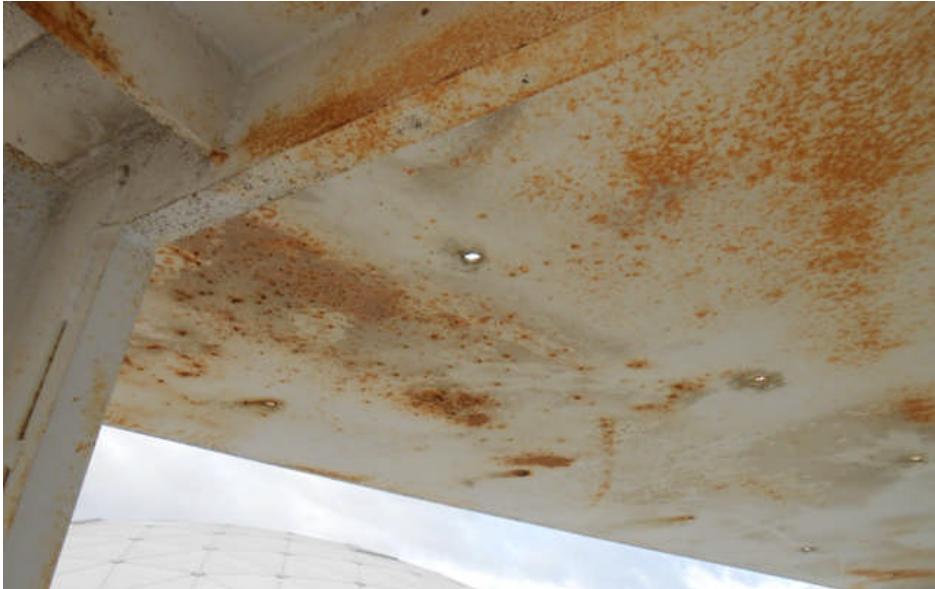
004 Coating Failure on Top Side of Wind Girder

005 Coating Failure on Top Side of Wind Girder

006 Coating Failure on Top Side of Wind Girder

007 Coating Failure on Underside of Wind Girder

008 Coating Failure on Underside of Wind Girder

009 Coating Failure on Underside of Wind Girder

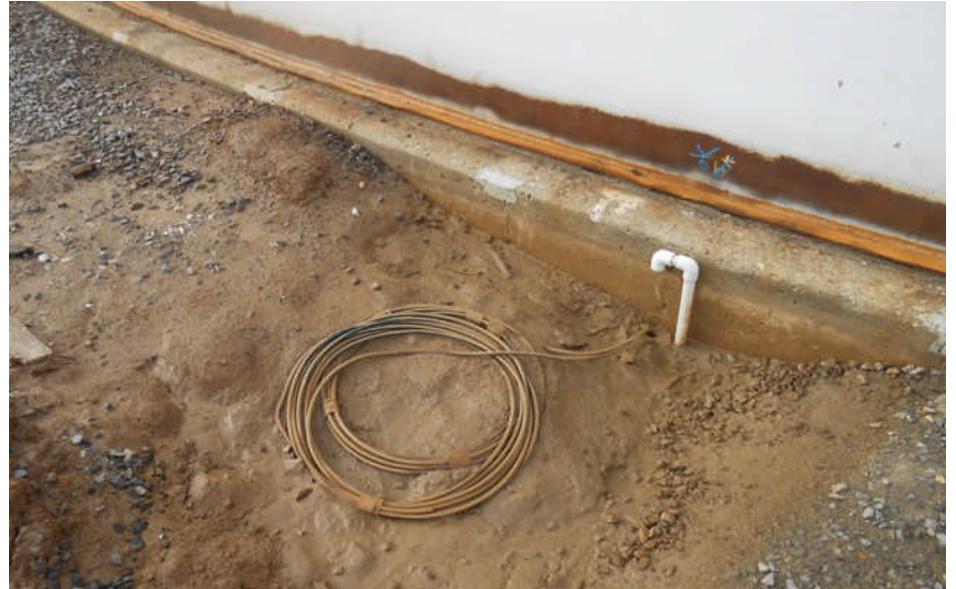
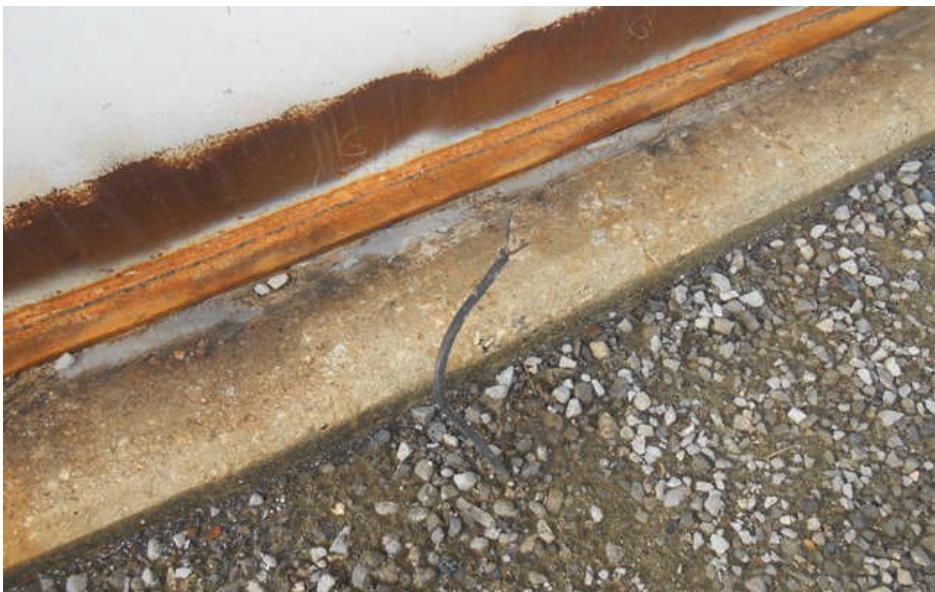
010 External Shell-to-Bottom Weld Repairs

011 External Shell-to-Bottom Weld Repairs
