PetroChem

**INTERNAL / EXTERNAL AND ULTRASONIC
POST REPAIR TANK INSPECTION REPORT
FOR
BENGAL PIPELINE COMPANY
TANK 125
JACKSON, LOUISIANA
JUNE 13, 2013
DECEMBER 2, 2013 (POST REPAIR)
AND
APRIL 21, 2014 (FINAL INSPECTIOn)**

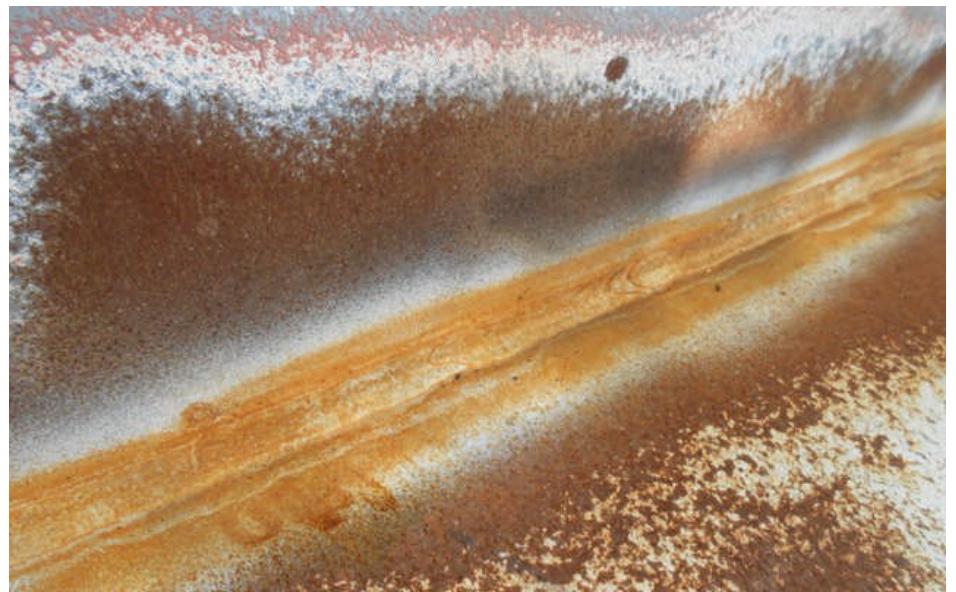
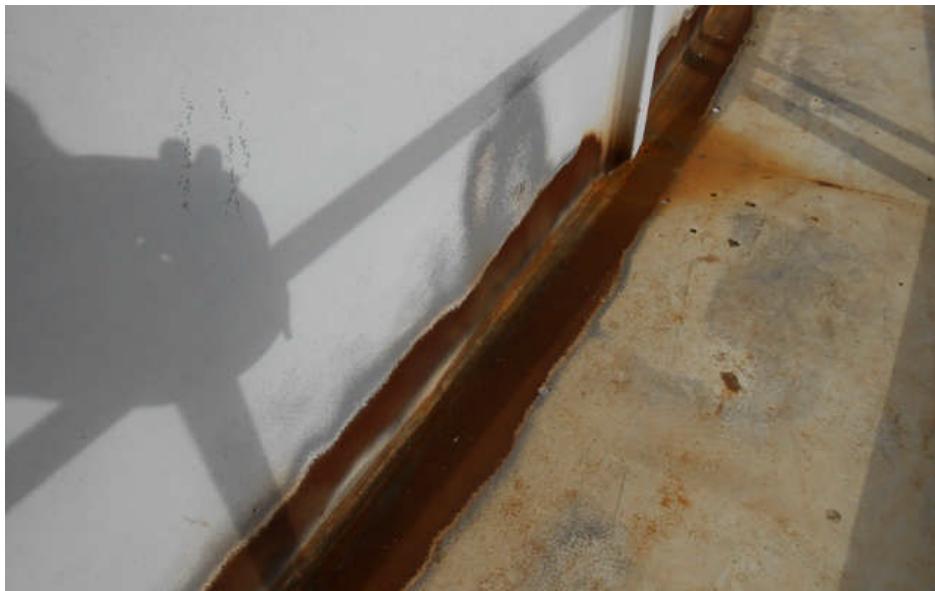
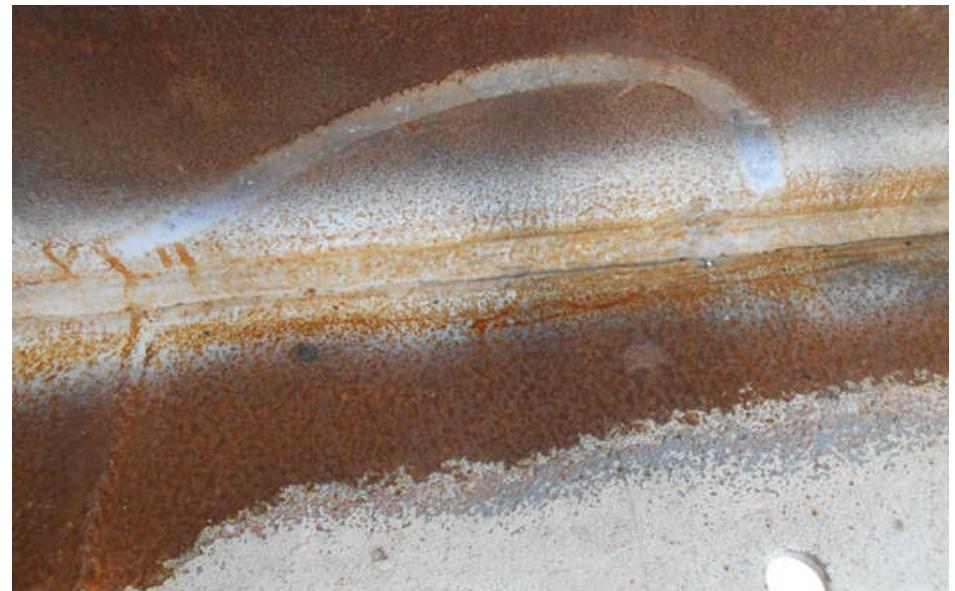
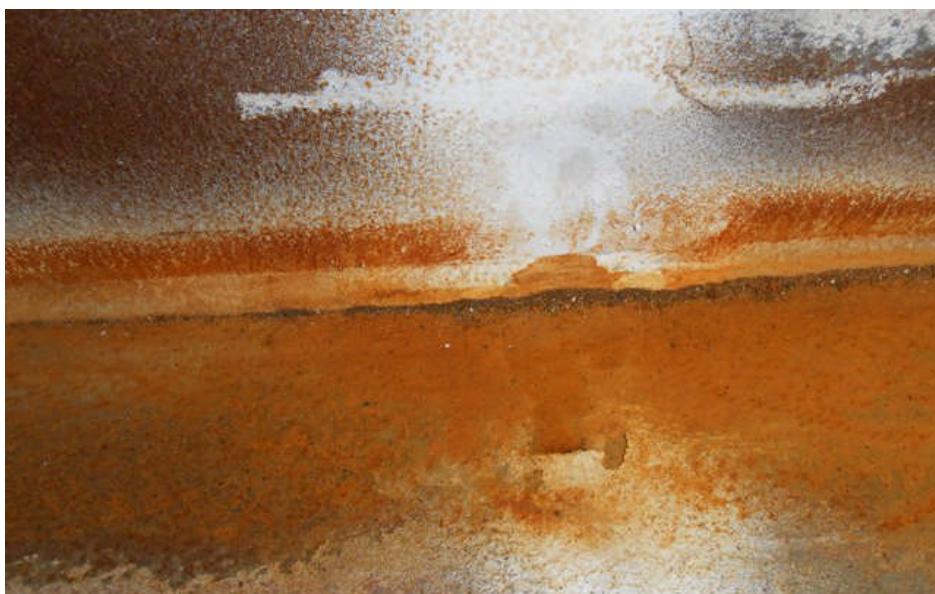
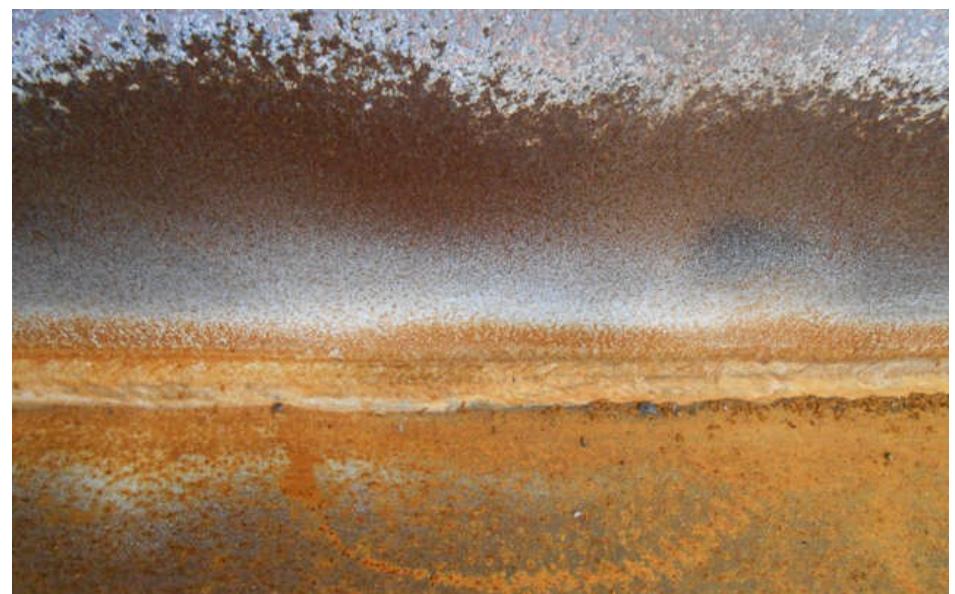
012 Wind Girder-to-Shell Weld Repairs

013 Wind Girder-to-Shell Weld Repairs

014 Wind Girder-to-Shell Weld Repairs

015 Wind Girder-to-Shell Weld Repairs

016 Wind Girder-to-Shell Weld Repairs

017 Wind Girder-to-Shell Weld Repairs

POST REPAIR: A new bottom was installed and found to be acceptable. The wind girder-to-shell weld defects were repaired and found to be acceptable. All required NDE was performed by Capitol Ultrasonics & CAPE.
--

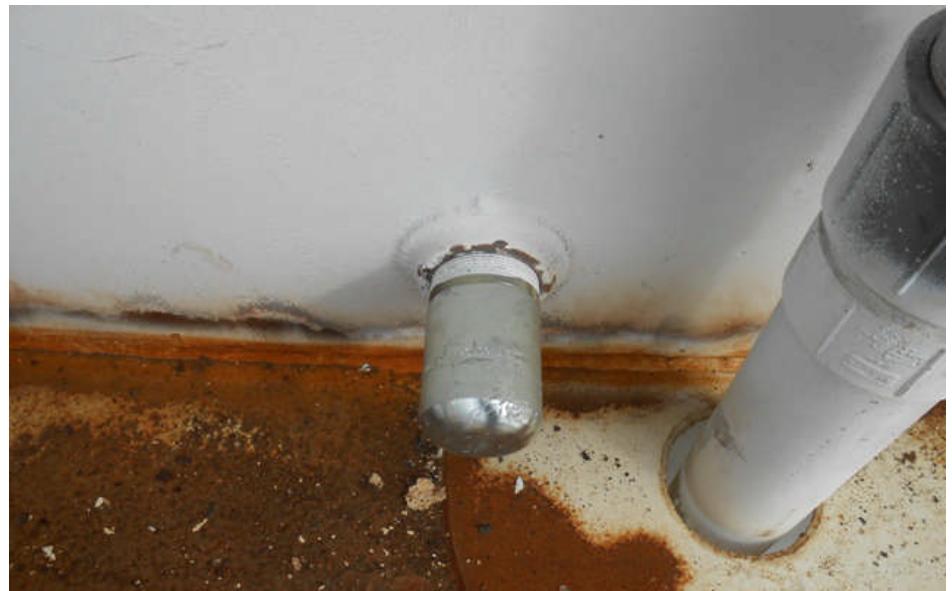
018 New Threaded Covers

POST REPAIR: The 4 inch holes were plugged with threaded covers and found to be acceptable.

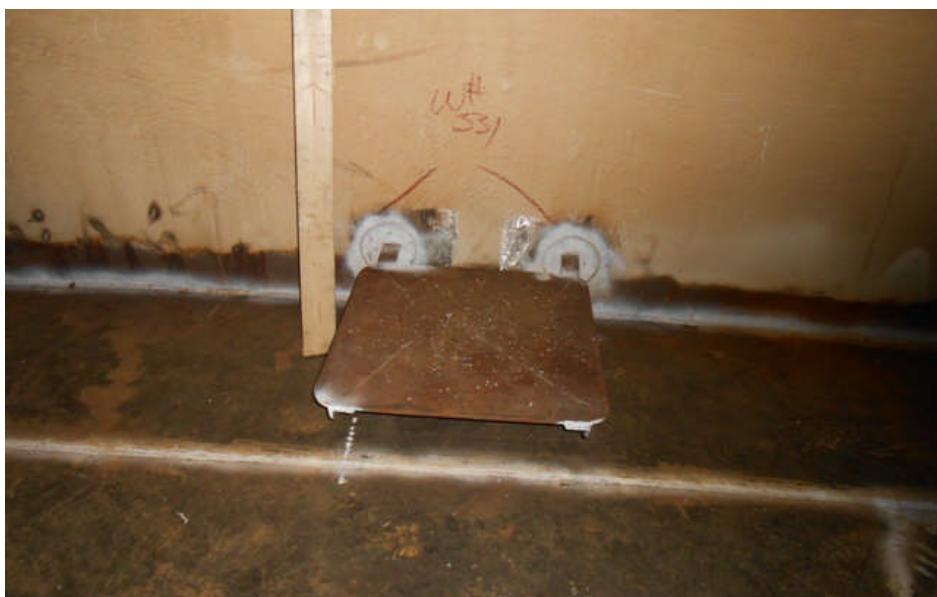
019 New Datum Plate

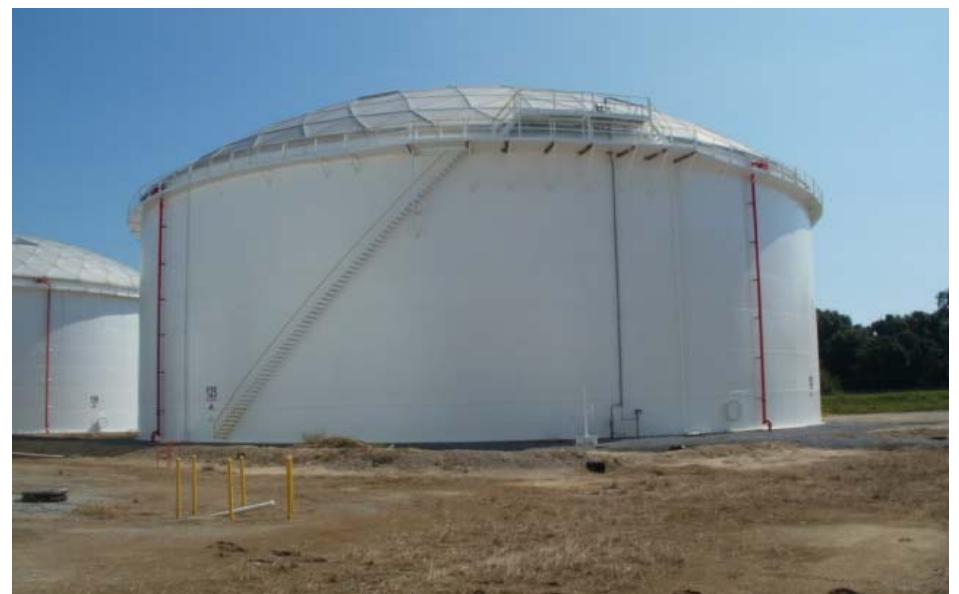
004 Overview of Tank

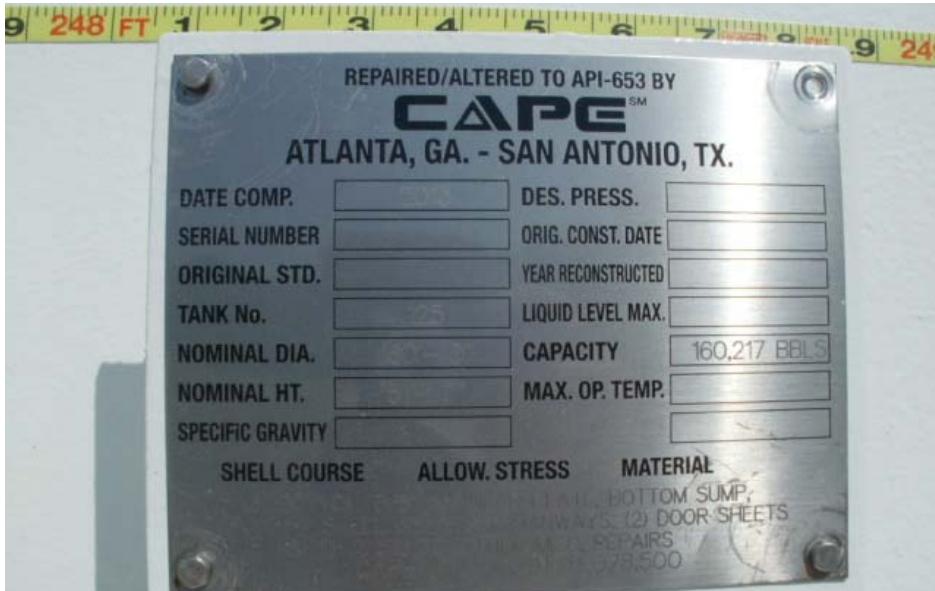
005 Nameplate

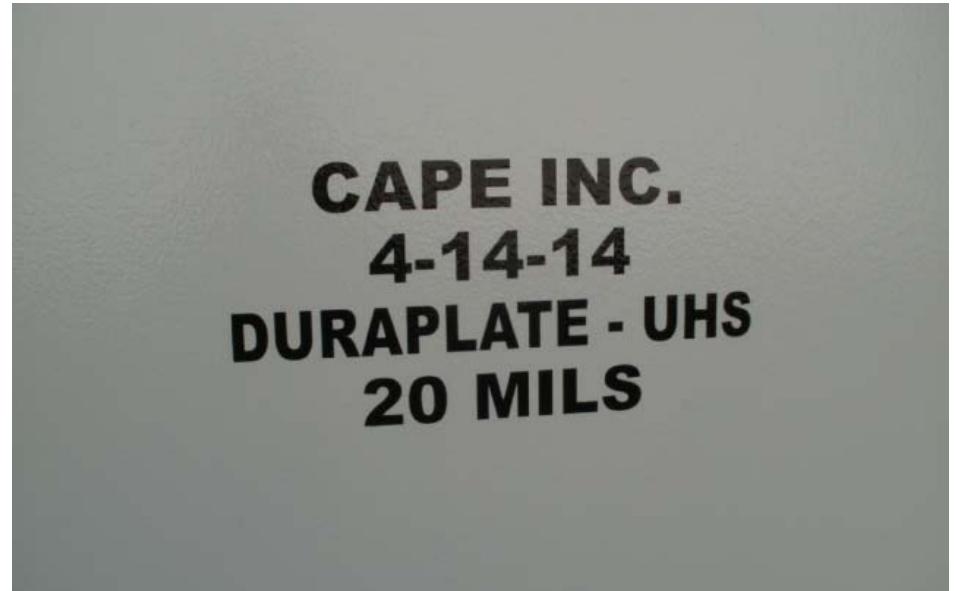
006 Coating Data

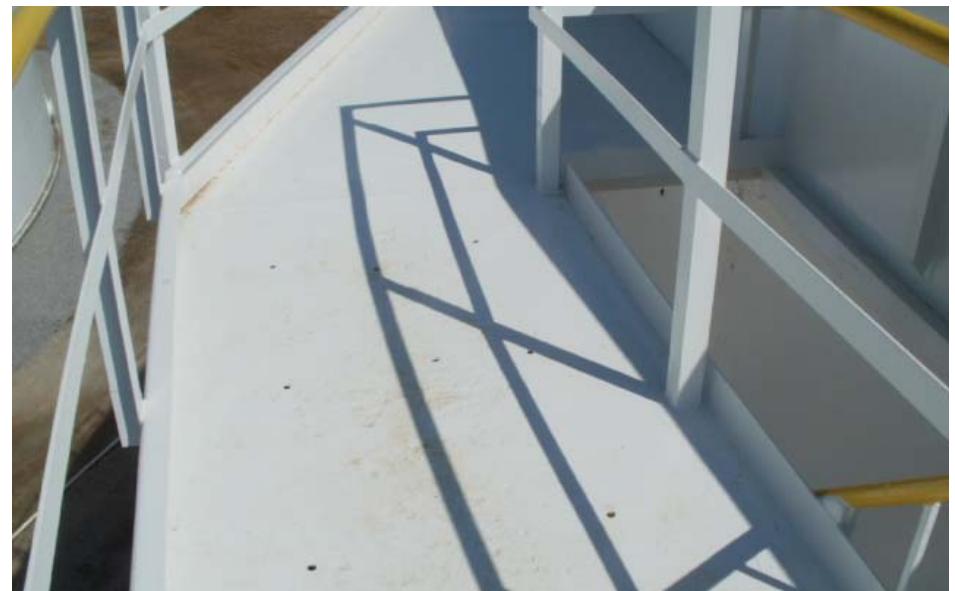
008 Wind Girder

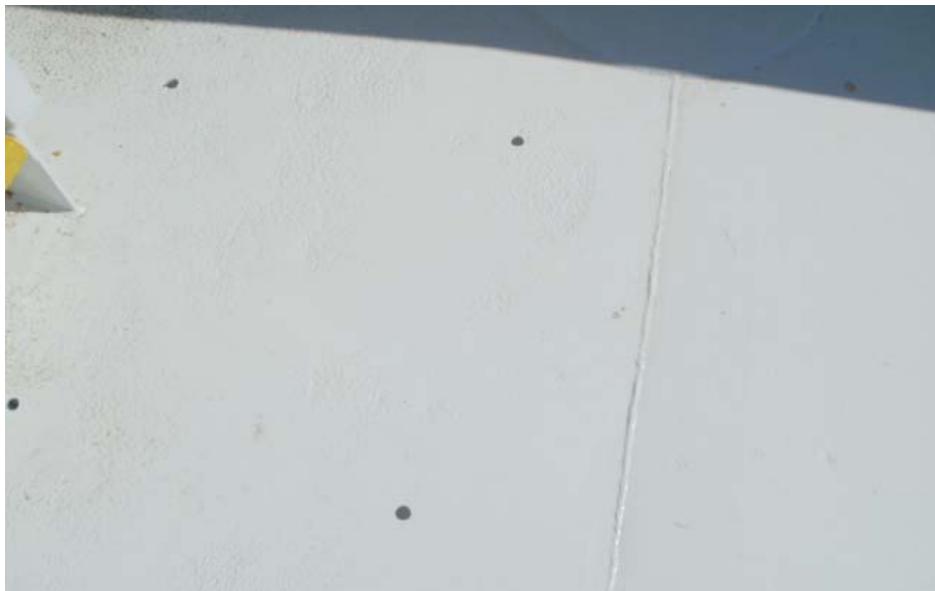
009 Wind Grider

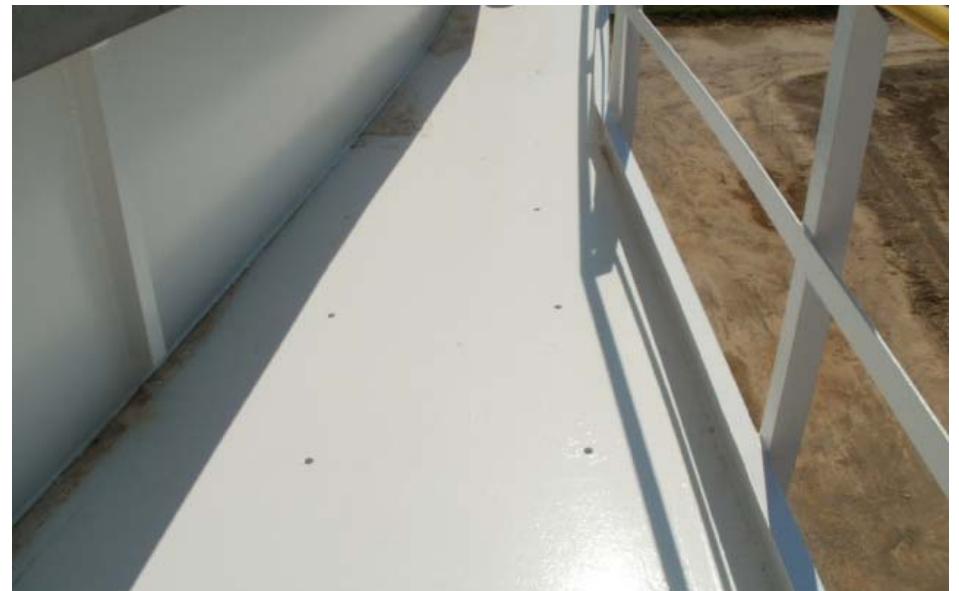
010 Wind Grider

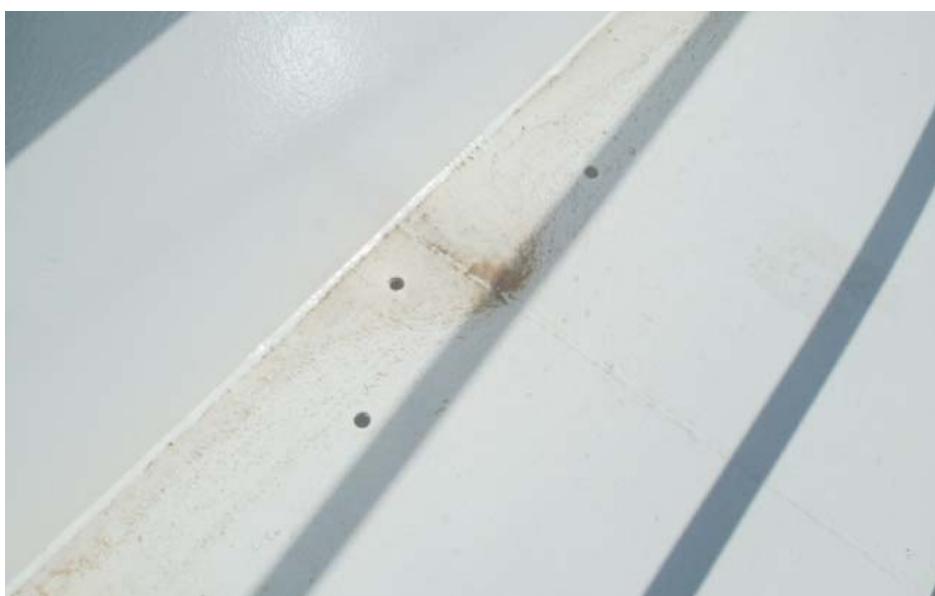
011 Additional Drain Hole

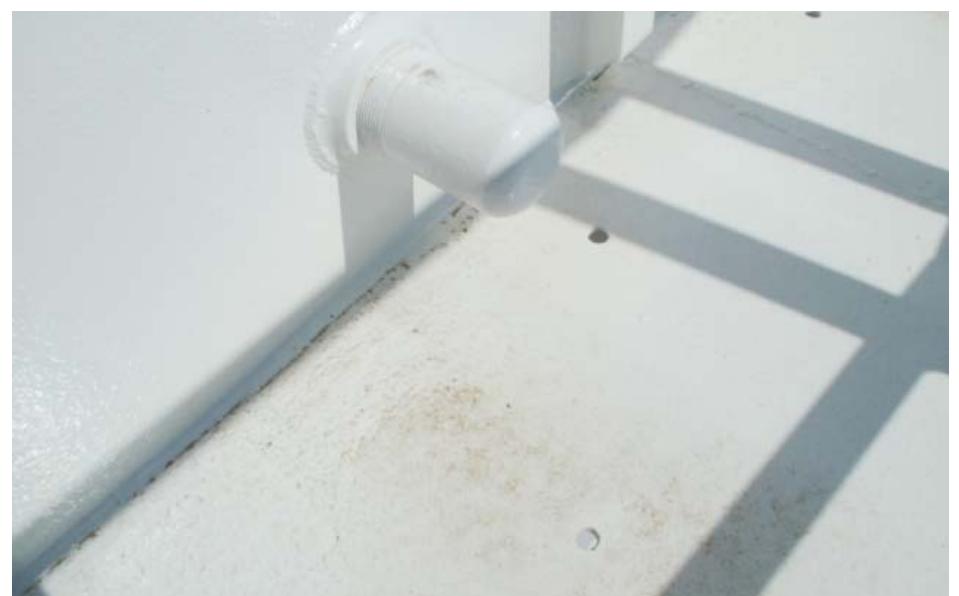
012 Additional Drain Hole

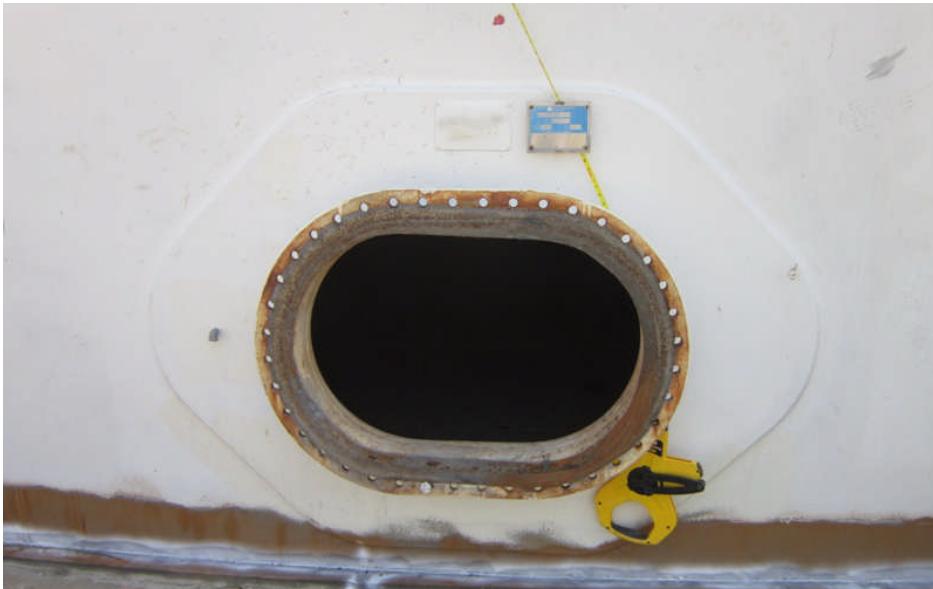
001 Manway A

ITEM 33 / COND. CODE 2 (Initial Inspection June 13, 2013) / ITEM 33 / COND. CODE 4 (Post Repair Inspection December 2, 2013): The weld spacing between the shell-to-bottom weld and the reinforcing plates of Manways A and L is less than that required by the current edition of API 650, Para. 5.7.3. The weld spacing between the shell-to-bottom weld and the neck of Coupling M is less than that required by the current edition of API 650, Para. 5.7.3. Visual (VT) inspection of these items did not reveal any anomalies. These details have been present for an extended period of time and no immediate corrective action is required.

ITEM 33 / COND. CODE 2 (Initial Inspection June 13, 2013) / ITEM 33 / COND. CODE 4 (Post Repair Inspection December 2, 2013): Manway A has a reinforcing plate that does not meet the minimum size requirements of API 650 (ref. Table 5-6b, Columns 5 and 6). However, per our calculations, this nozzle is adequately reinforced (ref. API 650, Section 5.7.2 and API 620, Section 5.16). This detail has been present for an extended period of time and no immediate corrective action is required.

ITEM 33 / COND. CODE 2 (Initial Inspection June 13, 2013) / ITEM 33 / COND. CODE 4 (Post Repair Inspection December 2, 2013): The centerline elevation of Manway A does not meet the requirements of API 650 Table 5.6b, Columns 8c or 9c. This detail has been present for an extended period of time and no immediate corrective action is required.

POST REPAIR: Manway A was replaced with a new Manway and thickened insert. All required NDE was performed by Capitol Ultrasonics & CAPE.

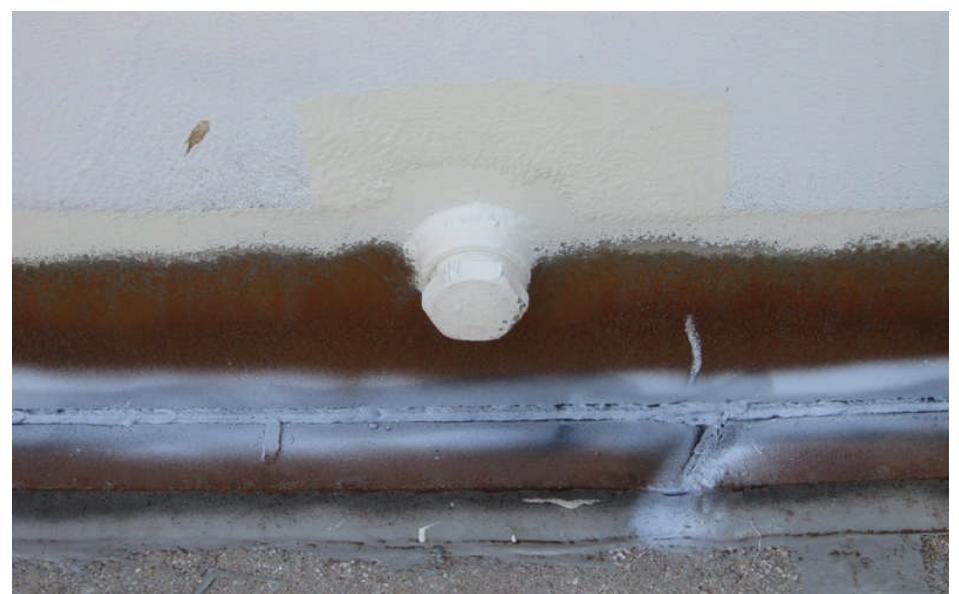
ITEM 33 / COND. CODE 2 (Initial Inspection June 13, 2013) / ITEM 33 / COND. CODE 4 (Post Repair Inspection December 2, 2013): Coupling M (2.50 inch coupling) does not have a reinforcing plate as suggested by API 650, Para. 5.7.2.1 which states that, "Openings in tank shells larger than required to accommodate a NPS 2 flanged or threaded nozzle shall be reinforced." A reinforcing plate should be installed around this nozzle neck.

012 Coupling M

POST REPAIR: Coupling M was removed and a shell insert was installed. All required NDE was performed by Capitol Ultrasonics & CAPE.

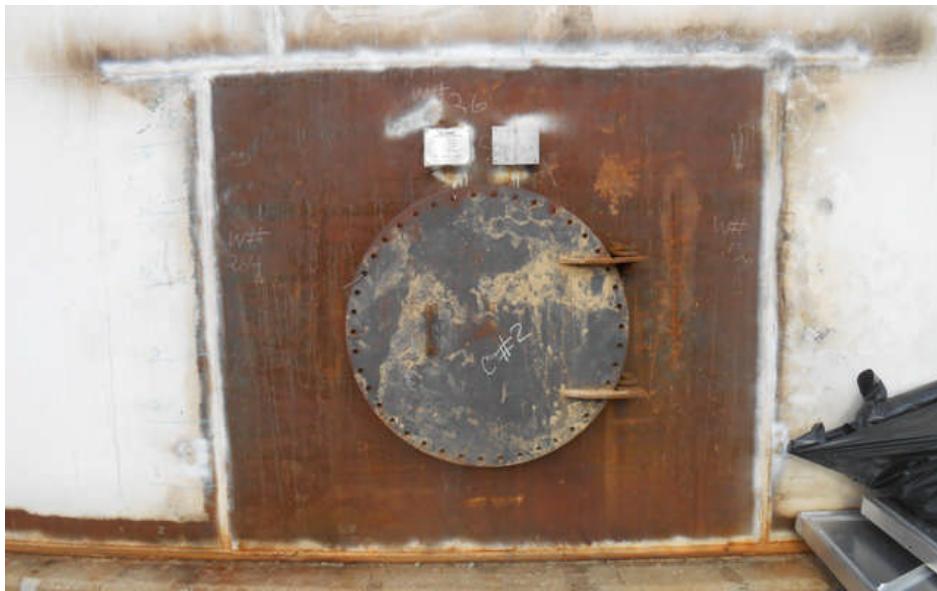
001 New Manway A

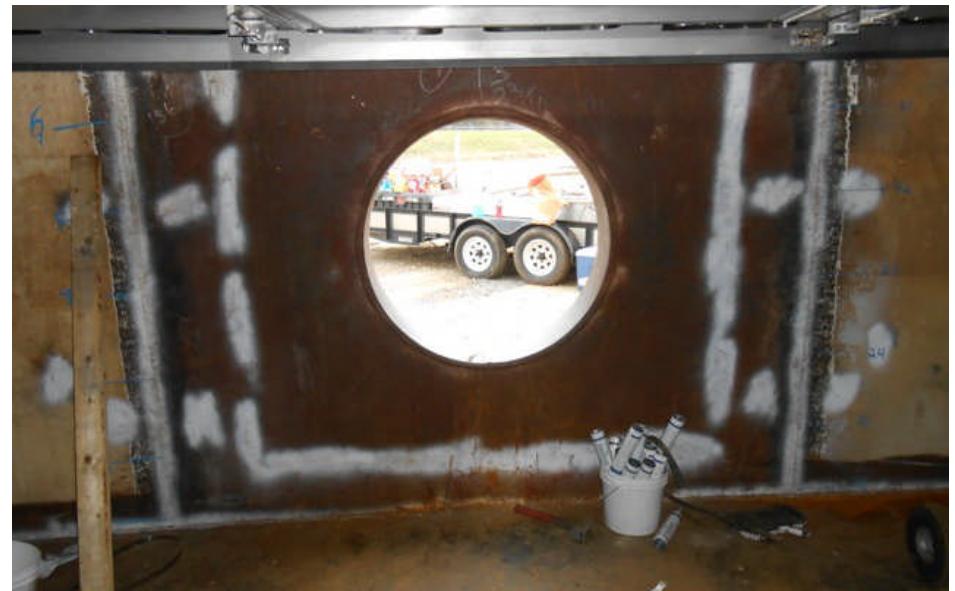
002 New Manway A Internal

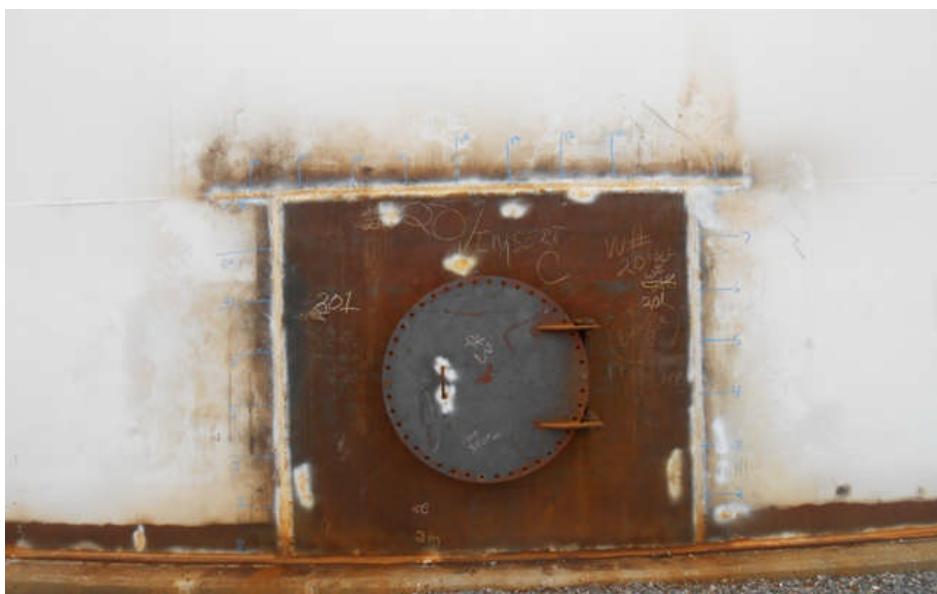
003 New Manway L

POST REPAIR: Manways A and L have been replaced with new Manways and thickened inserts. Coupling M was removed and a shell insert was installed. All required NDE was performed by Capitol Ultrasonics & CAPE.

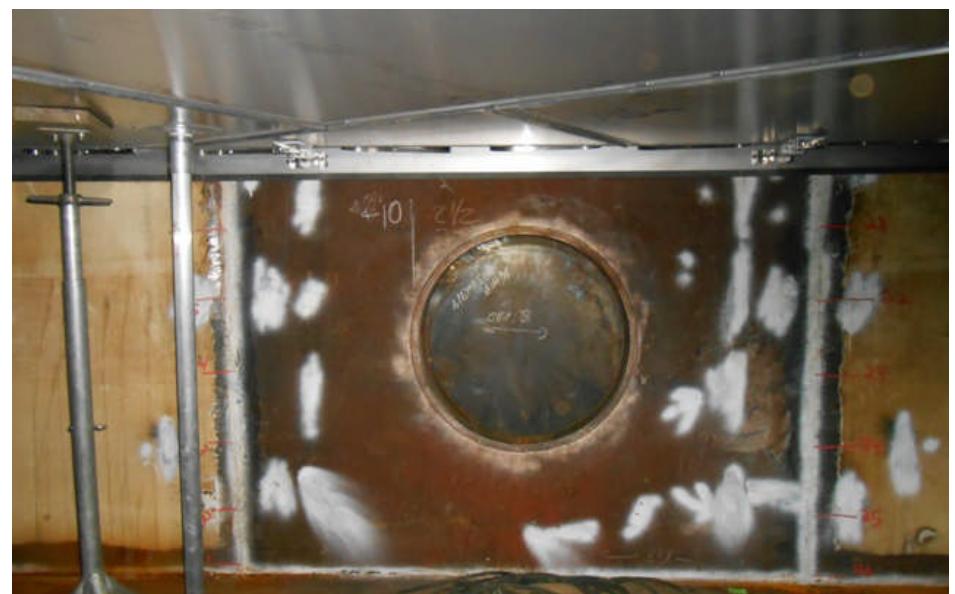
004 New Manway L Internal

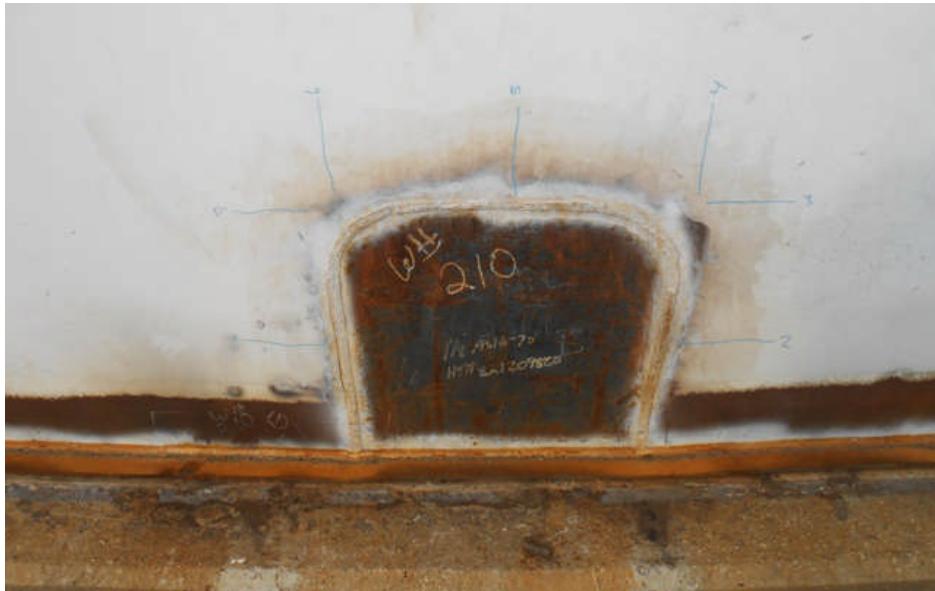
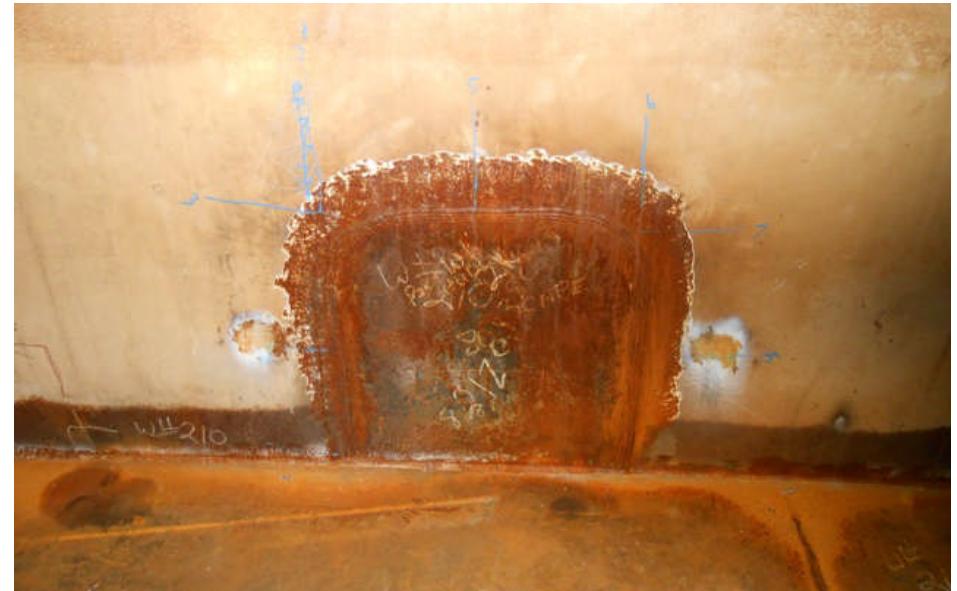
005 Coupling M Replaced with Shell Insert

006 Coupling M Replaced with Shell Insert Internal

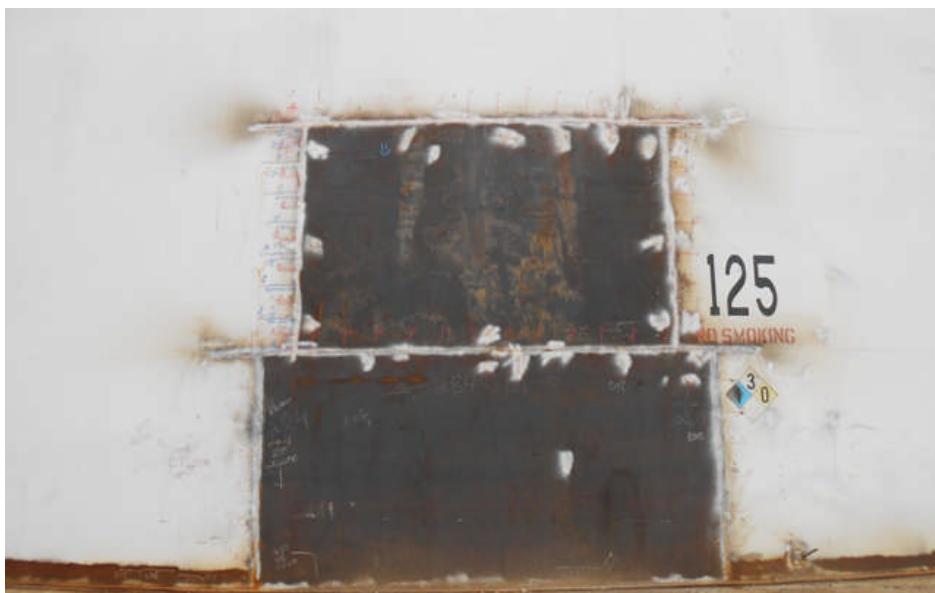
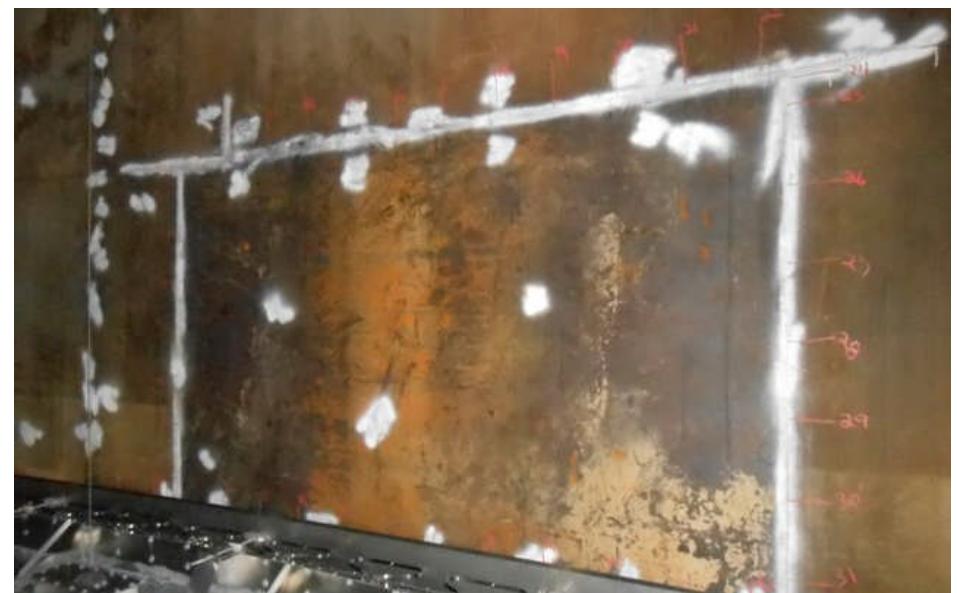
007 New Doorsheet

008 New Doorsheet Internal

ADDITIONAL POST REPAIR: A new doorsheet was installed.

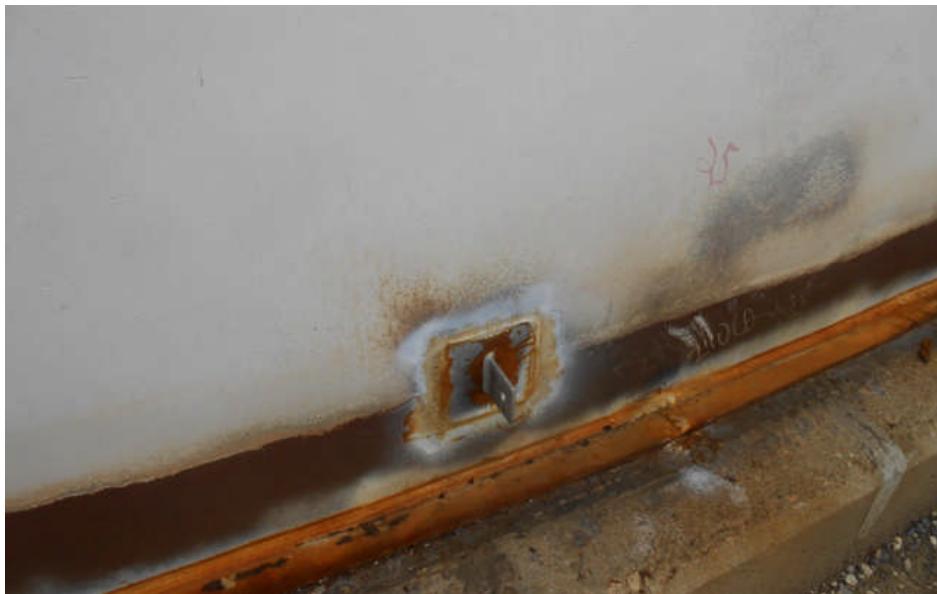
009 New Ground Clip

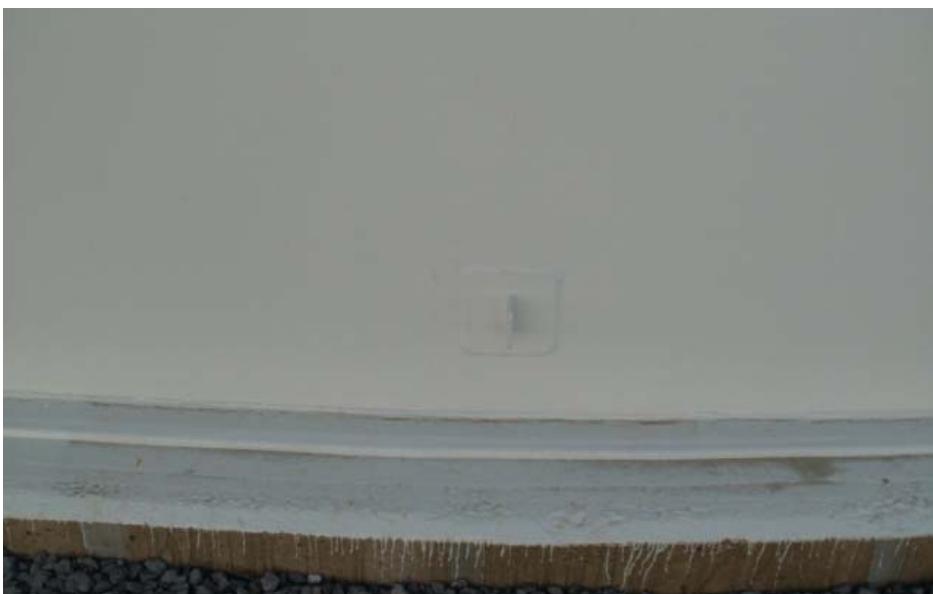
007 Ground Clip E

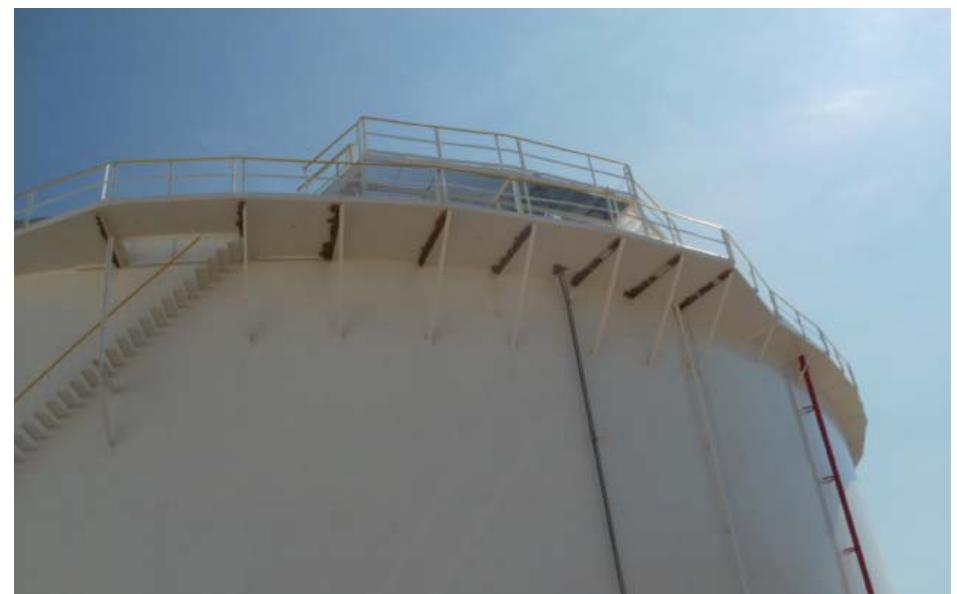
008 Platform F

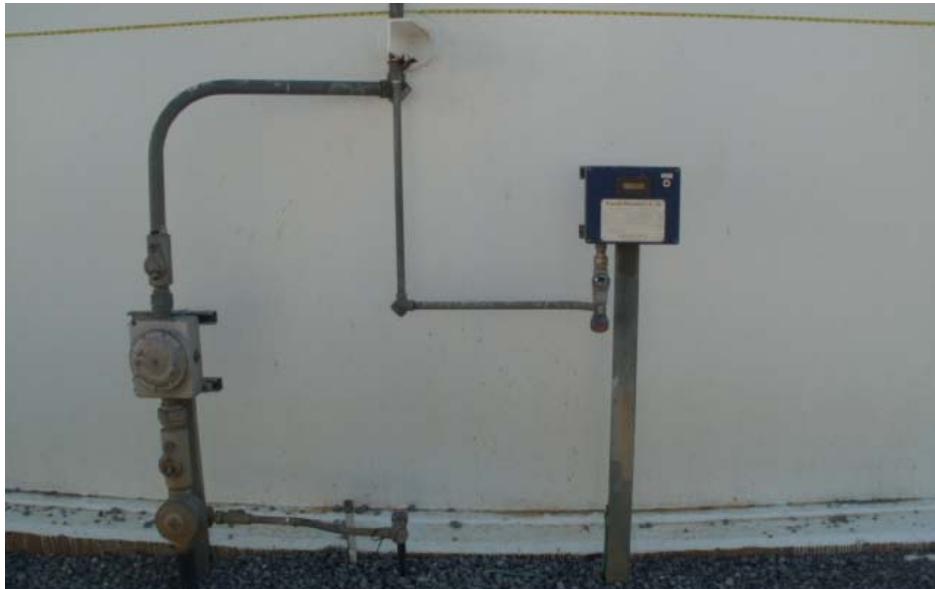
009 Digital Gauge G

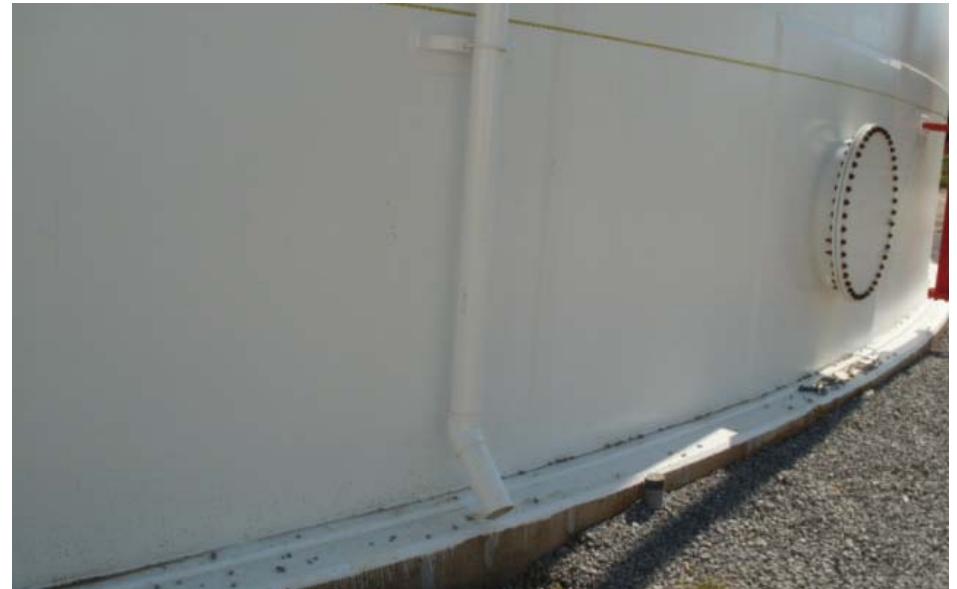
010 Roof Drain H

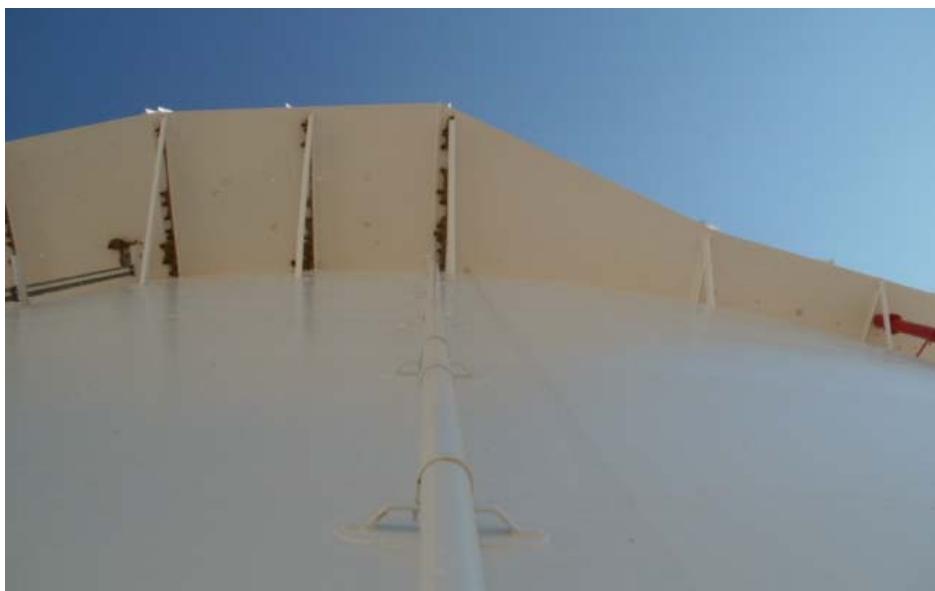
011 Roof Drain H

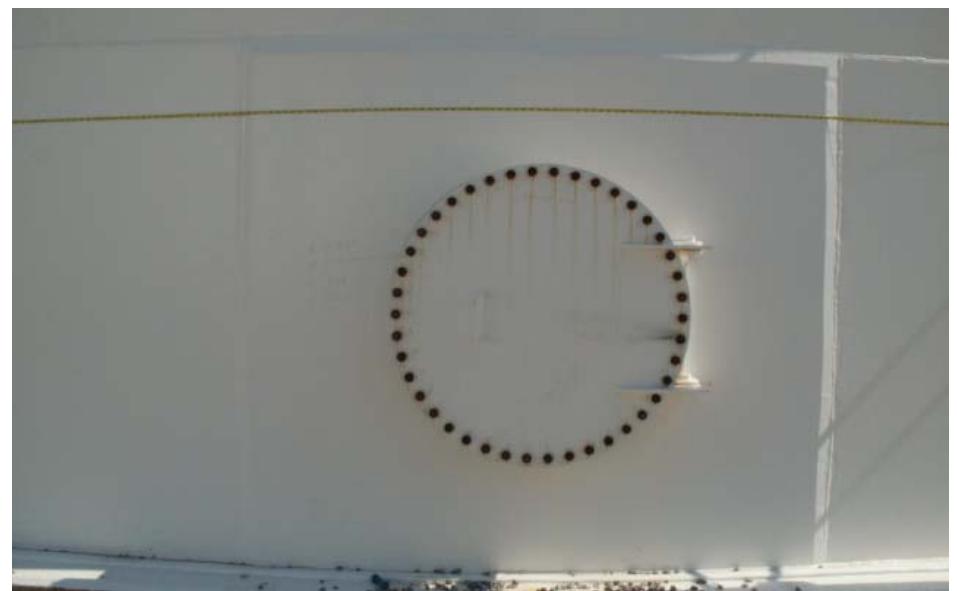
012 Manway I

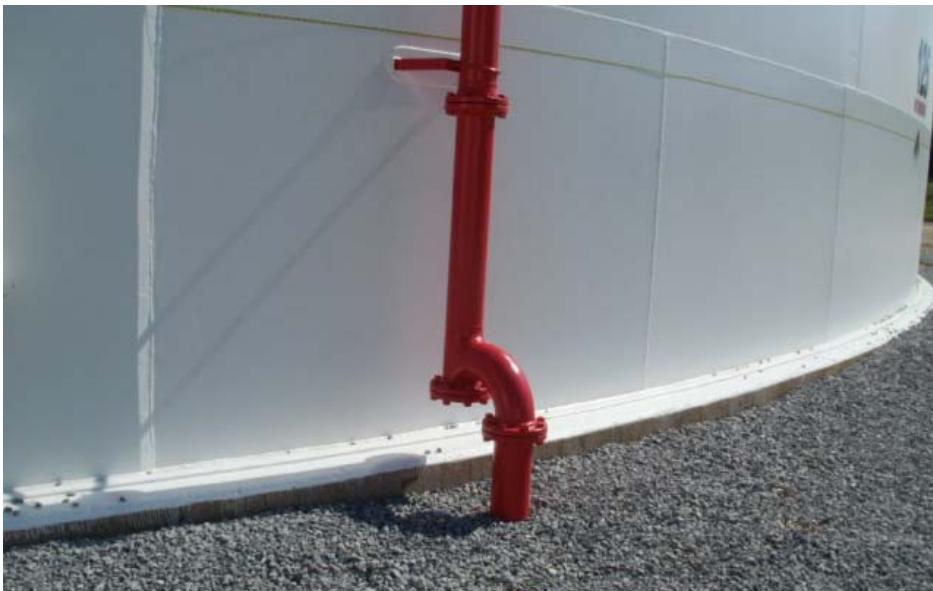
013 Foam Line J

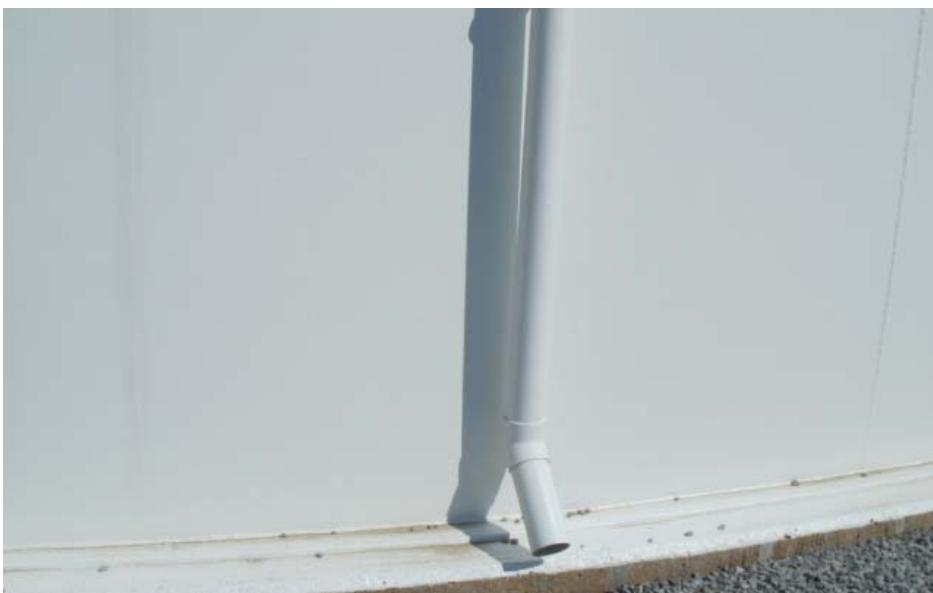
015 Roof Drain M

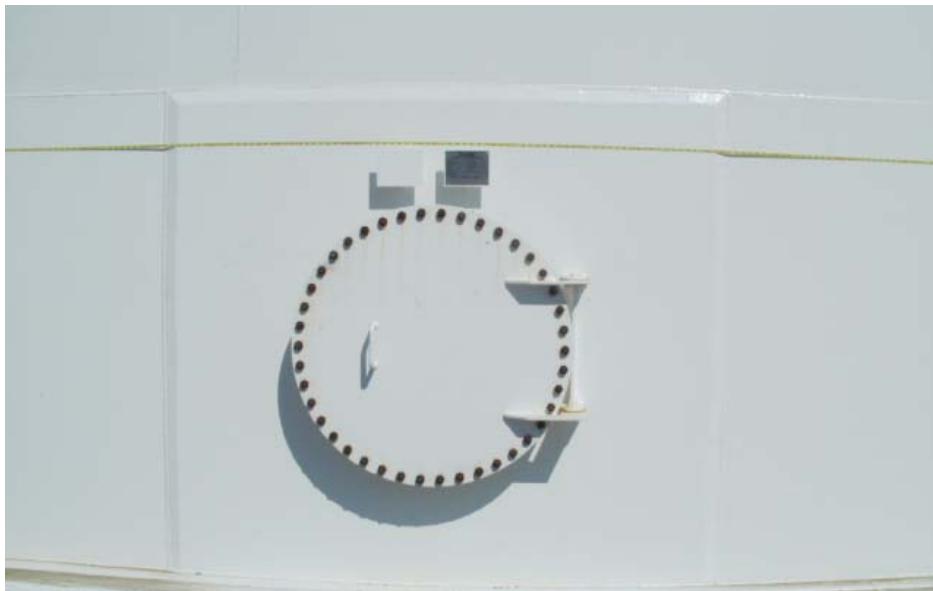
017 Manway N

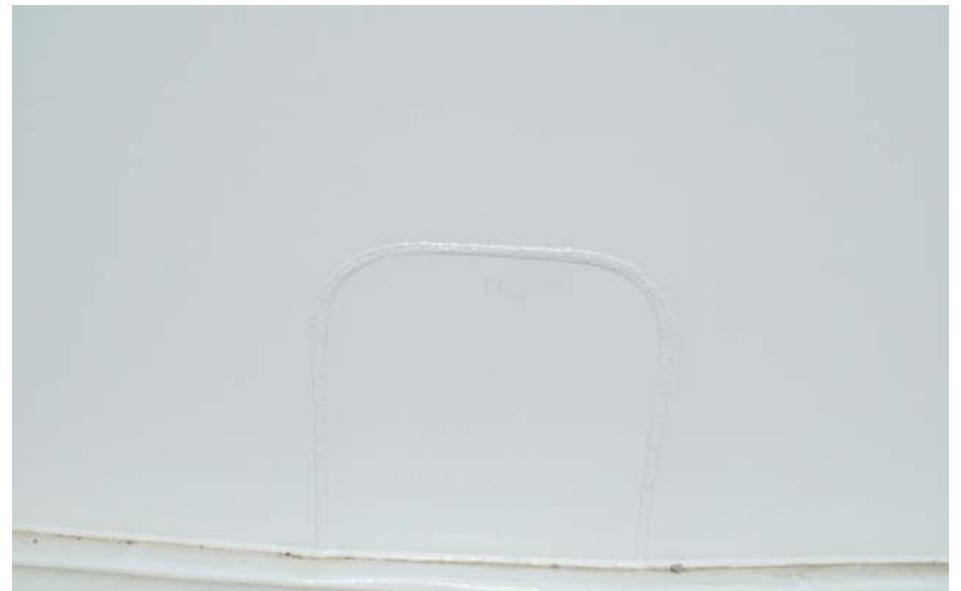
018 Insert O

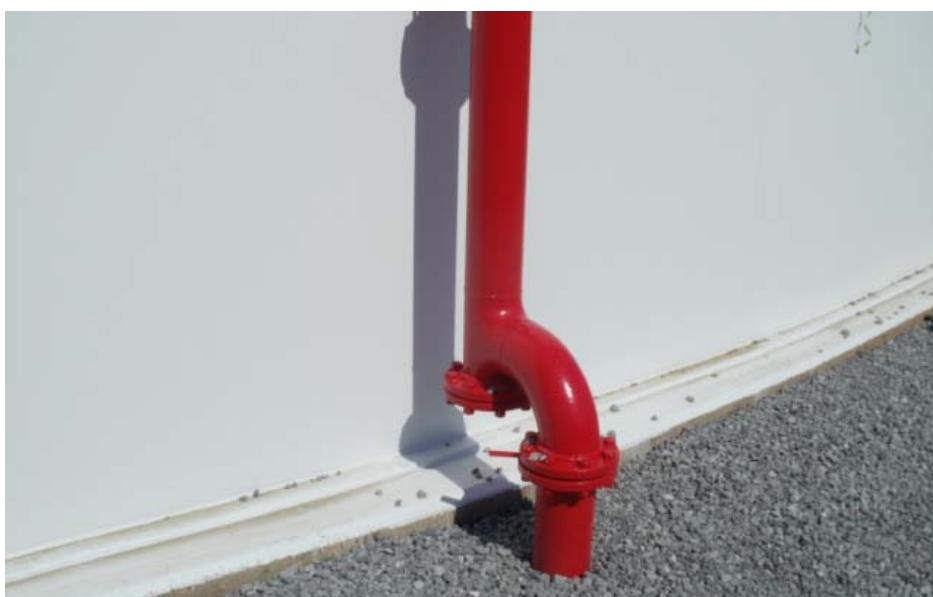
019 Foam Line P

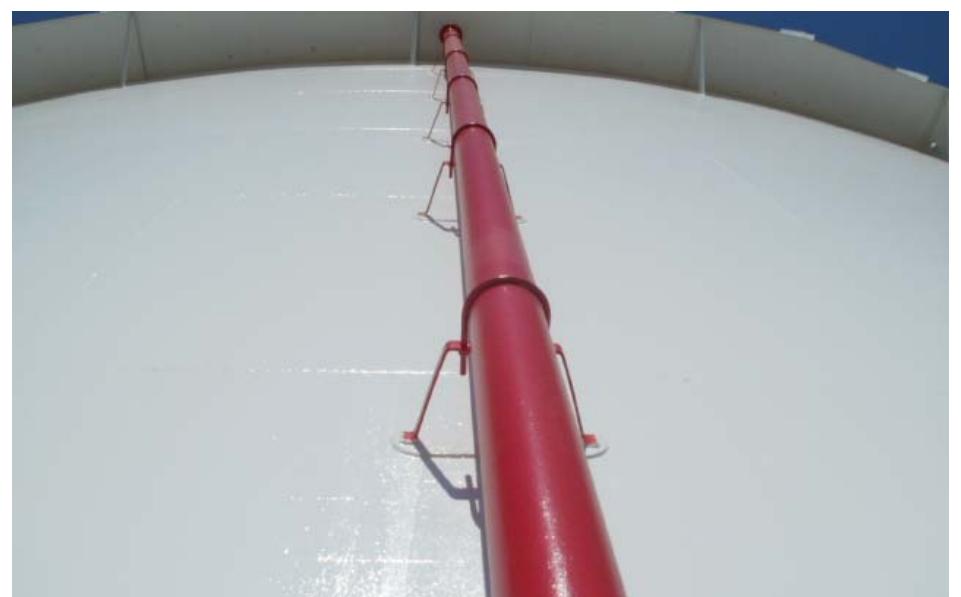
020 Foam Line P

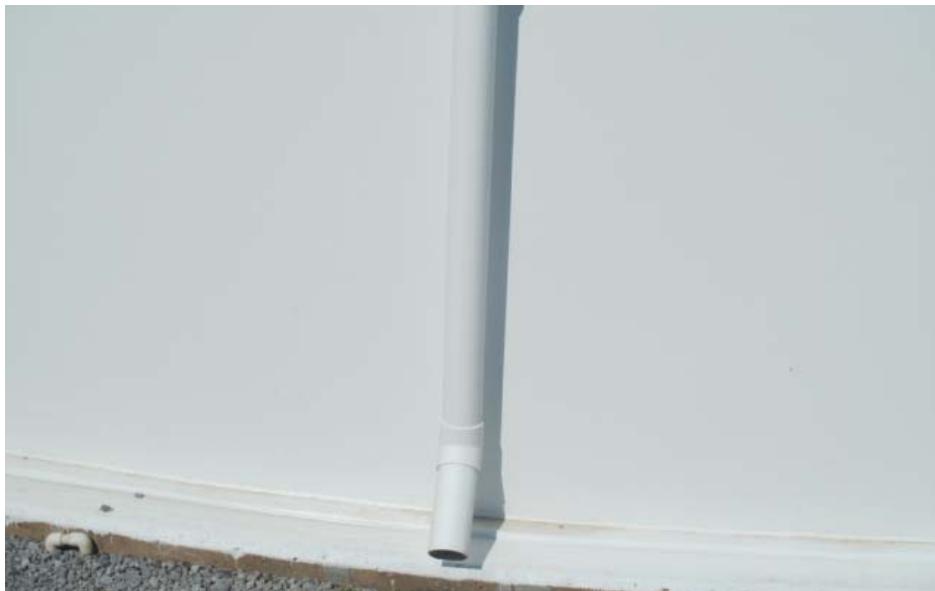
021 Roof Drain Q
