PetroChem

**INTERNAL / EXTERNAL AND ULTRASONIC
POST REPAIR TANK INSPECTION REPORT
FOR
BENGAL PIPELINE COMPANY
TANK 125
JACKSON, LOUISIANA
JUNE 13, 2013
DECEMBER 2, 2013 (POST REPAIR)
AND
APRIL 21, 2014 (FINAL INSPECTIOn)**

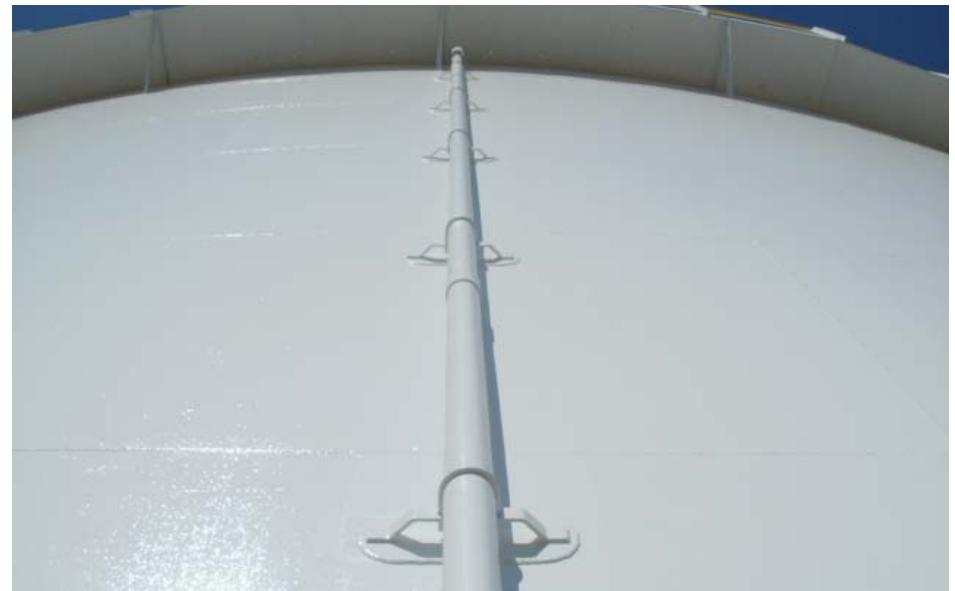
022 Roof Drain Q

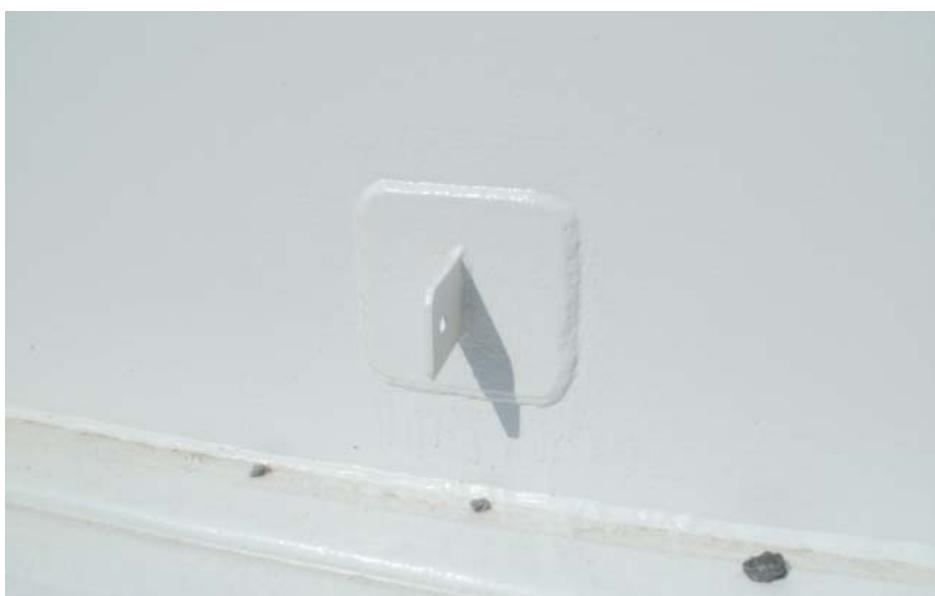
023 Ground Clip R

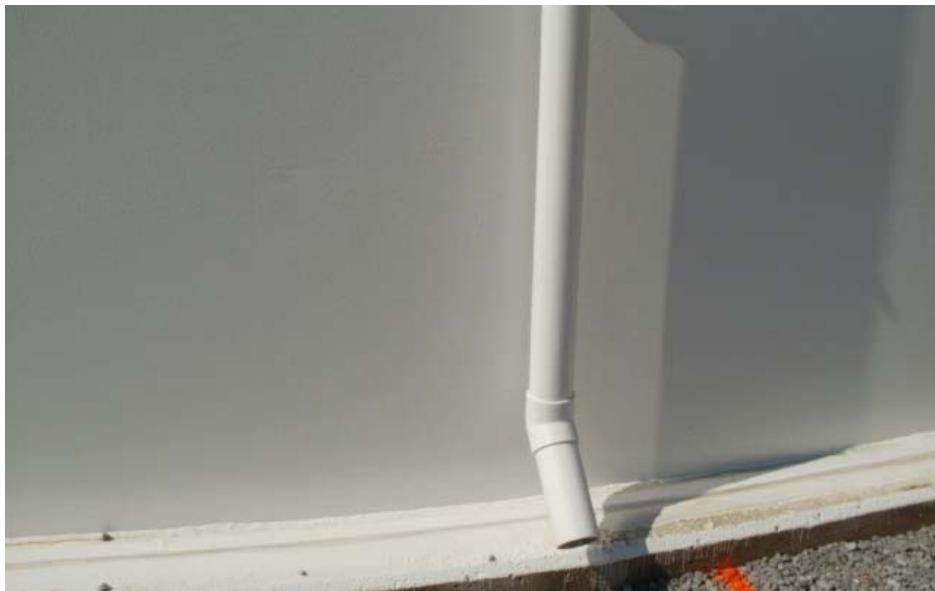
025 Roof Drain T

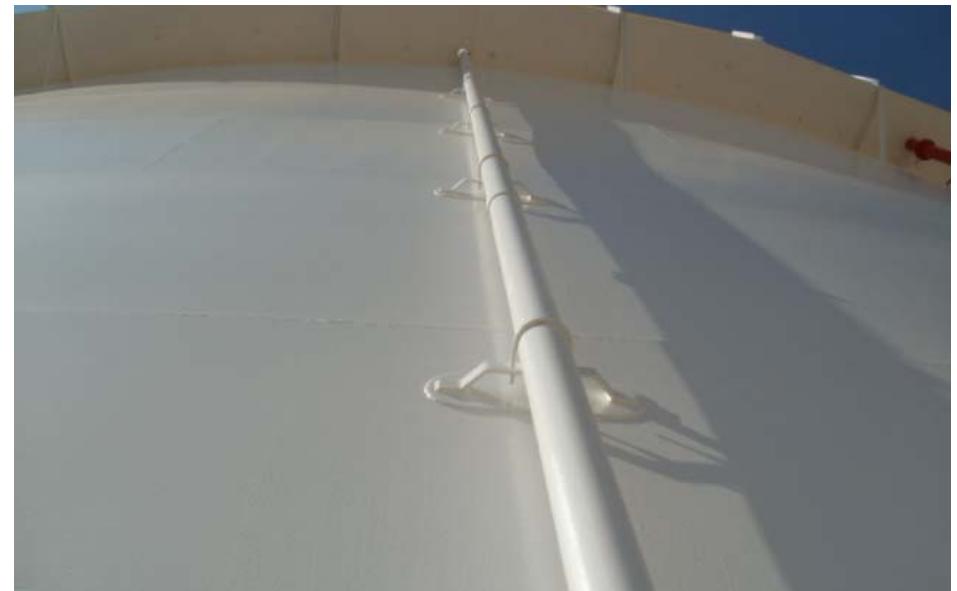
026 Roof Drain T

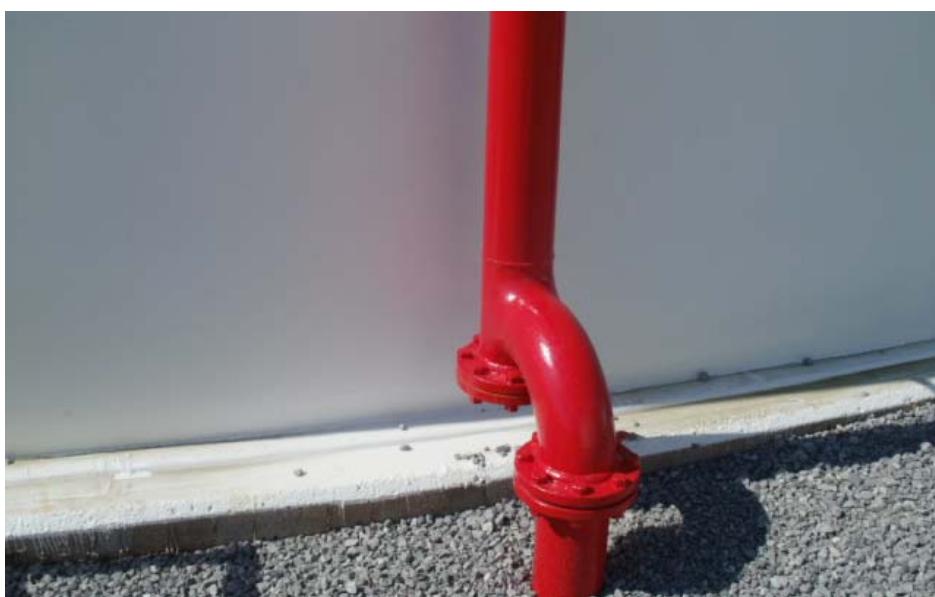
027 Foam Line U

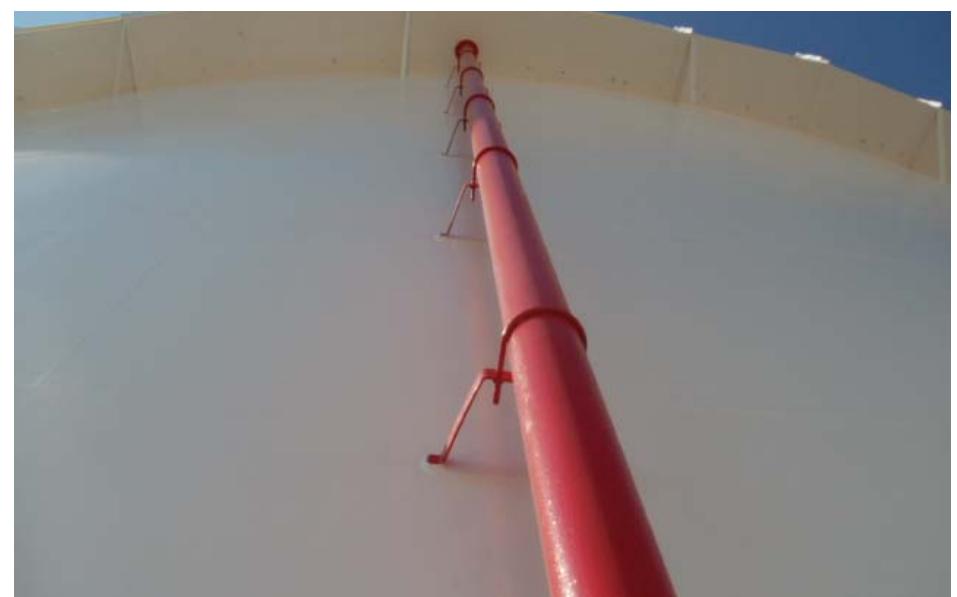
028 Foam Line U

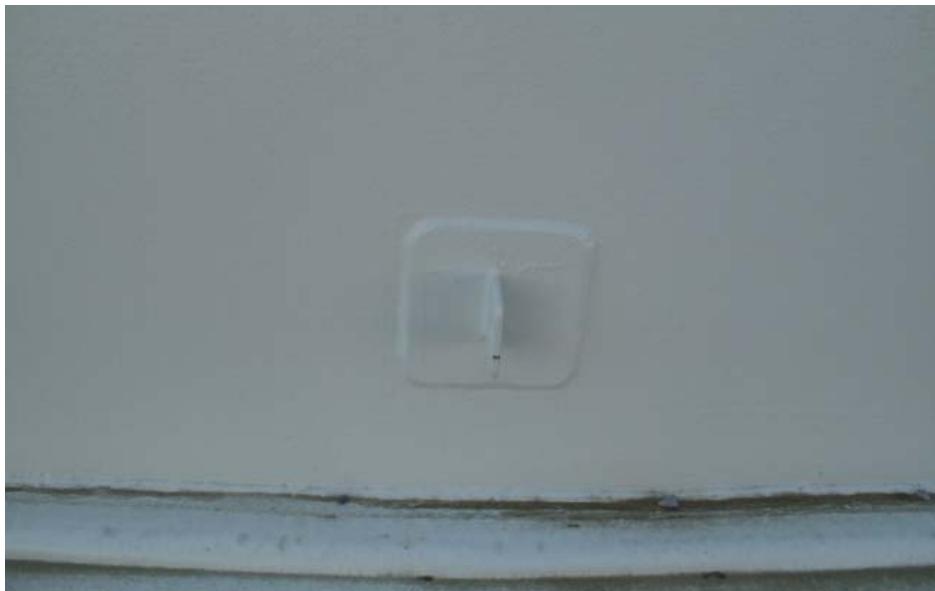
029 Ground Clip V

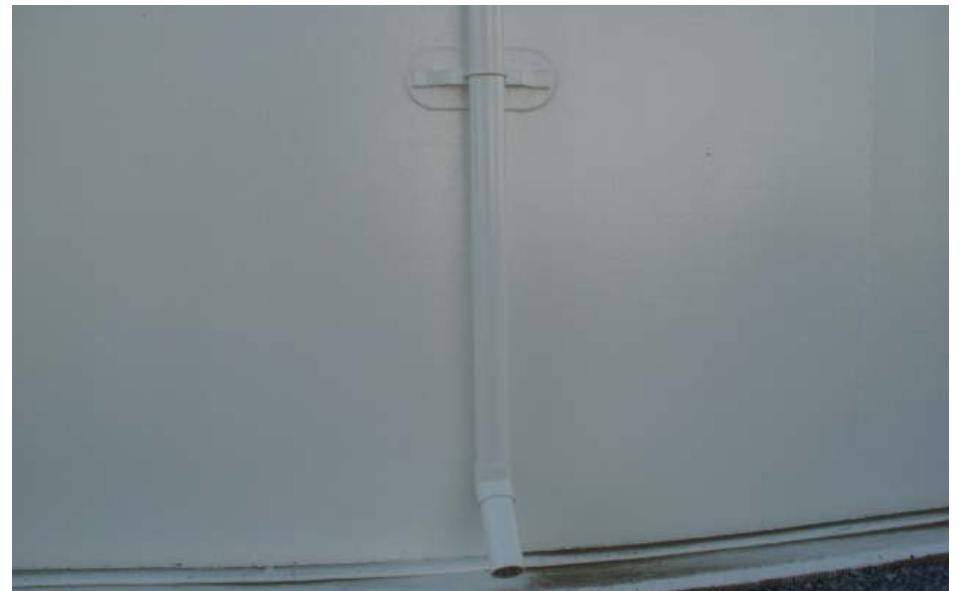
030 Roof Drain W

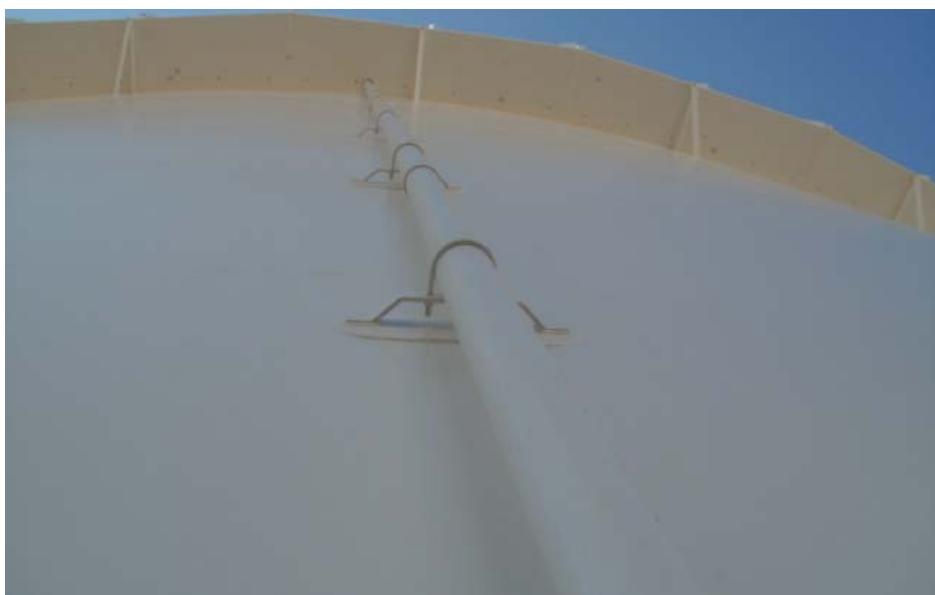
031 Roof Drain W

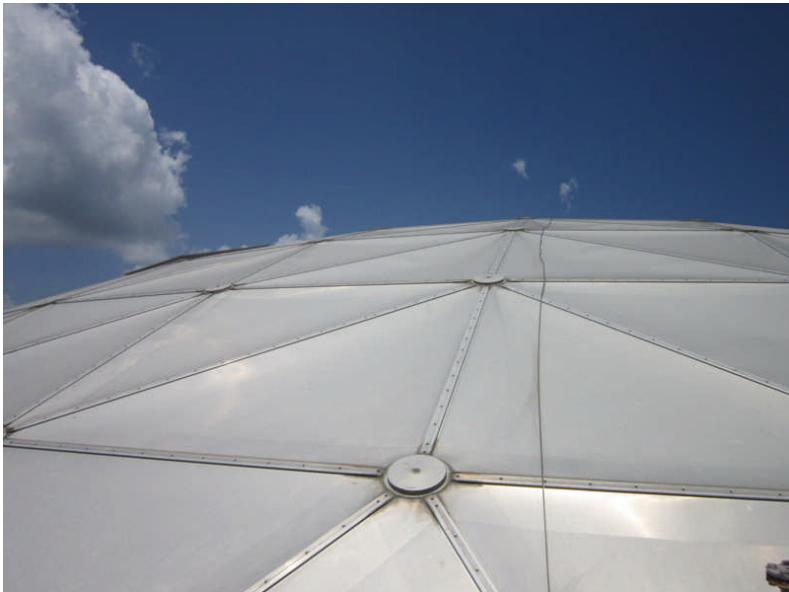
The geodesic dome was found to be in acceptable condition.

001 Overview of Geodesic Dome

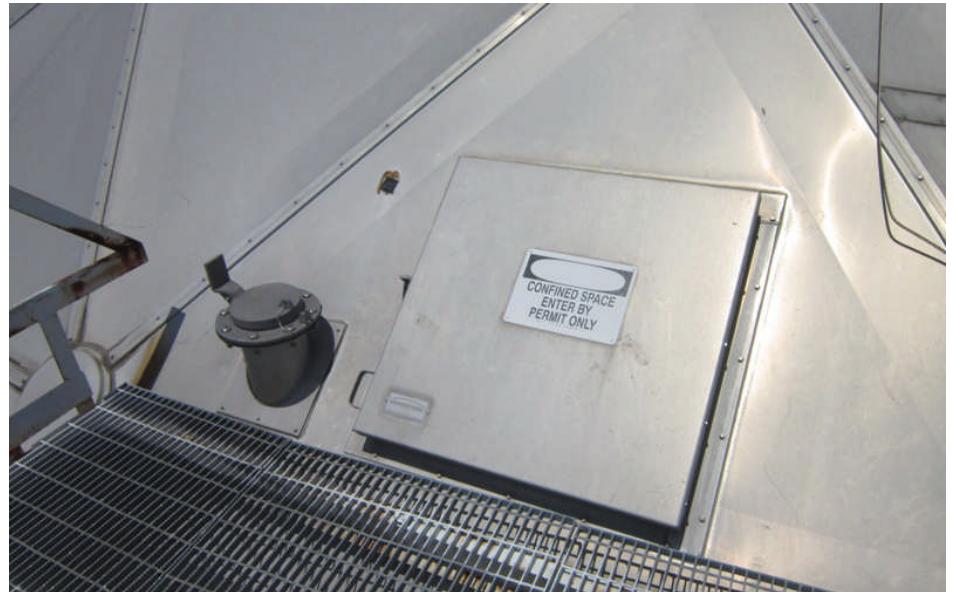
002 Access Hatch

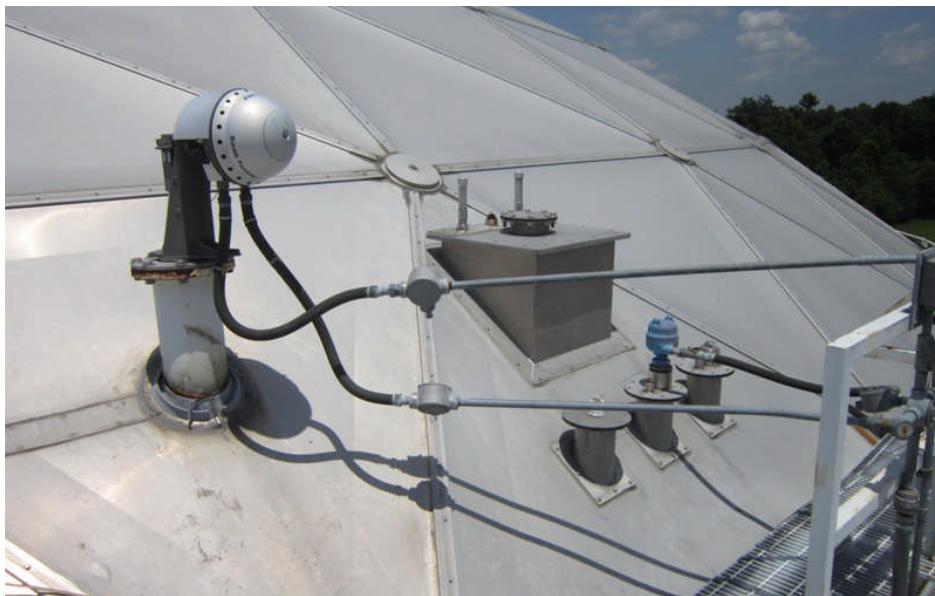
003 Nozzles

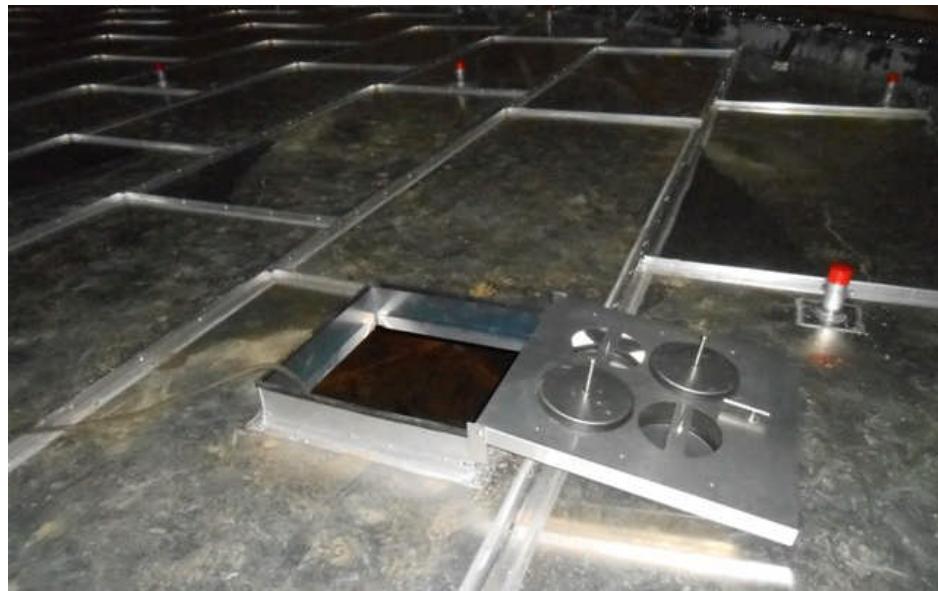
POST REPAIR: A new aluminum honeycomb floating roof and mechanical shoe primary seal were installed and found to be acceptable. Visual (VT) inspection of the primary seal did not reveal any seal gaps or vapor barrier damage, tears, or rips.

001 Partial View of Floating Roof

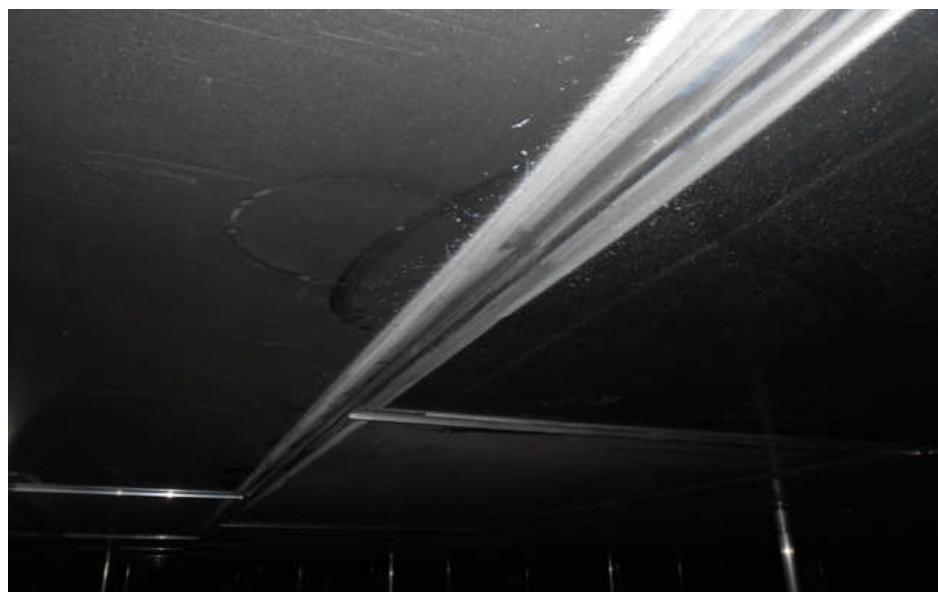
003 Underside of New Floating Roof

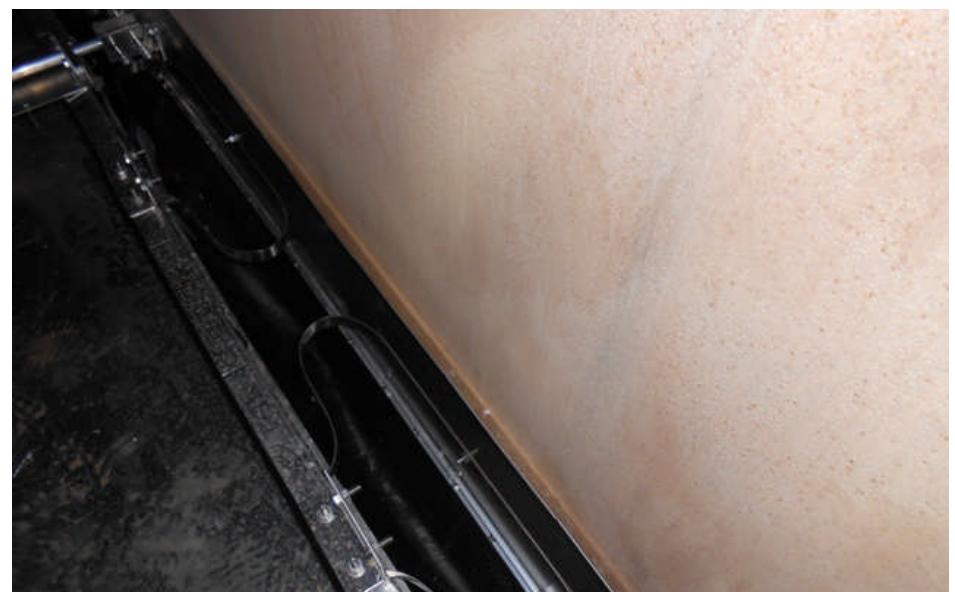
004 Primary Seal

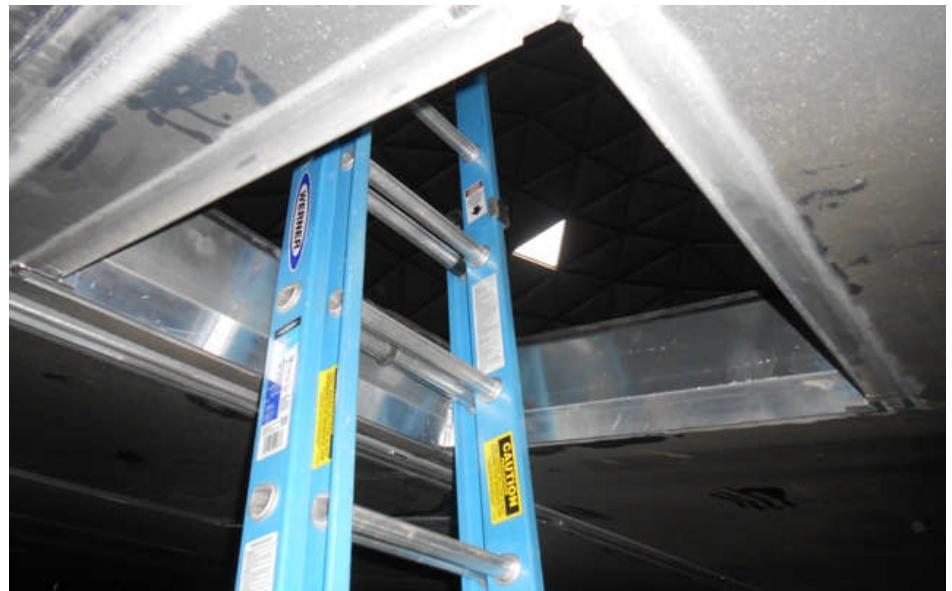
006 Access Hatch

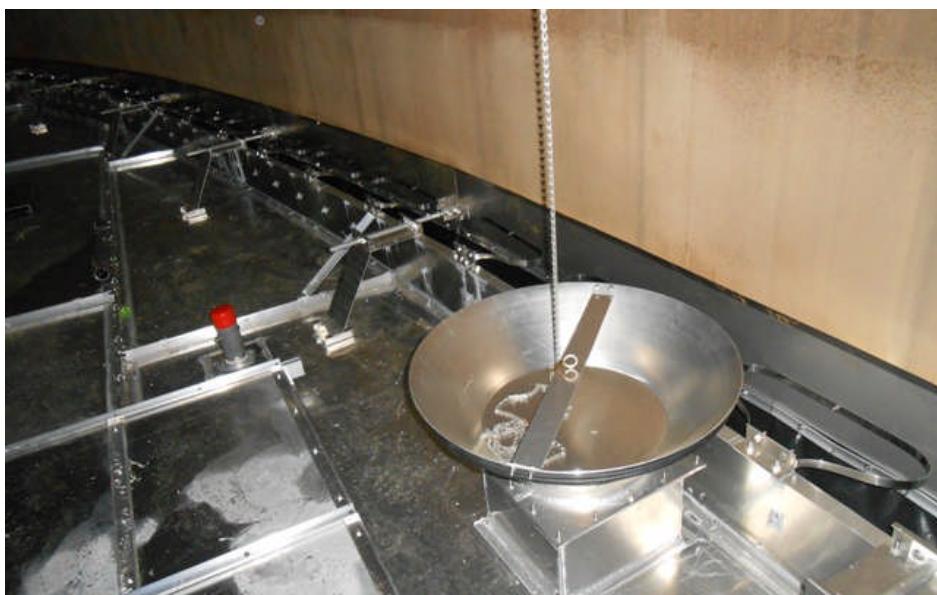
007 Floating Roof Nozzle

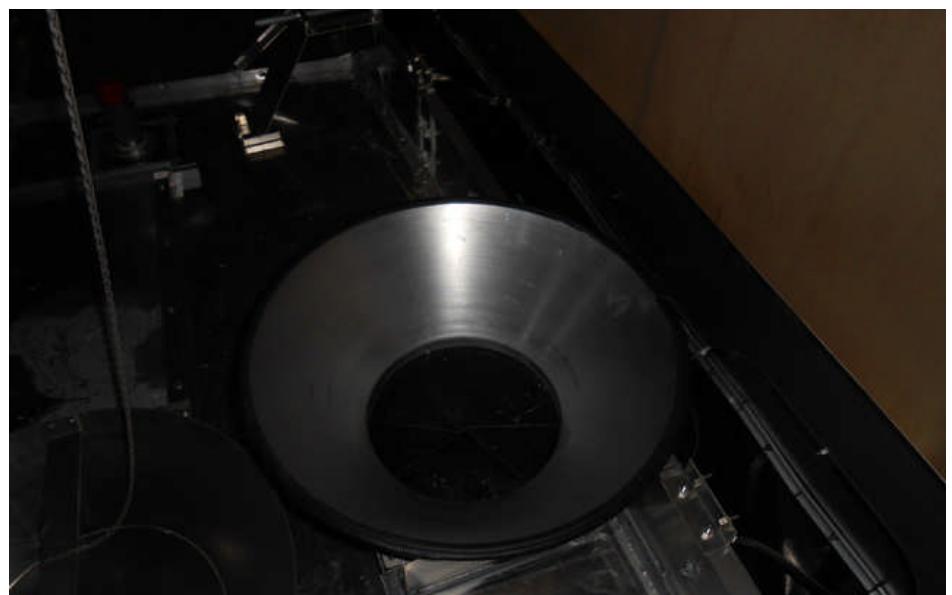
008 Floating Roof Nozzle

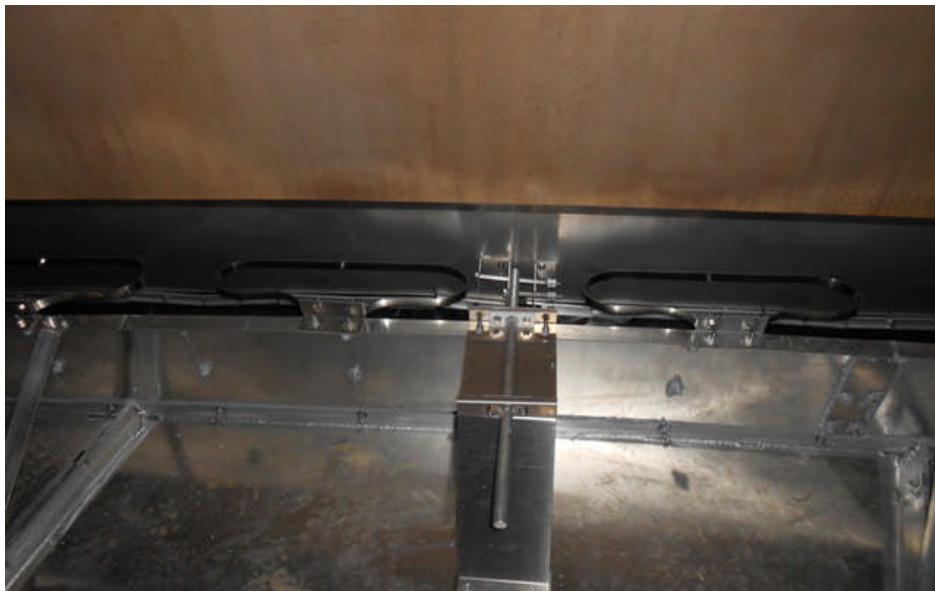
009 Anti-Rotation

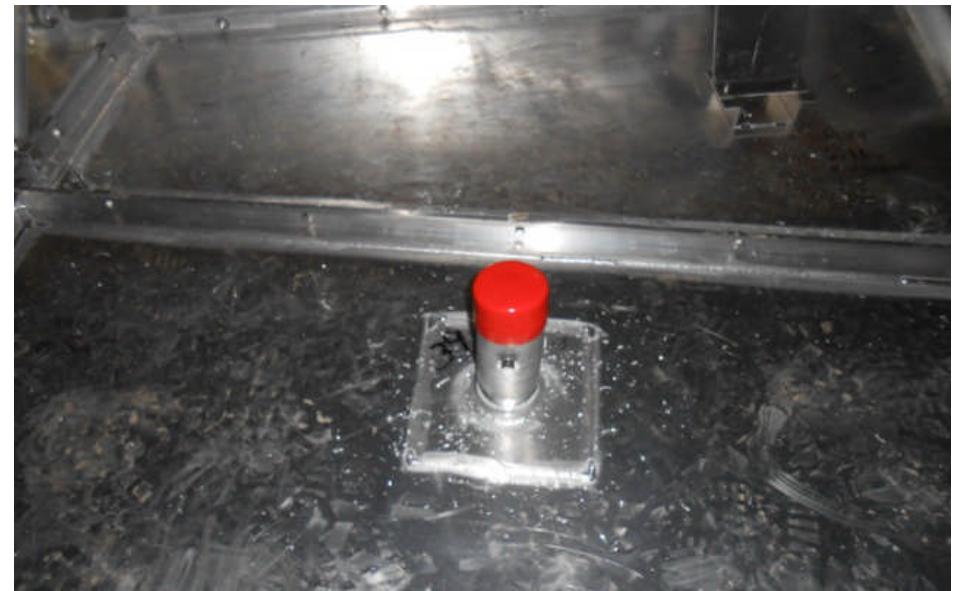
010 Floating Roof Leg

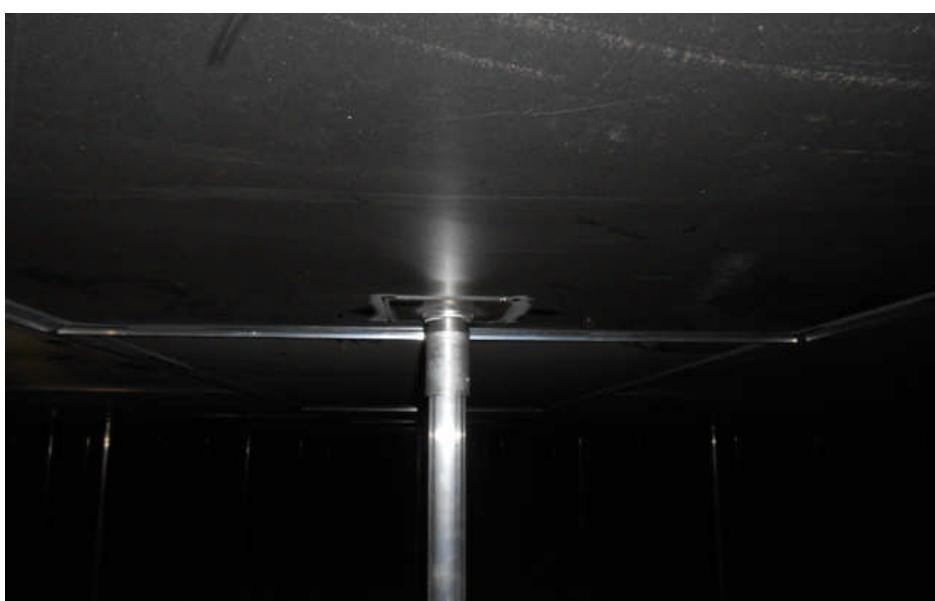
011 Floating Roof Leg
