**66 Lower Court Road  
Epsom  
KT19 8SN**

**Assessment of Known Defects  
and  
Recommendations on Remedial Works**

**Prepared for:  
Stephen Hamilton  
November 2024**

**W&L Job No.** 24-BS-148  
**Issued** 11/11/24  
**Revised** V1.0

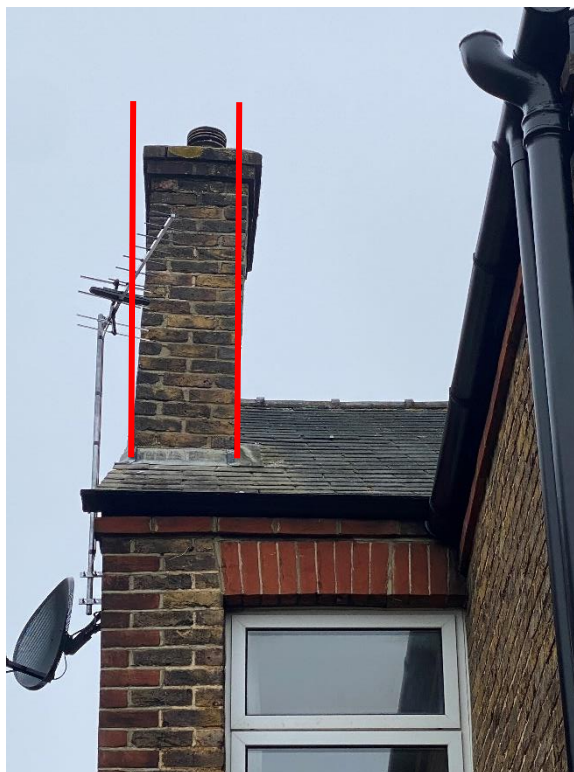
The rear flank chimney breast, which protrudes above the roof structure for 21 courses of brickwork, giving it an approximate height of 1.8m above the roof structure, was observed to be leaning inwards significantly (Image 4). Additionally, there was evidence of moisture ingress at ground floor level within the masonry of the flank wall, adjacent to the rear flank chimney breast (Image 5).

Image 4: Rear flank chimney breast leaning inwards.

It is believed that a lack of support for the structure has resulted in the observed leaning of the chimney breast. From ground level, the external brickwork and mortar of the chimney breast appear in good condition, with no obvious defects. The chimney protrudes approximately 1.8m above the roof structure and there is no additional support above the roof structure, the lack of support has allowed the chimney breast to lean substantially inwards. A visual inspection of other properties on Lower Court Road indicated that this had occurred to the other properties too, with many having removed the rear flank chimney breast to below the roof structure. It is therefore assumed that the observed leaning of the chimney breast has been caused by a construction defect, namely the lack of any support above the roof structure.

The chimney stack should be reduced in height to below the roof level as the chimney is no longer in use, with the internal fireplaces now covered. A roofing contractor should be instructed to remove the chimney stack to below the roof level, and to install new roof finishes to cover where the chimney stack currently protrudes from the roof structure, in order to prevent moisture ingress within the chimney breast. The reduced height chimney stack should be covered to prevent any materials or moisture getting into the disused flues. The reduction and covering of the chimney stack will also help to address the moisture ingress within the masonry of the flank wall that was observed during the site visit and will help to protect the external masonry, as this is believed to have been caused by the lack of capping on the chimney flues allowing water into the flues through rainfall.

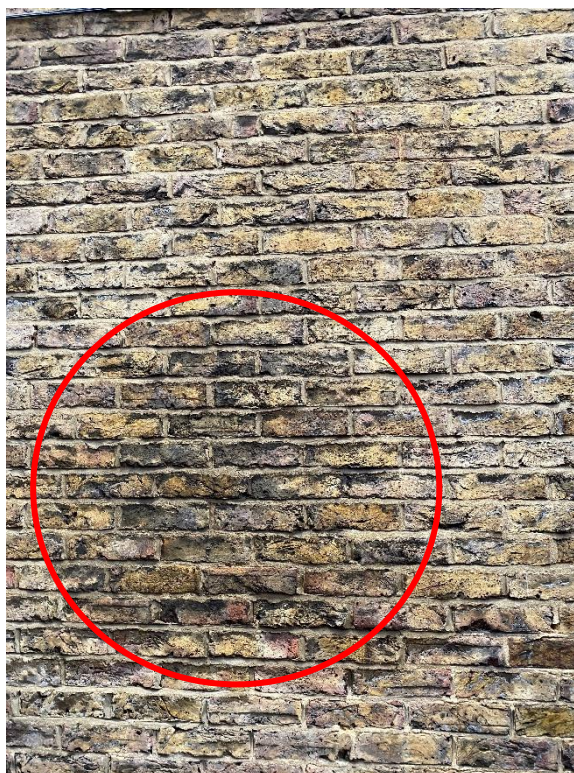
Image 5: Evidence of moisture ingress within flank wall masonry adjacent to rear flank chimney breast.

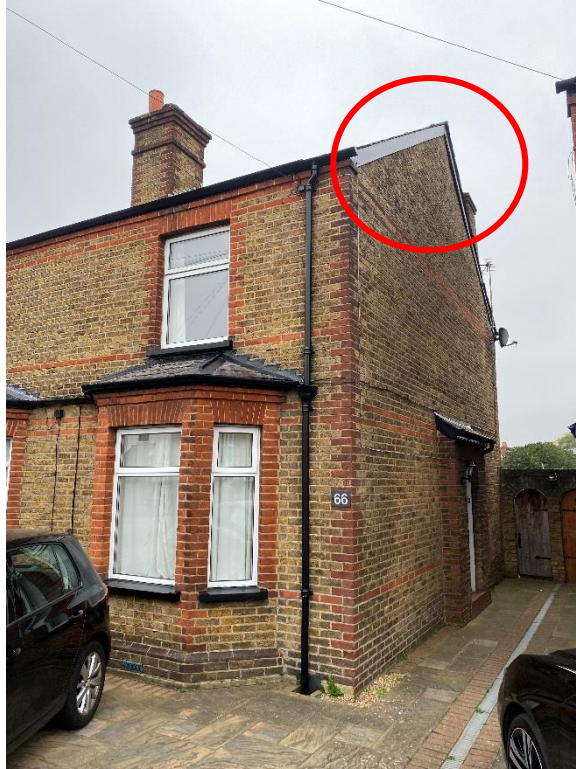
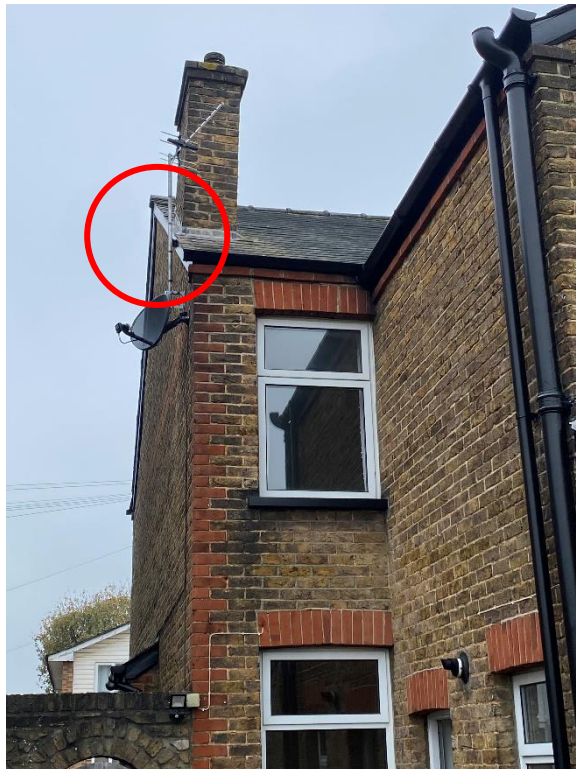
The external masonry to the end gable (flank) wall was noted to be bulging, notably towards the ridge line of the roof structure (Images 6 & 7). Within the internal loft space, missing, cracked and bulging brickwork was observed. There was also evidence of gaps in the roof finishes and moisture ingress within the internal loft space.

Image 6: End gable (flank) wall out of level at top of wall, near to ridge line.

Image 7: End gable (flank) wall out of level at top of wall, near to ridge line.

The bulging of the brickwork to the end gable wall is believed to have been caused by insufficient tying together of the inner masonry leaf and outer masonry leaf with wall ties. During the site visit, the presence of wall ties was observed, however it is believed that these wall ties are either defective through corrosion, or alternatively that there are not a sufficient number of wall ties to correctly tie the two structures together and prevent the observed movement. It was also observed that sections of masonry within the inner leaf were missing, meaning that there are no wall ties tying the structures together at these locations.

Any areas of defective masonry are required to be replaced with new masonry and any areas where missing masonry was observed to be missing, notably within the inner leaf within the internal loft space, should be filled with new masonry. A greater number of wall ties are required to correctly tie the inner leaf and outer leaf together and to prevent the bulging brickwork that was observed. Where new masonry is being installed, wall ties can be installed simultaneously. Where existing masonry is not being replaced, wall ties can be installed within the existing masonry. It must be ensured that any newly installed wall ties are correctly installed, and will therefore correctly tie the inner leaf and outer leaf together, preventing the observed bulging from occurring. Ideally, wall ties should be evenly distributed so that there are a minimum of 2.5 wall ties per square metre and they should be staggered between courses of brickwork.

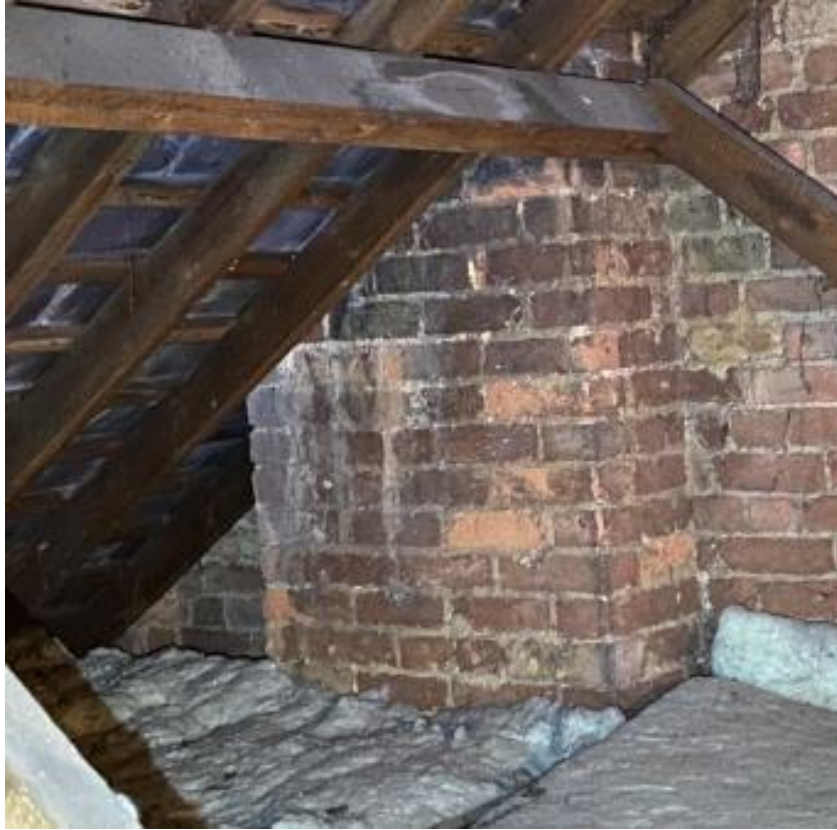
Image 8: Rear flank chimney breast within internal loft space.

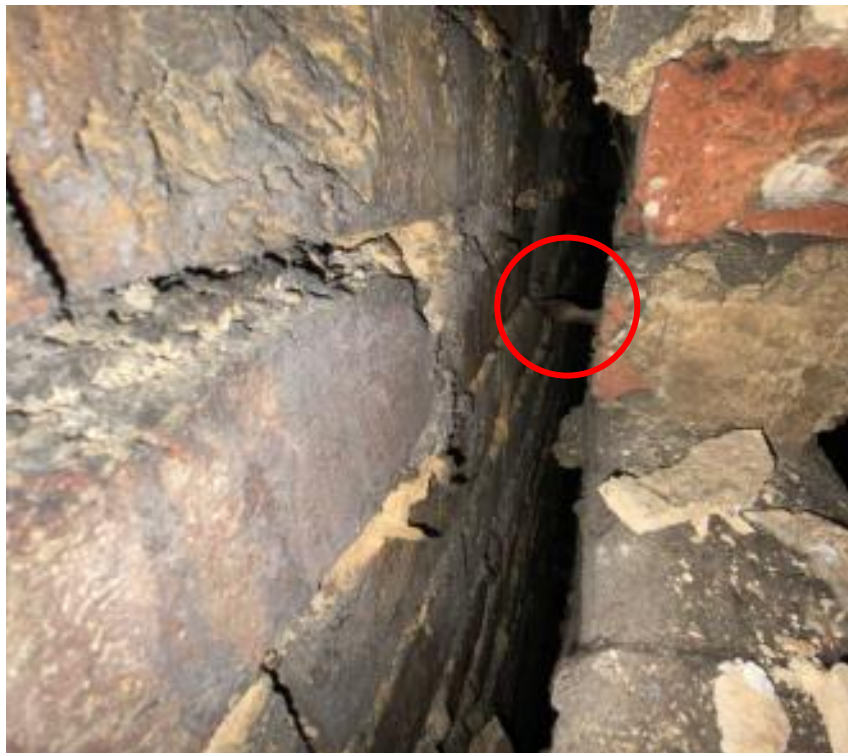
Image 9: Bulged and missing brickwork within internal loft space. Wall tie circled.

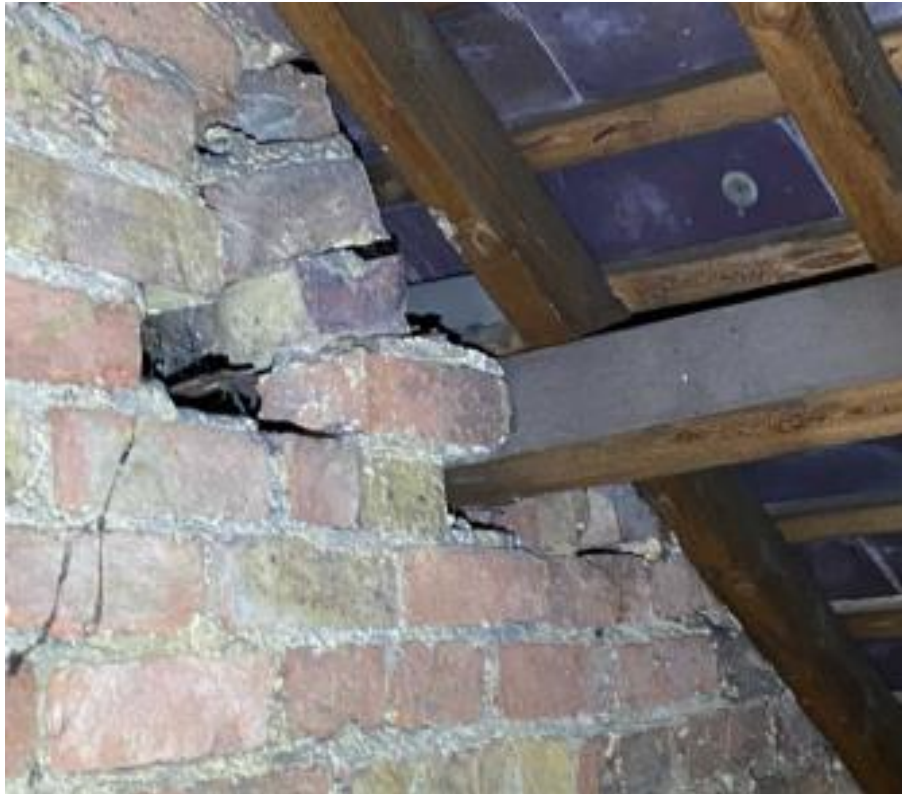
Image 10: Missing brickwork beneath front roof purlin.
