# **BYZANTINE ARCHITECTURE IN ALBANIA**

**CONSOLIDATION AND RESTORATION OF THE  
CHURCH OF THE NATIVITY OF ST. MARY  
IN LABOVË E KRYQIT – GJIROKASTËR**

**RESTORATION OF THE CHURCH OF ST.  
MARY IN PESHKËPI E SIPËRME,  
GJIROKASTËR**

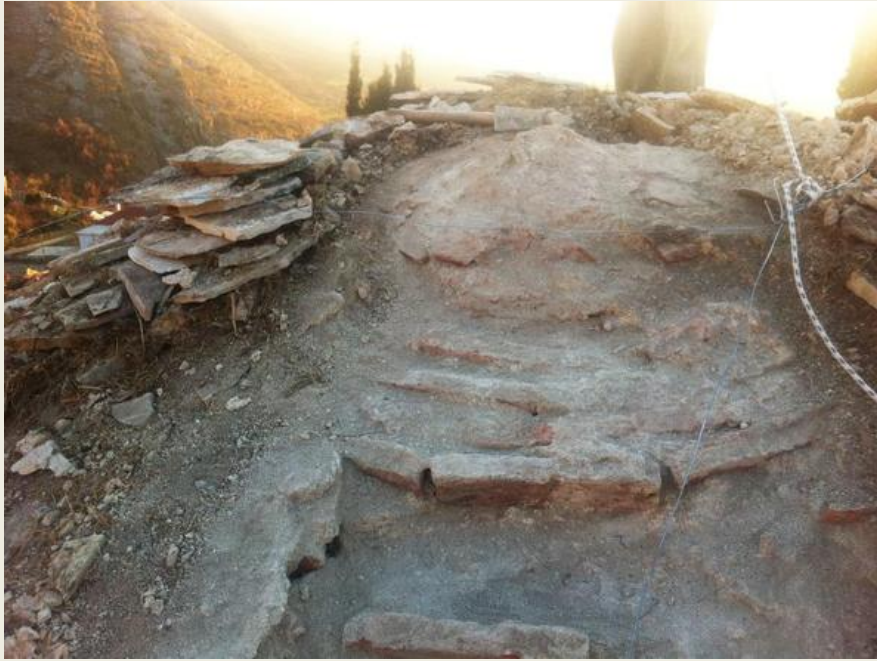
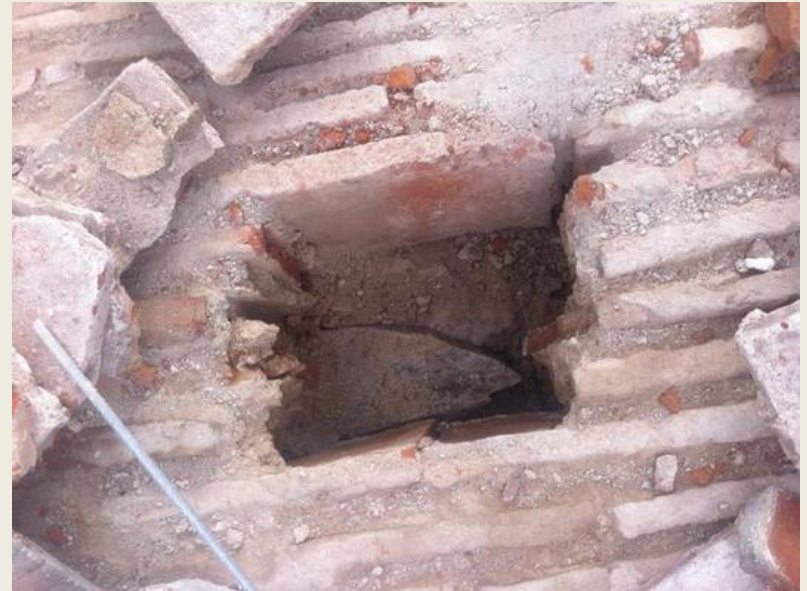
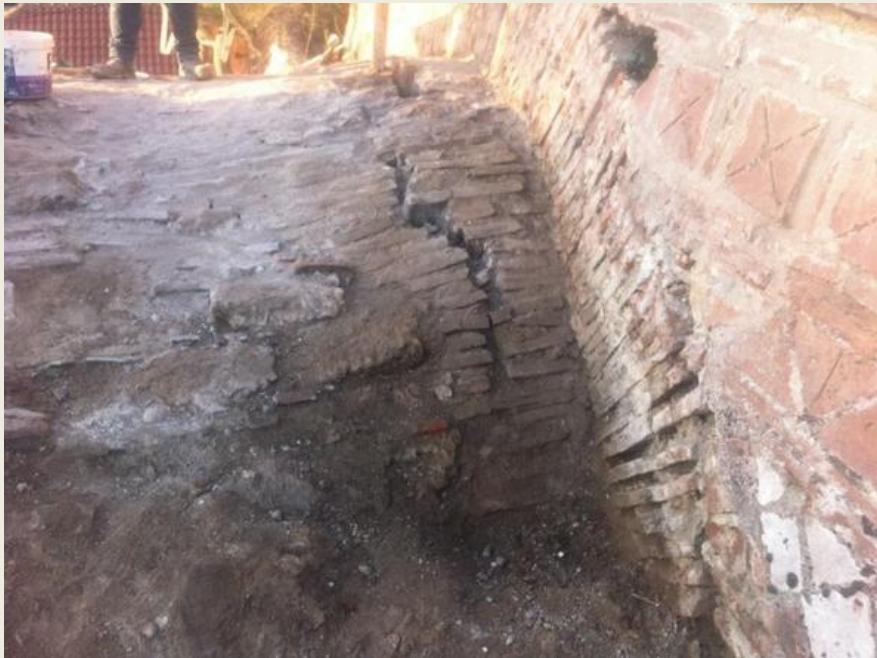
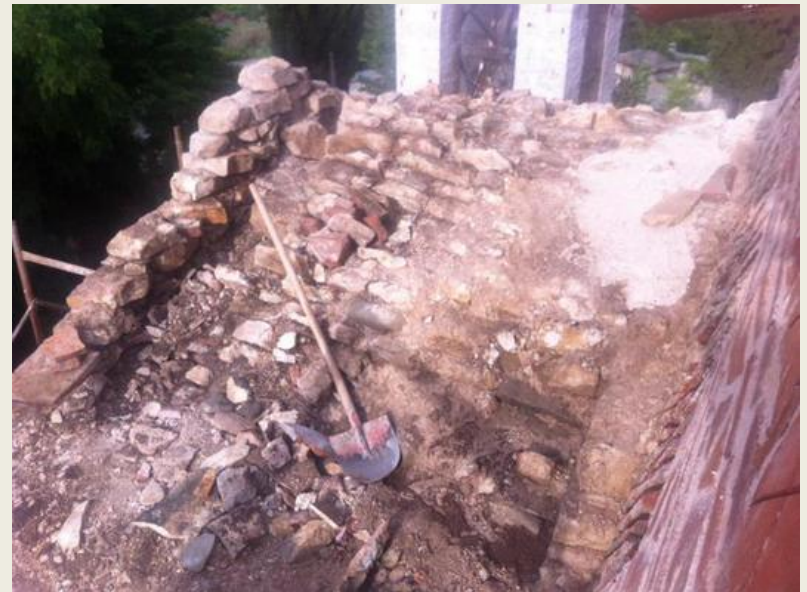
## THE DAMAGES TO THE STRUCTURE

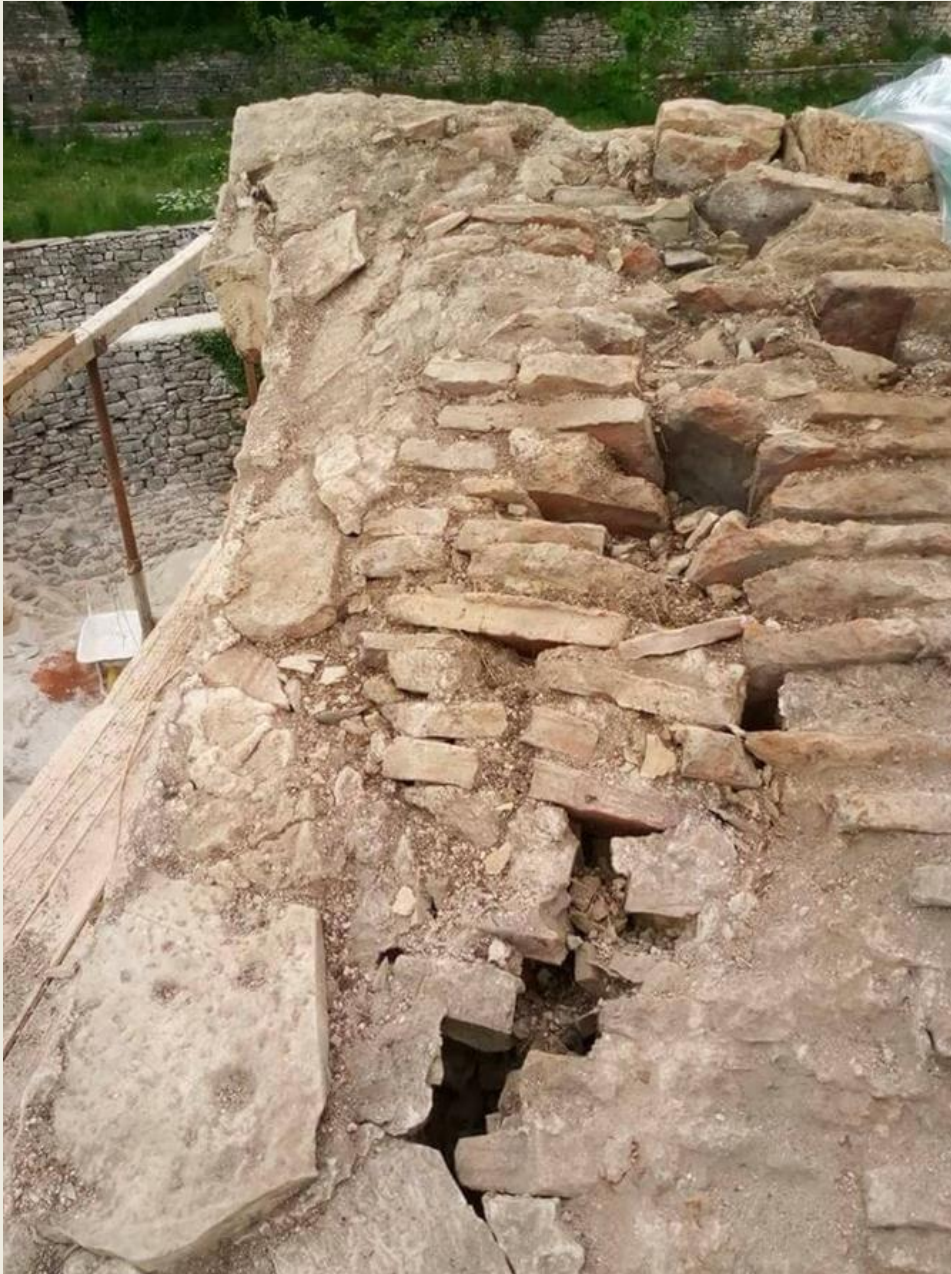
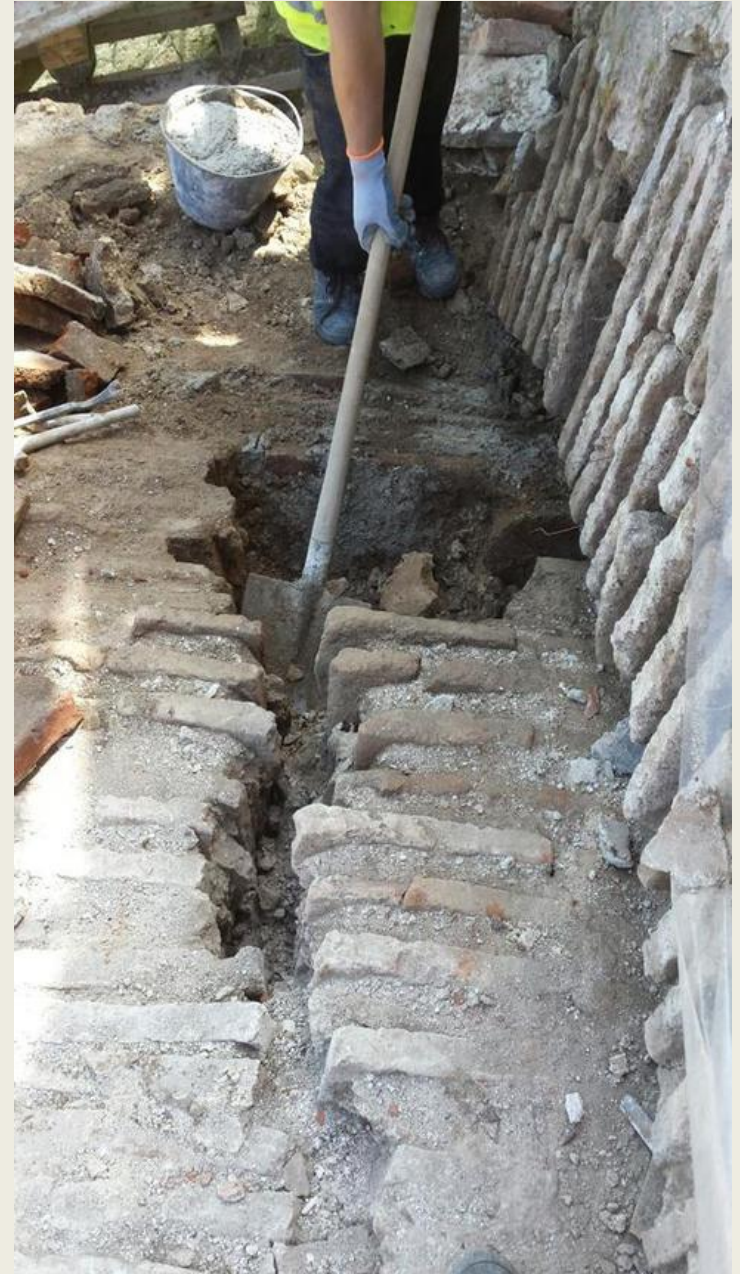
## THE DAMAGES TO THE STRUCTURE

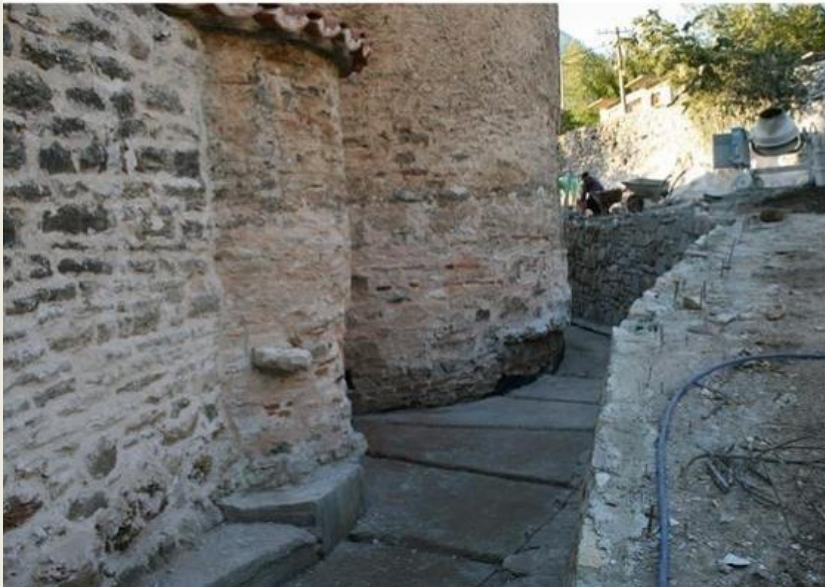
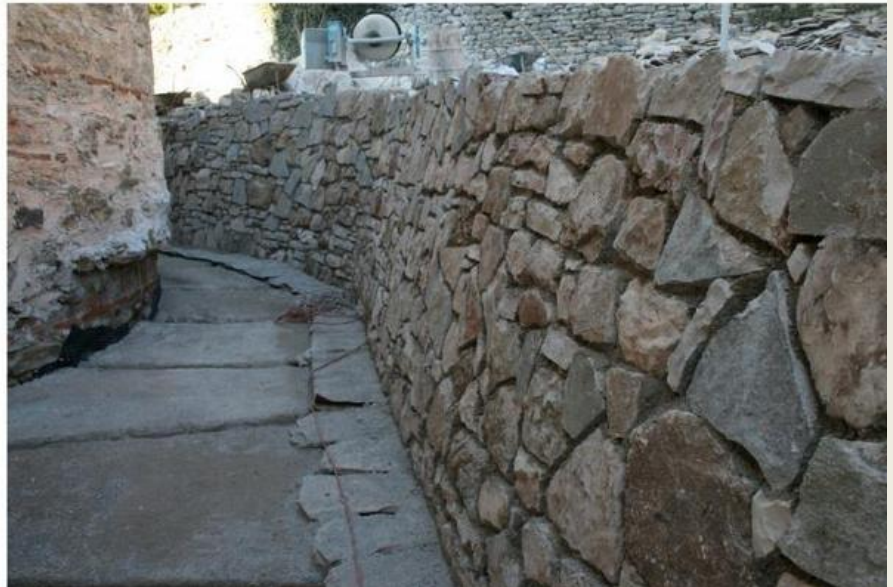
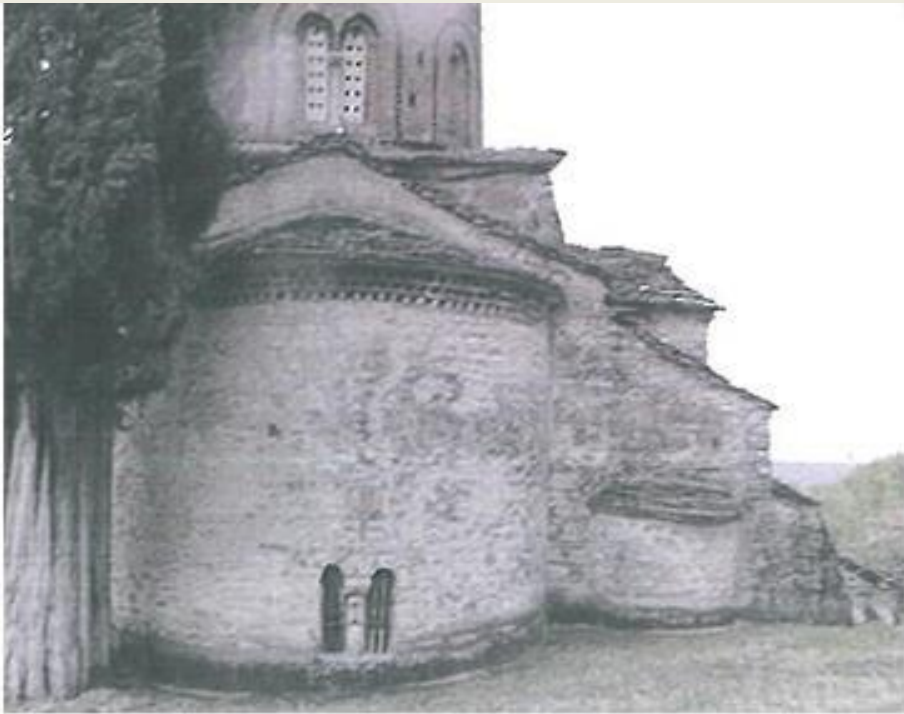
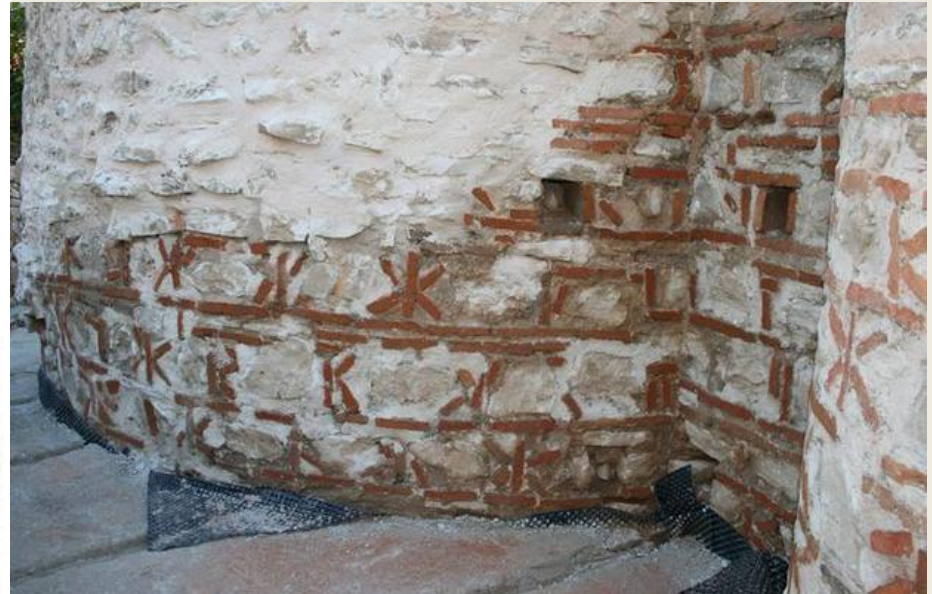
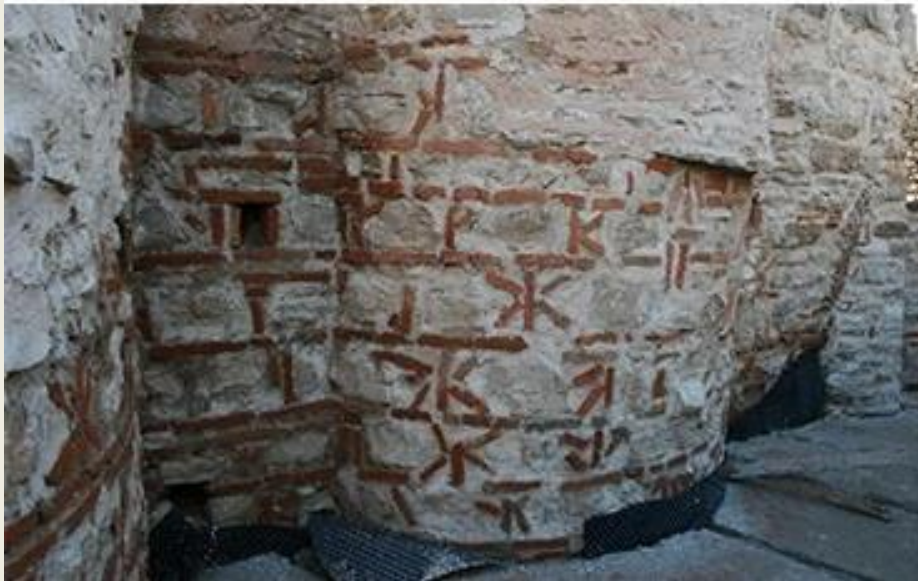
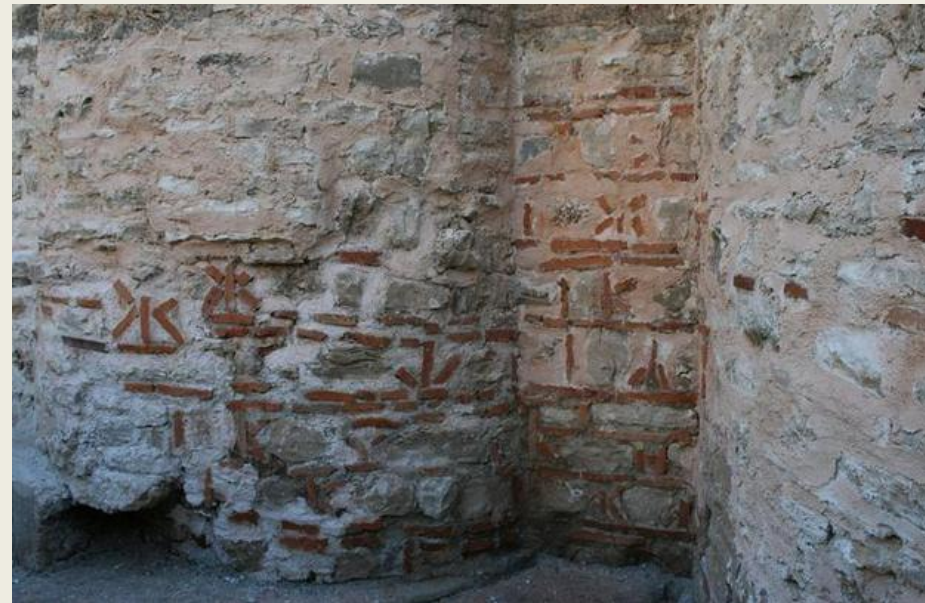
# THE UNCOVERING OF THE EASTERN FAÇADE

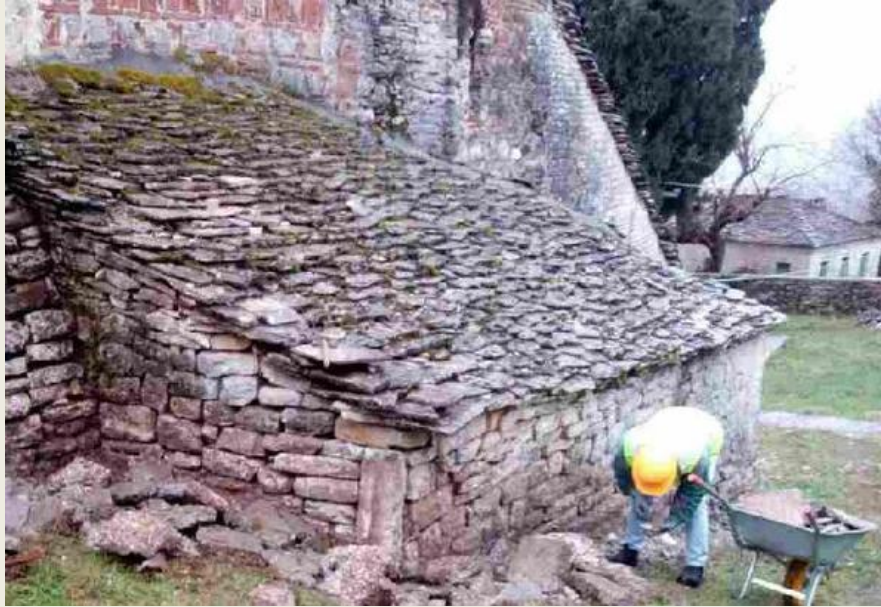
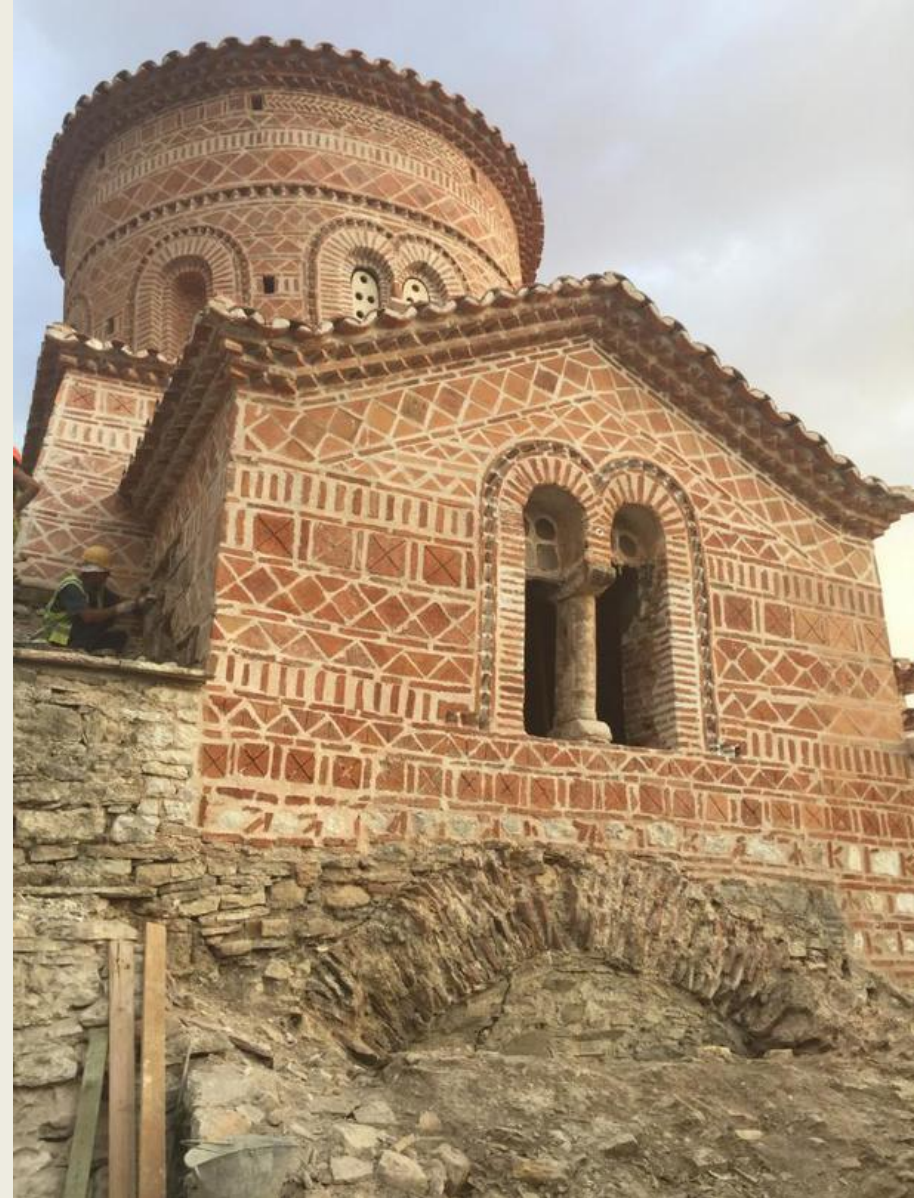
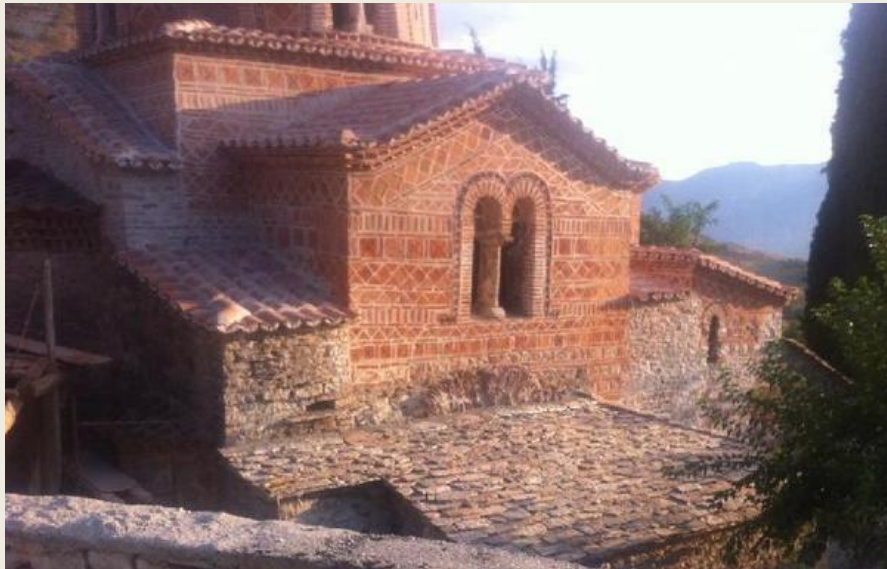
# THE UNCOVERING OF THE NORTHERN FAÇADE

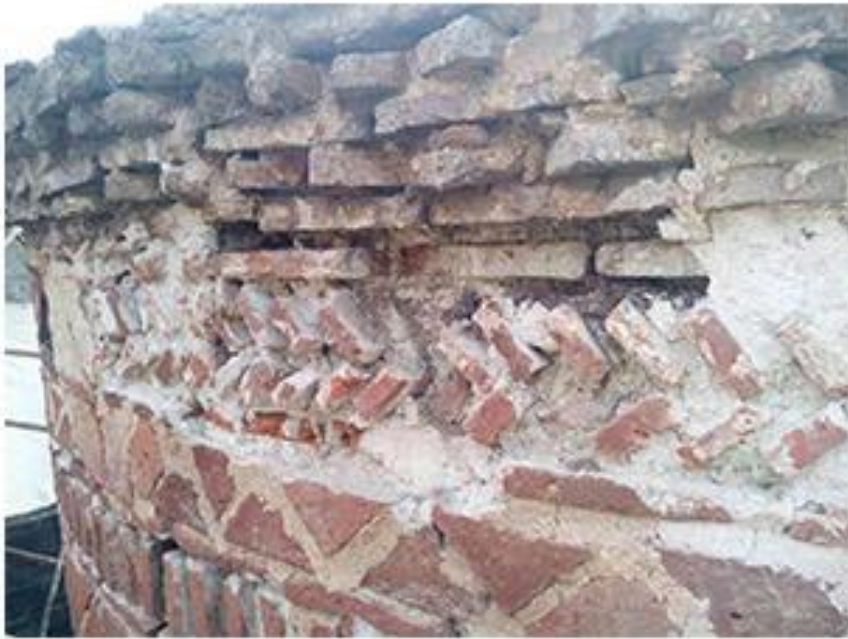
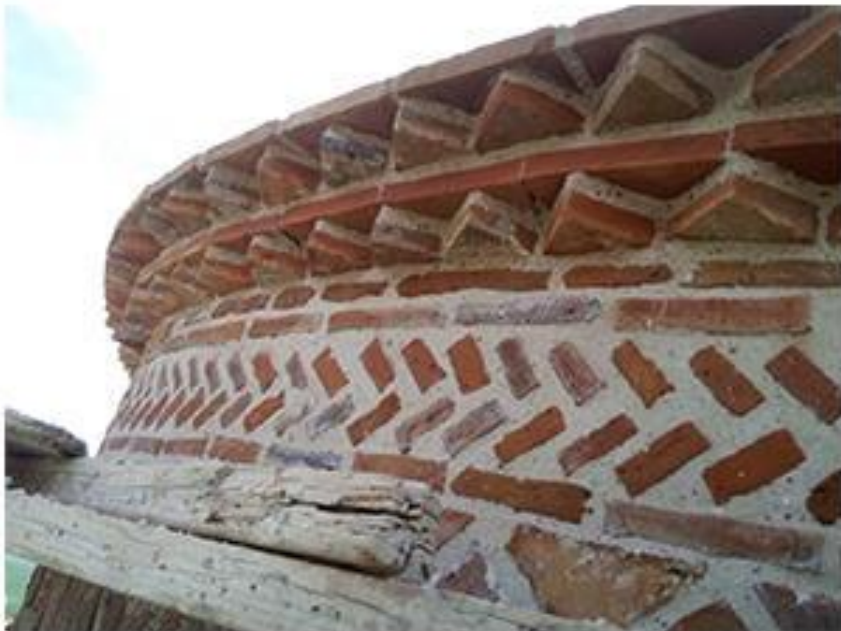
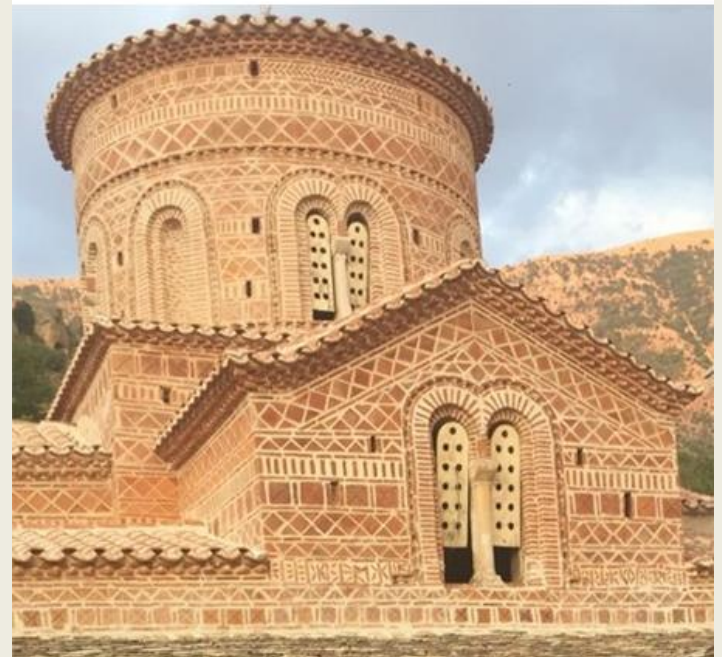
# THE RESTORATION OF THE DECORATION

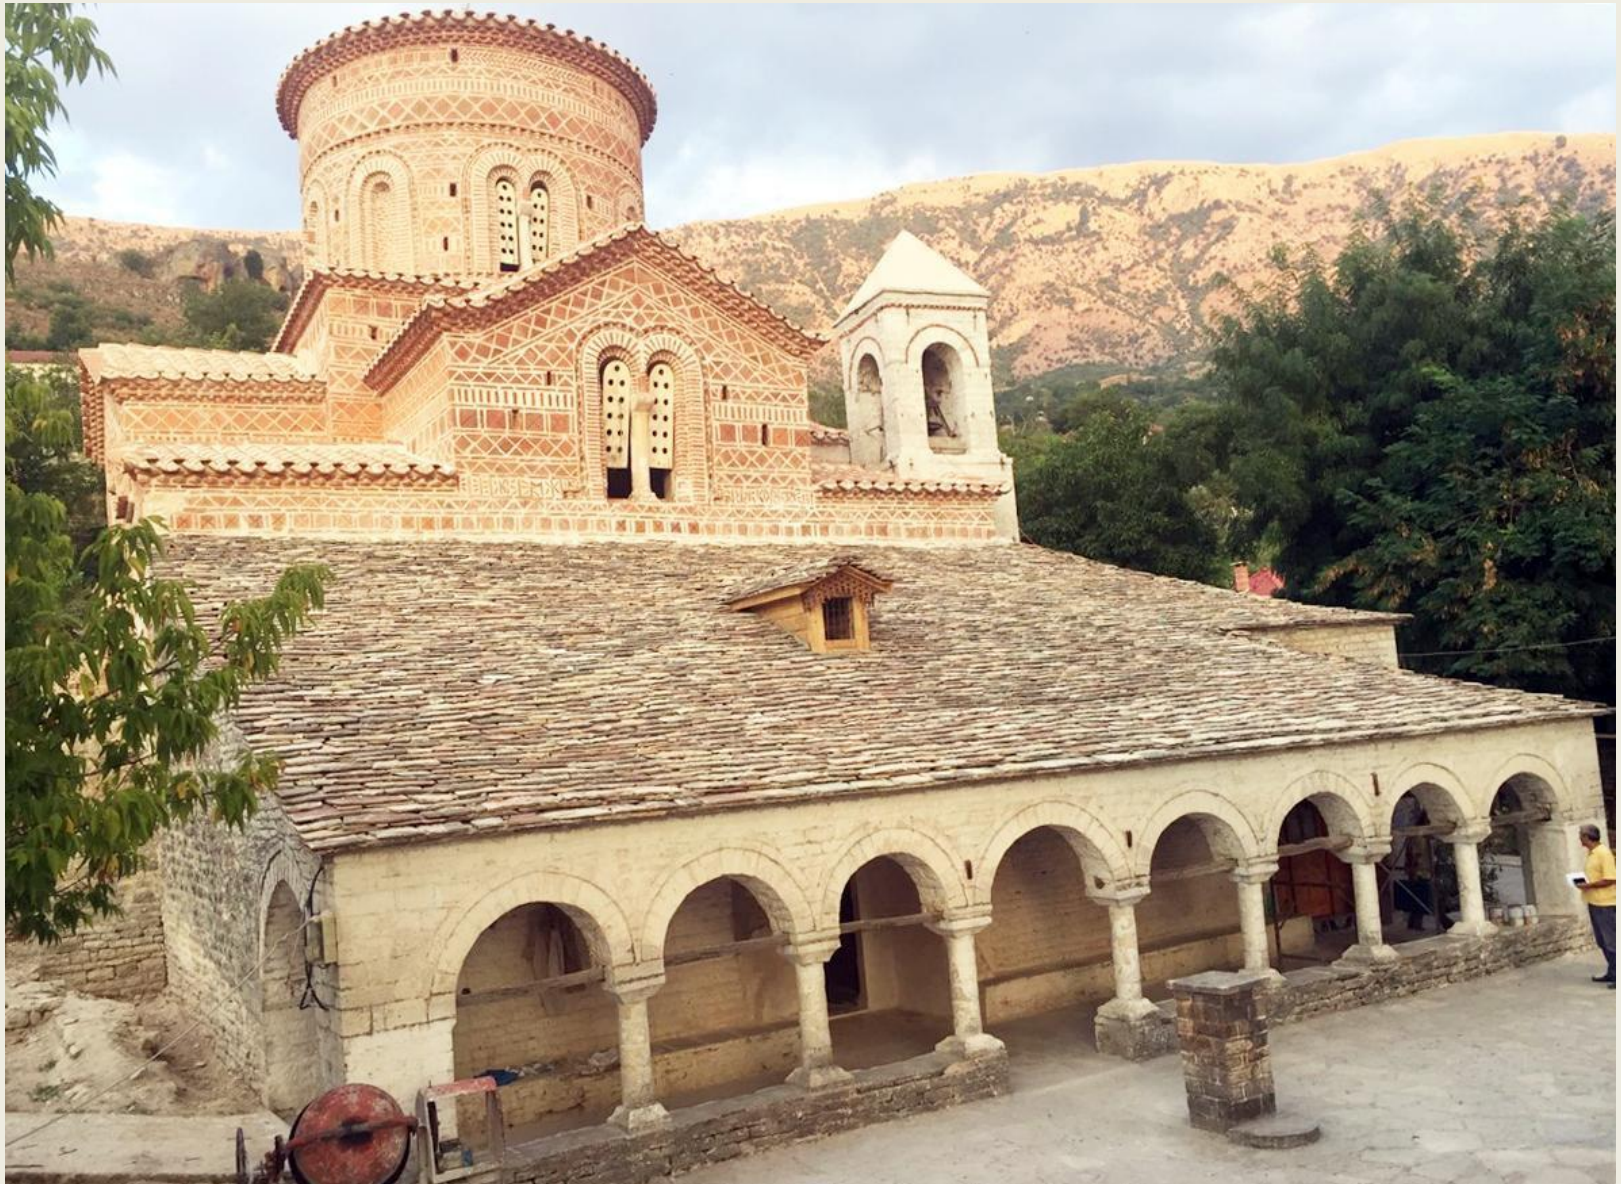
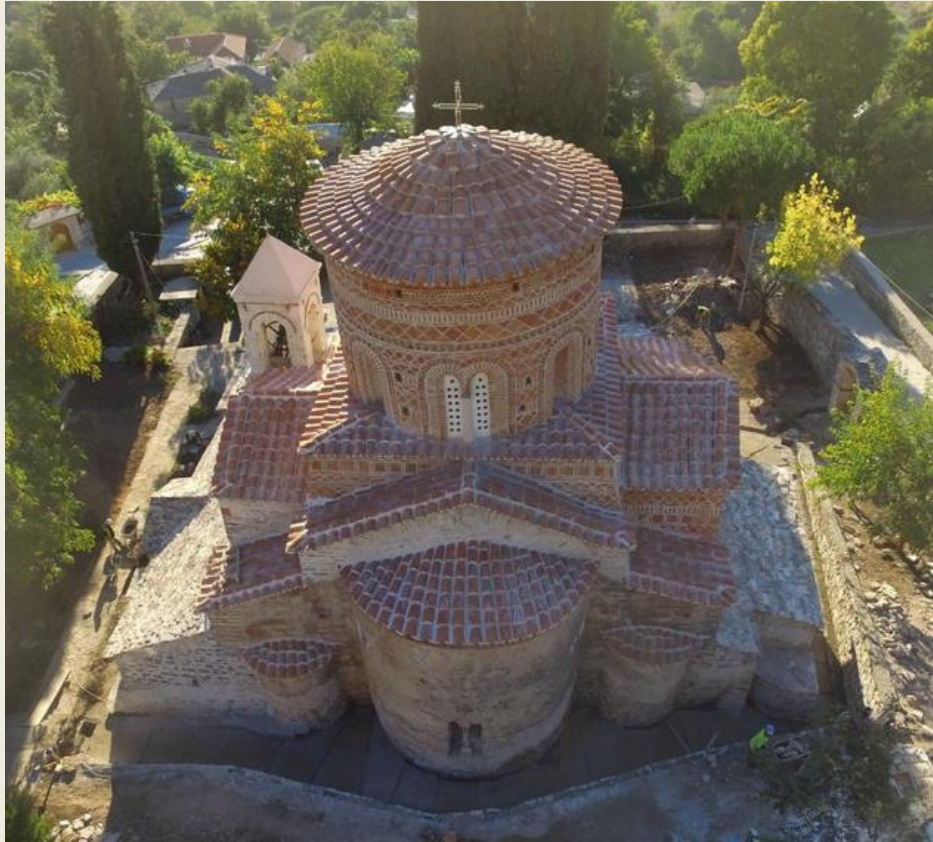
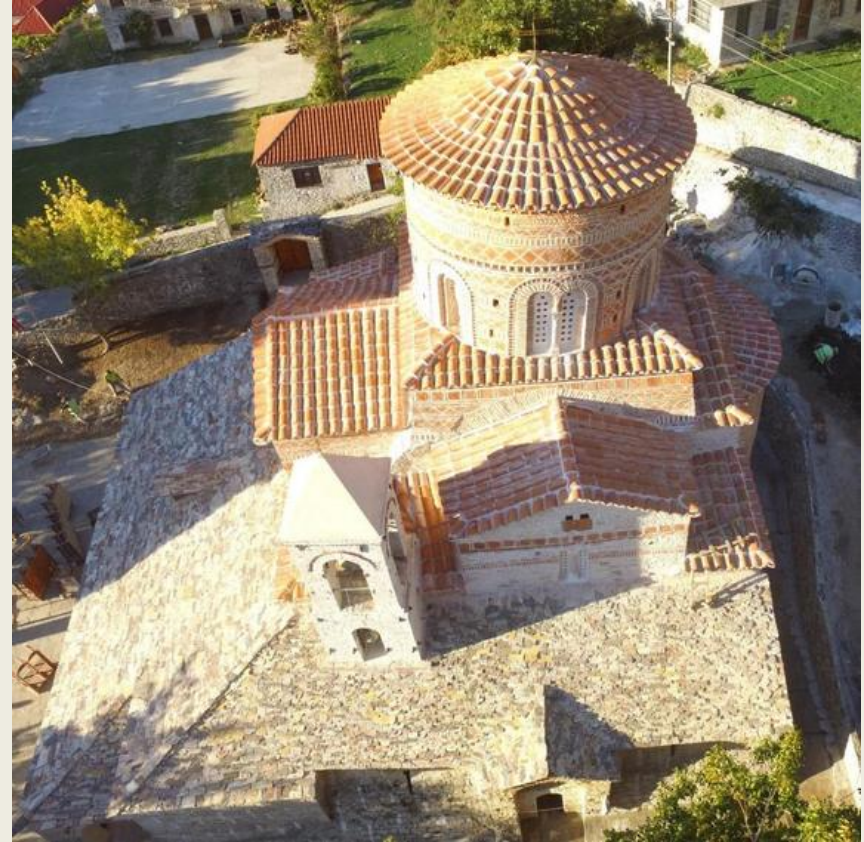
# THE MONUMENT AFTER RESTORATION

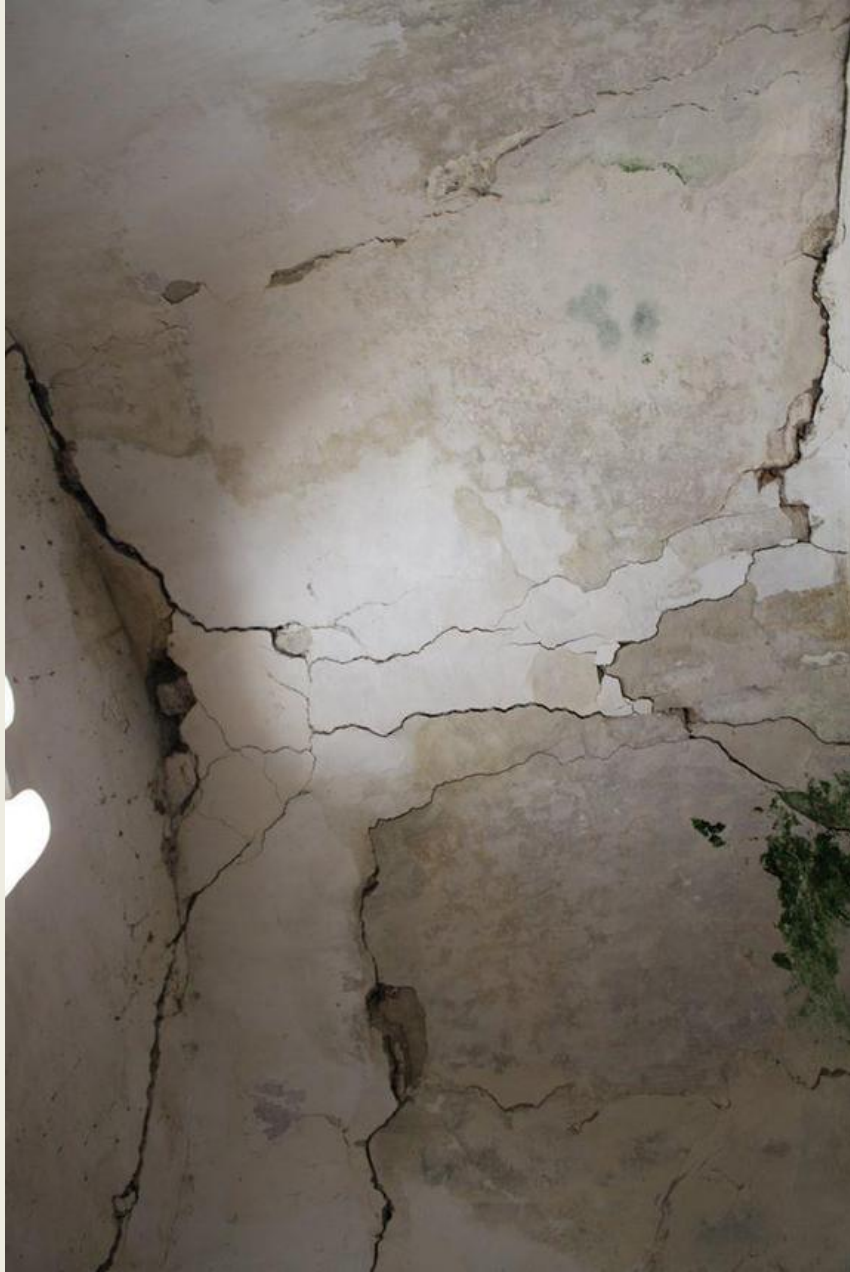
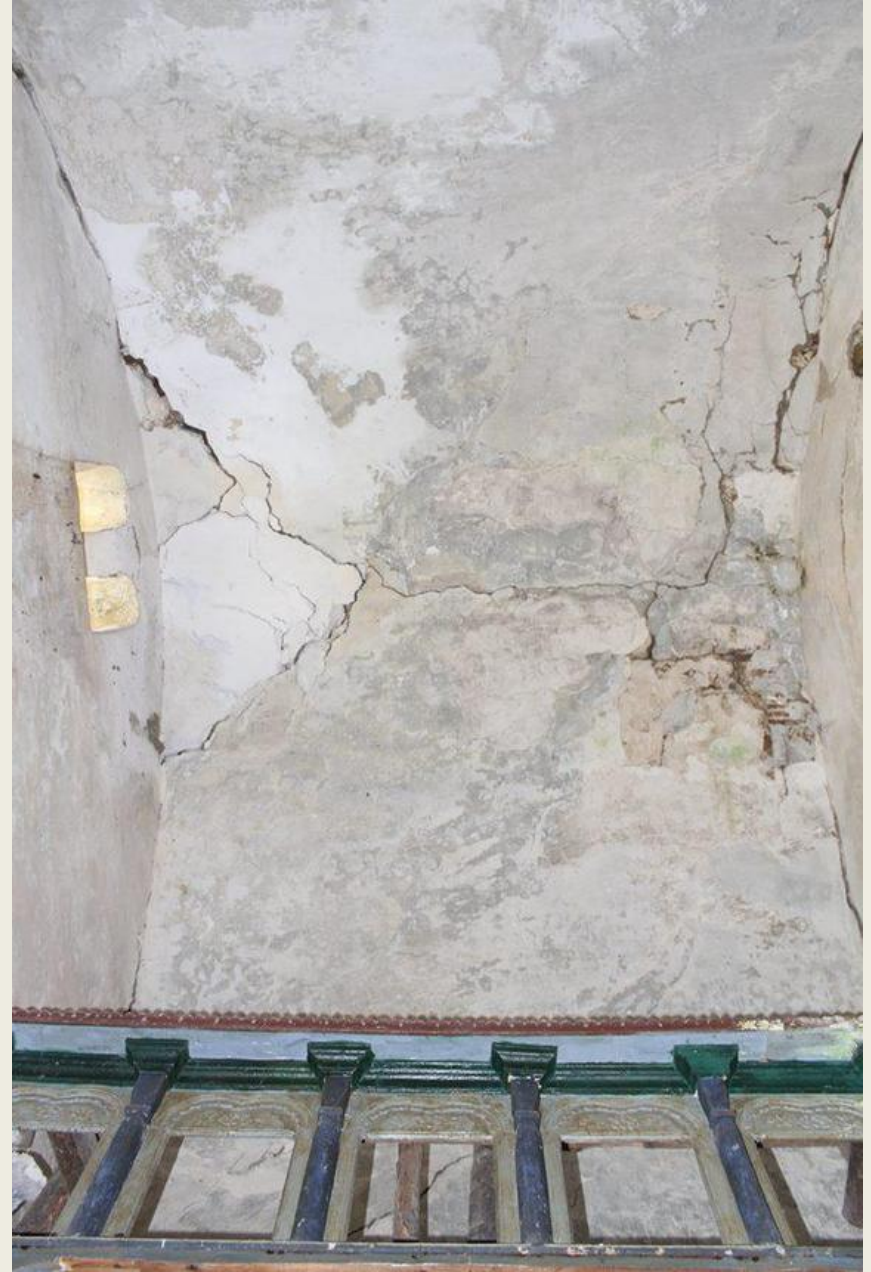
# CRACKS IN CURVED STRUCTURES

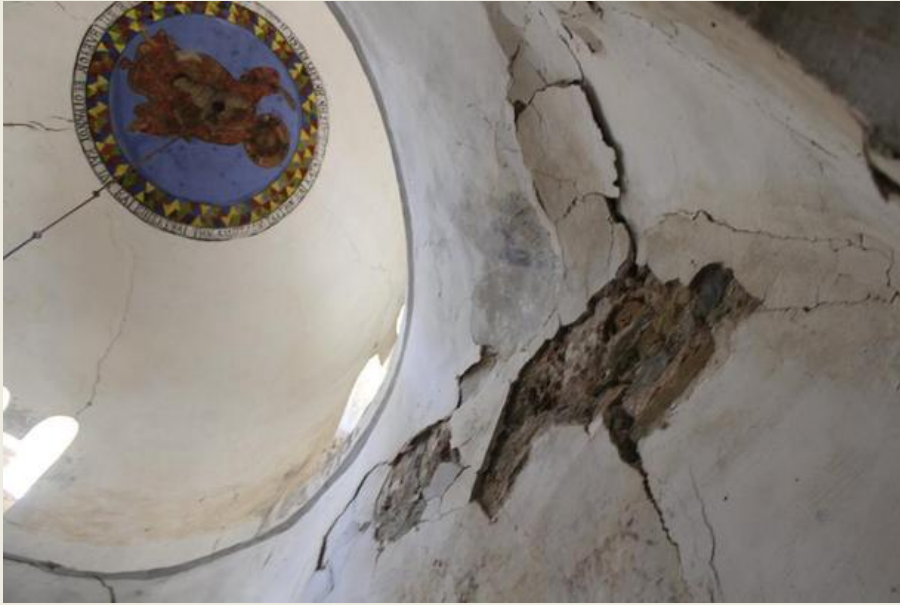
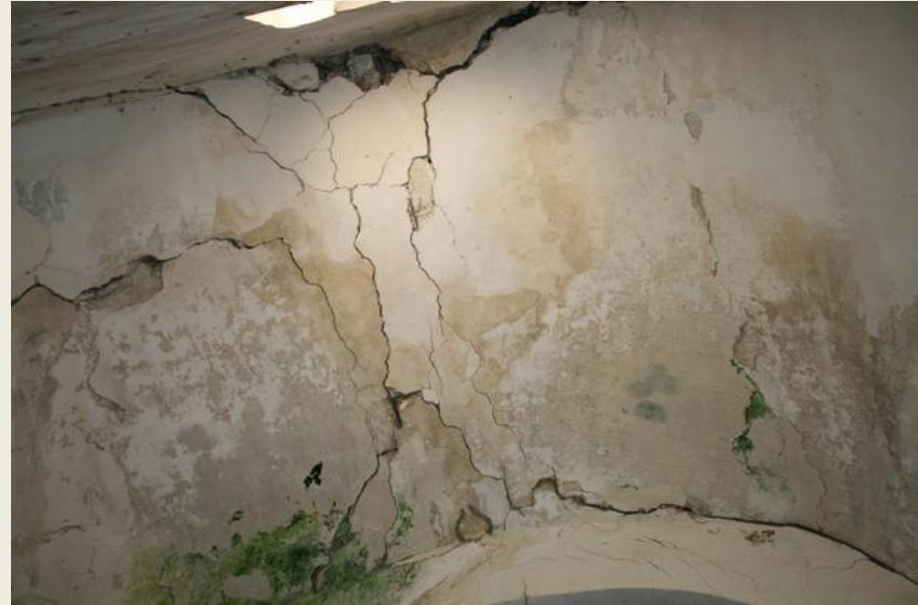
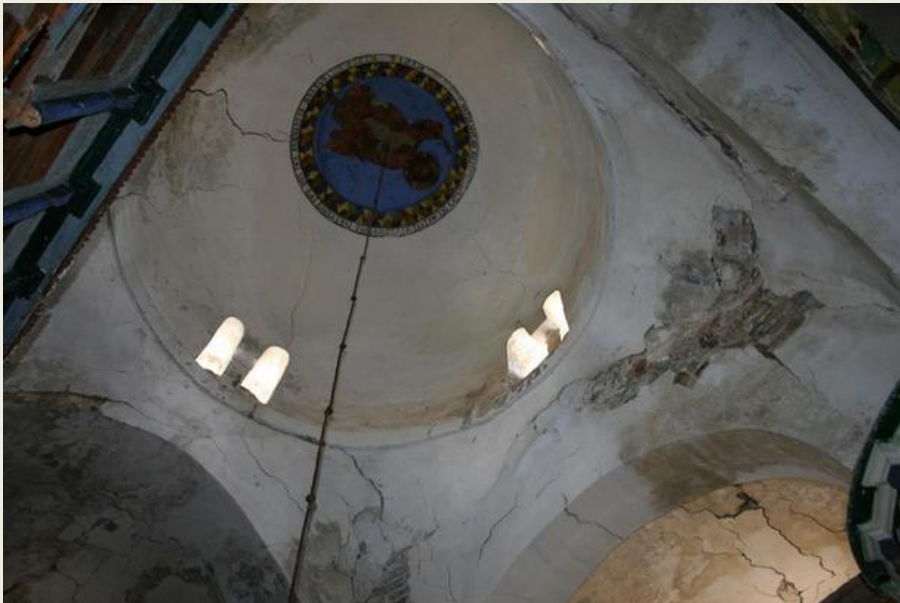
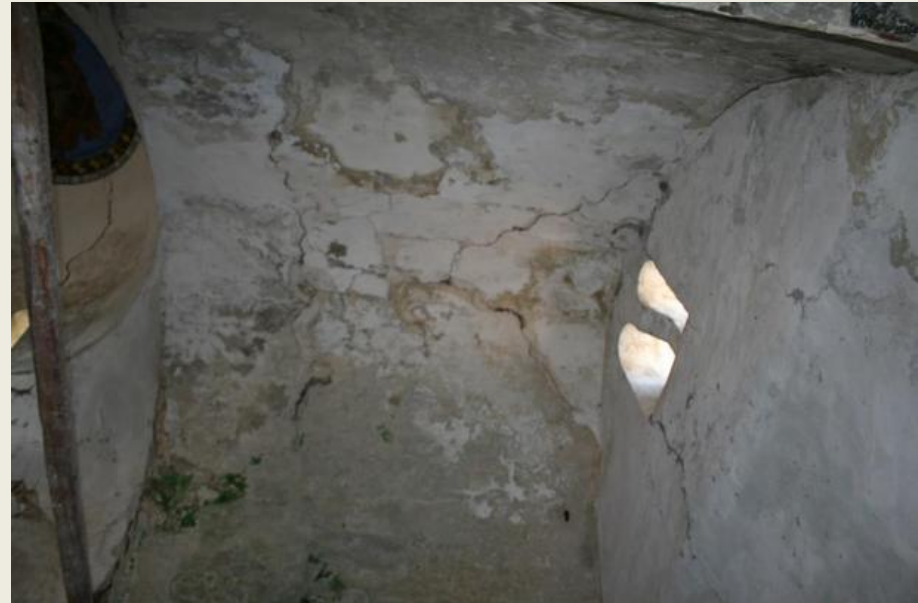
# CRACKS IN CURVED STRUCTURES

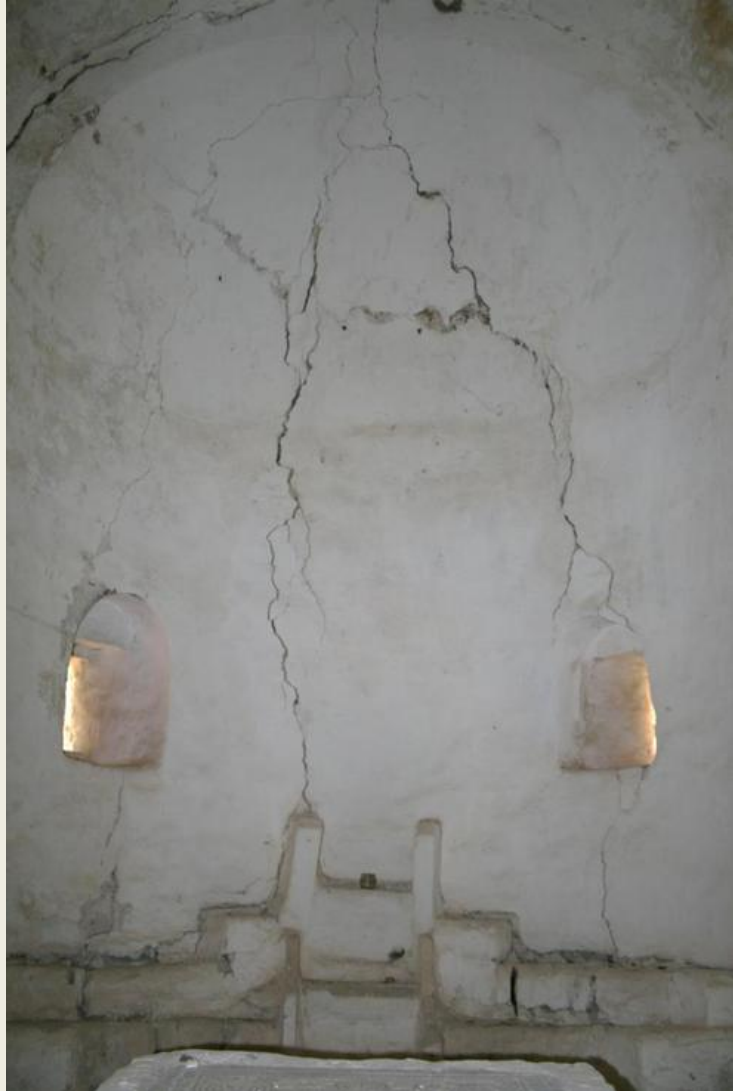
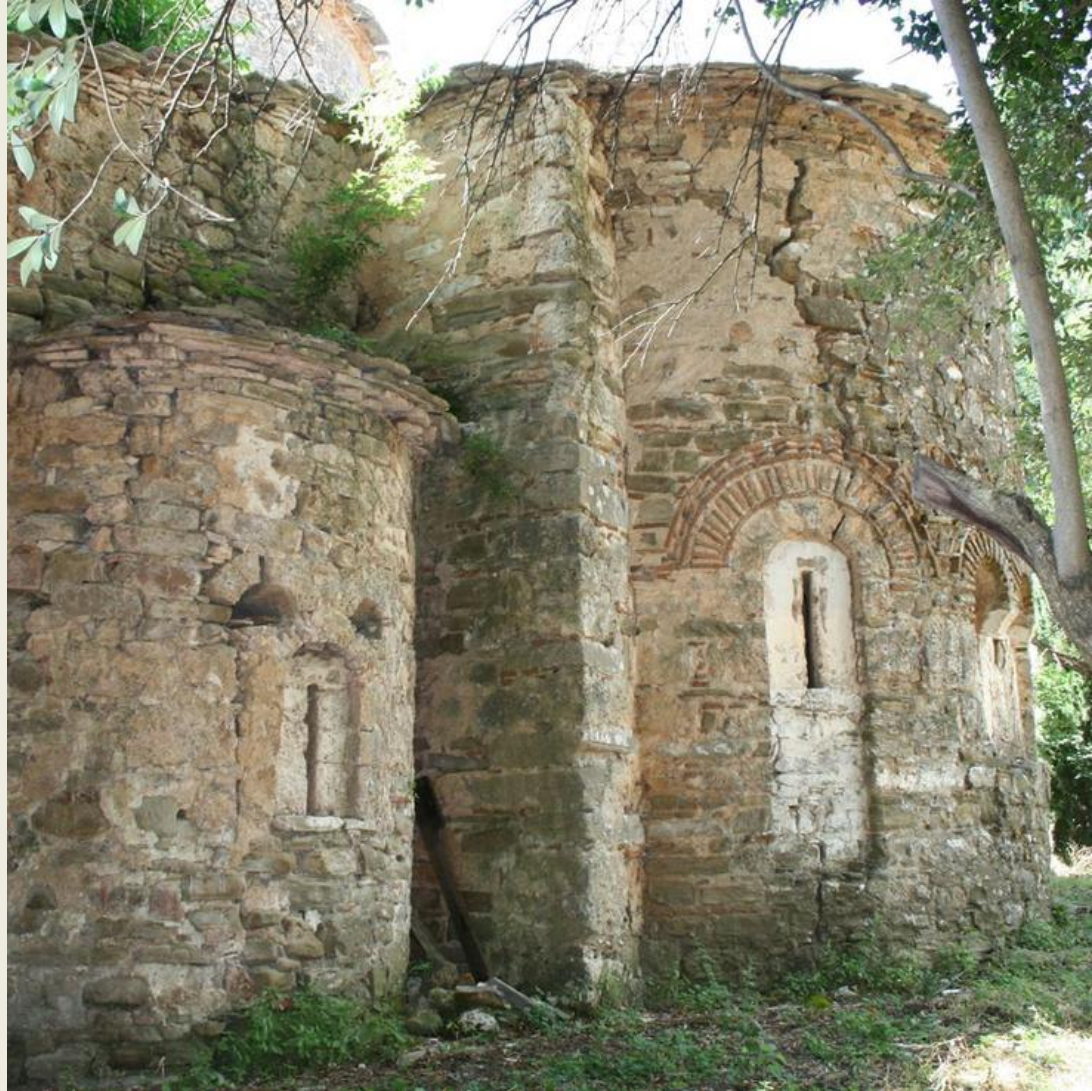
## CRACKS IN THE APSES

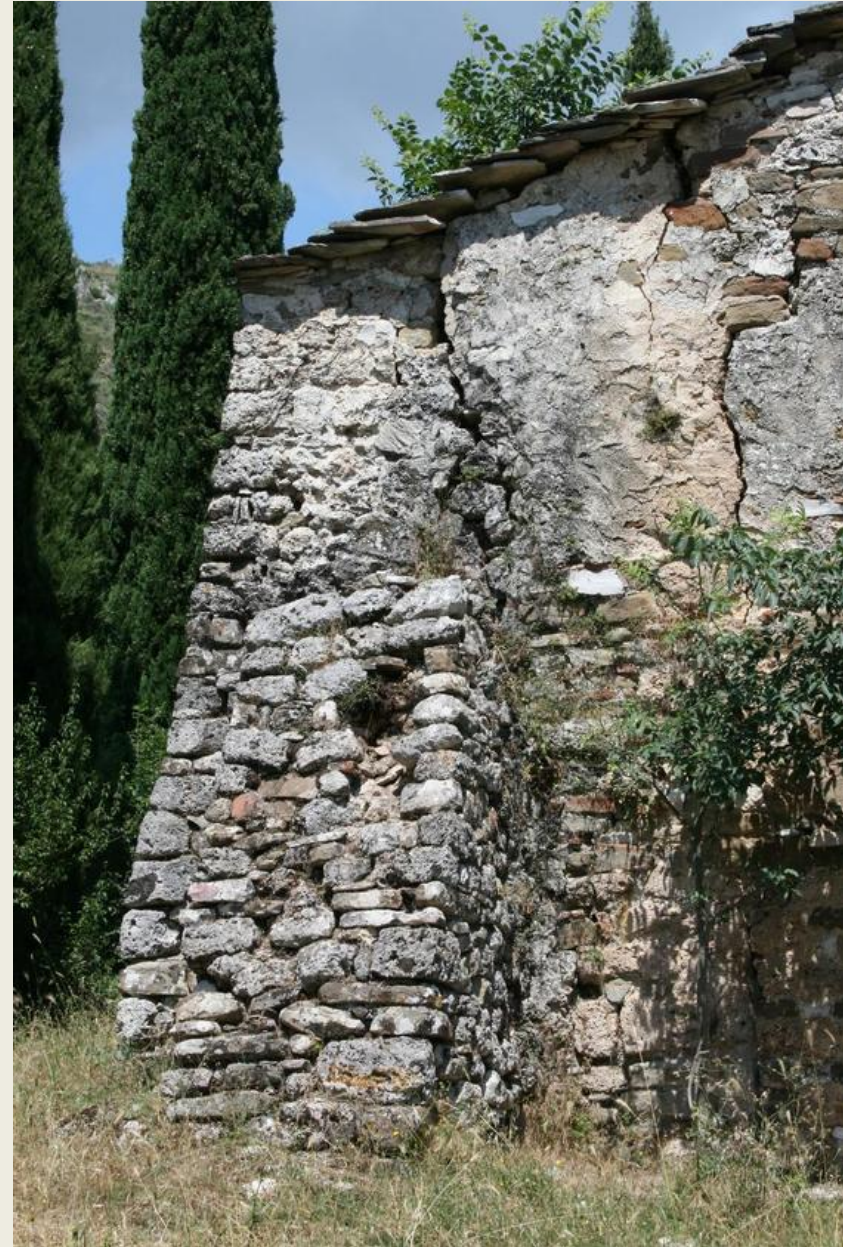
# CRACKS IN MASONRY
