# **BYZANTINE ARCHITECTURE IN ALBANIA**

**CONSOLIDATION AND RESTORATION OF THE  
CHURCH OF THE NATIVITY OF ST. MARY  
IN LABOVË E KRYQIT – GJIROKASTËR**

**RESTORATION OF THE CHURCH OF ST.  
MARY IN PESHKËPI E SIPËRME,  
GJIROKASTËR**

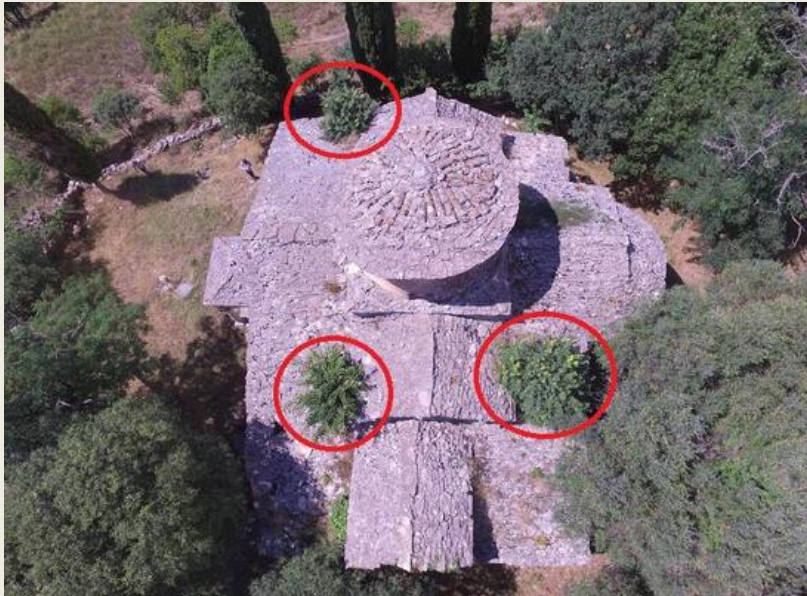
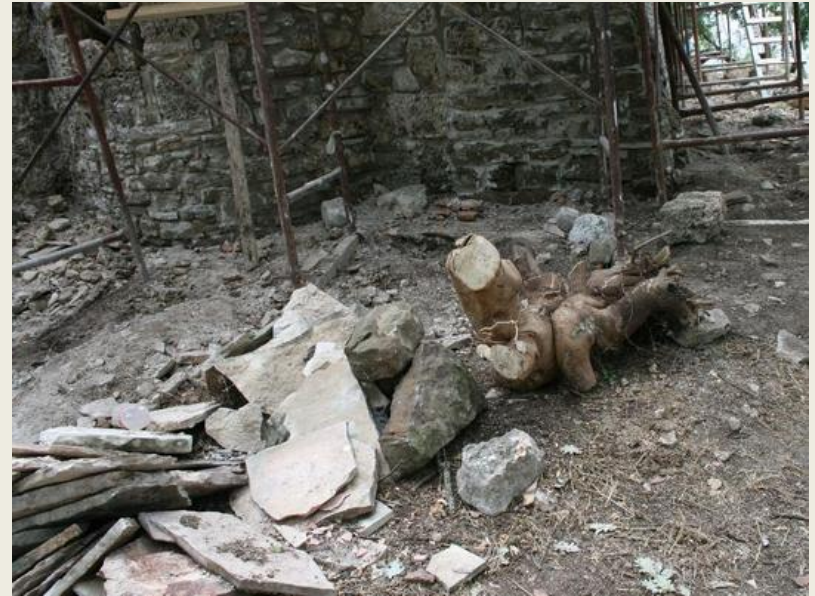
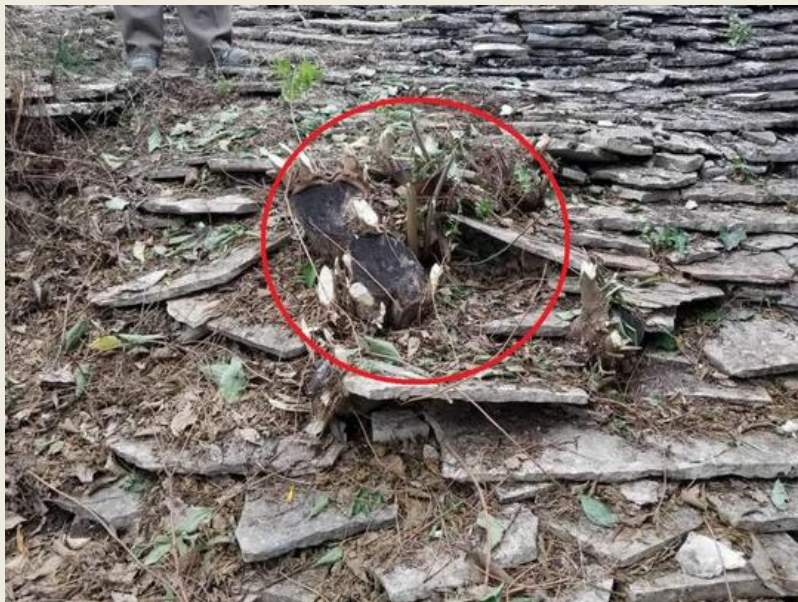
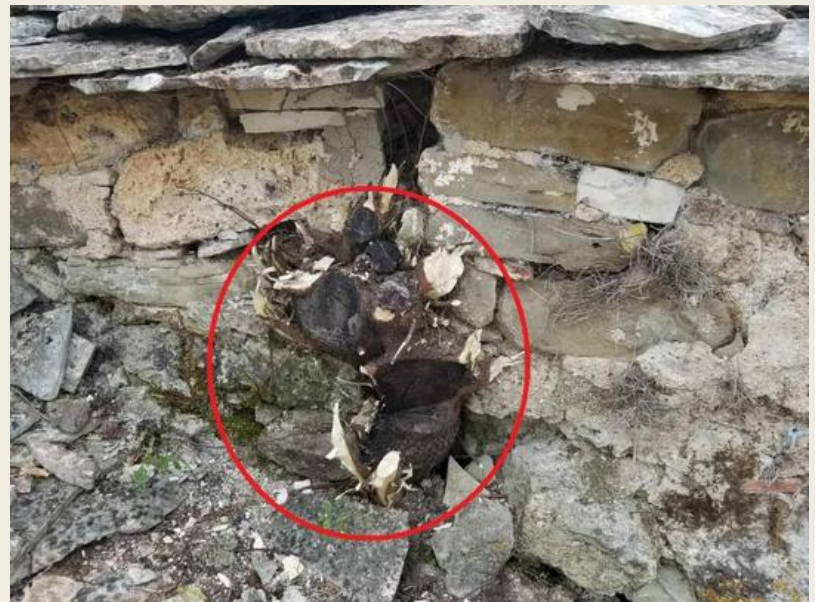
# THE GROWTH OF TREES INSIDE THE CHURCH

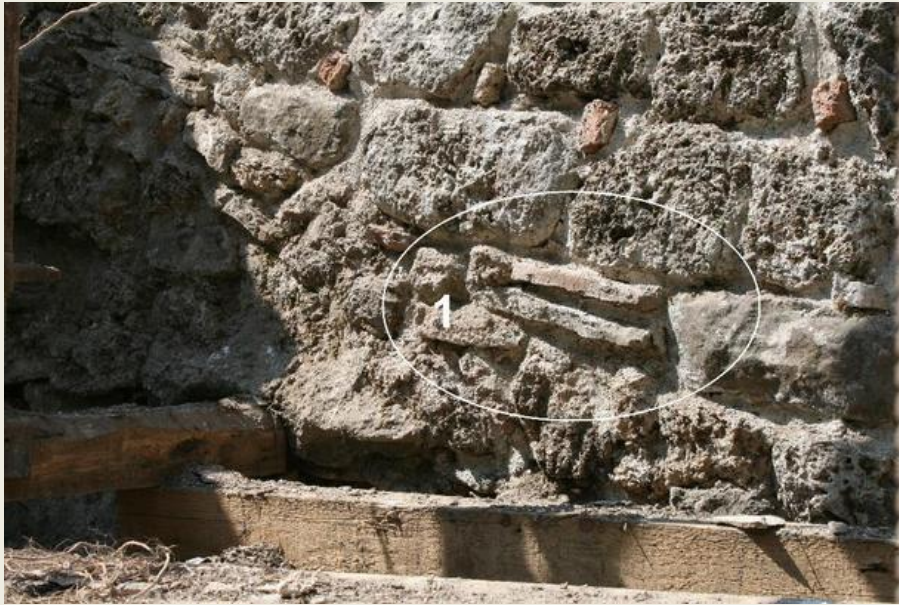
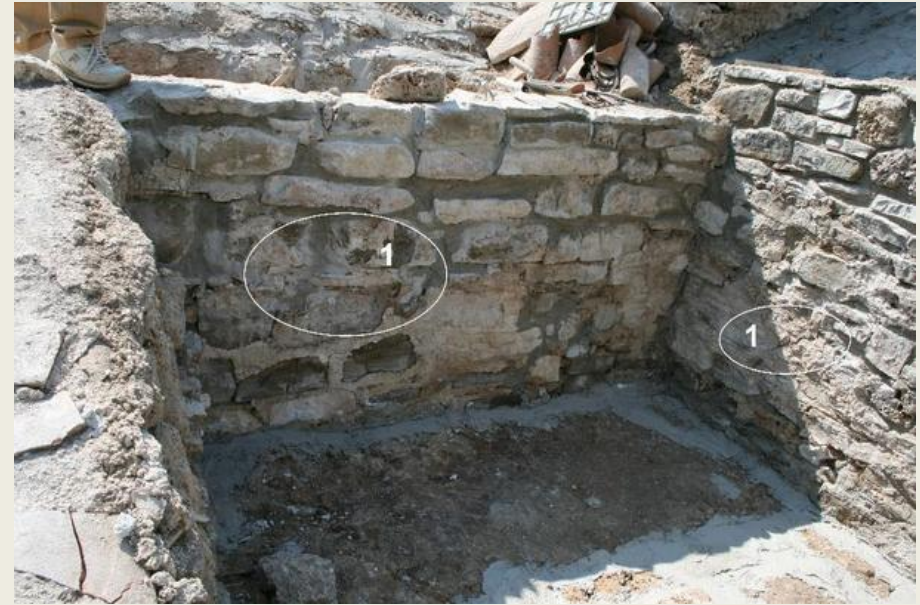
1 A. TRACES OF THE CORNICES  
OF THE ROOFS OF THE CORNER  
SPACES ON THE EASTERN WALL  
B. TRACES OF THE ROOF LEVELS  
OF THE NORTHEASTERN  
CORNER SPACE

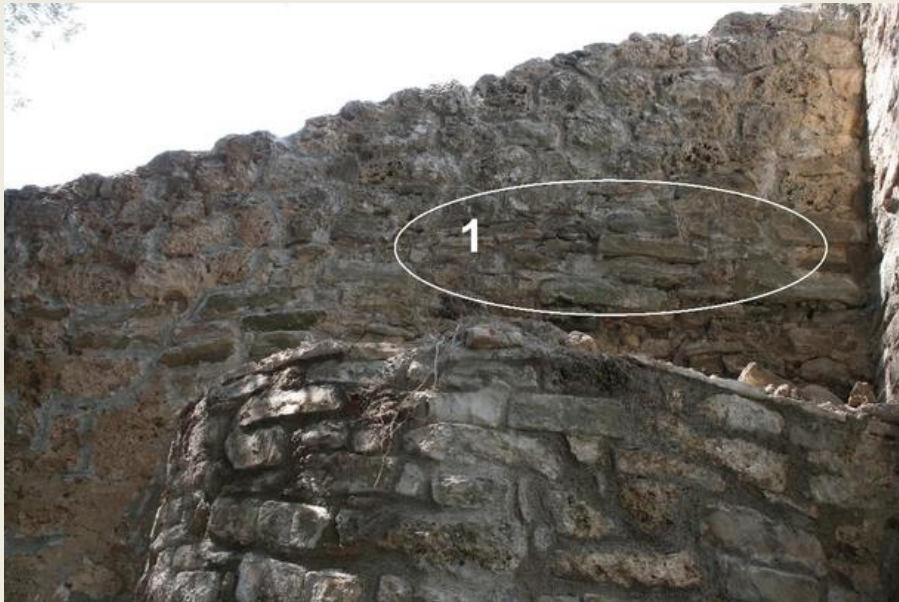
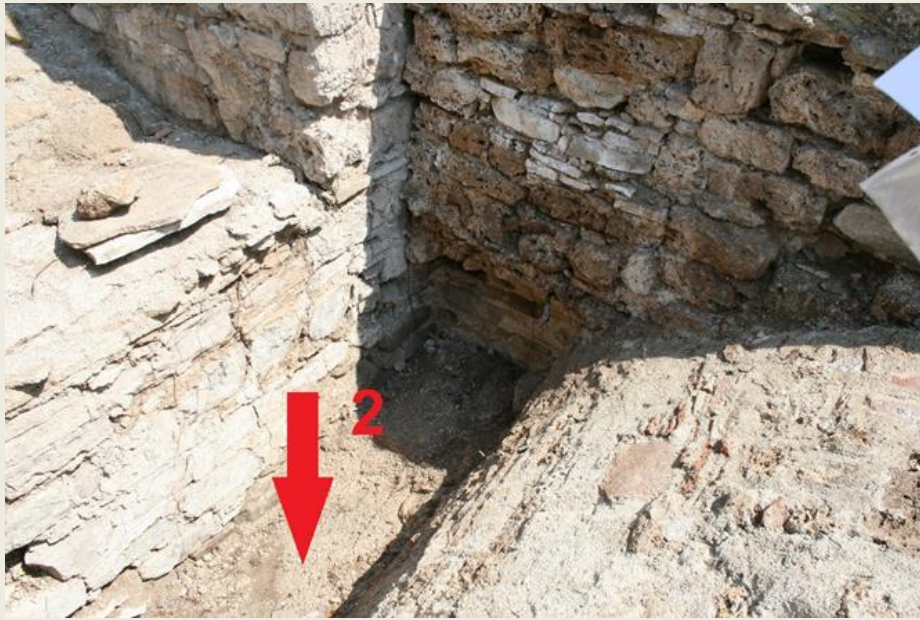
2 A. TRACES OF THE GUTTER  
BETWEEN THE ROOFS OF THE  
CORNER SPACES AND THE  
DOUBLE-PITCHED ROOFS OF  
THE SOUTHERN ADDITION  
(SECOND CONSTRUCTION  
PHASE OF THE CHURCH)

2 B. TRACES OF THE GUTTER  
OUTLET ON THE EASTERN WALL

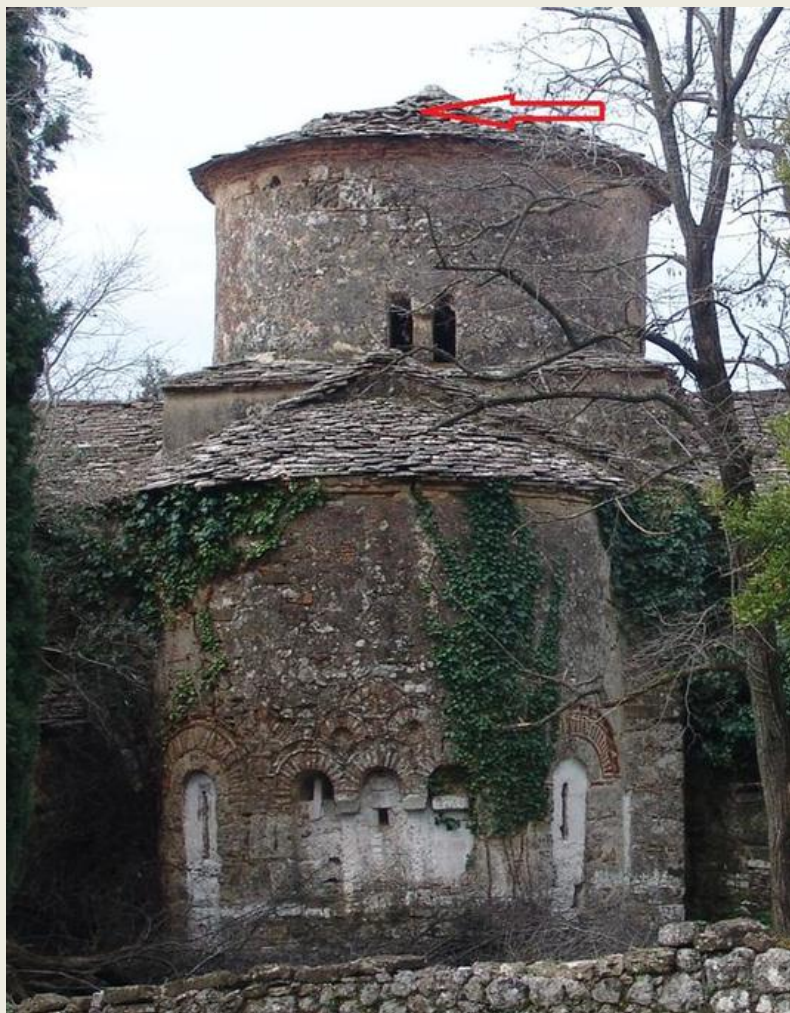
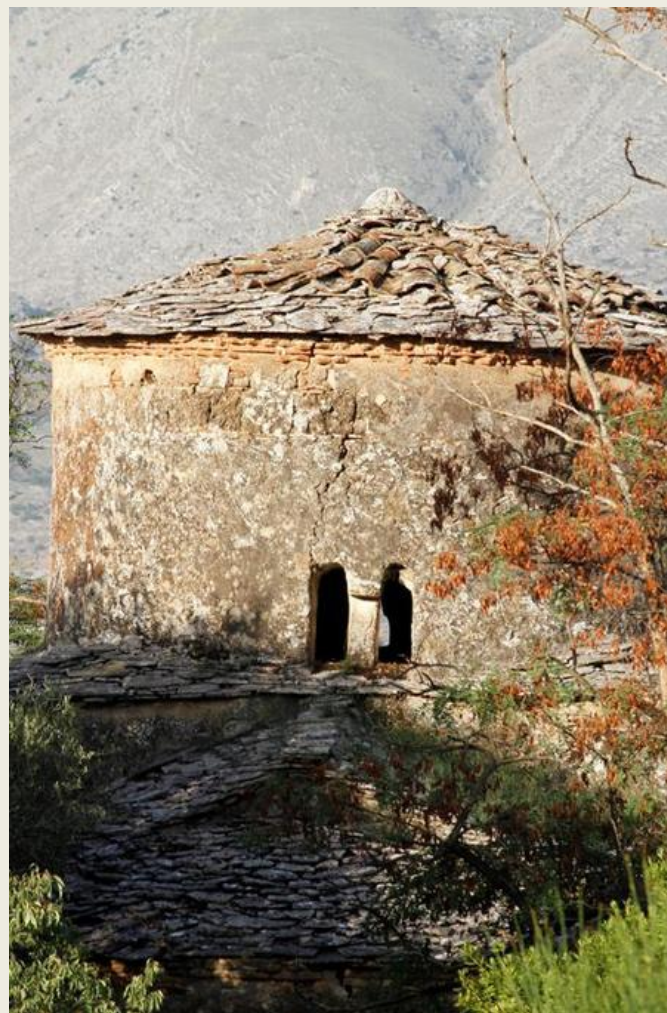
## TRACES OF THE TILES FROM THE ORIGINAL ROOF COVERING

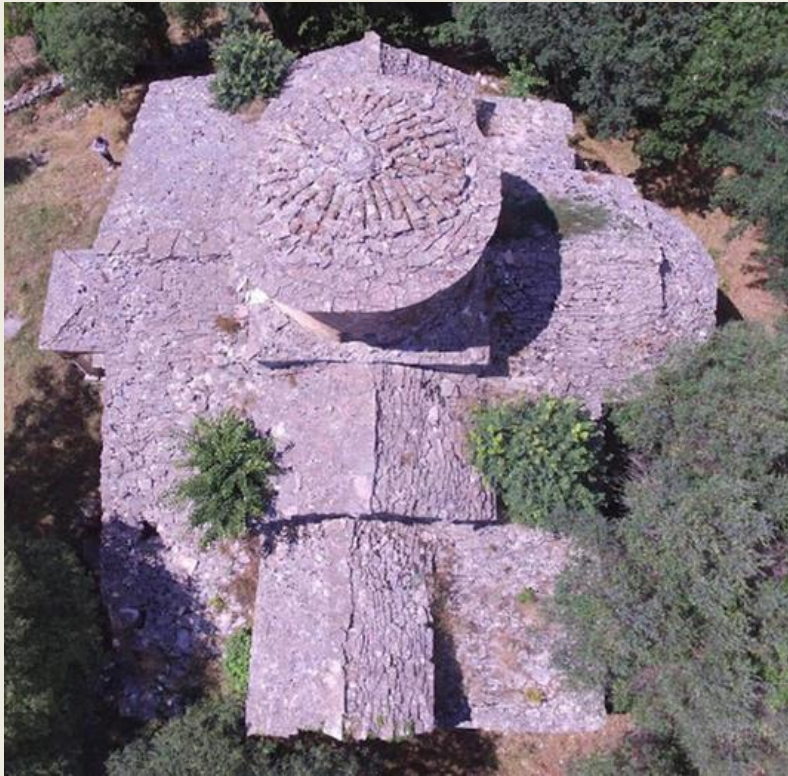
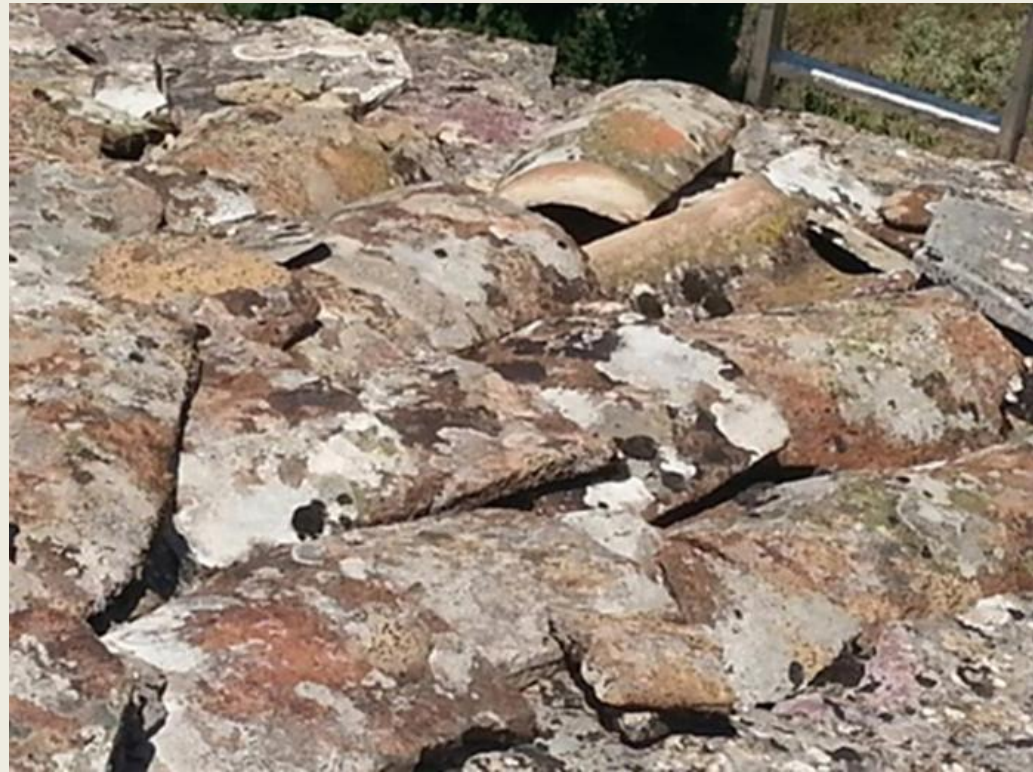
## TRACES OF THE TILES FROM THE ORIGINAL ROOF COVERING
