THE ORTHODOX AUTOCEPHALOUS CHURCH OF ALBANIA

**RESTORATION  
OF THE ORTHODOX CHURCH  
MONUMENTS IN ALBANIA**

TIRANA, 2005

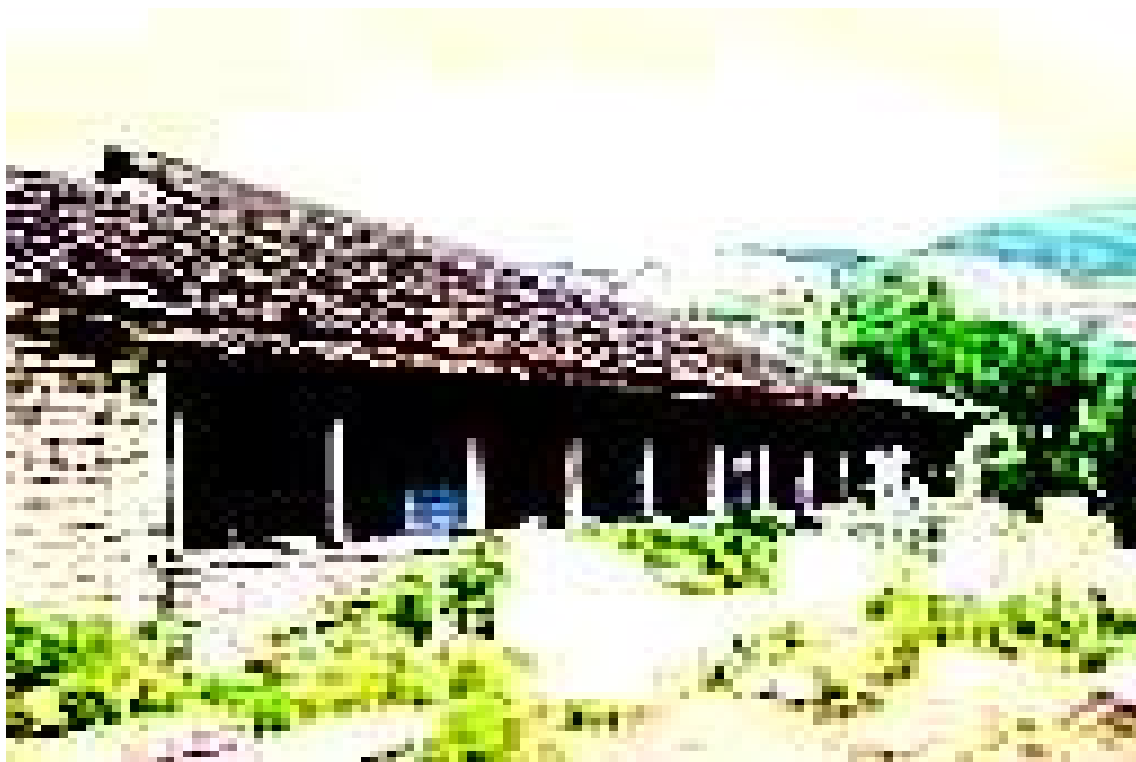
The monument survived, but was badly damaged with regard to its structural integrity and the completeness of the architectural and decorative elements. The roof of the apse and parts of the masonry walls of the naos, narthex, gallery and belfry tower collapsed. There was deterioration in the remainder of the masonry, the roof, large parts of the inner arcade, and other places.

*South view of the church before restoration.*

- Reinforcement of the masonry by means of deep tamp pointing, stitching of the fissures, and injections.
- Rebuilding the missing parts in the masonry of the naos, narthex, gallery and belfry tower.
- Rebuilding the wooden colonnade of the gallery.
- Completely rebuilding the roof.

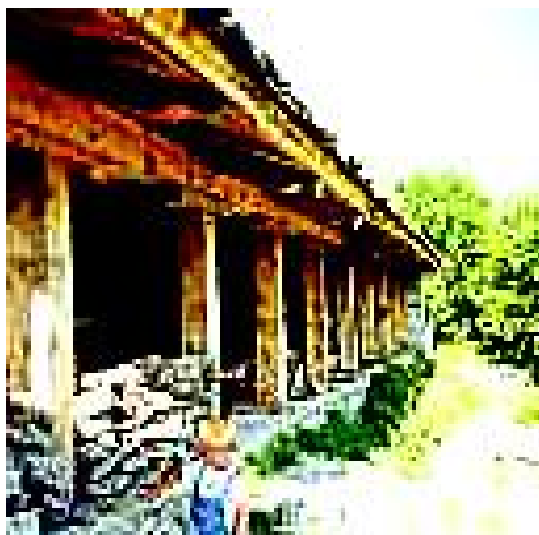
*South view of the church after restoration.*

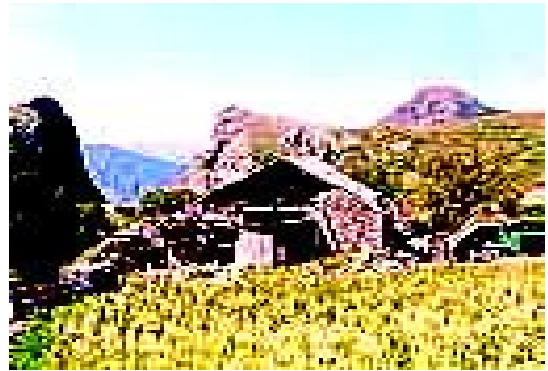
*East view of the church before restoration.*

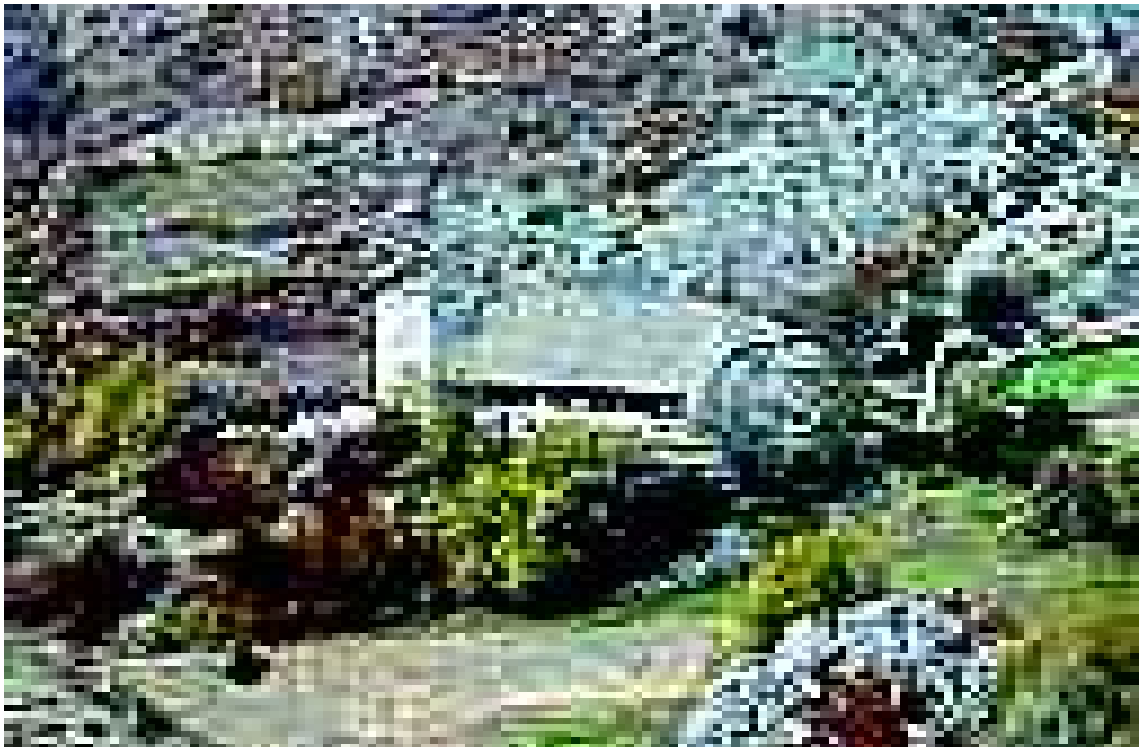
*General view of the church after restoration.*

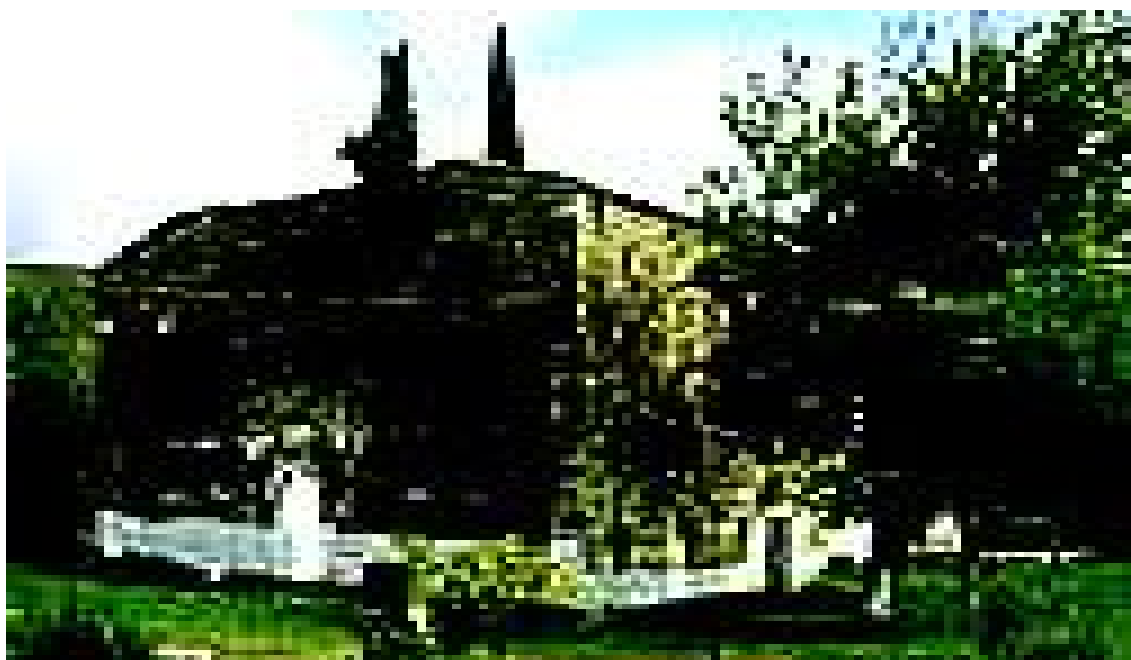
*View of the church before restoration.*

The monastery church had survived to the present, but not in a functional condition. The roof had collapsed entirely. Because of the lack of maintenance and long abandonment, even the structural parts were damaged, and their integ-

- Consolidation of the masonry of the church. This was accomplished by stitching the fissures, especially in the northeast and southeast corner. The fissures were of considerable size and were endangering the integrity of the building. The work also included injecting the masonry and tamping pointing it in the areas where the mortar had decayed.

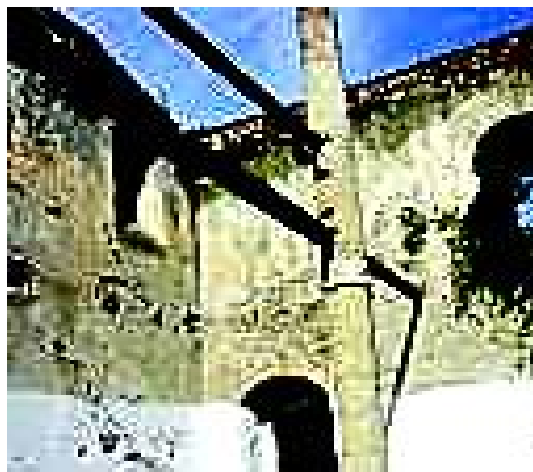
*Views of the ginekonitti:  
above, before restoration;  
below, after restoration.*

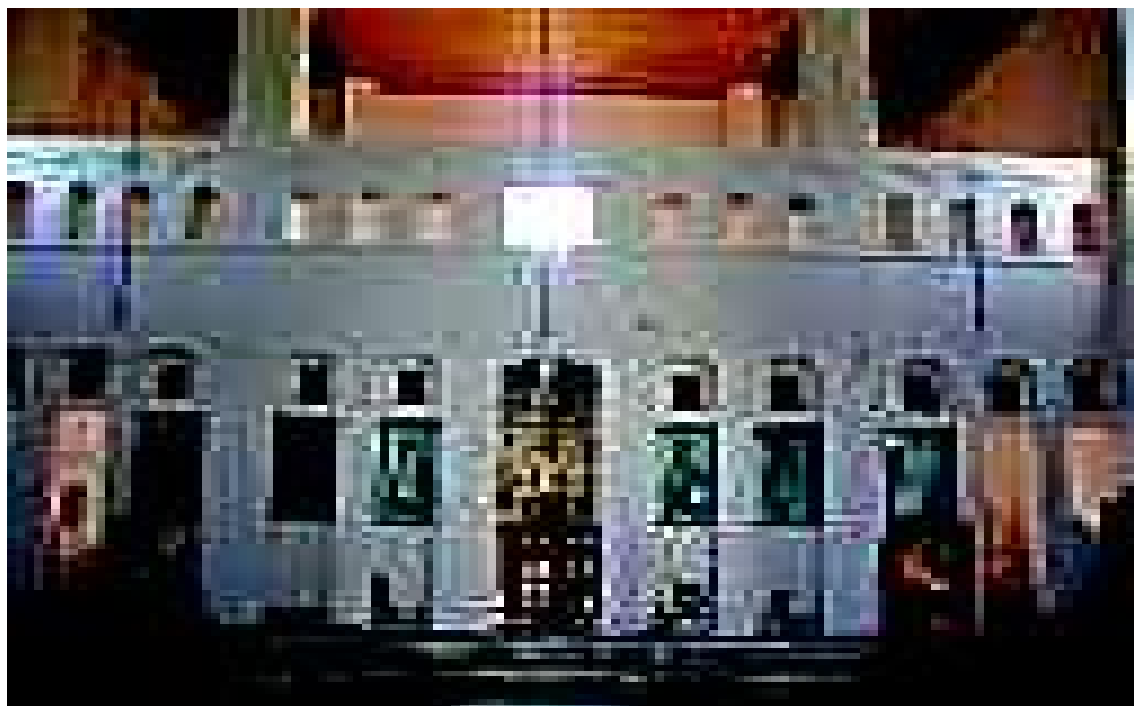
*The iconostasis of the church before restoration.*

*The iconostasis of the church after restoration.*

- Re-plastering of the interior;
- Restoration of the iconostasis;
- Reconstruction of the *ginekonitti*;
- Re-paving the floor with ceramic tiles, preserving and mending the existing central belt that is paved with stone slates and contains the decorative rosette in the centre.

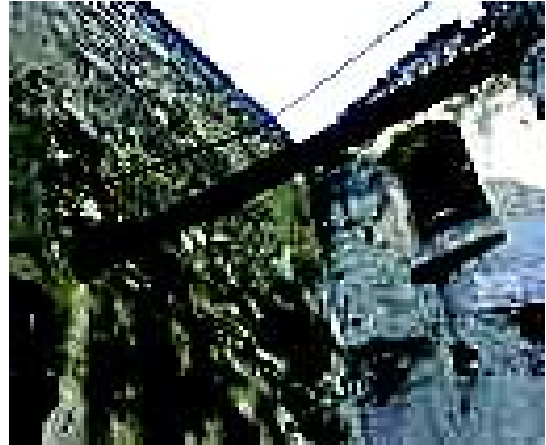
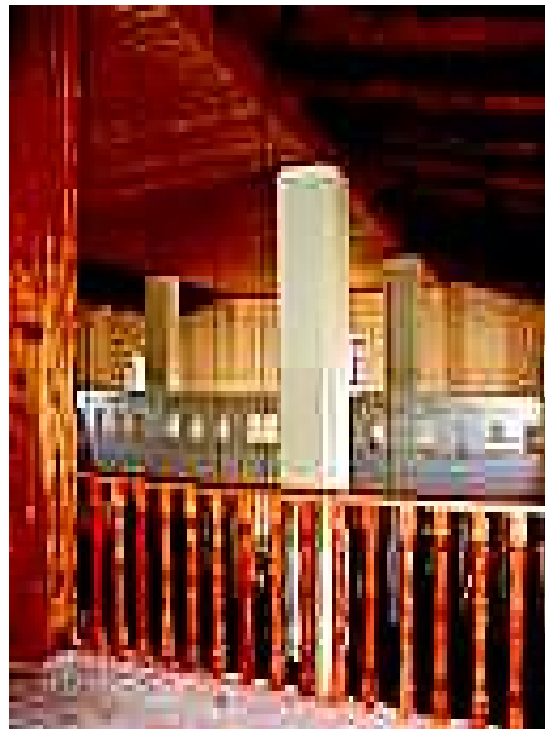
*Views of the interior:  
above, before restoration;  
below, after restoration.*

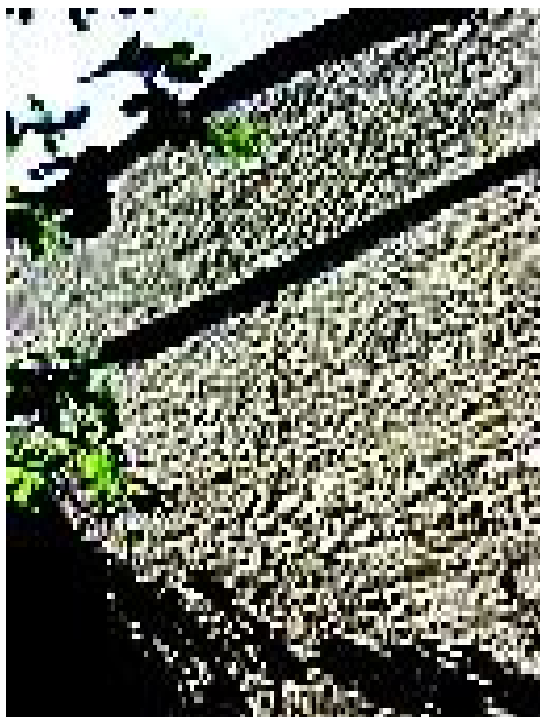
*East view of the church: above, before restoration, below, after restoration.*

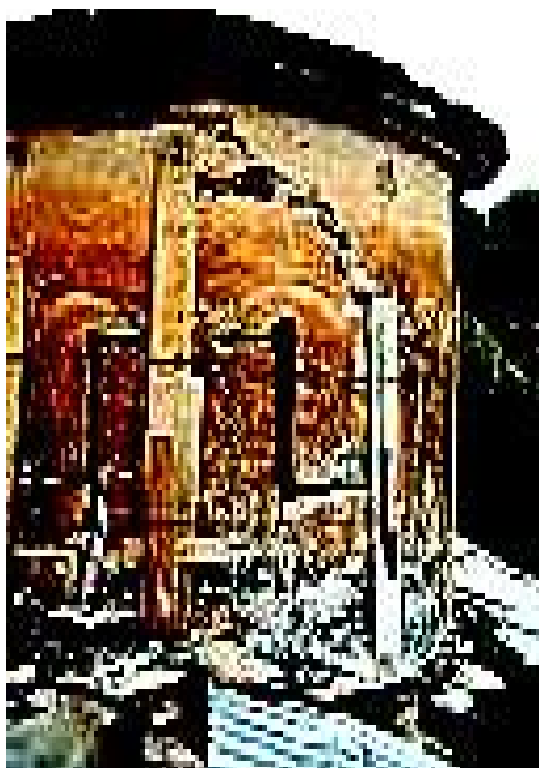
*Inclination of the columns.*

*Damage to the drum.*

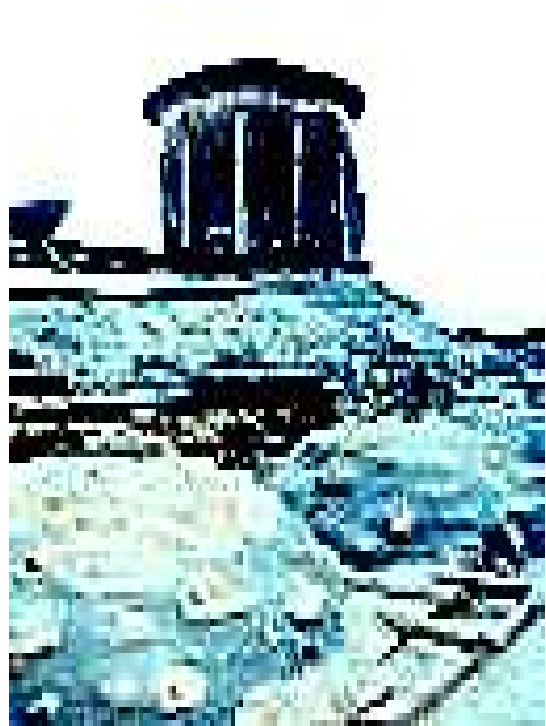
*Work of consolidation of the construction.*

·**Geological phenomena:** The church building stood over two different geologic formations with different physical and mechanical properties, thus putting its foundations on an unequal footing and causing differential settlement. The demarcation line of these formations coincided roughly with the longitudinal axis of the church.

·**Hydro-geological phenomena:** The presence of a large amount of poorly drained surface and underground water negatively affected the stability of the building. This led to the emergence of a *suffosa* phenomenon, that is, the elimination of minute fractions of the geological strata because of hydro-mechanical pressure. The surveys discovered the presence of deep caverns below the foundations of the building, endangering its longevity.

·Reinforcement of the building foundations by enlarging and deepening them with walls, reinforced concrete underpinning, foundation columns and reinforced concrete beams.

·Infilling spaces and caverns below the foundations of the building.

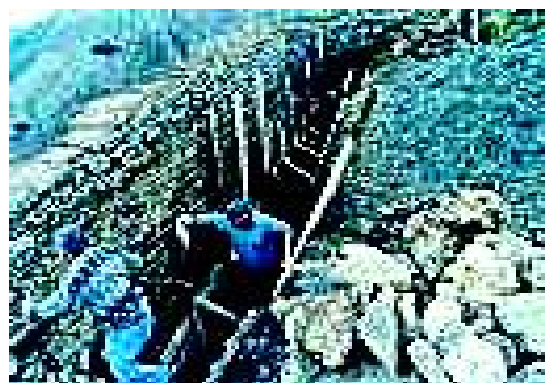
*Work of consolidation of the foundations of the building.*

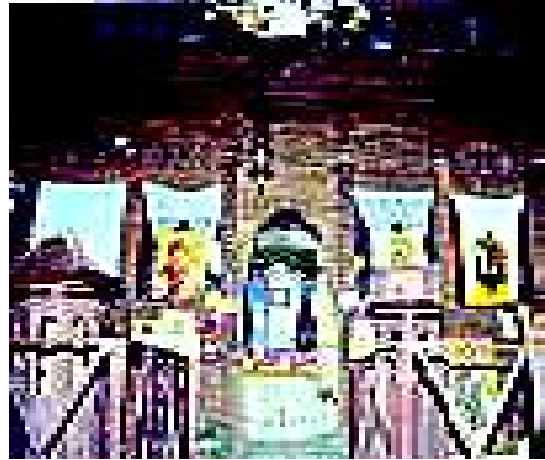
*View of the interior of the church before restoration.*

*View of the interior of the church after restoration.*

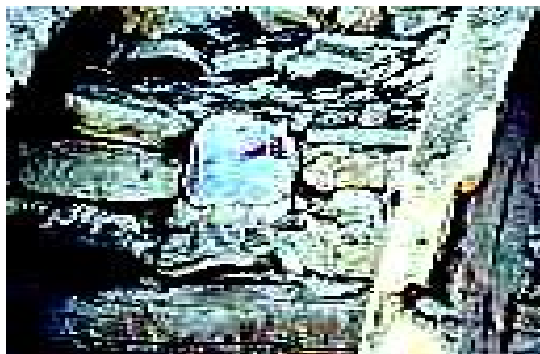
*Painted stones from the wall reused in the building of the vaults.*

Throughout the course of the work, many elements were discovered, such as the re-used stones in the superstructure, which contained old pieces of fresco; fragments of the old foundations in the substructure, a part of which was covered with frescos; and other elements that verified the initial hypothesis of the existence of an older building on this site. The most interesting fragments are preserved *in situ* and are displayed for visitors.

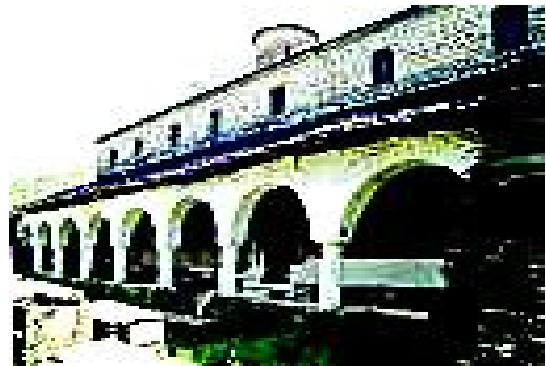
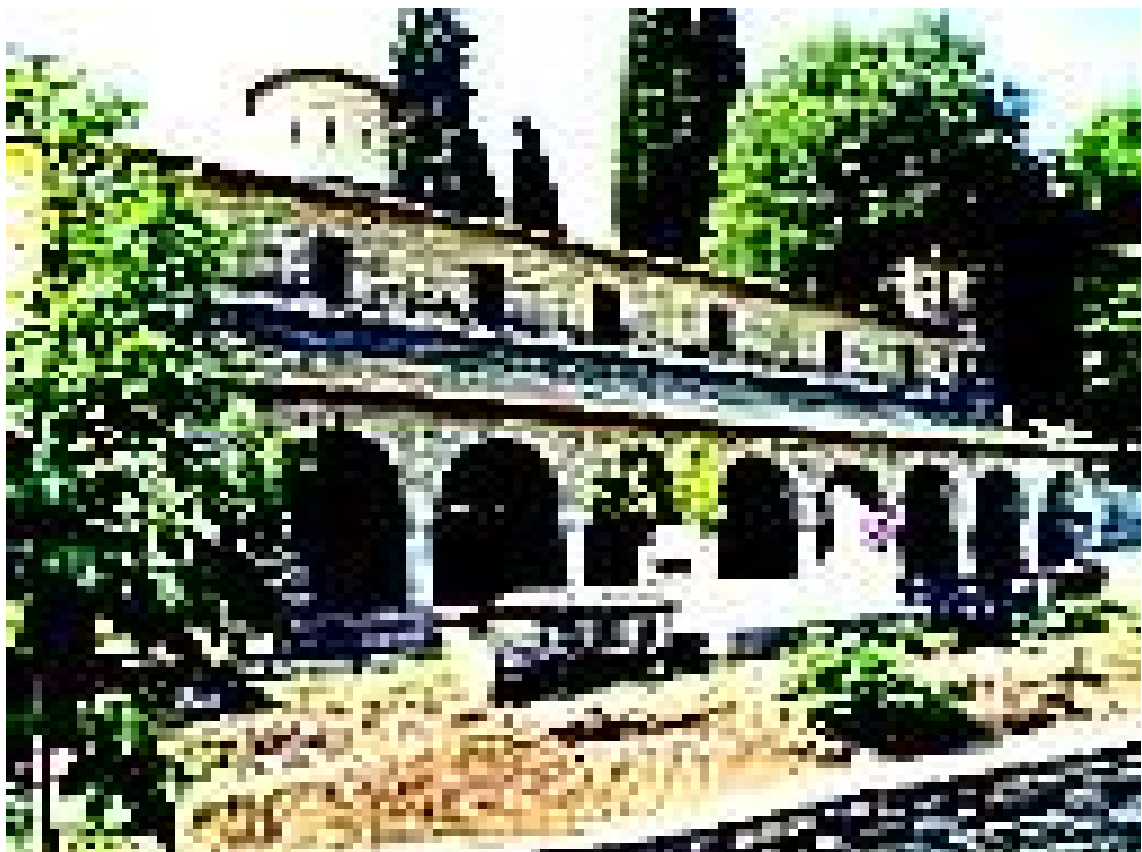
*View from the north of the church before restoration.*

*View from the north of the church after restoration.*

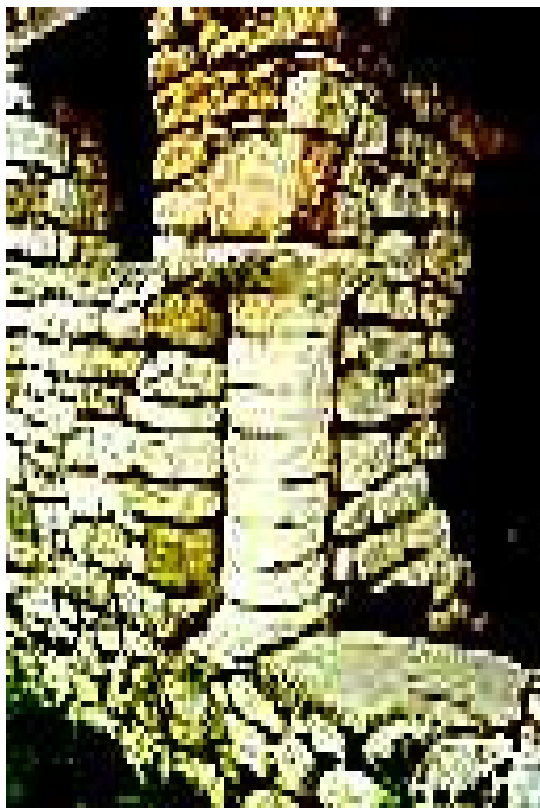
*Traces of the columns of the gallery.*

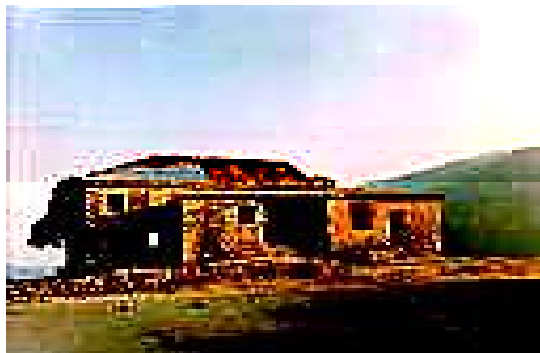
tural centre, the narthex became a bakery, and in the north an addition was built that served as a clinic for the village. In addition to this, the long abandonment of the building created severe problems for its structural integrity, as follows: there was decomposition of the connecting mortar and total damage to the roof, non-functioning of the braces of the arches, fissures in the masonry and in the curved roof of the interior, weakened cross sections of the columns, and severe weakening at the capitals of the columns, where they were in contact with the spring lines of the arches.

*View of the church from the north-east, before restoration.*

- Closing up large fissures in the masonry and in the arches of the roof with iron bars.
- Complete tamp pointing of both the masonry and the roof system.
- Repairing the collapsed parts in the roof system.
- Consolidating the columns and arch supports

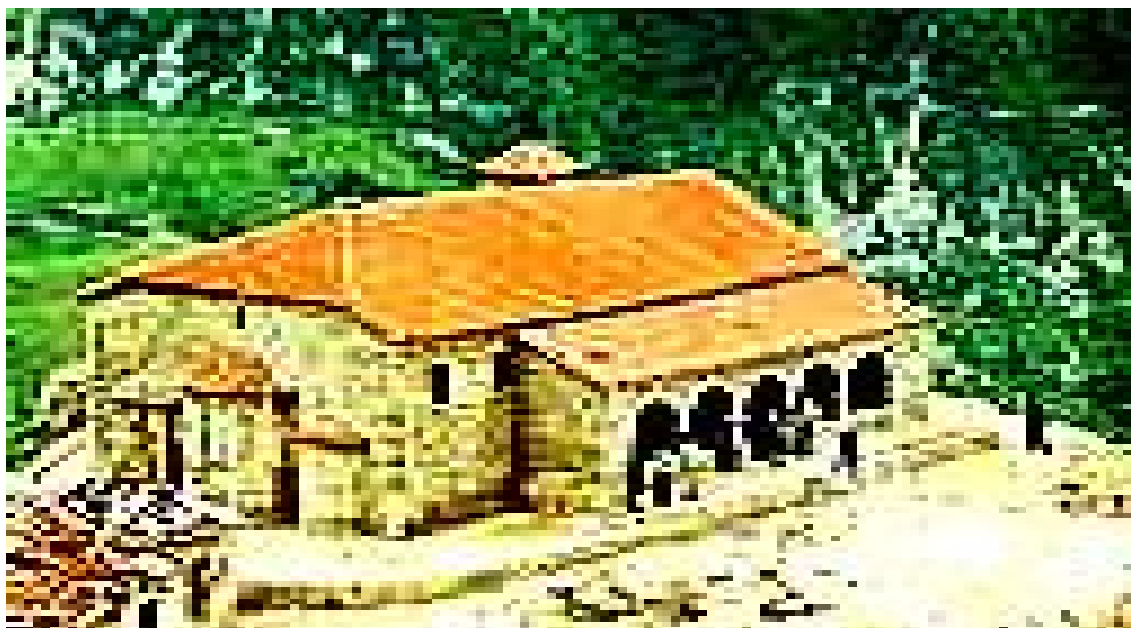
*View of the church from the north-east, after restoration.*

- The installation of new metal braces and wooden in-fill for aesthetic reasons.

- The building of a reinforced concrete tie beam on top of the masonry.

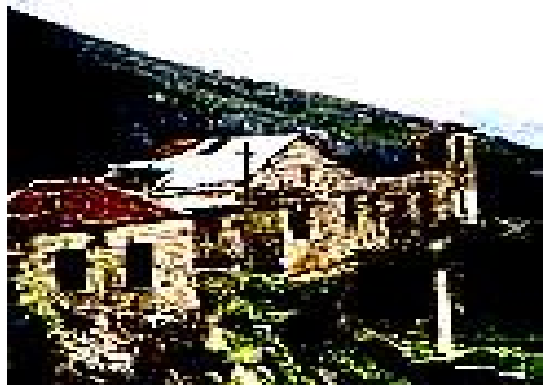
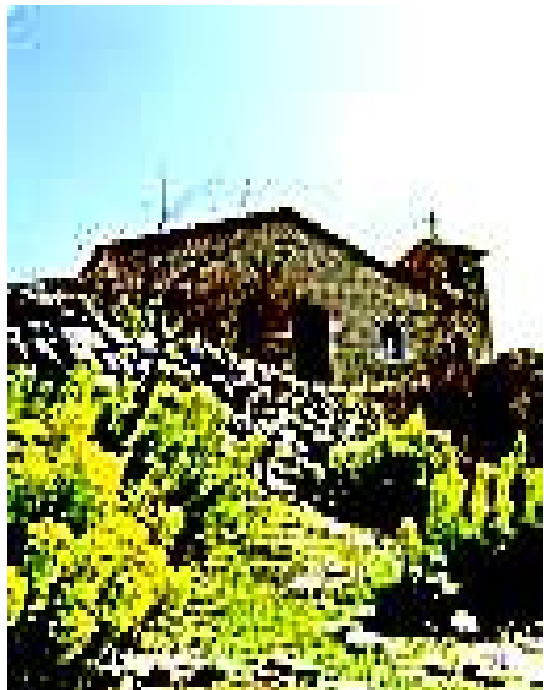
*Views of the western side of the church, before and after restoration.*

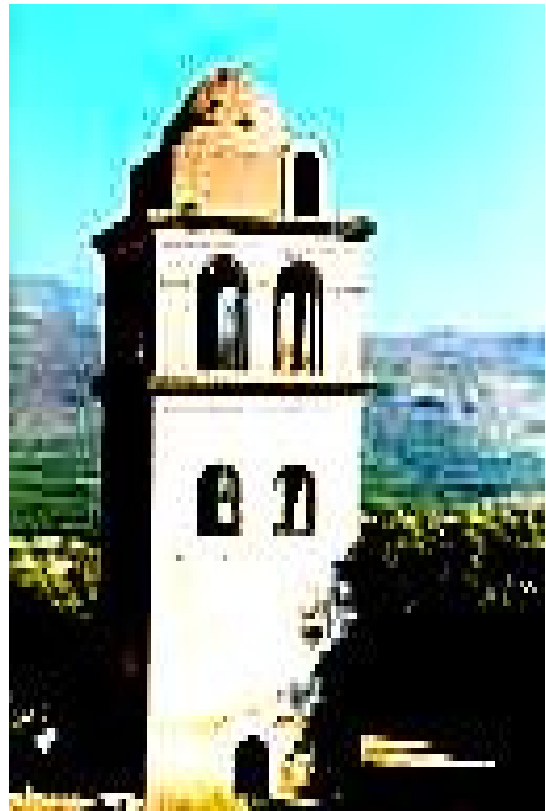
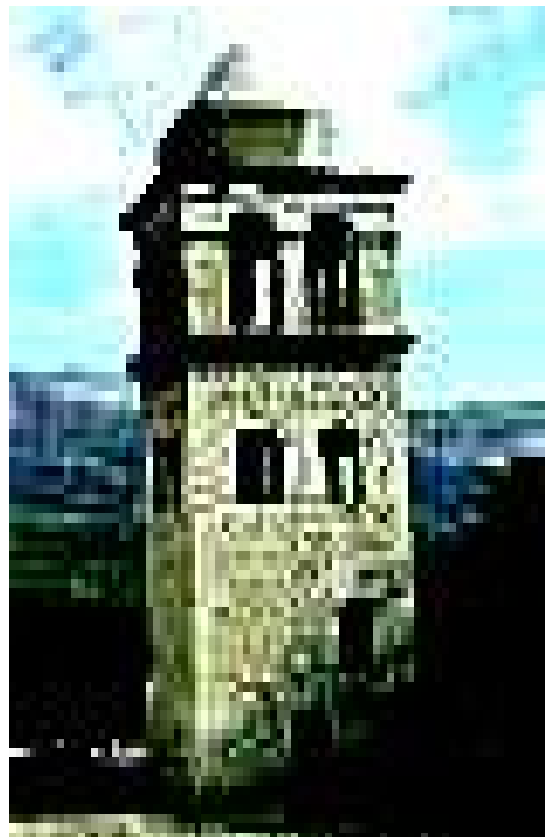
*Views of the belfry tower before and after restoration.*

- Completing the floor level of the church.
- Internal plastering.
- External tamp pointing of the masonry.
- Restoring the belfry tower.
- Electrical and plumbing installations.

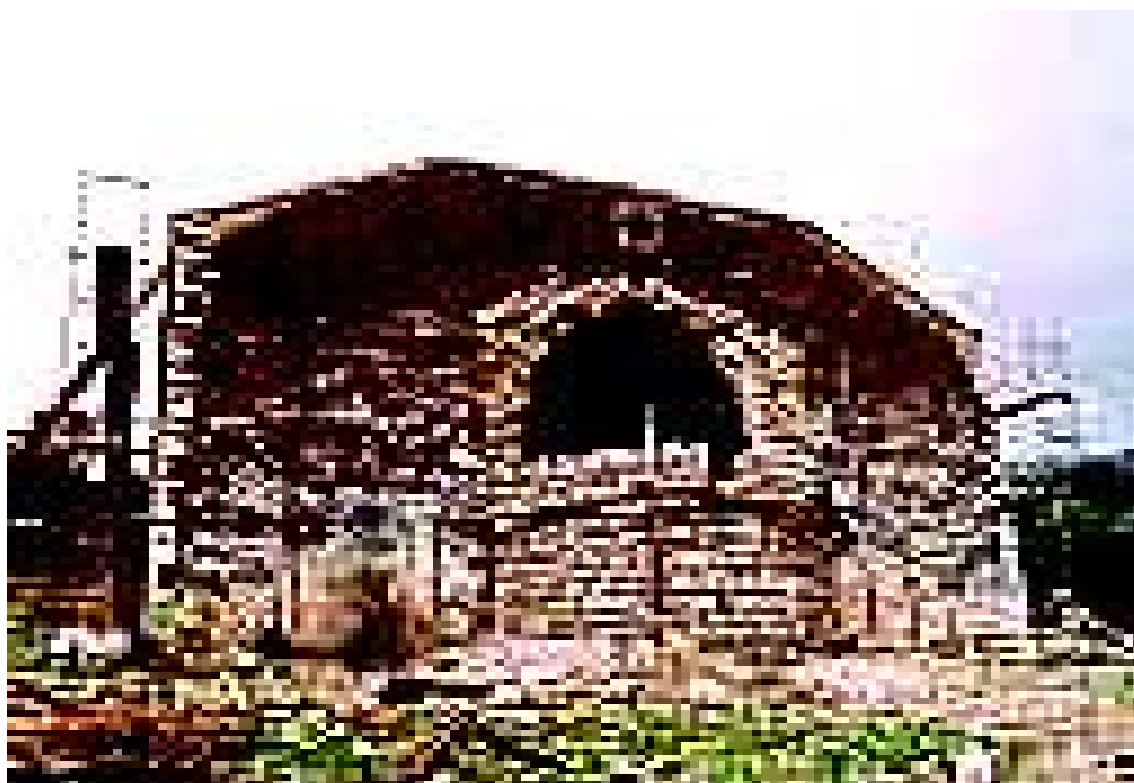
During the Communist regime, the church was converted into a warehouse, and the apse was demolished. But the worst damage was to the iconostasis, which was carelessly taken out and abandoned. The building, too, suffered structural damage as a result of abandonment: there were fissures and cracks in the masonry, and the roof had completely deteriorated, causing the ornamental ceiling to collapse.

*East view of the church before restoration.*

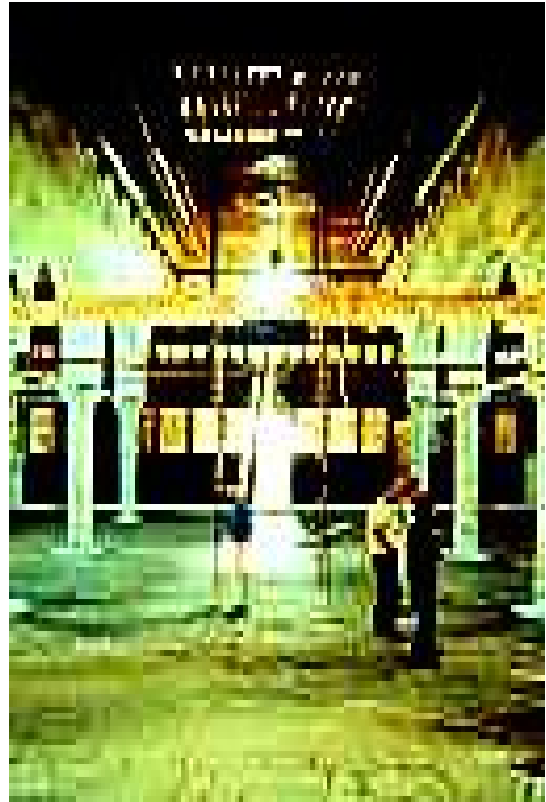
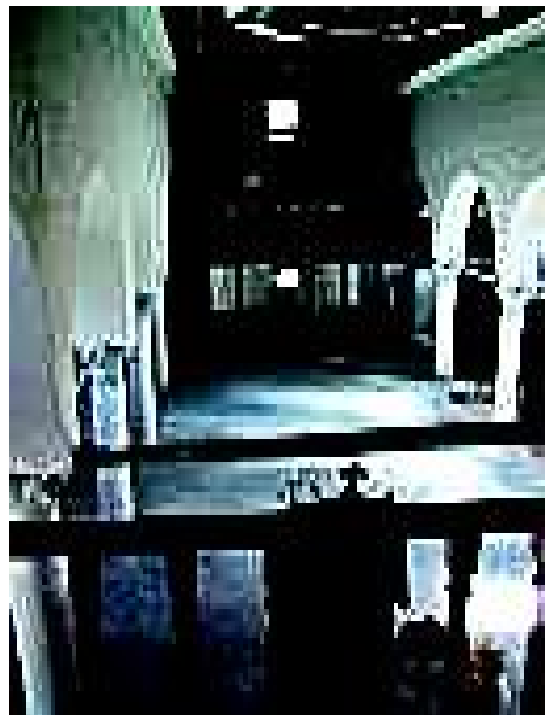
The condition of the ceiling presented problems both as to structural integrity and as to aesthetic value. The central part had settled and suffered visible deformations from the damage to the structure. This led to damage to the ornamentation, the paintings on the plaster, the paint-

*View of the interior of the church during restoration.*

*View of the interior of the church after restoration.*

ings on the canvas, and the wooden carvings. The infiltration of humidity as a result of the damage to the roof had created bleached or layered areas and problems from salination. In addition, the ceiling was affected both by micro-organisms and by bird droppings. All of this had caused decomposition of wooden fragments, making them spongy or powdery.

- Reinforcement of the supports by replacing structural elements that had deteriorated.
- Elevation, levelling and stabilizing of the central rosette.
- Decontamination of the entire wooden structure.
- Completion of the missing parts.
- Consolidation of decomposed or spongy parts.
- Removal of excess layers, colour changes, and decomposed varnish.
- Pictorial reintegration of the entire surface area of the ceiling.

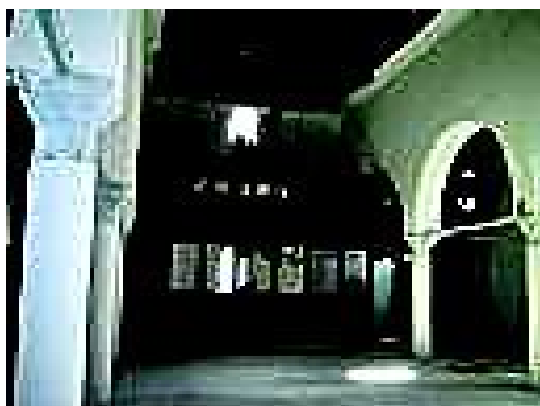
As a result of the poor condition of the building and the penetration of humidity into the interior, the iconostasis had suffered severe damage that had affected its entire surface area. The

effects of micro-organisms and humidity had decayed the iconostasis and reduced its bottom part to a spongy state. Micro-organisms had even affected the new construction implemented by the Institute of Monuments. The entire front surface was covered with decomposed or rusted varnish, thus creating darkening and, in places, charring of the engraved parts.

*Iconostasis during and after restoration.*

- Combating and removing micro-organisms, that is, entirely decontaminating the structure and the engraved surface area.
- Cleaning the dust and unnecessary layers.
- Reinforcing and securing the detached parts.
- Consolidating the spongy parts.
- Chemically cleaning decomposed varnishes and oil-painted layers.
- Staining wood that had lost its natural colour.
- Varnishing and chromatically integrating the entire engraved surface area.

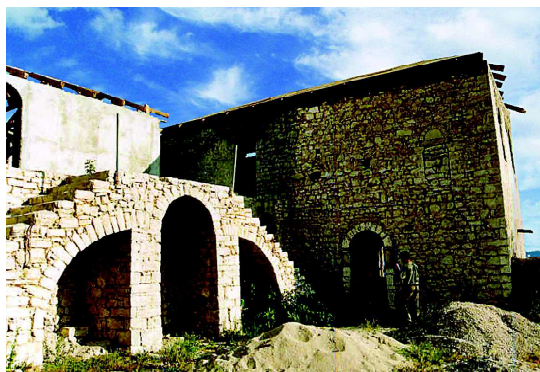
In the pre-restored condition of the guesthouse, many of its morphological features had been transformed. In addition, the structural condition of the church was not satisfactory. There were fissures in its structures, such as the masonry, arches, and vaulting system. With the passage of time, this would have brought about the collapse of the structure and consequently the loss of the architectural and monumental value that it embodies. The badly damaged roof of the church, which allowed rainwater to enter the interior and its structure, worsened the situation.

*View of the guesthouse before restoration.*

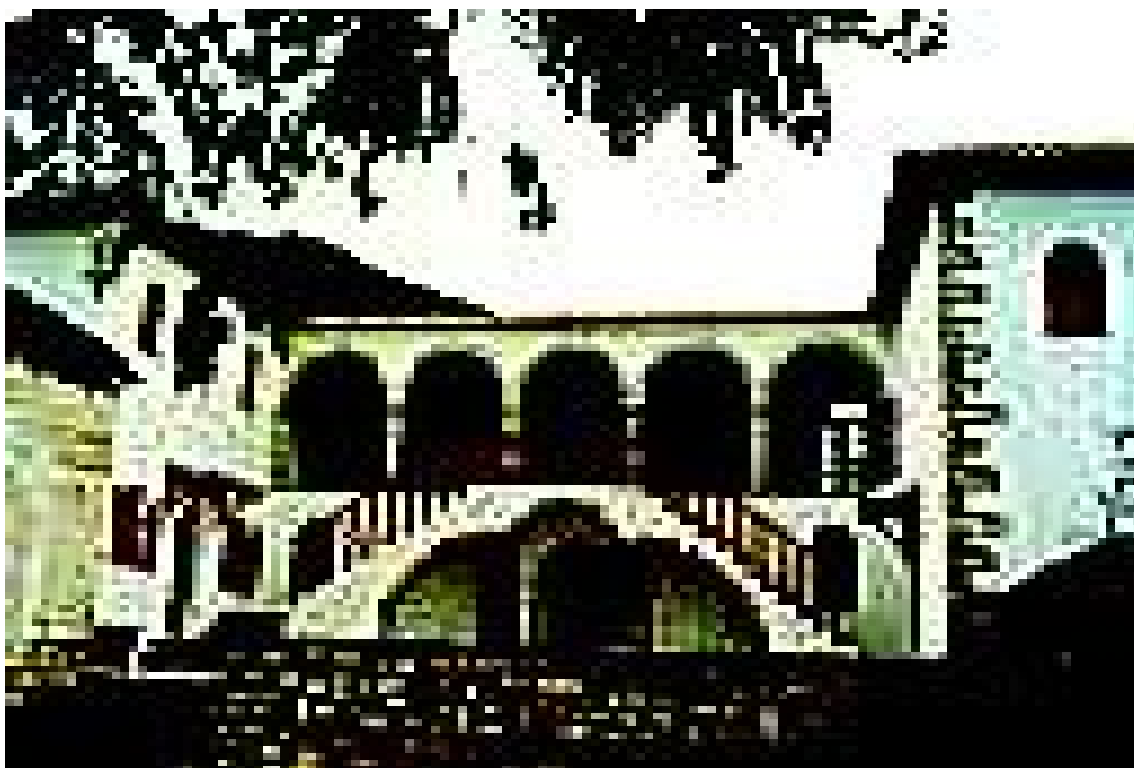
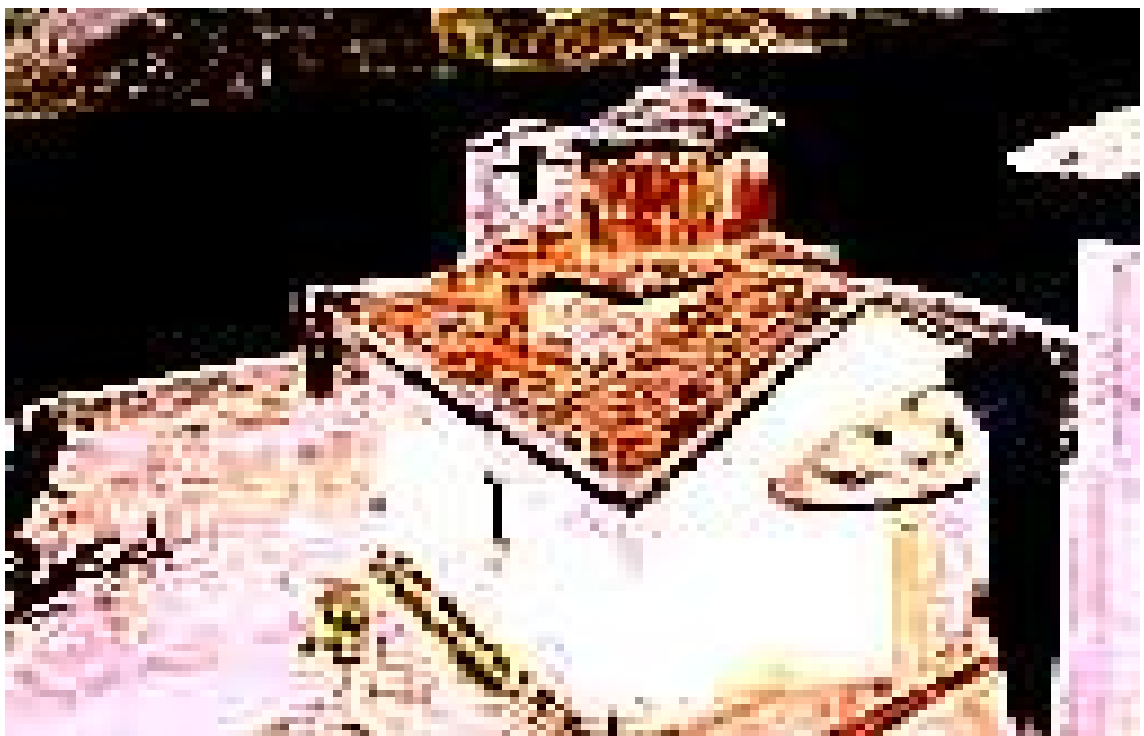
*View of the guesthouse after restoration.*

*The missing parts and the open gallery in the centre were rebuilt while preserving the original elements, based on the traces and oral testimony, as well as by analogy with other buildings of the same architectural genre and building period.*

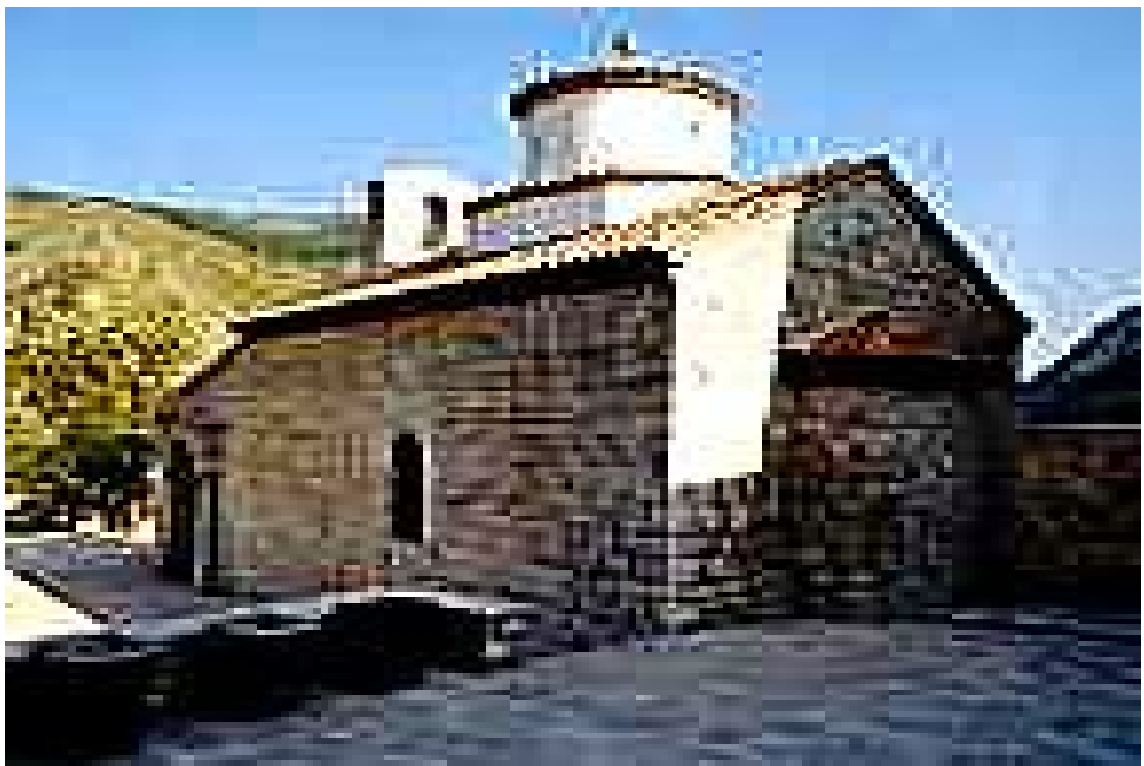
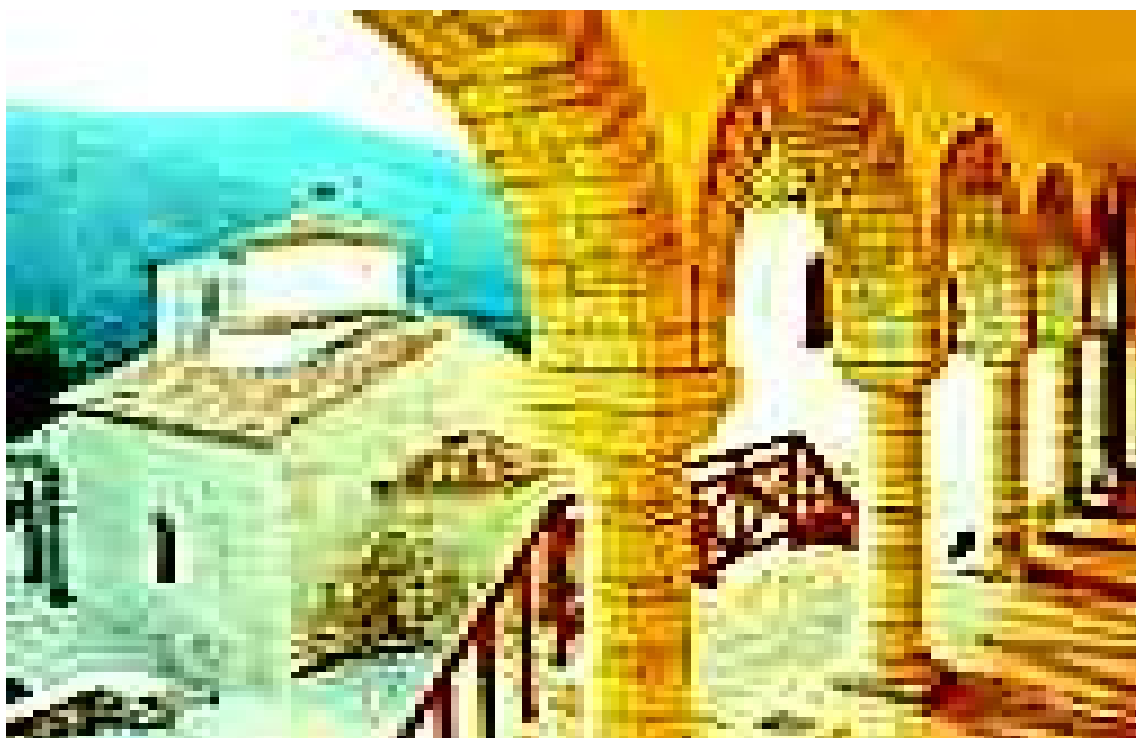
*Views from the southeast of the church before and after restoration.*

of the consolidation of the structures, the reconstruction of the roof, and the treatment of the masonry by deep tamp pointing. Also, a new addition was constructed towards the west. This addition was to function as an exo-narthex or gallery, since the existing church lacked such an

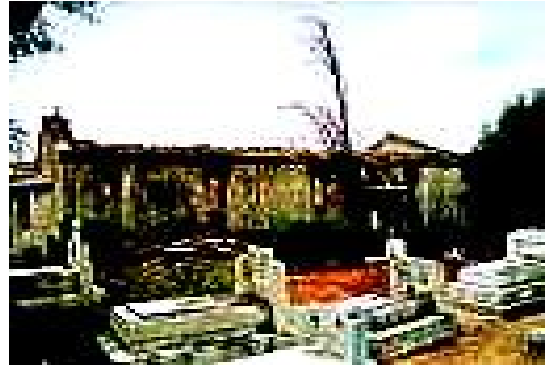
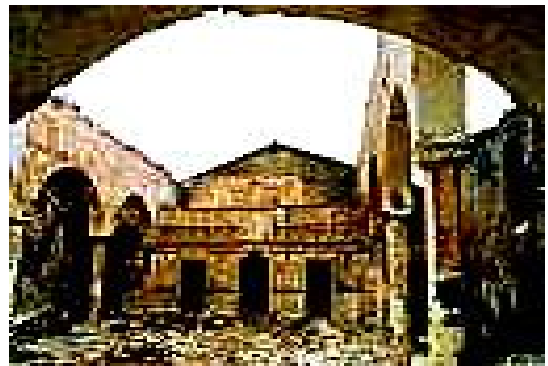
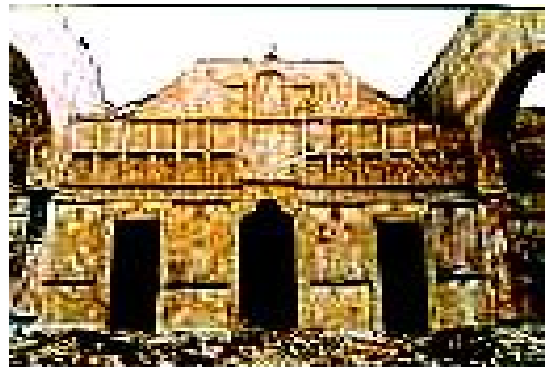
For unknown reasons, the church suffered a major fire, which burned the roof and ceilings completely and damaged the wall paintings beyond repair, as well as weakening the structural integrity of the masonry.

*Views of the church after the fire.*

After the fire, the Institute of Monuments of Culture undertook work consisting of re-covering the church and re-vetting the masonry, but the artistic and decorative values of this church were irretrievably lost, causing incalculable damage to the national cultural heritage.

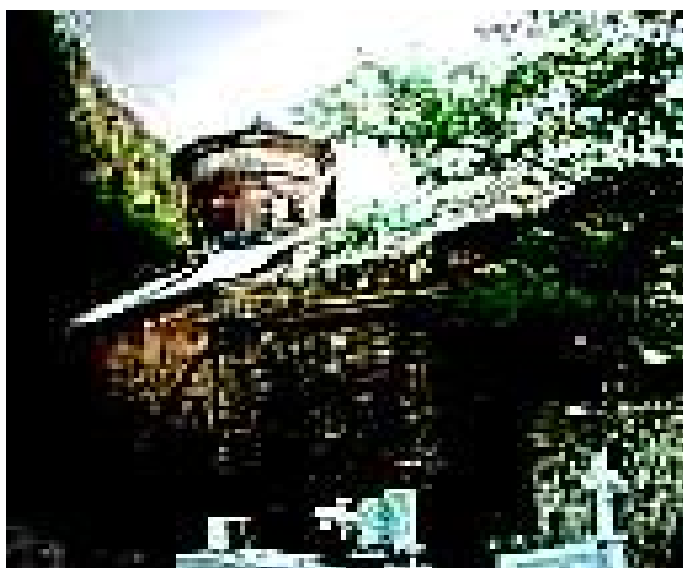
*View from the northwest of the church before restoration.*

- Fissures that were both numerous and of considerable size in the masonry and in the system of both the arches and the vaulting of the roof.
- Inclinations from the vertical of the perimeter walls of the church that went as far as 13 cm (5.11 inches).
- Settlement of the floor and settlement of the roof that were off the horizontal as much as 40 cm (15.7 inches).
- Dangerous caverns below the foundations.
- Clear detachment of the apse from the remainder of the building, with damage to the slate roof that allowed rain water to penetrate into the interior.

- Strengthening the existing construction, such as by tamp-pointing, stitching and injections.
- Increasing the support integrity of the building by reinforcement of the foundations with reinforced concrete underpinnings and reinforced concrete walls and by filling in the caverns below them.
- Adding other structural elements, such as mounting metal braces to absorb the horizon-

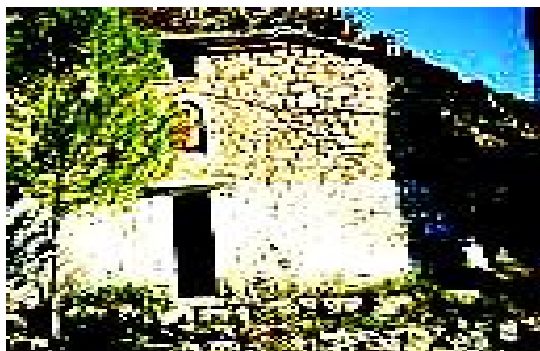
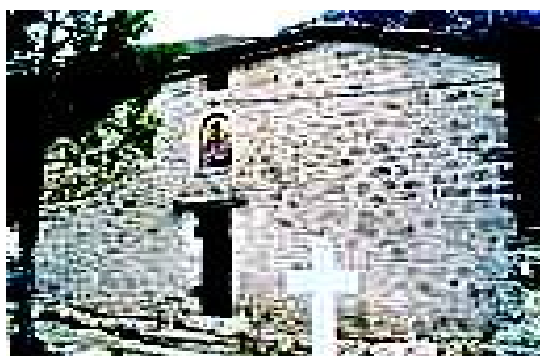
*Views of the church from the west  
before and after restoration*

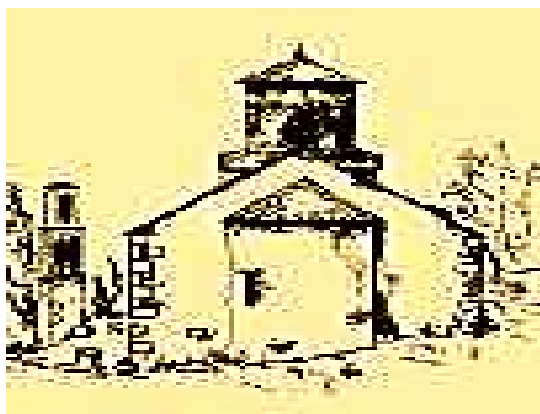
*Elevation view from the east.*

The major damage to the church building was in its structural integrity, consisting of the following:

This caused severe harm to the wall paintings, artefacts, and other interior ornamentation.

The work undertaken was in accordance with the needs of the church's condition. It consisted of the consolidation of the construction in order to restore and improve its structural integrity, which had been lowered considerably. This was achieved by:

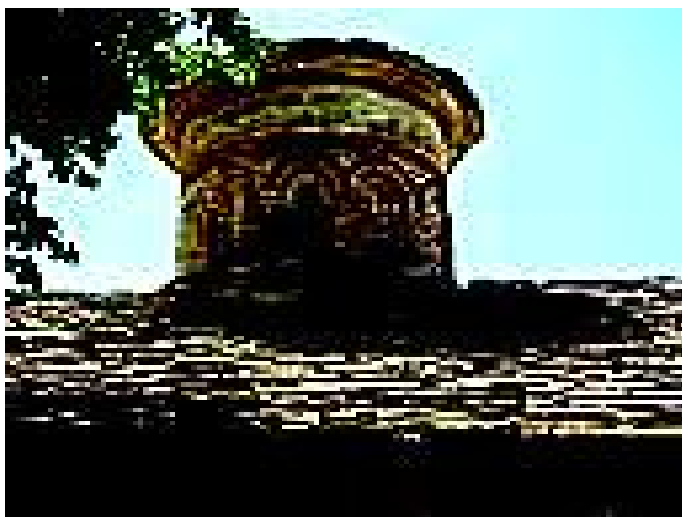
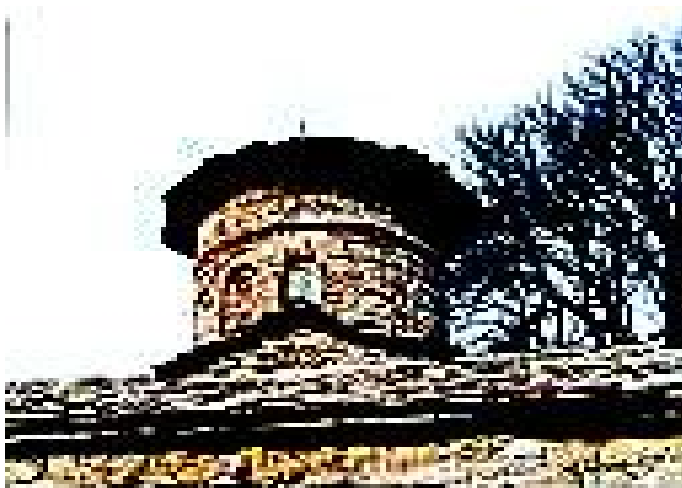
*Views of the cupola before and after restoration.*

tal thrust of the arches and vaults and installing metal plates for the anchoring of the apse.

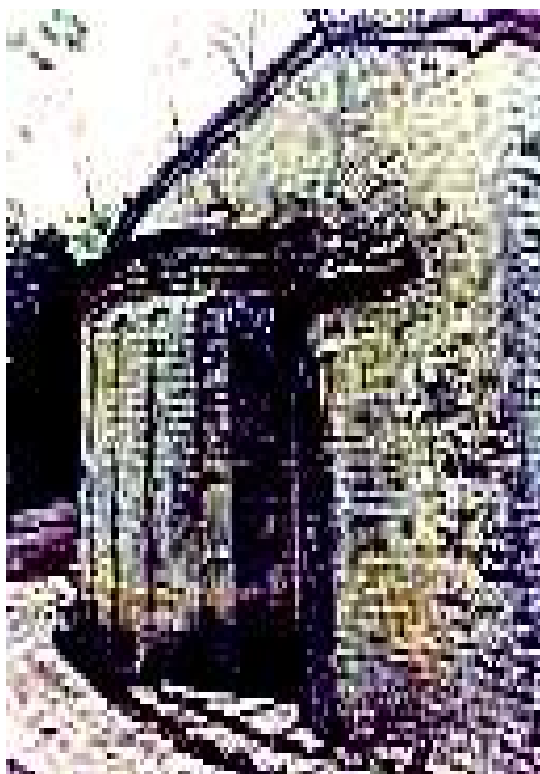
*Situation of the apse before restoration.*

*View of the apse after restoration.*

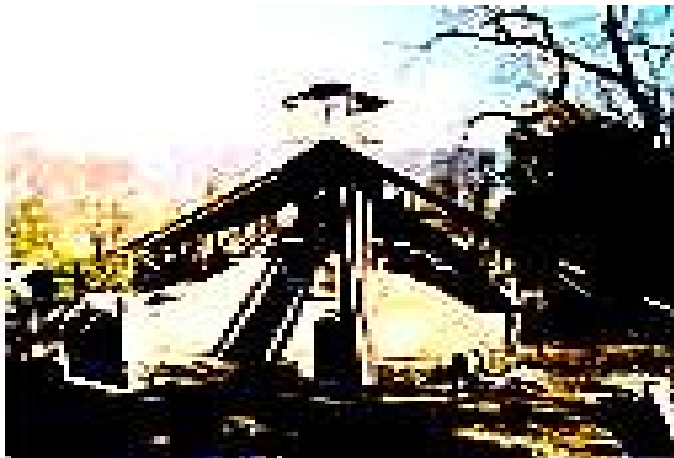
The church suffered from serious structural damage, resulting in a catastrophic situation. The collapse of the vaults was advancing; and there were visible inclinations of the perimeter walls as far as 29 cm (11.4 inches) off the vertical, considerable fissures in the roof and the masonry,

The numerous fissures in the roof system of the naos resulted from the aging of the material, especially the wooden braces, which over time lost their function. Consequently, the system lost its structural stability because of the irresistible force of the horizontal thrust of the arches by means of their mutual cancellation. Because of this, a slight earthquake shock was enough to cause fissures in the structures and their collapse.

*View from the west of the church before restoration.*

ing mentioned above were insufficient to achieve their objective. It includes the substitution of horizontal braces, the placing of circular braces in the spherical calottes, reinforcement of the foundations of columns and other interventions.
