THE ORTHODOX AUTOCEPHALOUS CHURCH OF ALBANIA

**RESTORATION  
OF THE ORTHODOX CHURCH  
MONUMENTS IN ALBANIA**

TIRANA, 2005

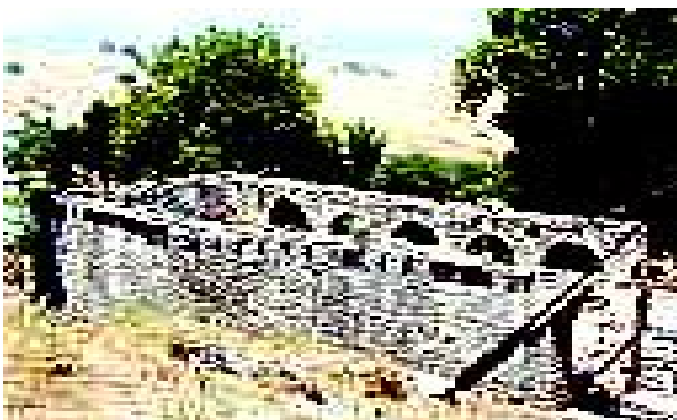
The masonry of the “gallery” was in poor condition. There were inclinations and numerous fissures at the northern and western walls; a portion of the western wall even reached 25 cm (9.8 inches) from the vertical. In addition, the entire eastern arcade inclined from within as far as 8 cm (3.14 inches).

Damage to the “gallery” also resulted from the system’s loss of structural stability, caused principally by the collapse of the roof and the separation of the arcade braces. This removed the building’s transverse connection to the adjacent building, especially at the two longitudinal faces.

*View from the west of the gallery before restoration.*

*View from the east of the gallery before restoration.*

- Rebuilding the structure of the collapsed roof.
- Rebuilding the roof with wooden material, separate from the structure of the inner structure.
- Rebuilding the roof of the gallery.

- Rebuilding the northern portico.
- Rebuilding the southern arcade of the gallery, while preserving traces from the previous construction.

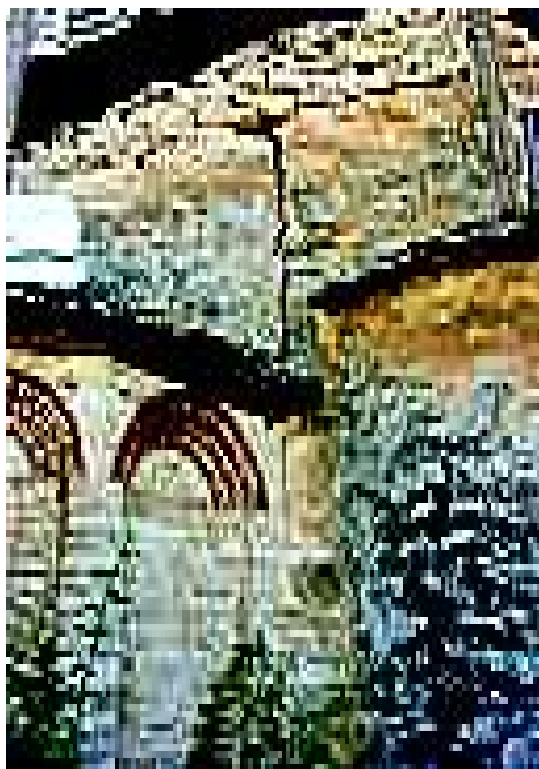
*Separated seams of the phases:  
above, view from the east, below,  
view from the north.*

· The first surveys were conducted in the foundations of the building, beneath the vertical seams. These surveys showed that the seams continued as far as the foundations, making it quite certain that these two phases were built at different times.

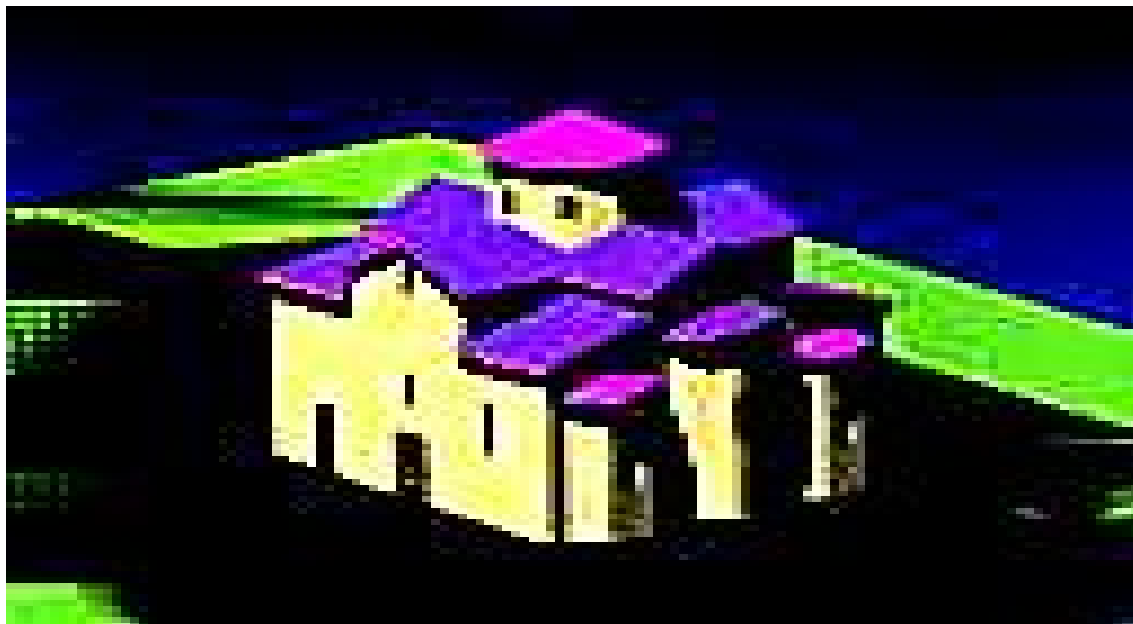
higher and all traces of the previous phases were covered up. This had negative consequences, both to the structural integrity of the building and in the monument's aesthetic aspect.

· Removing the covering, which was necessary for consolidating the construction, also brought to light many other important elements. Numerous traces of the tiles of the first phase were discovered, as well as the arms of both the cross and the cupola, the height of the roofs of later phases, fragments of cornices in saw-tooth form that ended up the masonry of the arms of the cross, as well as many other elements of different building phases.

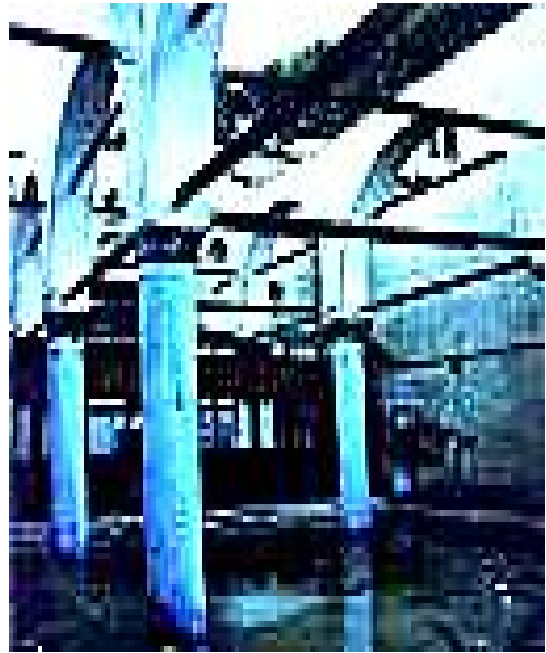
*Views from the interior before restoration. The roof was entirely ruined, and the presence of water can be seen, while the braces are out of function.*

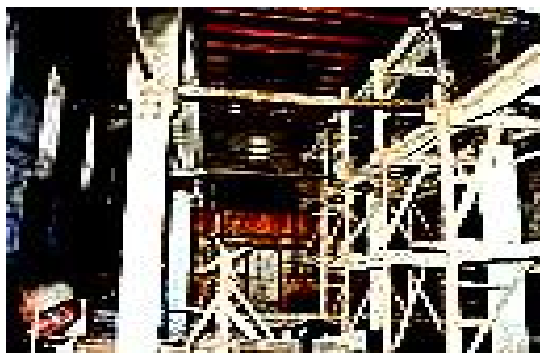
*View from the interior during restoration.*

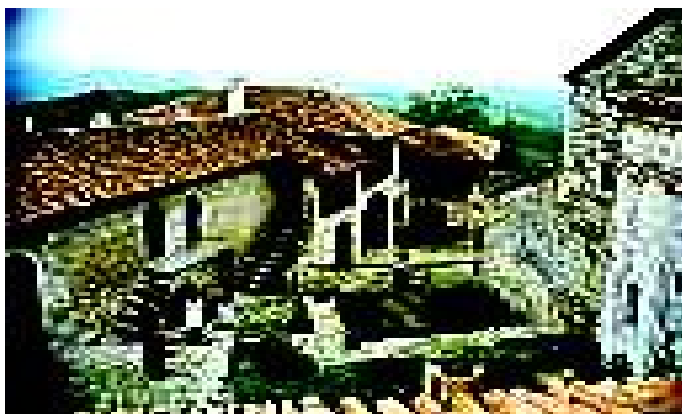
*View of the guesthouse on the southeast of the monastery before restoration.*

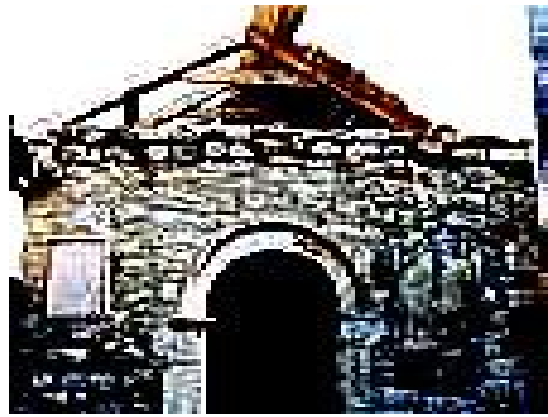
*Holy Trinity chapel before restoration.*

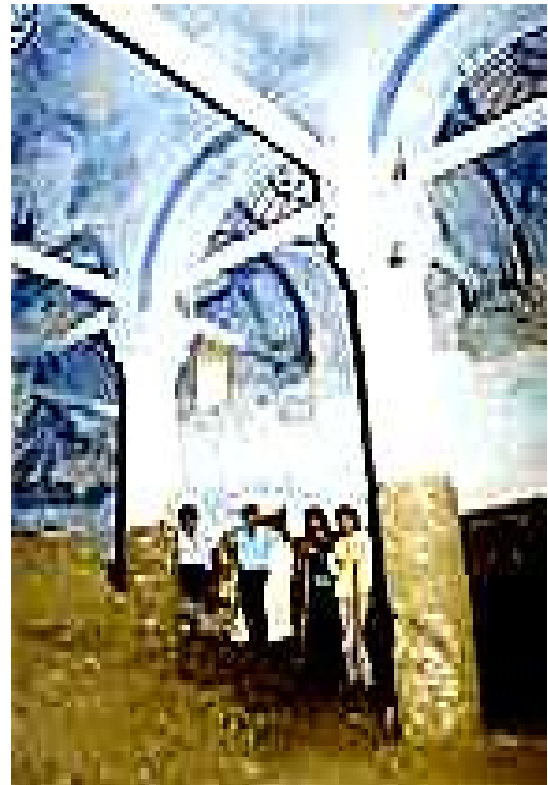
*View from the north of the katholikon after archaeological excavations.*

*In order to protect the building from any damage that could affect the new static situation, the masonry was reinforced with wooden braces.*

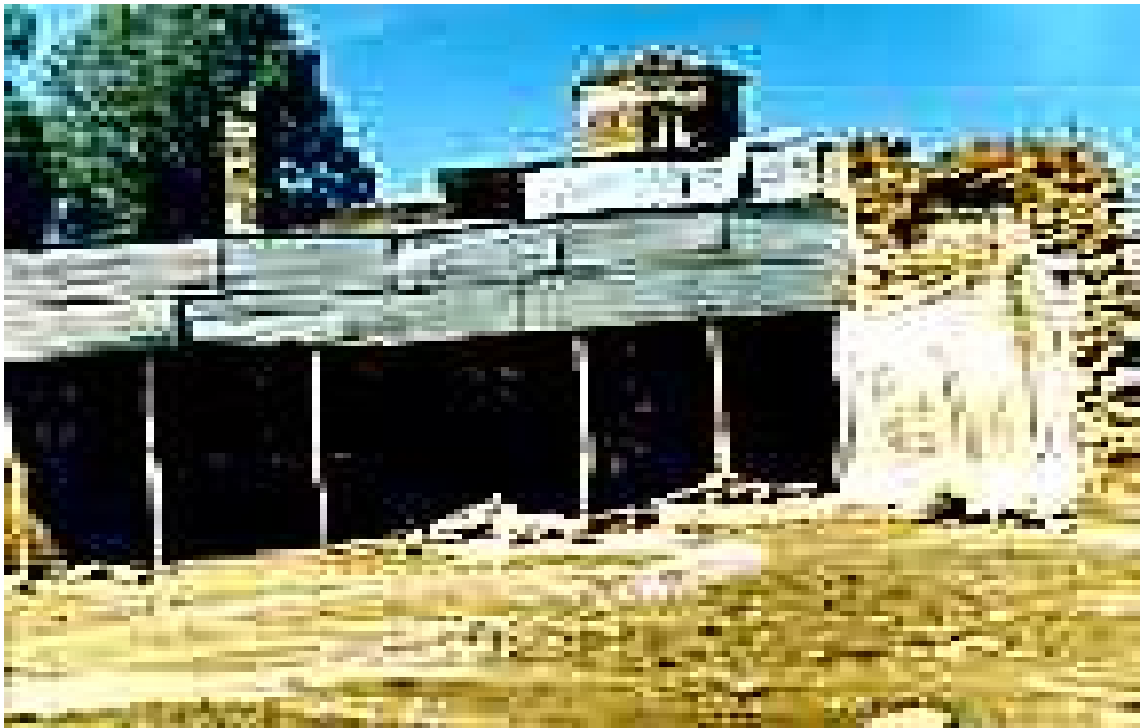
*A temporary tent was built with sheet-iron to protect the wall painting that had been discovered.*

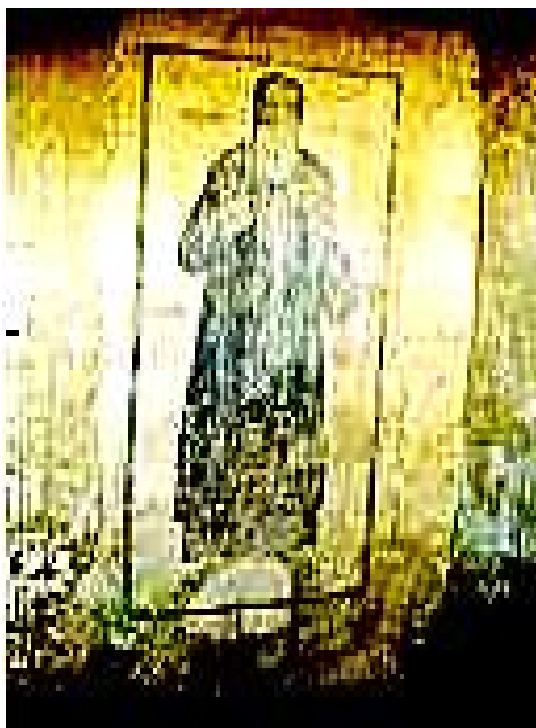
*Wall painting of St. Kozma and moments from the conservation interventions.*

· In the chapel of St. Kozma between the *katholikon* of the monastery and the Church of St. Mary, a wall painting showing St. Kozma standing was discovered. It was in poor condition, and in addition, because of the marked presence of humidity, conditions for preserving it were inappropriate. It was decided to detach it and re-mount it when measures have been adopted to assure an appropriate environment.

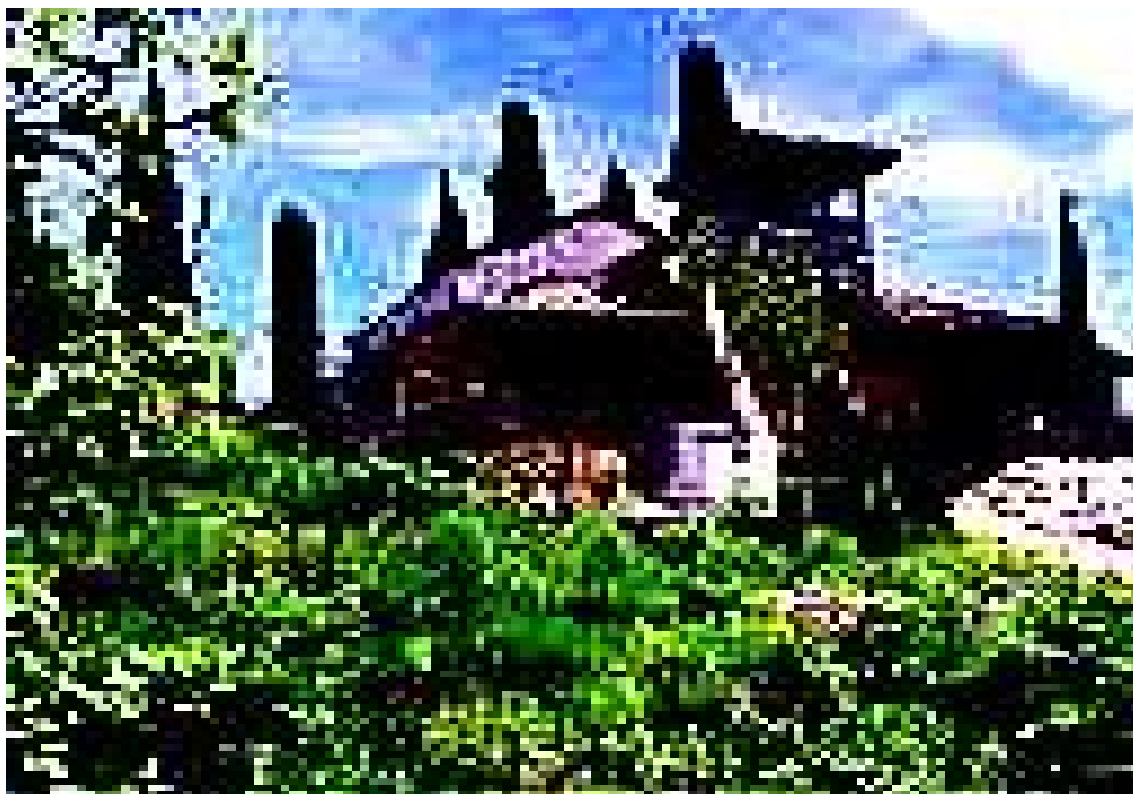
*View of the church before restoration. The total abandonment both of the building and its surroundings can be observed.*

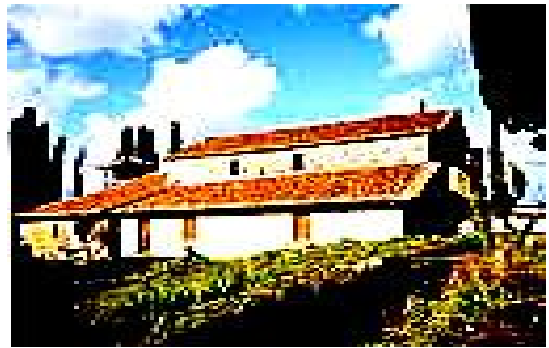
The monument survived, but with serious damage to the roof and masonry structures, especially at the galleries. This subsequently led to the damage of decorative interior elements of both the wall paintings and the ceiling. This damage was a result of the abandonment of the building and the intense presence of humidity both from underground and from rainfall.

*Views of the church: a. before restoration, b, c. after restoration.*

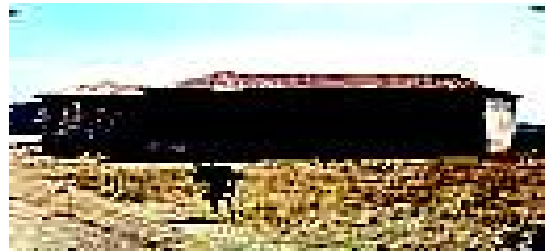
Because of the long abandonment, the guesthouses had suffered severe damage and became uninhabitable. The purpose of the restoration was to rescue this important monument of culture by returning it to its initial function as a monastery. Meanwhile, since the function of the monastery would temporarily be that of summer camps for the youth, there would be some adaptation for this interim function.

*Views of the guesthouse: a. before restoration, b. during restoration, c. after restoration.*

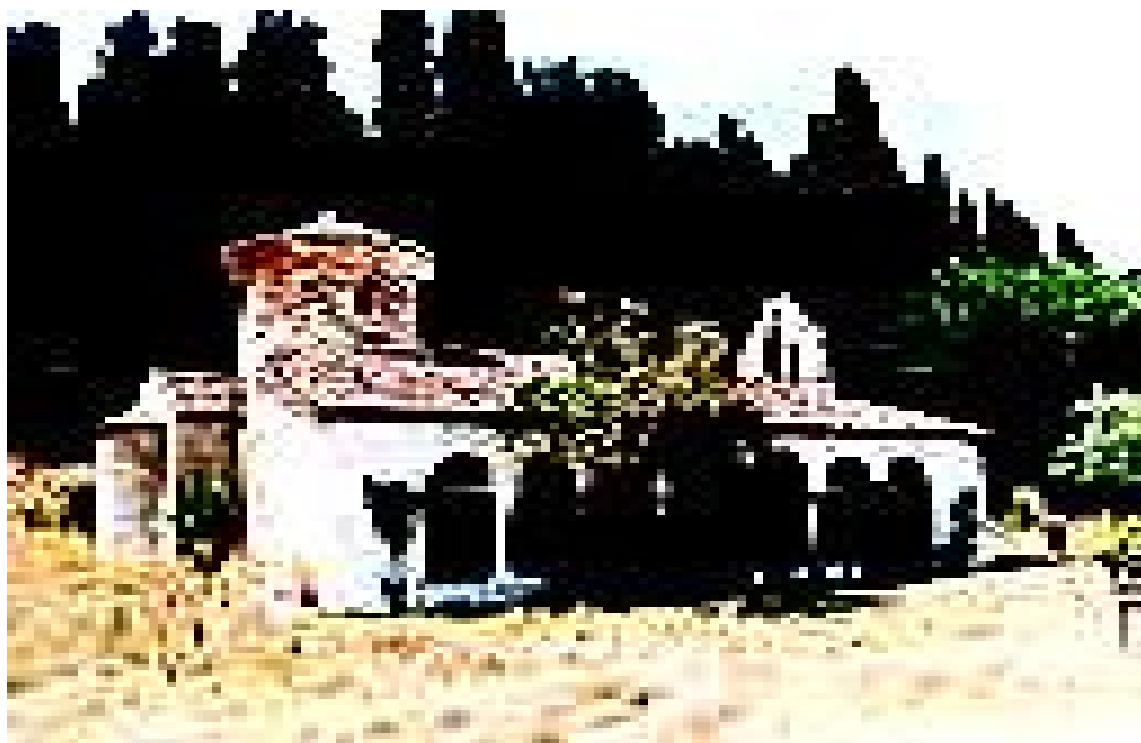
*View of the church from the north-east, before restoration.*

The monument survived, but was badly damaged. The deep corrosion in the masonry, caused by the saline atmosphere, had especially affected the binding mortar and the porous pumice stones

of which all the architectural-decorative elements of the exterior were built. This phenomenon is very obvious in the pumice columns of the gallery. As a result of it, the columns have taken on the shape of a clepsydra, with a dangerous thinning in the middle.

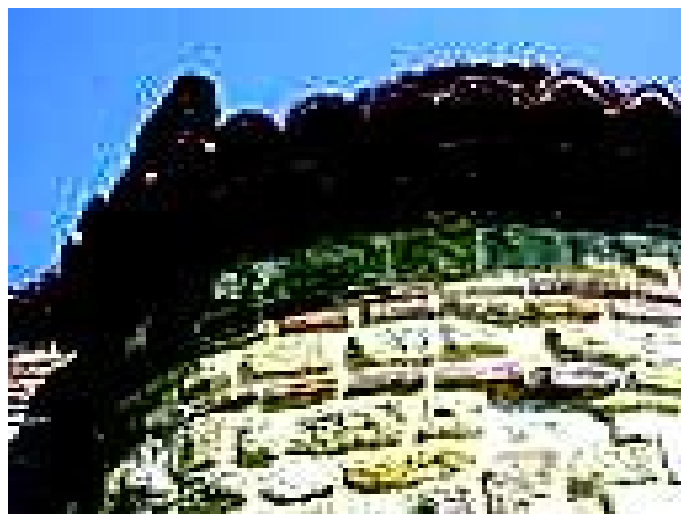
*Rebuilding of the cornice of the apse based on the preserved traces.*

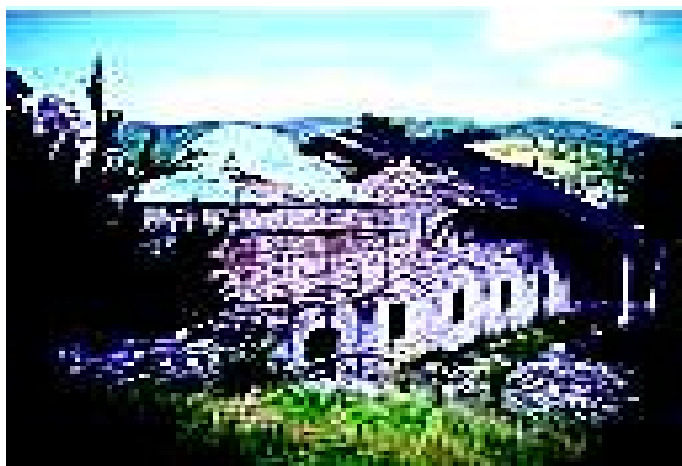
*Church of the Dormition before restoration.*

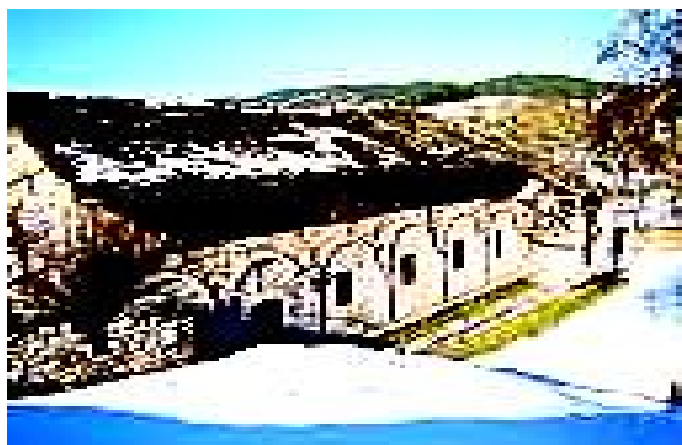
*Church of the Dormition before restoration.*

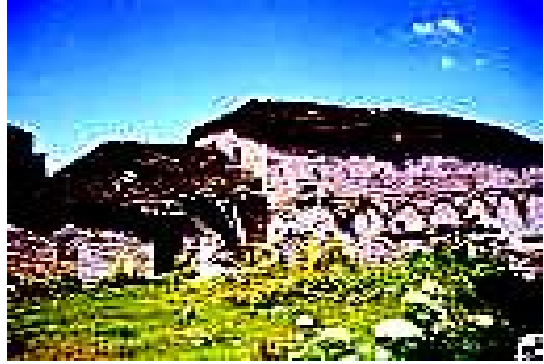
a.

The roof of this church also suffered severe damage. It was completely decayed. For this reason, the emergency work was primarily concentrated on rebuilding the whole roof.

*Church of the Archangels: a., b. before restoration c. after restoration.*

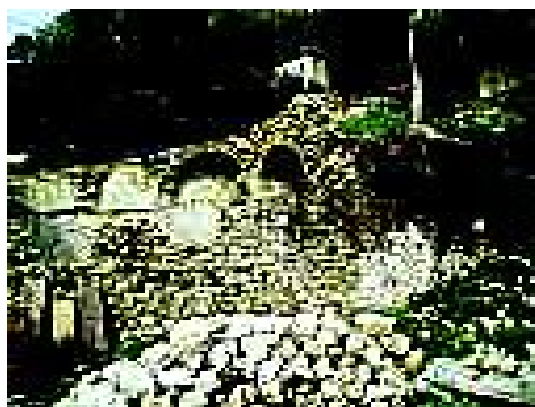
*Ruins of the Church of “The Entry  
of Our Lord in the Temple”.*

Under these circumstances, survey work was conducted and the ruins were dug up in order to determine the plan of the old church. A project was prepared for conservation of the parts that remained and for reconstruction of the church. The existence of the new buildings has so far impeded the realization of the project.

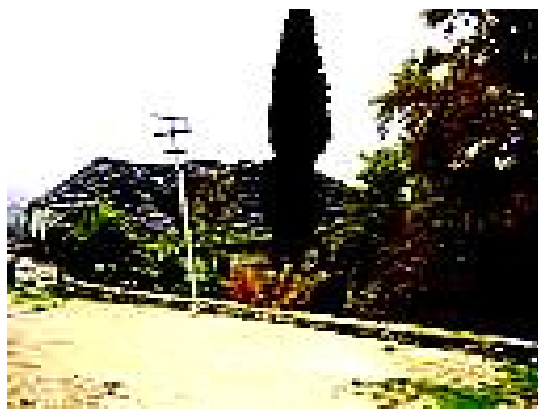
*View of the church before restoration.*

The roof was entirely destroyed, leaving all construction, masonry, arches and spherical calottes exposed to atmospheric agents. In addition, the rusting or decaying of the metal braces had led to a disequilibrium of the structural system and to the free action of the horizontal thrusts, resulting in the creation of inclinations of the masonry and the columns, as well as numerous fissures in the arches and spherical calottes.

With regard to the typology, the collapse of the gallery on the southern side had caused damage. The plastering had also come down, and the doors and windows were destroyed.

- Shoring of the arches and spherical calottes that contained the most fissures.
- Shoring of the circular column on the southeast, which was the one most inclined.
- Easing the load on the damaged superstructure by removing the ceiling stones and the in-fill underneath.
- Rebuilding the roof and covering it.
- Consolidation of the masonry of the narthex by rebuilding the parts that had collapsed and performing hydro-isolation of the end of the masonry with stone slabs, after removal of the roof.
- Installation of doors and windows.

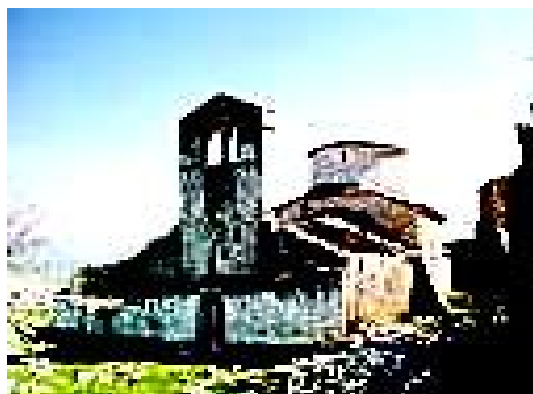
The efforts made by the restoration department of the Institute of Monuments for restoration of the roofing with stone slabs were unsuccessful. The slabs used were unsuitable, and unqualified master builders implemented the work. This overloaded the structure and led to a loss of aesthetic value. For this reason, restoration work was conducted, consisting of:

*View of the church from the southwest, before restoration.*

- Re-covering the roof of the naos.
- Consolidation of the masonry of the

narthex with a hidden reinforced concrete tie-beam.

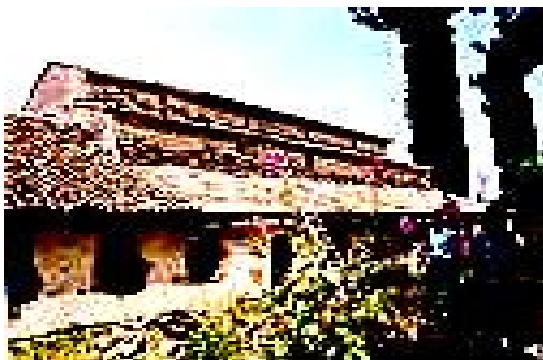
*View of the church from the south,  
before restoration.*

A long time elapsed from the abandonment of the church, and consequently serious damage occurred. For this reason, rescue measures were adopted, of which the most important ones were the entire rebuilding of the roofs of the naos and the galleries, as well as displacement and removal of the earth around the church to avoid damage from humidity.

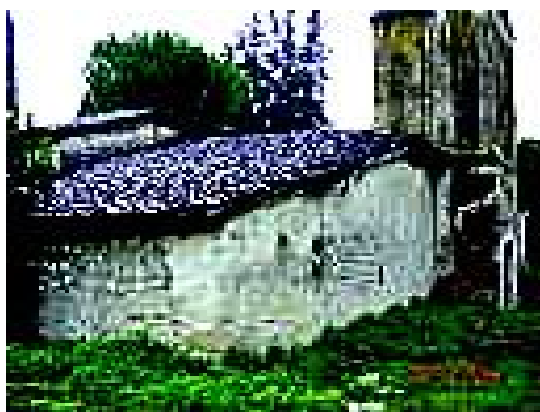
*Damaged roof and fissures in the masonry.*

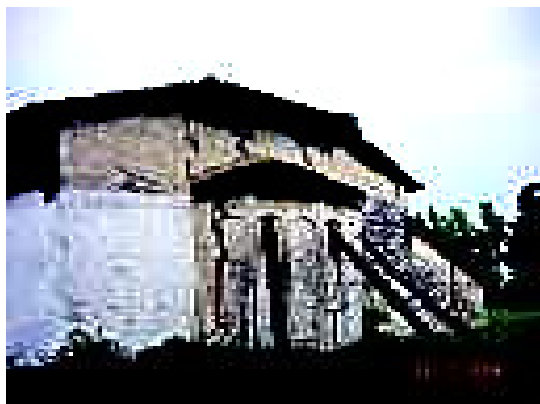
- There were a considerable number of fissures in the masonry. Most problematic were those in the apse, which posed the danger of complete detachment of this part from the rest of the building.
- As a result of the damage to the support structure of the roof, there was a marked deviation from the vertical in the masonry in the north and south.
- Separation of the wall faces from one another, that is, swelling of the masonry, could also be observed.
- The damaged roof and its covering had permitted rainfall to penetrate into the church interior, thereby seriously damaging the ornamental ceilings and wall paintings and also endangering the structural integrity of the building.

- The anchoring or connection of the northern masonry to the southern masonry with a steel cable, in order to prevent additional detachment of the building.
- The anchoring of the apse to the body of the naos, first strengthening the masonry of the building and the foundations underneath.
- The mending of the roof: replacing the deteriorated structural elements and restoring the roof completely.
- The shoring of the ornamental ceilings.
- The renovation of the shoring of the southern wall, and
- The cleaning and systemization of the western gallery and the consolidation of its wooden structures.
