DOES THE CRUMBLING MARSHALL BUILDING POSE A THREAT TO US?

MARSHALL BUILDING UNSAFE FOR STUDENTS? (Continued From Front Page)

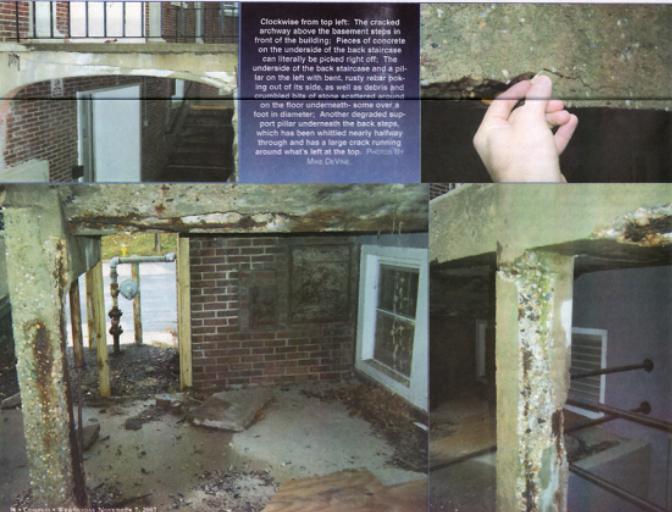
structure, is also in poor condition, with the same disintegrating cement and chipping paint that plagues the fire escapes, as well as large cracks running along the sides of the steps themselves, which likely don't bond well for the archway's safety.

The basement level can also be accessed around the back of the building, where a set of concrete stairs or staircase which is perhaps meant by the name of the building's poor level of upkeep. Consisting of a set of softened and unevenly built steps which chip away at the slightest poke, and a large, crumbling slate of concrete about one foot at its thinnest and about half that where the cement has completely peeled off, it rests on just one concrete pillar which is visibly damaged at first glance looks as though a bite had been taken out of it like an apple—near the top where it meets the slab the pillar is nearly half gone, leaving rusty rebar poking through what's left, and a large crack running along what's left of the topmost portion.

Large chunks of the concrete that once made up the rest of the staircase can be seen strewn across the ground

beneath the structure itself, and what remains in place is segmented by large cracks running along the surface on both the top and bottom—cracks which are deep enough that when it rains, water is able to seep through to the underside of the slabs. Ironically enough, the staircase is supported on one side by a wooden railing that has obviously been recently installed, attached to the side of the diminishing concrete pillar.

Clockwise from top left: The cracked and broken concrete steps leading up to the front of the building. Pieces of concrete on the underside of the back staircase are shown. A close-up of the underside of the back staircase and a pillar on the left with bent, rusty rebar poking out of the side. A view of debris and rusted rebar on the floor underneath some over a foot of concrete. A view of a support pillar underneath the back stairs, which has been whittled nearly halfway through by a large crack running around what's left at the base. Photos by Mike DeVine.

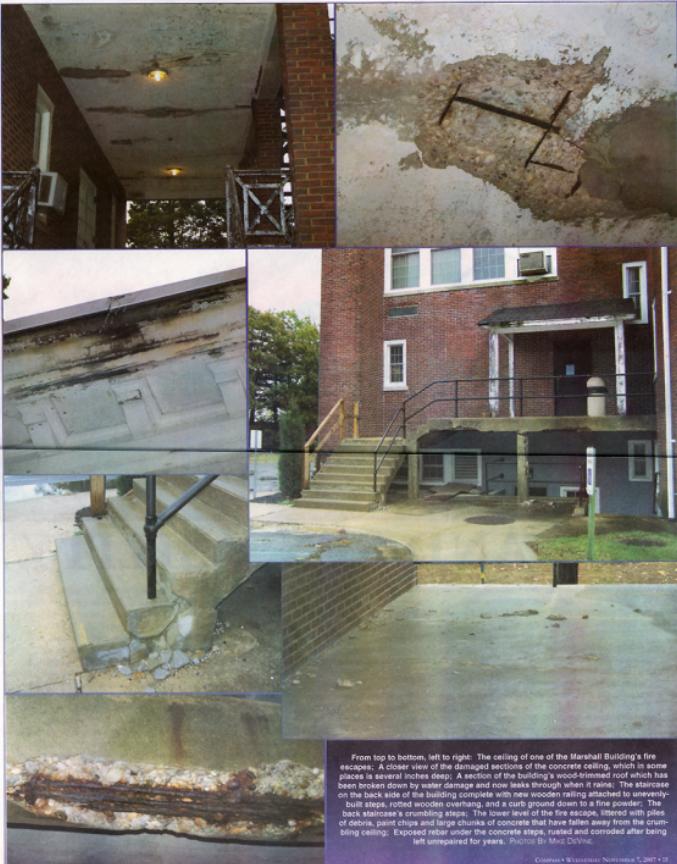
and the safety of others who use the porches, citing the apparent structural instability of the balconies as indicated by the crumbling cement and exposed rebar—metal bars used inside of large concrete slabs to provide support—which is made more obvious by the ever-growing piles of large cement chunks and paint chips on the floors of the balconies beneath the neglected slabs.

The officers' fears are heightened by the unthinkable scenario that may occur in the event of an emergency, in which the fire escapes may fail to support the weight of the several dozen people who would be using them to exit the building. There is also concern about the metal staircases leading up the sides of the porches, as neglect and poor maintenance has resulted in rust and chipping paint appearing across the entire surface of the handrails as well as on many of the support struts on the staircases' undersides, which once again brings into question the building's structural integrity.

From top to bottom, left to right. The ceiling of one of the Marshall Building's fire escapes; A closer view of the damaged sections of the concrete ceiling, which is several inches deep; A section of the building's wood-timbered roof which has collapsed onto the back side of the building complete with new wooden railing attached to unevenly built steps; rotted wooden overhang, and a curb down to a fine powder; The back staircase's crumpled metal railing. The building's exterior shows a set of concrete steps and large chunks of concrete that have fallen away from the crumbling ceiling; Exposed rebar under the concrete steps, rusted and corroded after being left unprepared for years. Photos by Mike DeVine.
