# **LIDAR Inspection Report of VUP ch.893 + 270**

**Bridge Chainage:** 893 + 270 (CKRP)

- **Bridge No:** -
- **Chainage:** 893 + 270
- **Structure type:** Slab Culvert

- **CKRP:** Chittorgarh to kota
- **State:** Rajasthan NH 27
- **Zone:** RJ-06

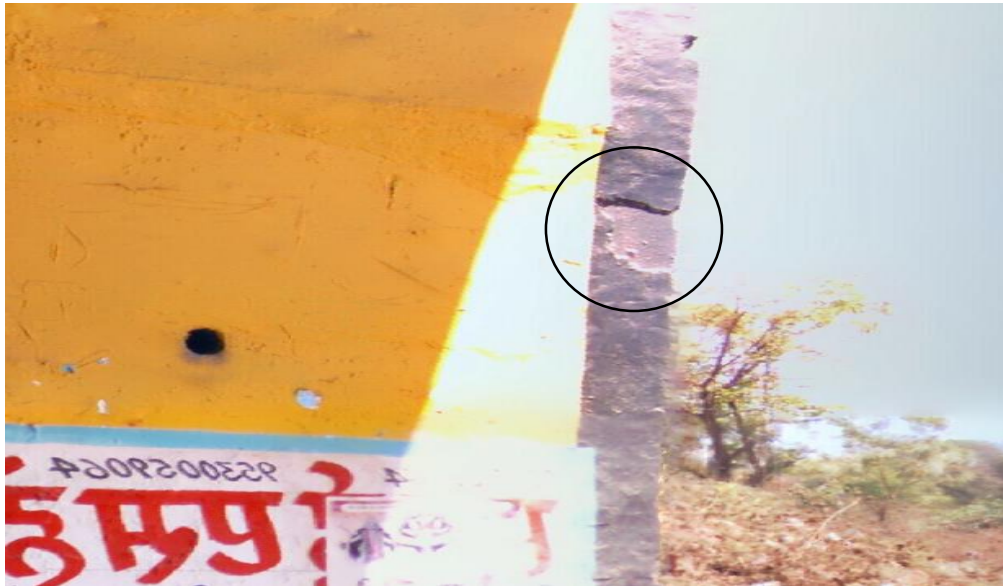
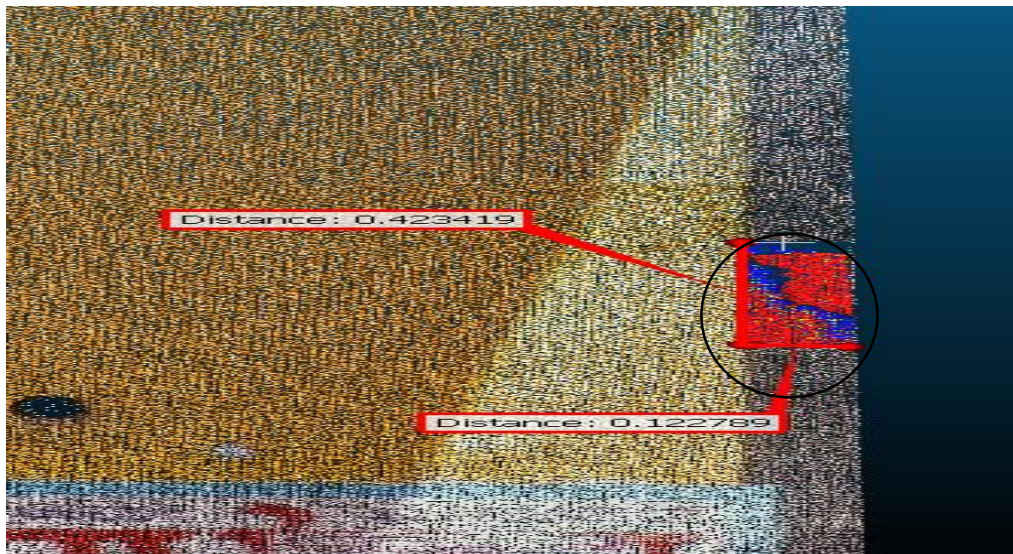
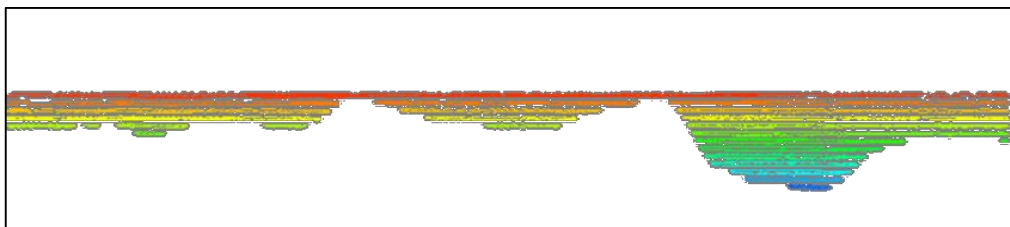
| Element Name | Observation | Location of Distress | Photo No. | Units | Distress Details | | | Area of Repair (Sq.m/ RMT/ m3) |
|---|---|---|---|---|---|---|---|---|
| Abutment 1 | Scaling | | 1 | M | 0.42 | 0.12 | - | 0.0504 |

**1. Scaling observed on Abutment 1 RHS , measuring 0.42 m in length and 0.12 m in width, covering an area of 0.0504 m<sup>2</sup>.**
