# **LIDAR Inspection Report of MNB ch.894+285**

**Bridge No:** MNB - 895/2

**Bridge Chainage:** 894+285 (CKRP)

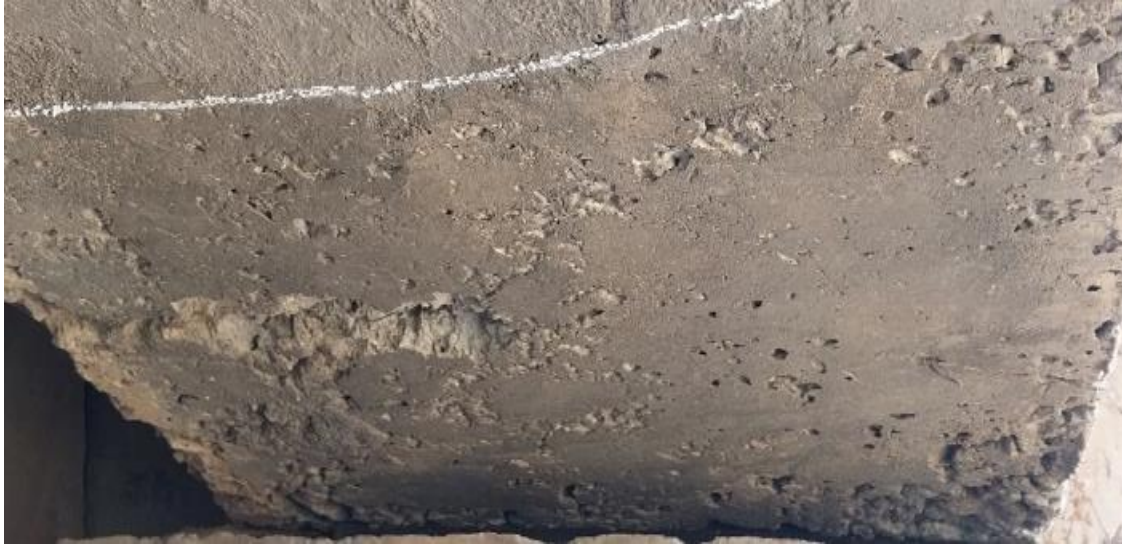
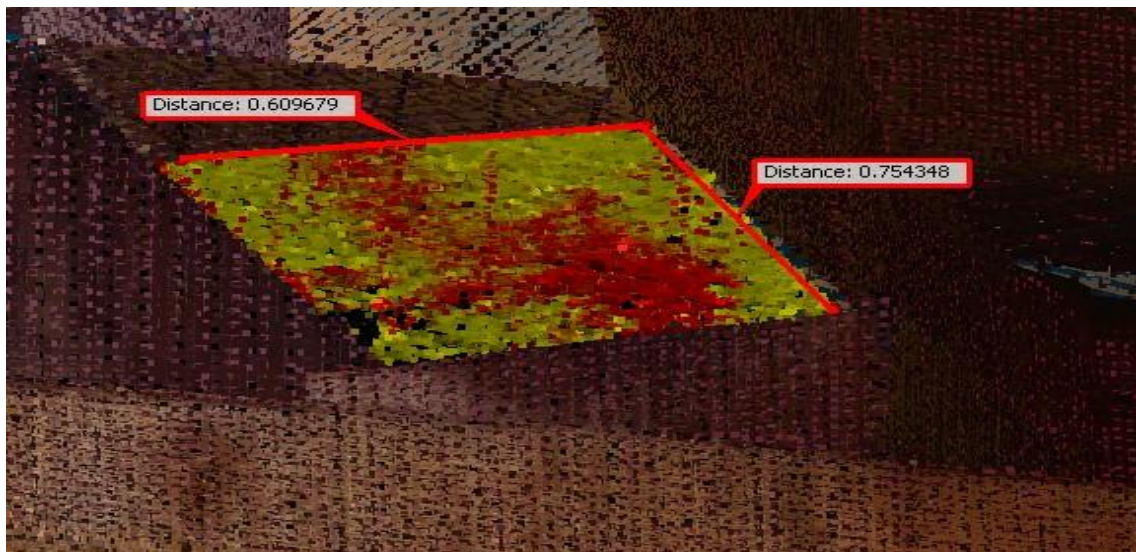
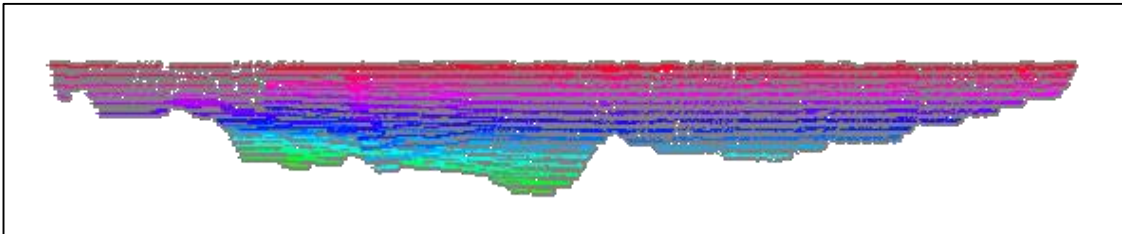
| Element Name | Observation | Location of Distress | Photo No. | Units | Distress Details | | | Area of Repair (Sq./RM T/m3) |
|---|---|---|---|---|---|---|---|---|
| Abutment 1 | Honeycombing | | 1 | | 0.75 | 0.60 | | 0.45 |

**1.Honeycombing observed on LHS Abutment 1, Girder 3, measuring 0.75 m in length and 0.60 m in width, covering an area of 0.45 m<sup>2</sup>.**

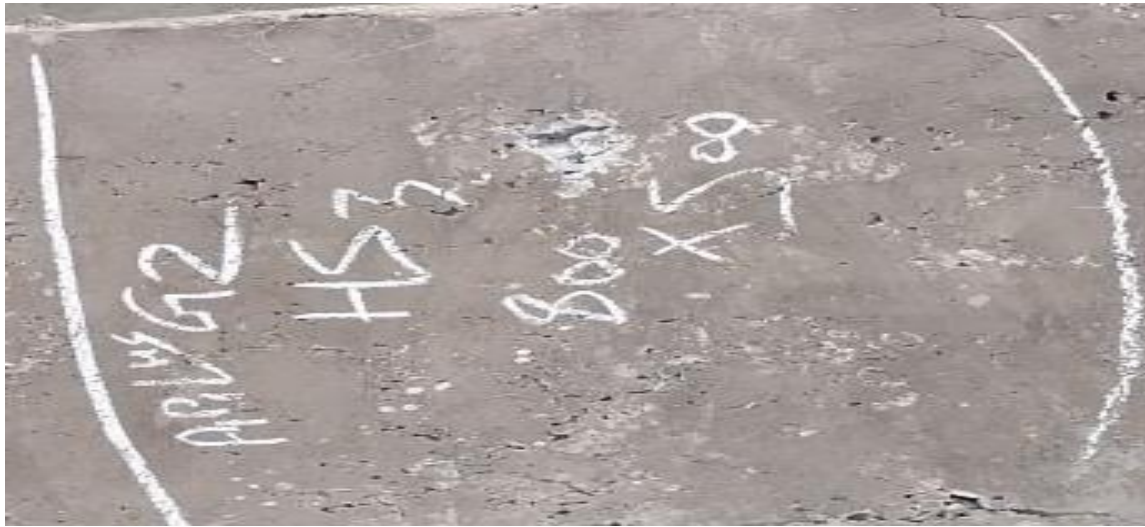
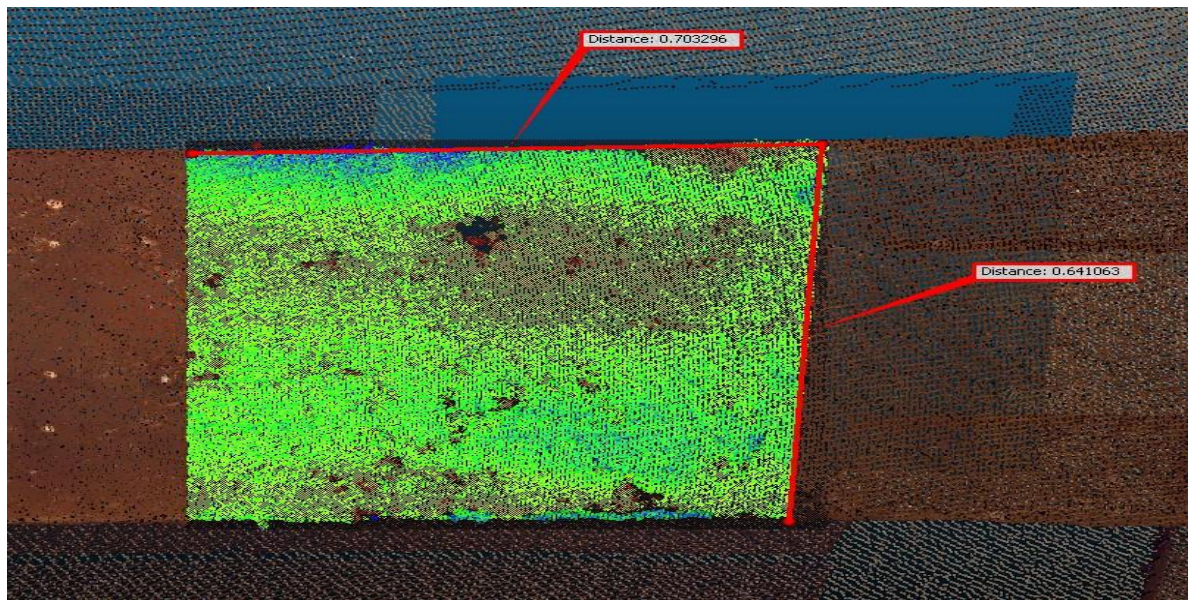
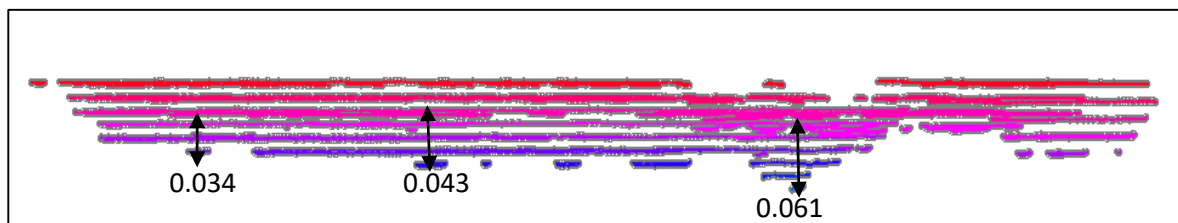
| Element Name | Observation | Location of Distress | Photo No. | Units | Distress Details | | | Area of Repair (Sq./RM T/m3) |
|---|---|---|---|---|---|---|---|---|
| Abutment 1 | Hollow section | | 2 | | 0.70 | 0.64 | 0.043 | 0.0192 |

2. Hollow section observed on LHS of Abutment 1 at Girder 2, measuring 0.70 m in length and 0.64 m in width. Depth ranges from 0.034 m (min) to 0.061 m (max), with an average depth of 0.043 m. The affected area is 0.0192 m<sup>2</sup>.

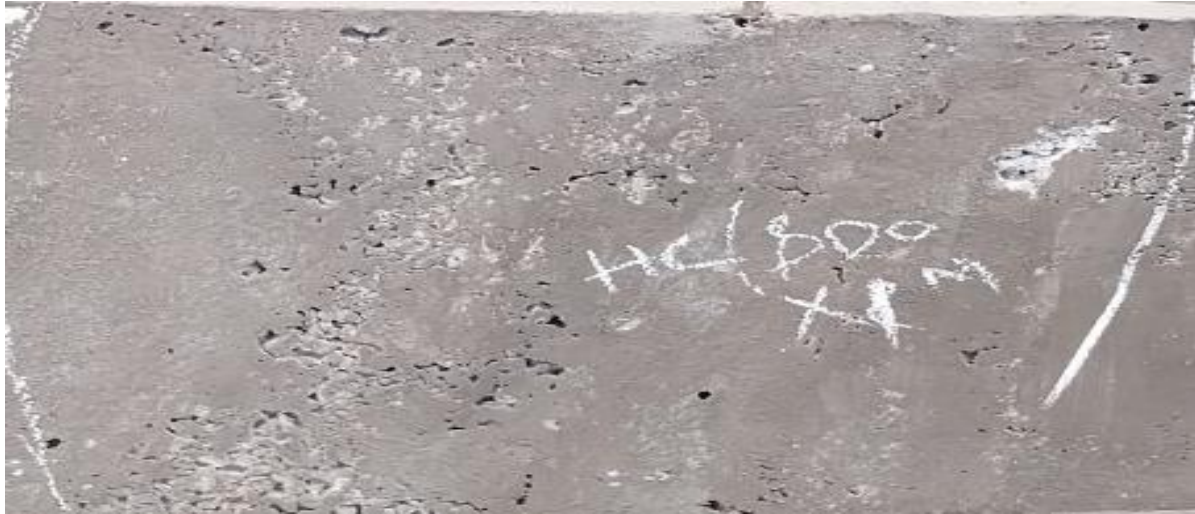
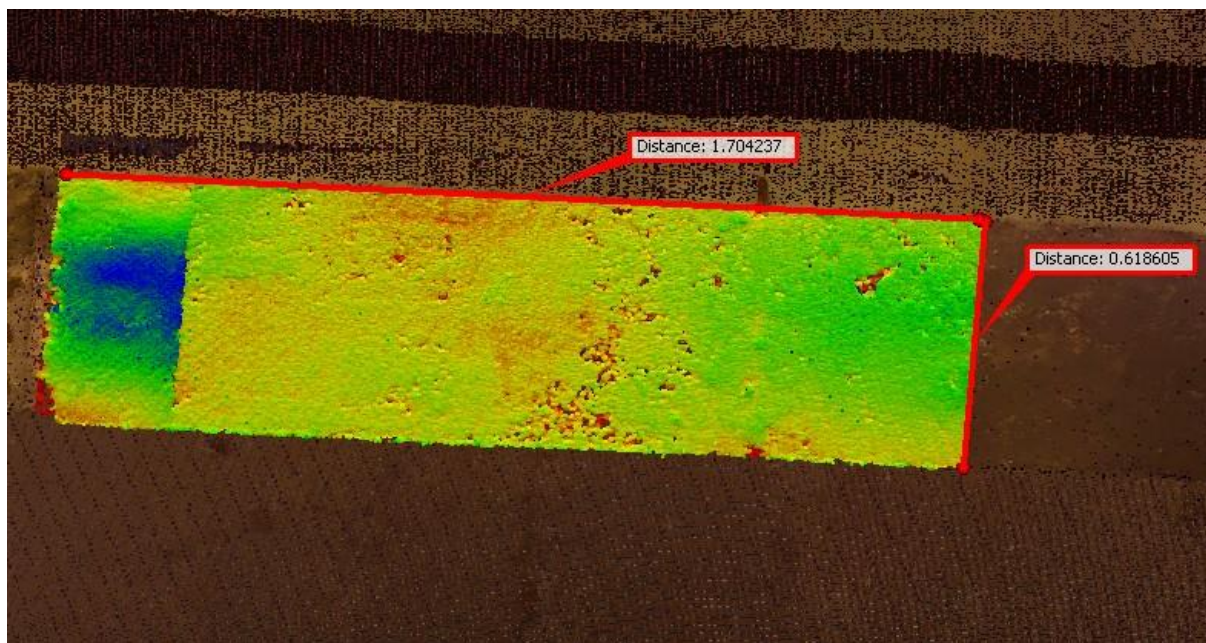
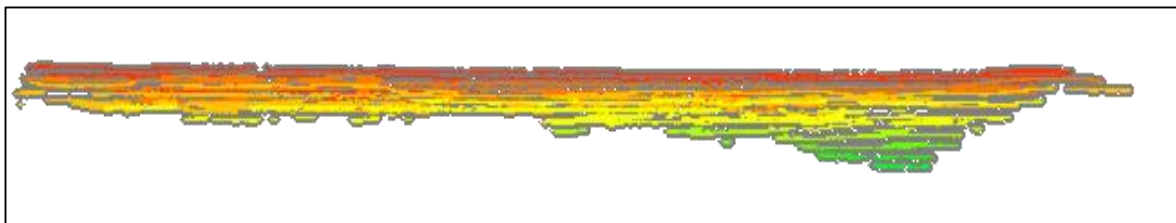
| Element Name | Observation | Location of Distress | Photo No. | Units | Distress Details | | | Area of Repair (Sq./RM T/m3) |
|---|---|---|---|---|---|---|---|---|
| Abutment 1 | Honeycombing | | 3 | | 1.70 | 0.61 | | 1.037 |

**3. Honeycombing observed on LHS Abutment 1, Girder 2, measuring 1.70 m in length and 0.61 m in width, covering an area of 1.037 m<sup>2</sup>.**

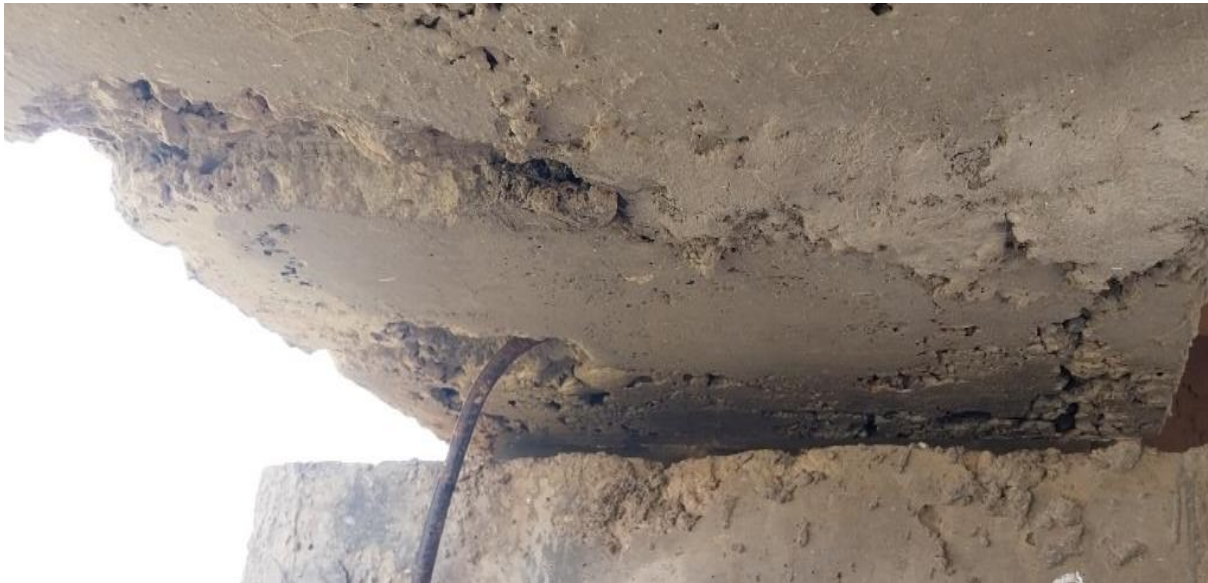
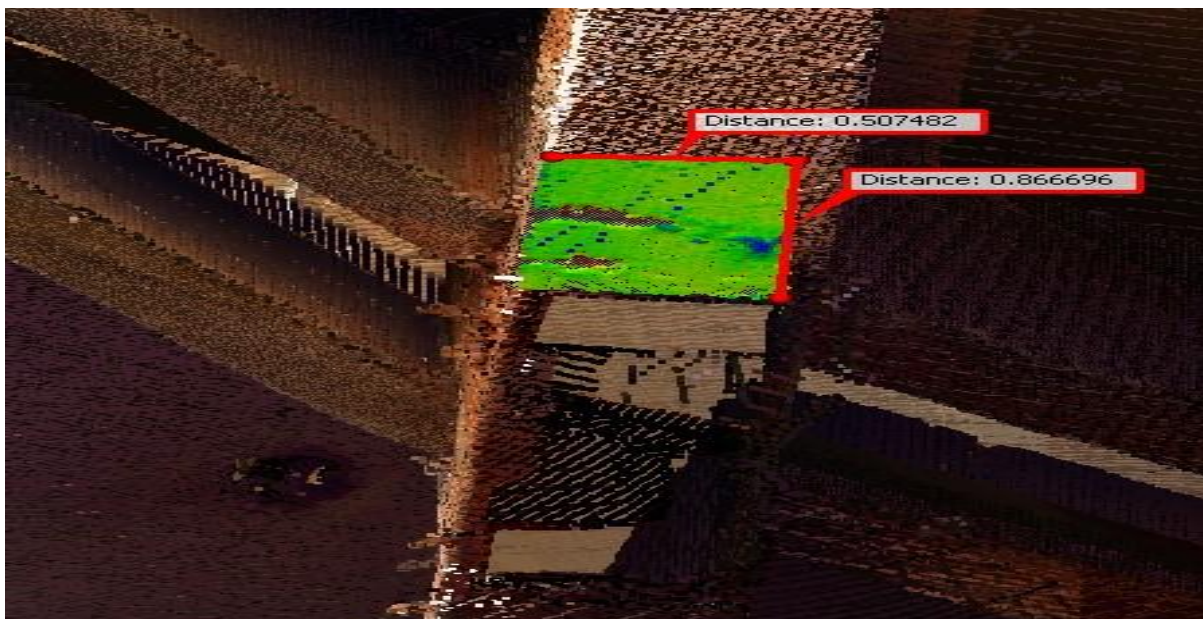
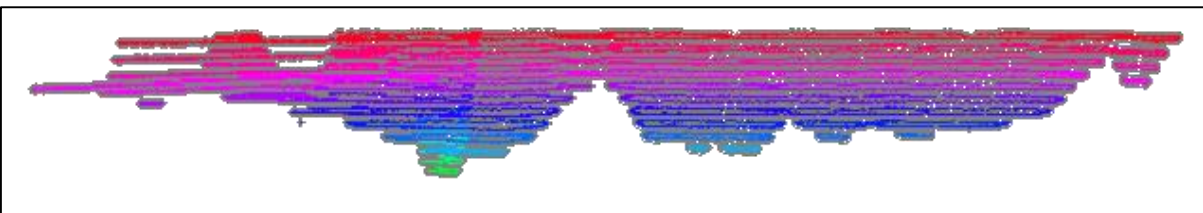
| Element Name | Observation | Location of Distress | Photo No. | Units | Distress Details | | | Area of Repair (Sq./RM T/m3) |
|---|---|---|---|---|---|---|---|---|
| Abutment 1 | Honeycombing | | 4 | | 0.50 | 0.86 | | 0.43 |

**4. Steel exposed and honeycombing observed on LHS Abutment 1 to Pier 1, Bearing 3, measuring 0.50 m in length and 0.86 m in width, covering an area of 0.43 m<sup>2</sup>.**

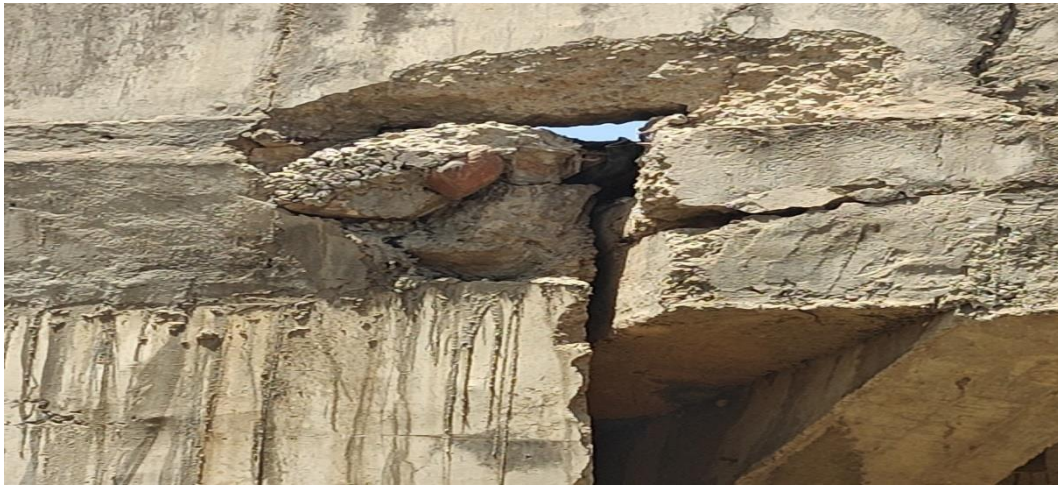
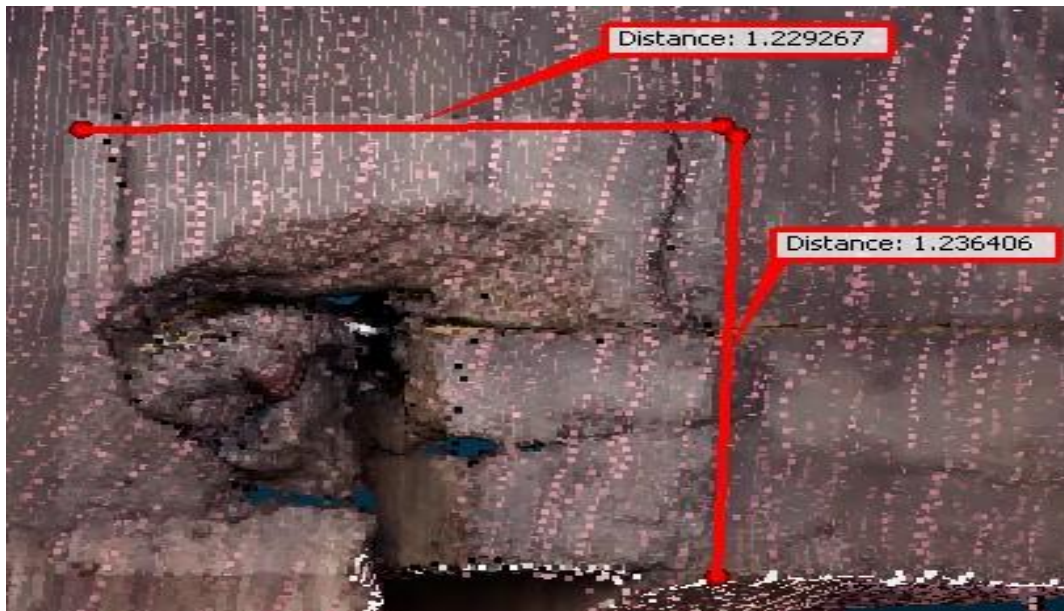
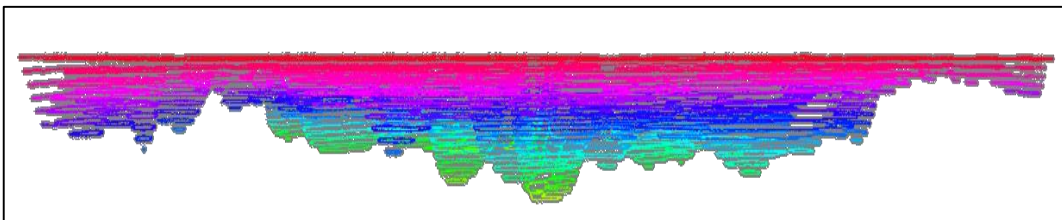
| Element Name | Observation | Location of Distress | Photo No. | Units | Distress Details | | | Area of Repair (Sq./RM T) |
|---|---|---|---|---|---|---|---|---|
| Abutment 1 | Damage | | 6 | | 1.22 | 1.23 | | 1.5006 |

**6. Abutment edge damage observed on RHS Abutment 1, measuring 1.22 m in length and 1.23 m in width, covering an area of 1.5006 m<sup>2</sup>.**

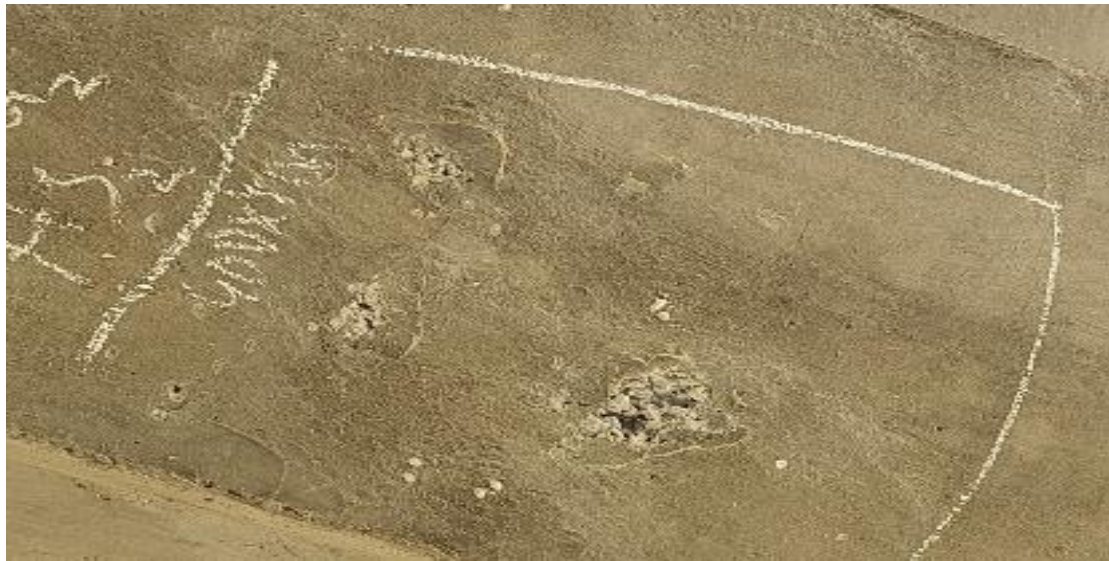
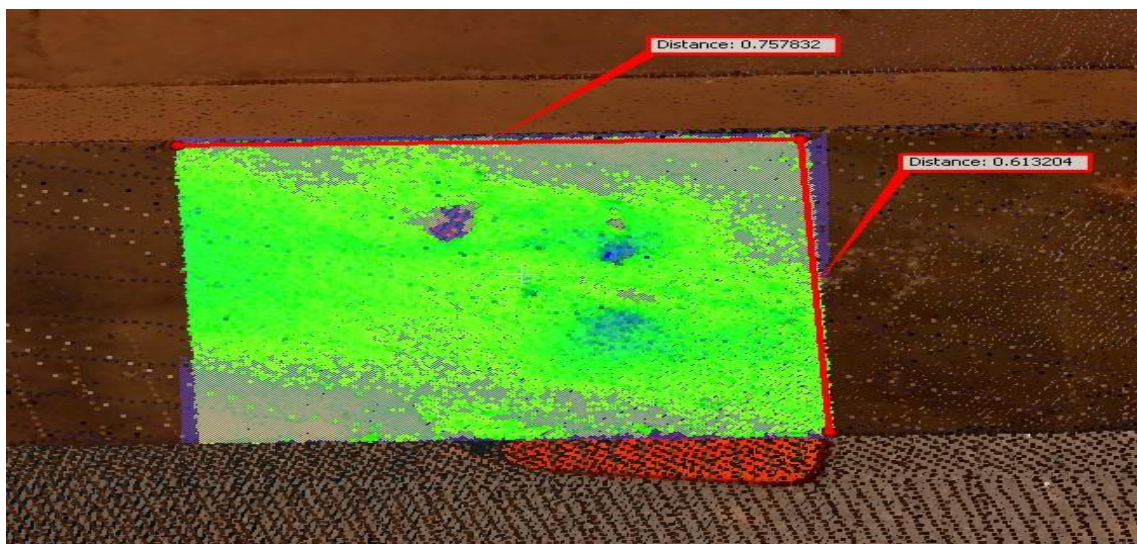
| Element Name | Observation | Location of Distress | Photo No. | Units | Distress Details | | | Area of Repair (Sq./RM T) |
|---|---|---|---|---|---|---|---|---|
| Abutment 1 | Hollow section | | 7 | | 0.75 | 0.61 | 0.047 | 0.0215 |

**7. Hollow section observed on RHS Abutment 1 to Pear 1, measuring 0.75 m in length and 0.61 m in width, Depth ranges from 0.033 m (min) to 0.073 m (max), with an average depth of 0.047 m. The affected area is 0.0215 m<sup>2</sup>.**

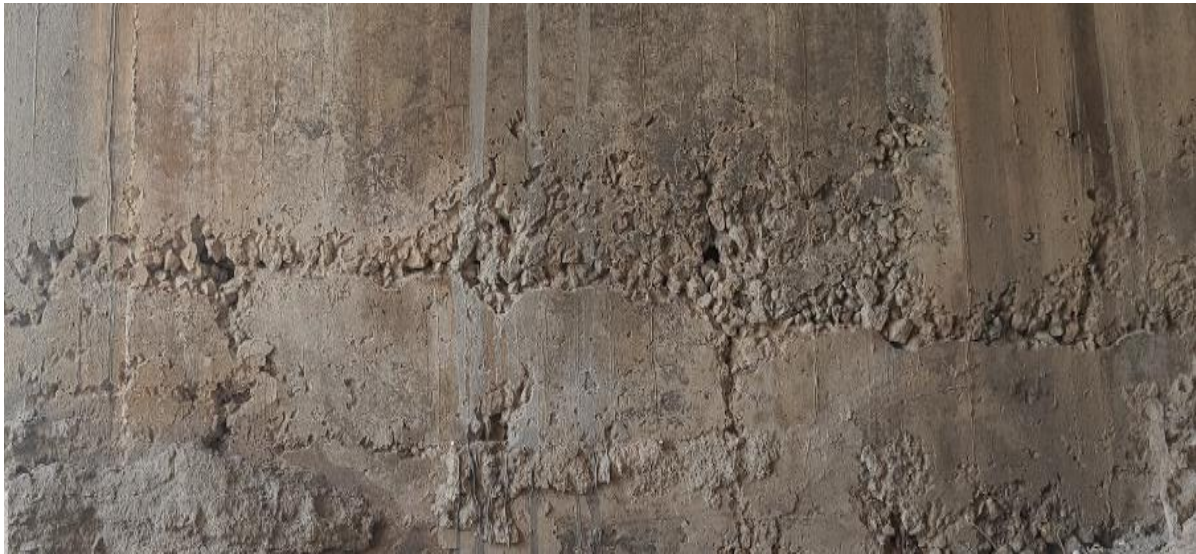
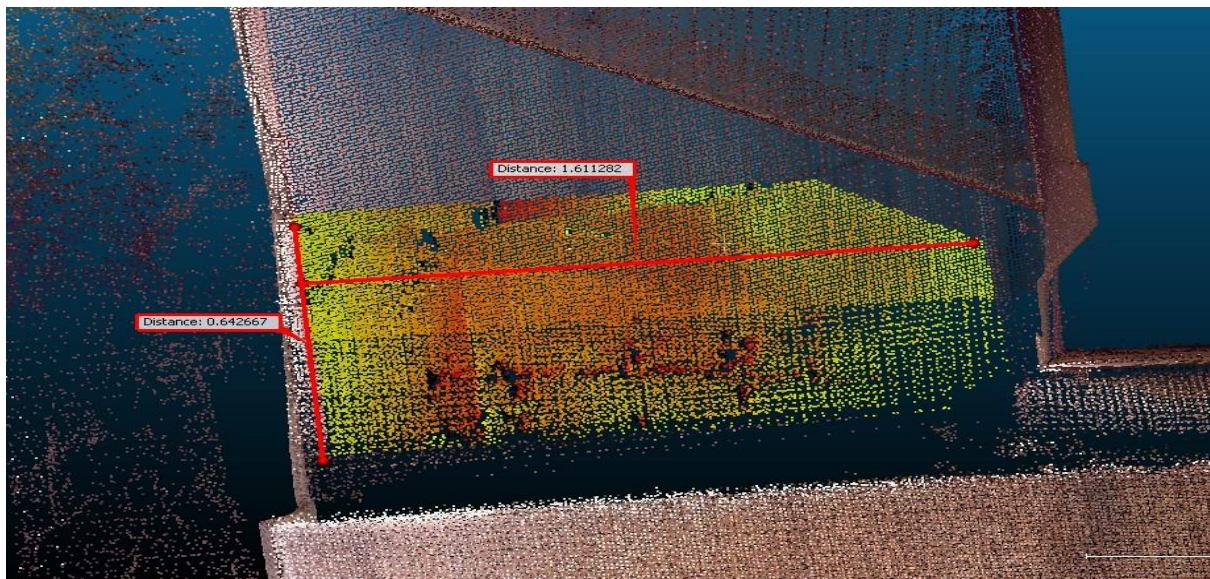
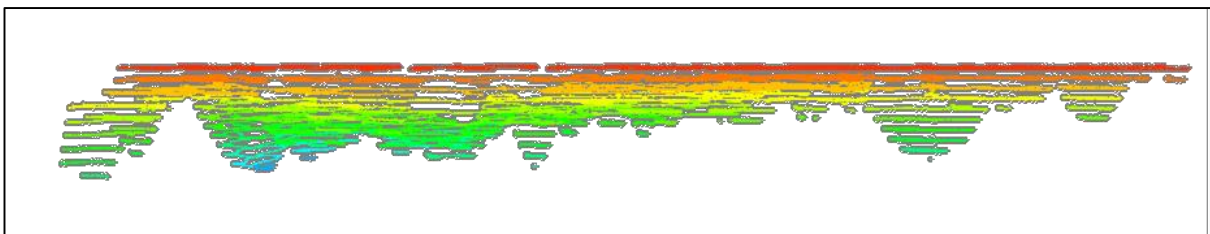
| Element Name | Observation | Location of Distress | Photo No. | Units | Distress Details | | | Area of Repair (Sq./RM T) |
|---|---|---|---|---|---|---|---|---|
| Abutment 1 | Scaling | | 8 | | 0.87 | 0.09 | | 0.078 |

**8. Scaling observed on Abutment 1 RHS near Bearing 3, measuring 0.87 m in length and 0.09 m in width, covering an area of 0.078 m<sup>2</sup>.**

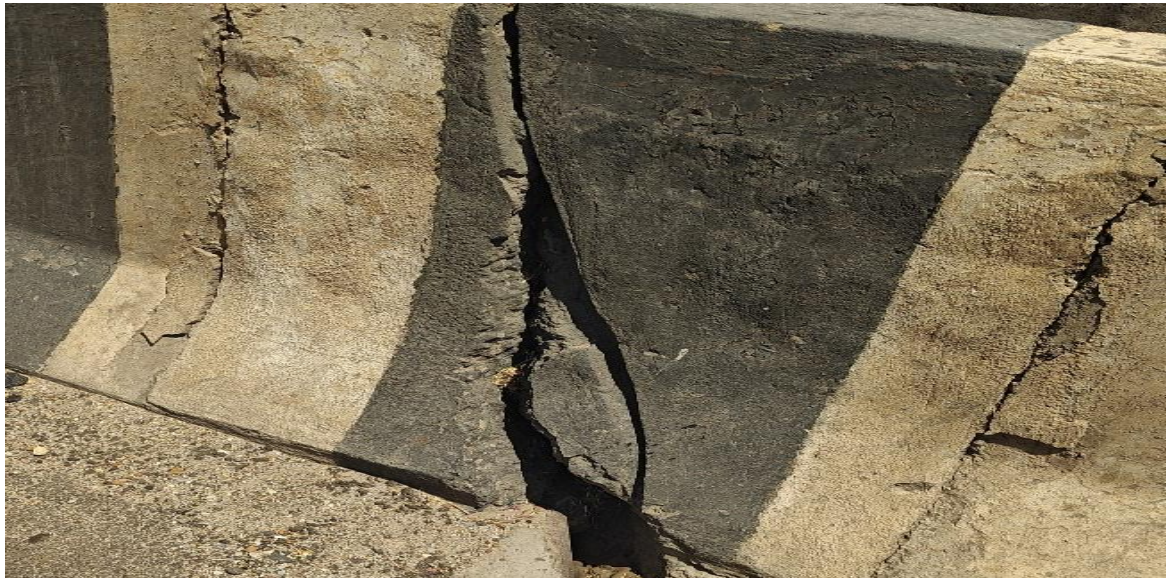
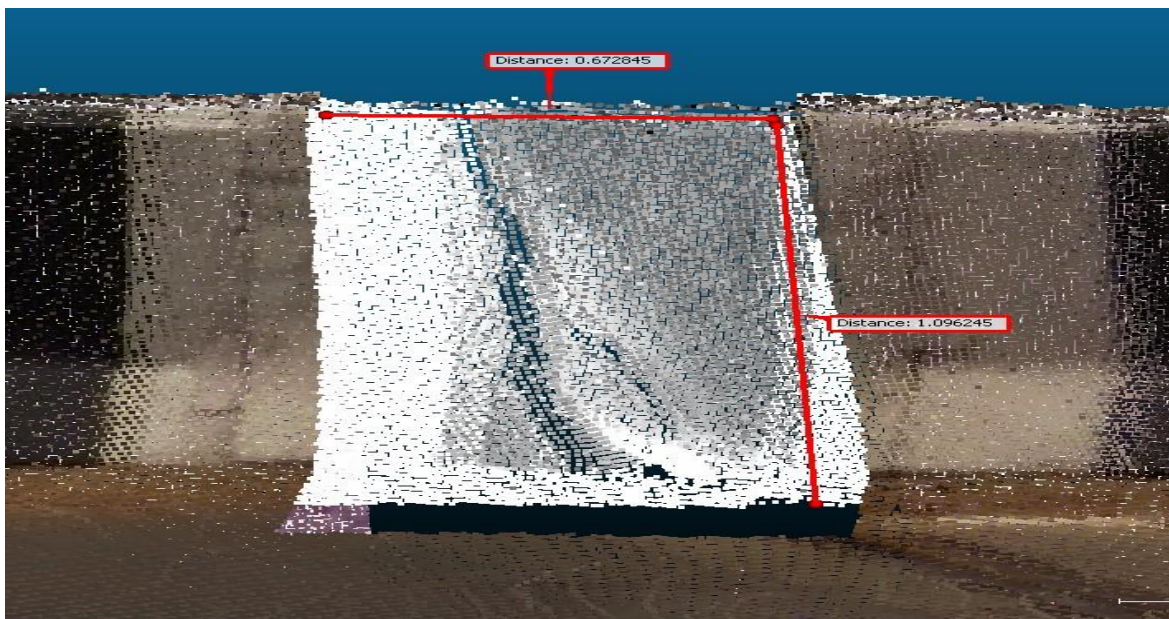
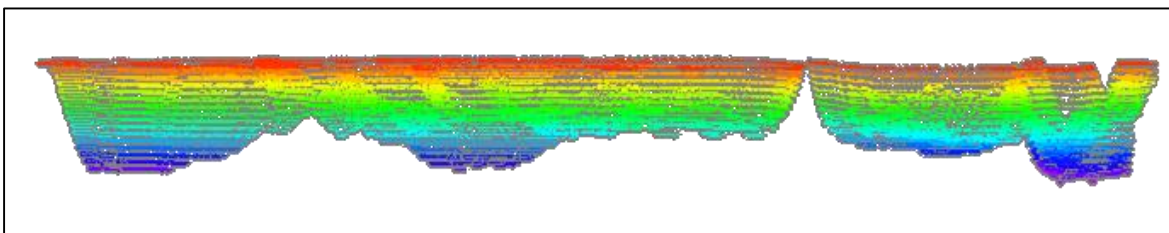
| Element Name | Observation | Location of Distress | Photo No. | Units | Distress Details | | | Area of Repair (Sq./RM T) |
|---|---|---|---|---|---|---|---|---|
| Crash barrier | Damage | | 9 | | 1.09 | 0.67 | | 0.730 |

**9. Crash barrier damage observed on RHS, measuring 1.09 m in length and 0.67 m in width, covering an area of 0.730 m<sup>2</sup>.**
