# **Satellite Structural Inspection Interferometric Synthetic Aperture Radar (InSAR) Based**

State – Rajasthan  
Bridge No. – 895/2  
Bridge Chainage – 894+285

Project - Chittorgarh to Kota  
Zone – RJ 06  
Structure Type – MNB

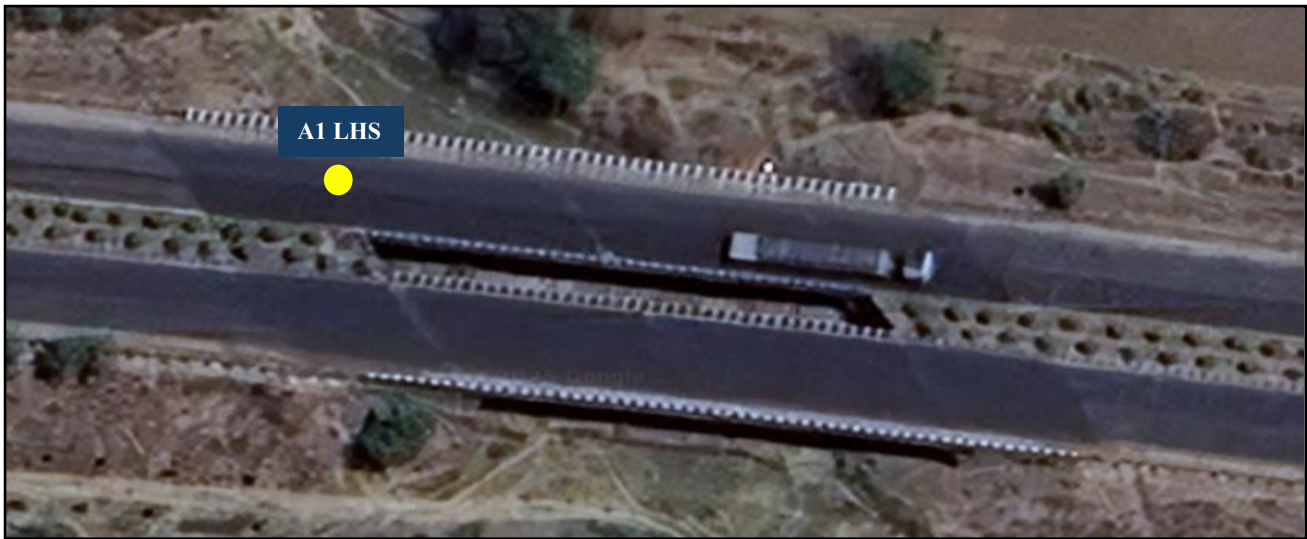
A1 LHS (24.83413159273759, 74.60056508002354)

- **Vertical Displacement (VV)** ranges roughly between  $-8$  mm and  $+15$  mm, showing alternating uplift and settlement phases.
- **Horizontal displacement (VH)** varies approximately between  $-4$  mm and  $+18$  mm, indicating moderate lateral movement across the monitoring period.

- **March 2025:** Simultaneous reduction in both VH and VV indicates a short-term disturbance or transient loading condition.
- **May-June 2025:** Peak VH ( $+18$  mm) and VV ( $+15$  mm) occur close together, suggesting a combined structural response, possibly influenced by thermal expansion or loading variation.

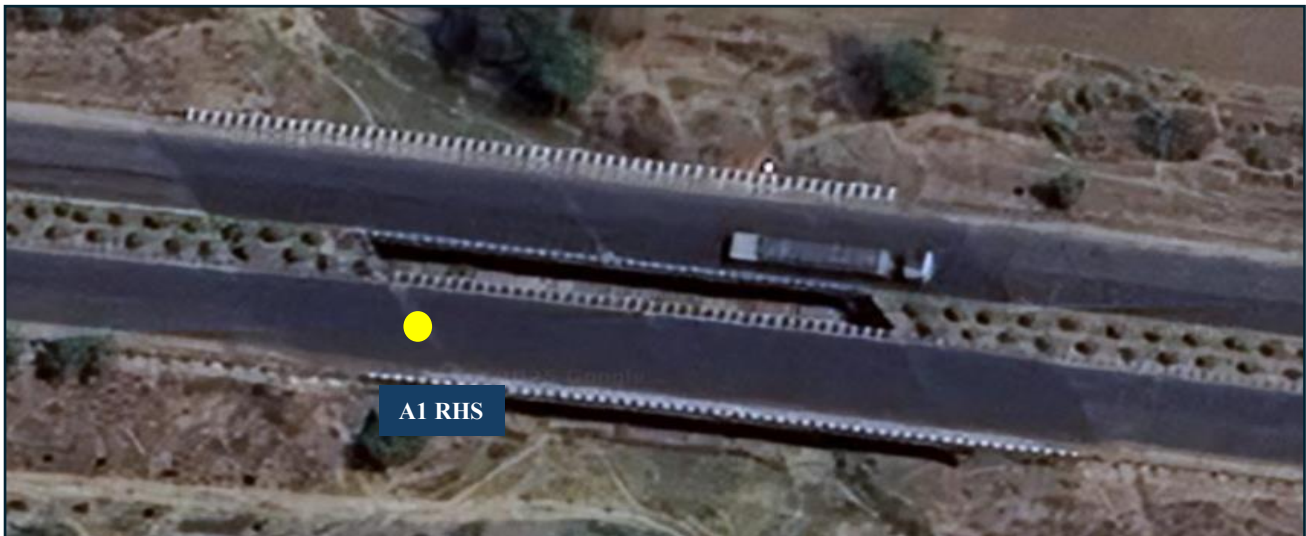
A1 RHS (24.834003942580367, 74.60062938037062)

- **Horizontal displacement (VH)** Horizontal displacement ranges approximately from -25 mm to -5 mm, indicating predominantly negative lateral movement throughout the monitoring period.
- **Vertical displacement (VV)** Vertical displacement varies approximately between -8 mm and +20 mm, showing alternating uplift and settlement.

- **March-April 2025:** Gradual increase in negative VH values indicates progressive lateral movement, possibly related to cumulative loading or foundation response.
- **June 2025:** VV reaches its maximum (+20 mm) while VH remains strongly negative, suggesting combined vertical uplift with lateral drift, which may reflect differential structural behaviour or thermal effects.

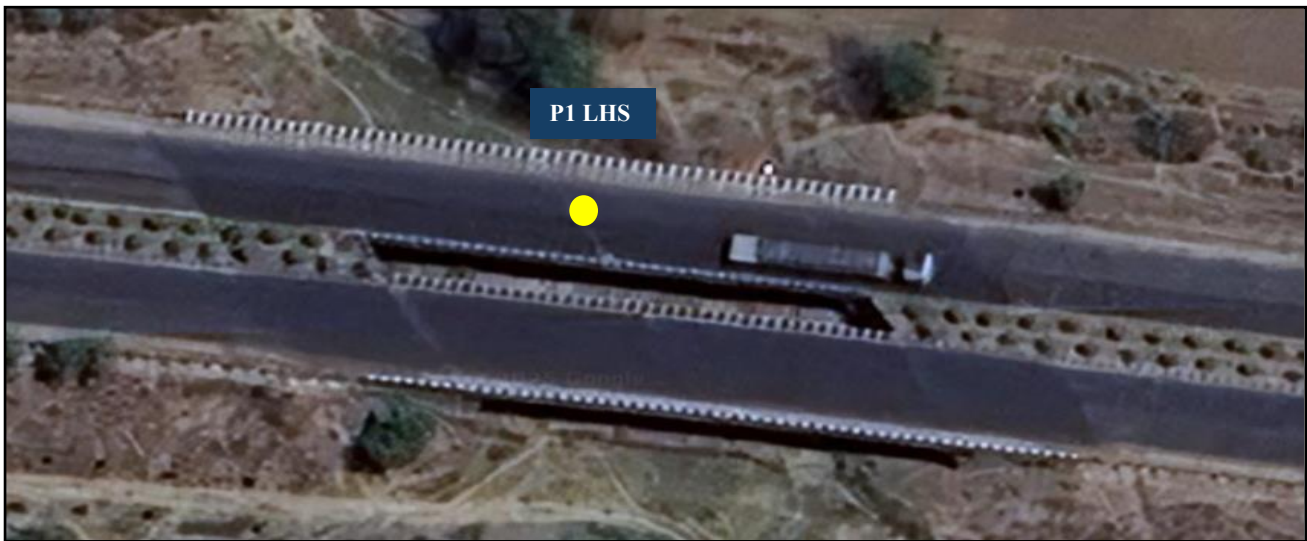
P1 LHS (24.83411609236837, 74.60073688251337)

- **Horizontal displacement (VH)** Horizontal displacement remains consistently negative, ranging approximately from -6 mm to -17 mm, indicating sustained lateral movement in one dominant direction.
- **Vertical displacement (VV)** Vertical displacement ranges approximately between -16 mm and +8 mm, showing alternating uplift and settlement phases. Toward the end of the monitoring period, VV partially recovers but remains predominantly negative

- **February to March 2025:** A clear downward trend in both VH and VV suggests a period of increased settlement
- **April 2025:** Minimum VH values coincide with continued negative VV, indicating combined lateral and vertical movement
- **June 2025:** Partial recovery in both components suggests stabilization, though full rebound is not observed.

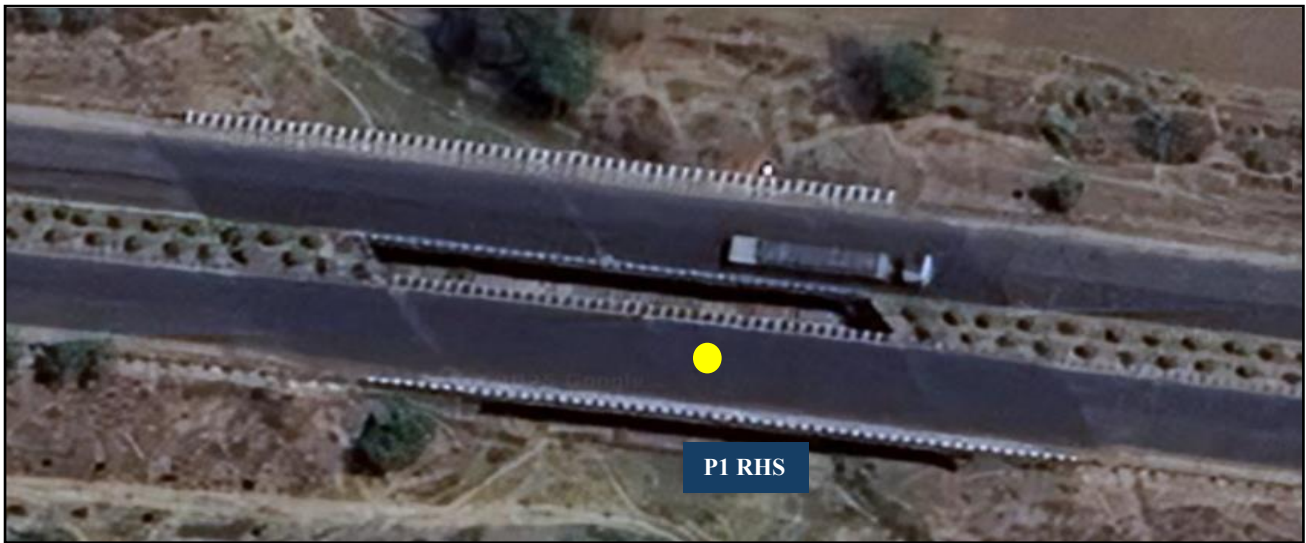
P1 RHS (24.833985706832877, 74.60079515470291)

- **Horizontal displacement (VH)** Horizontal displacement varies approximately between –6 mm and +10 mm, indicating moderate lateral movement throughout the monitoring period.
- **Vertical displacement (VV)** Vertical displacement ranges approximately between –8 mm and +22 mm, showing greater variability compared to VH.

- **March 2025:** A brief negative VV excursion (–8 mm) indicates short-term settlement prior to upward recovery.
- **April:** Simultaneous peak in VV (~+22 mm) and moderate VH response suggests a combined vertical–horizontal structural response, possibly influenced by thermal or loading effects
- **June 2025:** A second VV peak (~+18 mm) occurs, followed by stabilization, indicating transient rather than progressive behaviour.

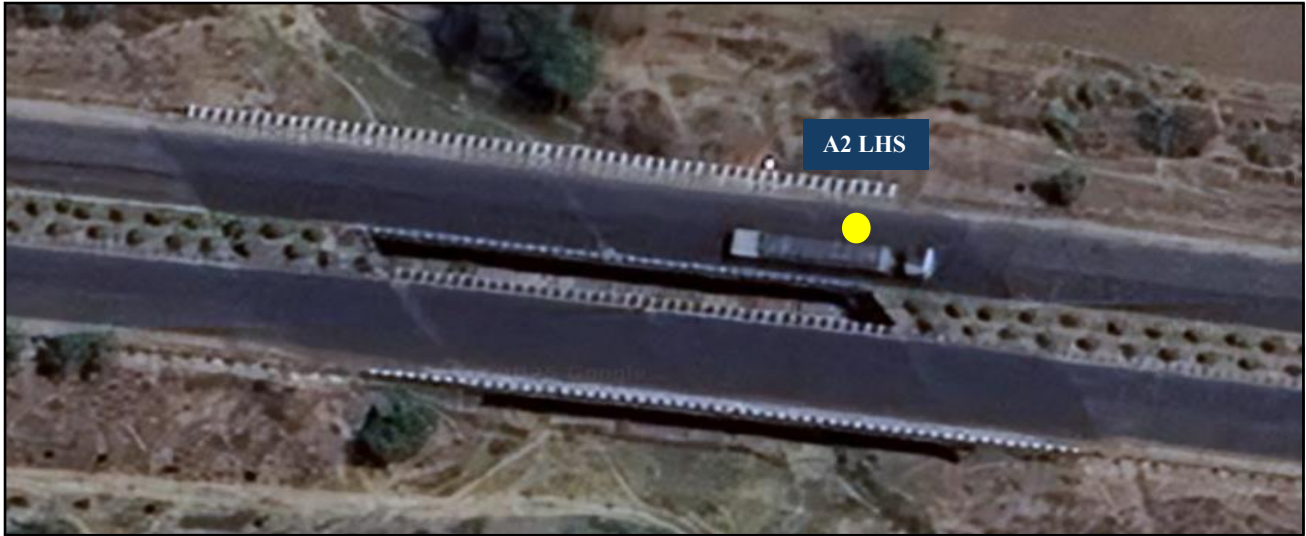
A2 LHS (24.834091474130936, 74.6009297835545)

- **Horizontal displacement (VH)** Horizontal displacement ranges approximately from -18 mm to +6 mm, indicating a dominantly negative lateral movement over the monitoring period.
- **Vertical displacement (VV)** Vertical displacement varies between approximately +3 mm and +26 mm, showing consistent uplift behaviour.

- **April 2025:** A sharp vertical peak (+26 mm) coincides with a moderate VH recovery, indicating a combined vertical-horizonal structural response.
- **May-June 2025:** VH reaches its most negative values while VV remains elevated, suggesting differential movement potentially influenced by foundation response or thermal effects.

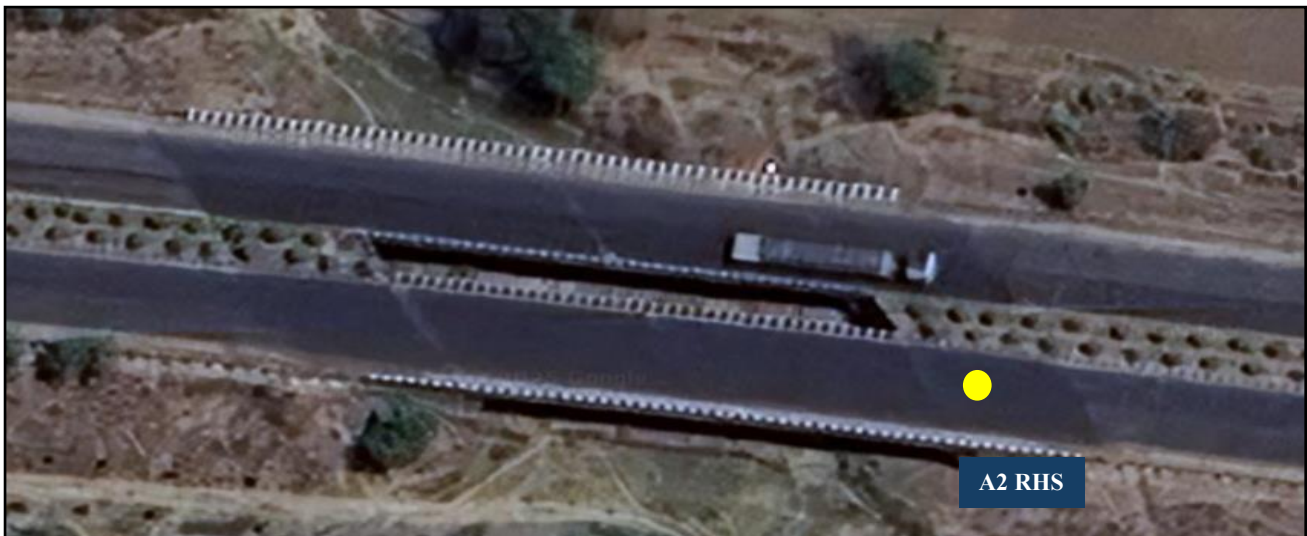
A2 RHS (24.83395926499424, 74.60101015898844)

- **Horizontal displacement (VH)** Horizontal displacement ranges approximately from –22 mm to +4 mm, indicating a predominantly negative lateral movement throughout the monitoring period.
- **Vertical displacement (VV)** Vertical displacement varies approximately between –12 mm and +20 mm, showing moderate-to-high variability.

- **April 2025:** A pronounced vertical uplift (+20 mm) coincides with a notable negative VH excursion, indicating combined vertical uplift and lateral movement.
- **June 2025:** VH reaches its most negative values (–22 mm), while VV remains elevated, suggesting differential structural response and possible redistribution of internal forces.
