# **LIDAR Inspection Report of VUP ch.896 + 090**

**Bridge Chainage:** 896 + 090 (CKRP)

**CH: 896 +090– VUP**

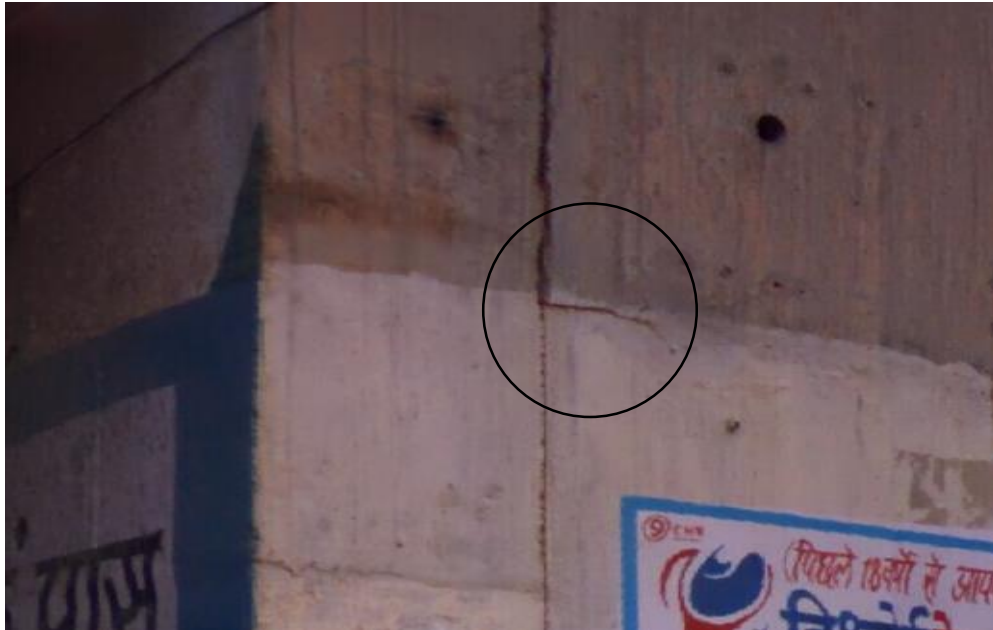
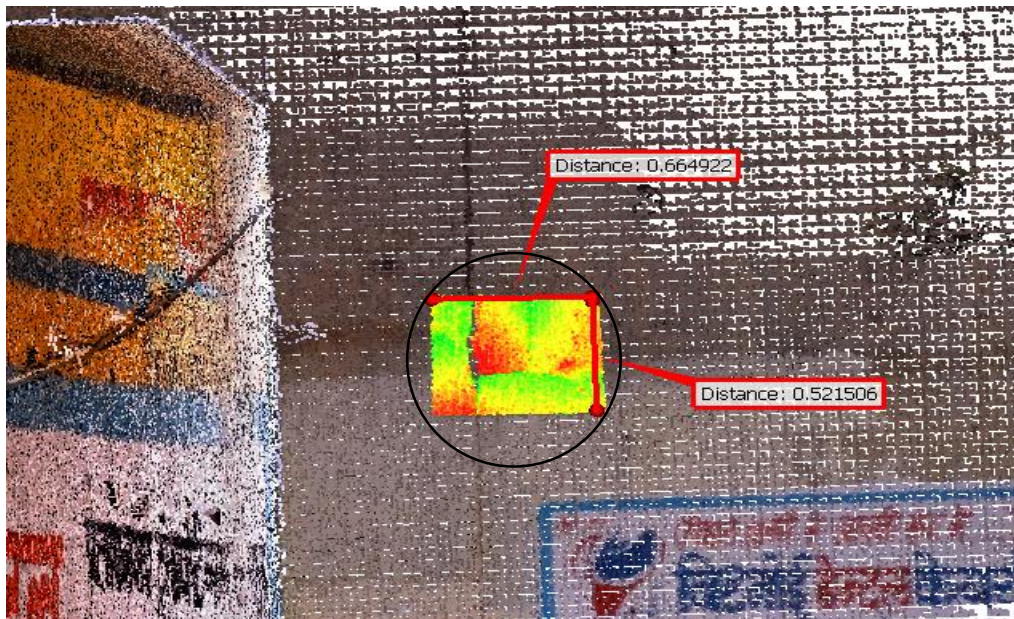
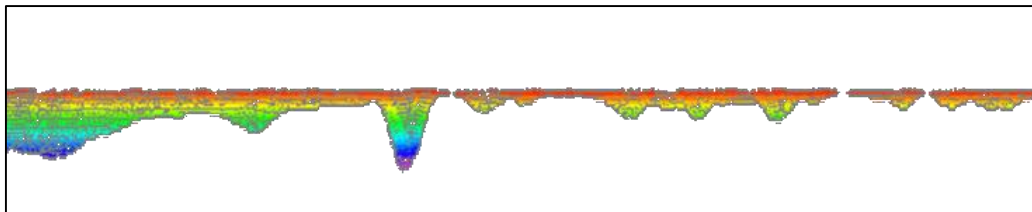
| Element Name | Observation | Location of Distress | Photo No. | Units | Distress Details | | | Area of Repair (Sq.m/R MT/m3) |
|---|---|---|---|---|---|---|---|---|
| Abutment 2 | Scaling | - | 1 | M | 0.66 | 0.52 | | 0.3432 |

**1. Scaling observed on Abutment 2 RHS , measuring 0.66 m in length and 0.52 m in width, covering an area of 0.3432 m<sup>2</sup>.**

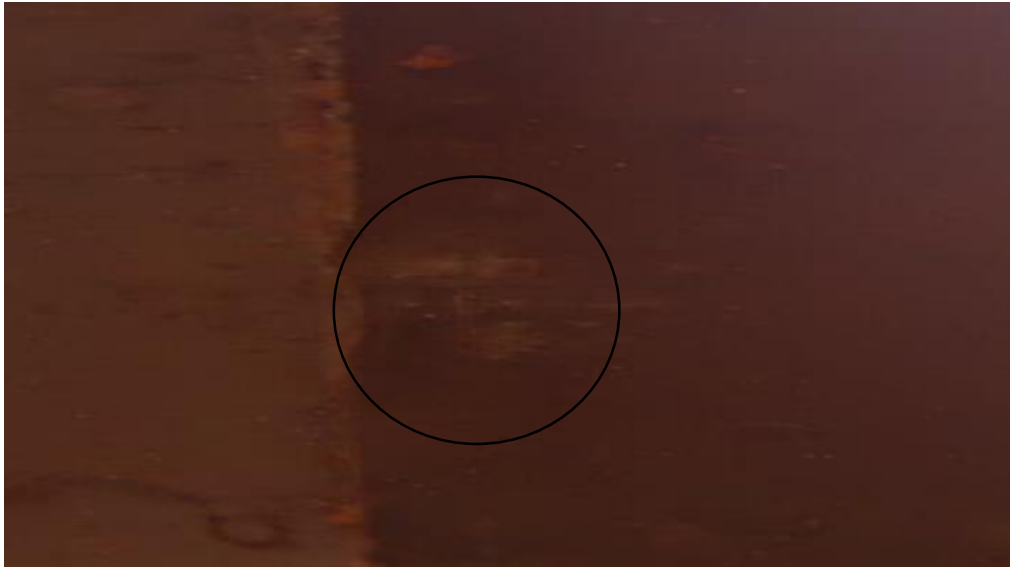
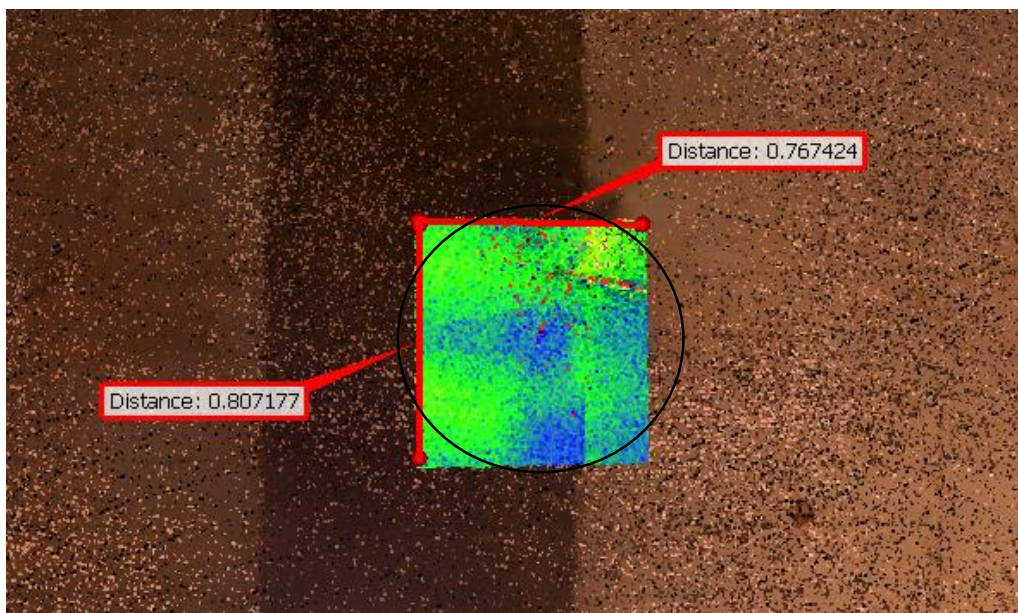
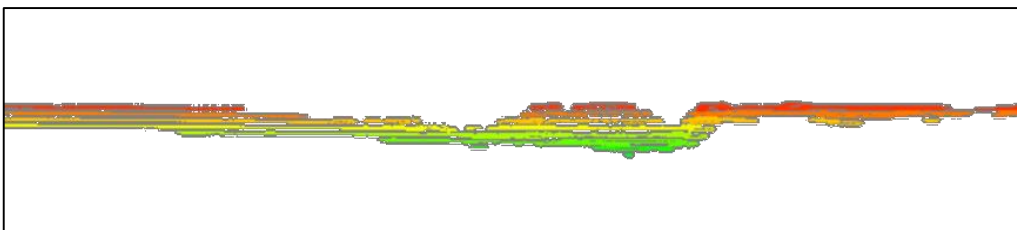
| Element Name | Observation | Location of Distress | Photo No. | Units | Distress Details | | | Area of Repair (Sq.m/R MT/m3) |
|---|---|---|---|---|---|---|---|---|
| Slab Bottom | Scaling | - | 2 | M | 0.80 | 0.76 | | 0.6080 |

**2. Scaling observed on Slab Bottom RHS, measuring 0.80 m in length and 0.76 m in width, covering an area of 0.6080 m<sup>2</sup>.**

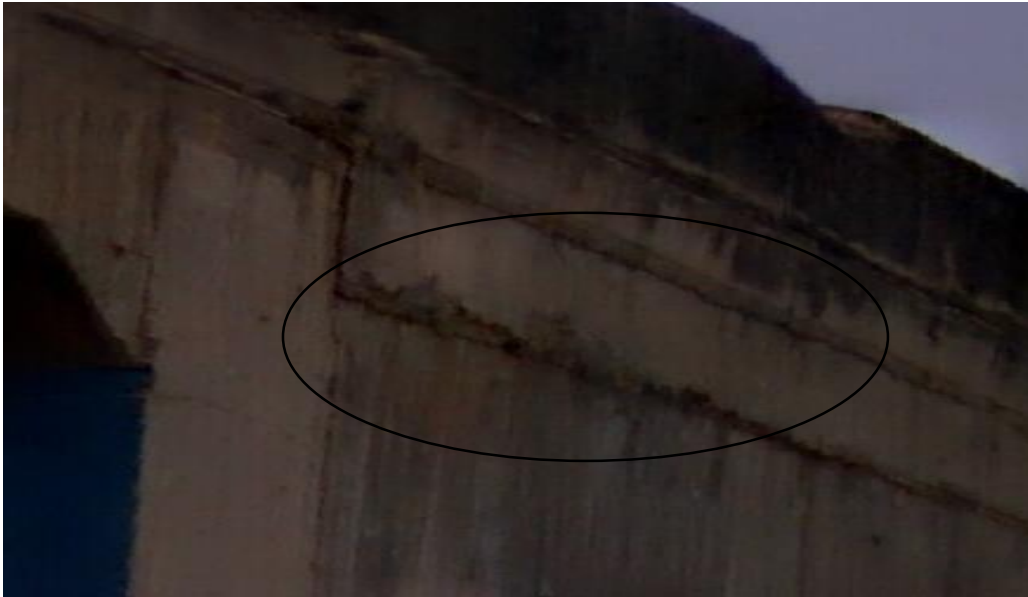
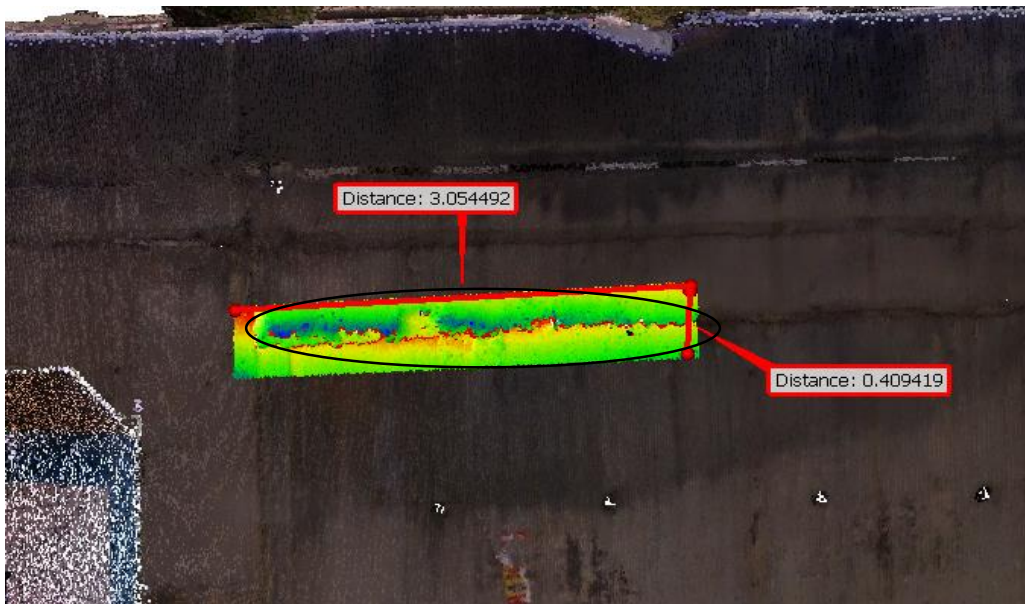
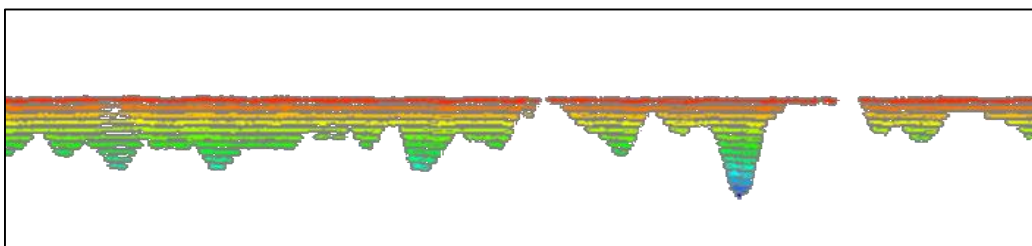
| Element Name | Observation | Location of Distress | Photo No. | Units | Distress Details | | | Area of Repair (Sq.m/R MT/m3) |
|---|---|---|---|---|---|---|---|---|
| Abutment 1 | Scaling | - | 3 | M | 3.05 | 0.40 | | 1.2200 |

**3. Scaling observed on Abutment 1 LHS, measuring 3.05 m in length and 0.40 m in width, covering an area of 1.2200 m<sup>2</sup>.**
