# **LIDAR Inspection Report of VUP ch.897 + 020**

**Bridge Chainage:** 897 + 020 (CKRP)

- **Bridge No:** -
- **Chainage:** 897 + 020
- **Structure type:** Slab Culvert

- **CKRP:** Chittorgarh to kota
- **State:** Rajasthan NH 27
- **Zone:** RJ-06

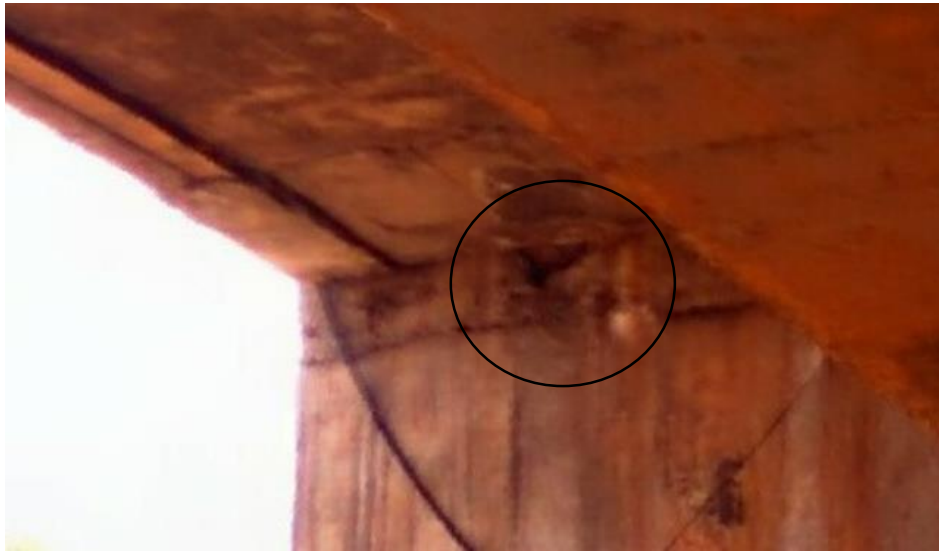
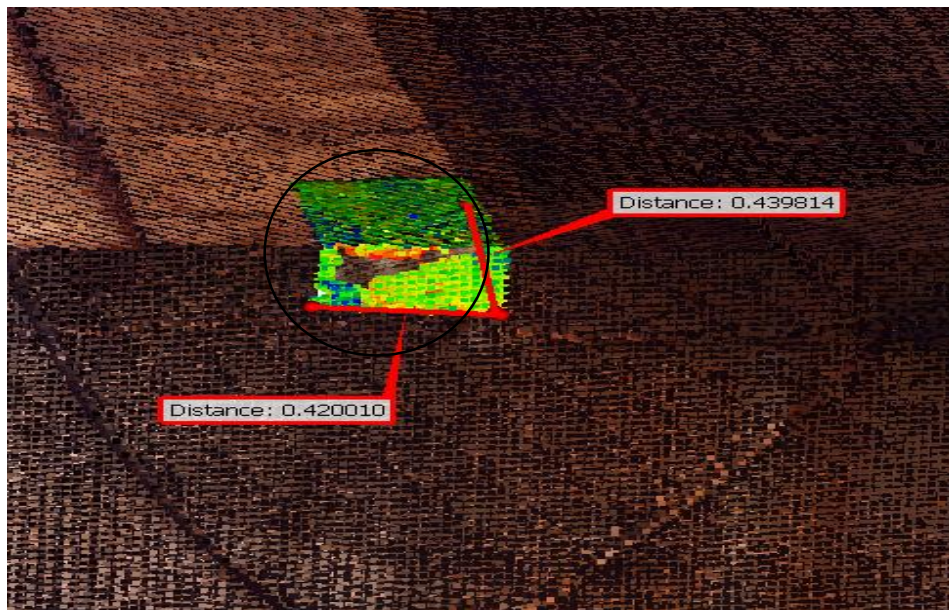
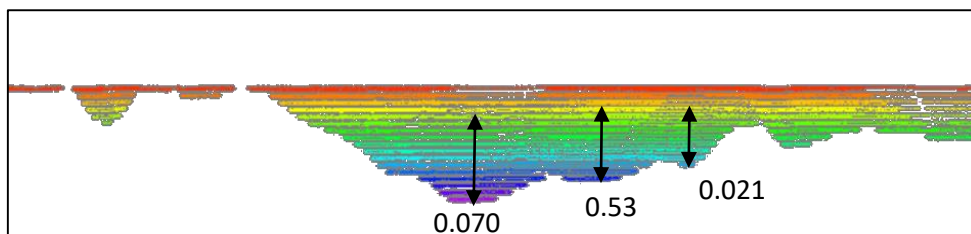
| Element Name | Observation | Location of Distress | Photo No. | Units | Distress Details | | | Area of Repair (Sq.m/ RMT/ m3) |
|---|---|---|---|---|---|---|---|---|
| Dirt Wall | Damage | | 1 | M | 0.42 | 0.42 | 0.053 | 0.0095 |

**1. Damage observed on Abutment 1 RHS Dirt Wall, measuring 0.43 m in length and 0.42 m in width, Depth ranges from 0.021 m (min) to 0.070 m (max), with an average depth of 0.053 m. The calculated volume of the distress is 0.0095 m<sup>3</sup>.**

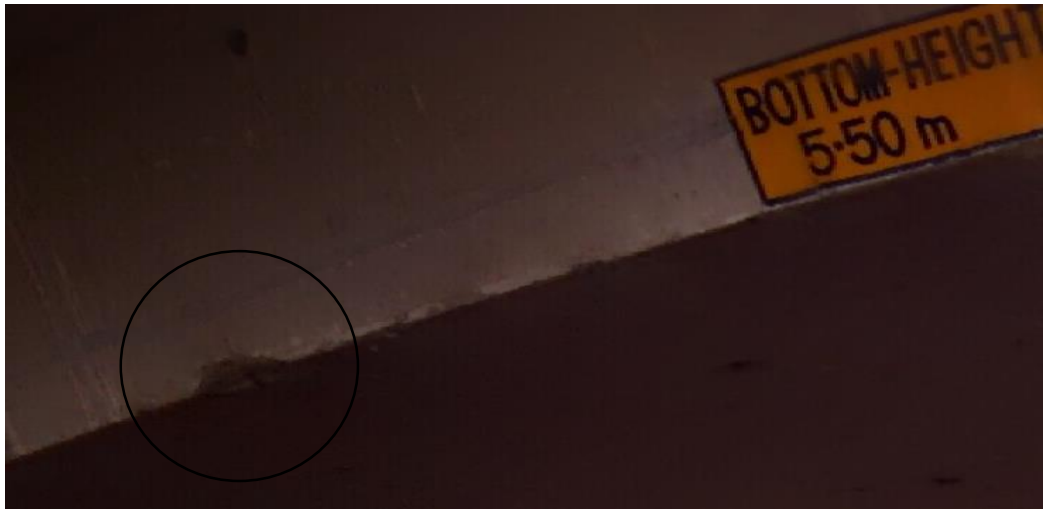
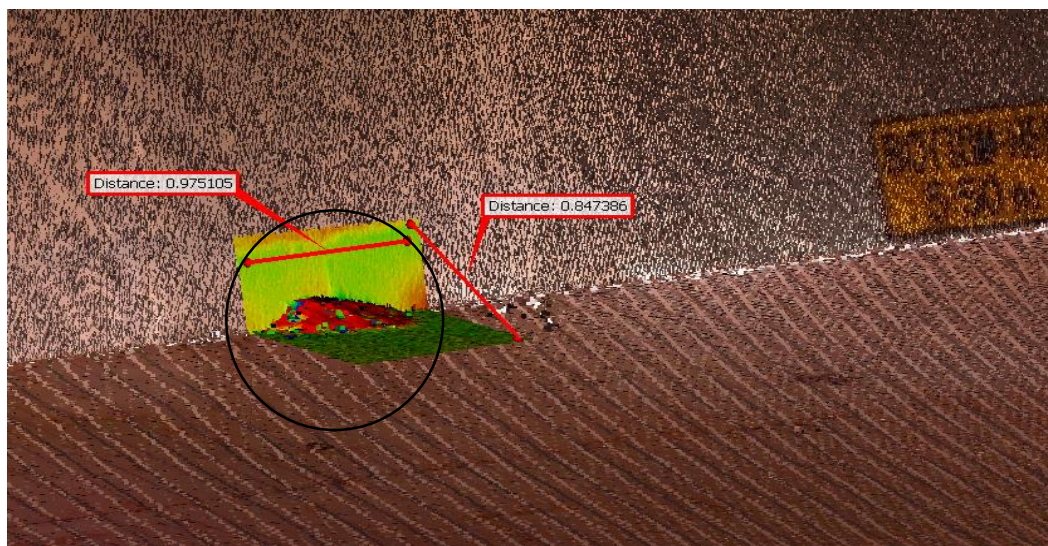
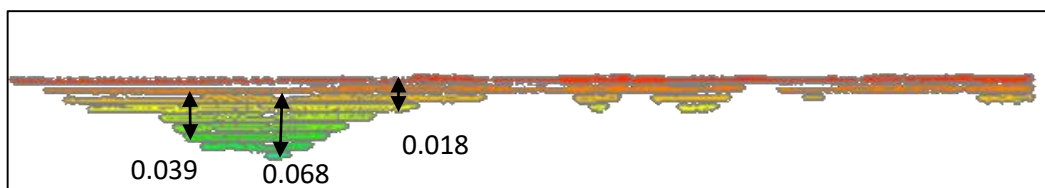
| Element Name | Observation | Location of Distress | Photo No. | Units | Distress Details | | | Area of Repair (Sq.m/ RMT/ m3) |
|---|---|---|---|---|---|---|---|---|
| Slab Bottom | Damage | | 2 | M | 0.97 | 0.84 | 0.039 | 0.0317 |

**2. Damage observed on LHS Slab Bottom Corner 1, measuring 0.97 m in length and 0.84 m in width, Depth ranges from 0.018 m (min) to 0.068 m (max), with an average depth of 0.039 m. The calculated volume of the distress is 0.0317 m<sup>3</sup>.**

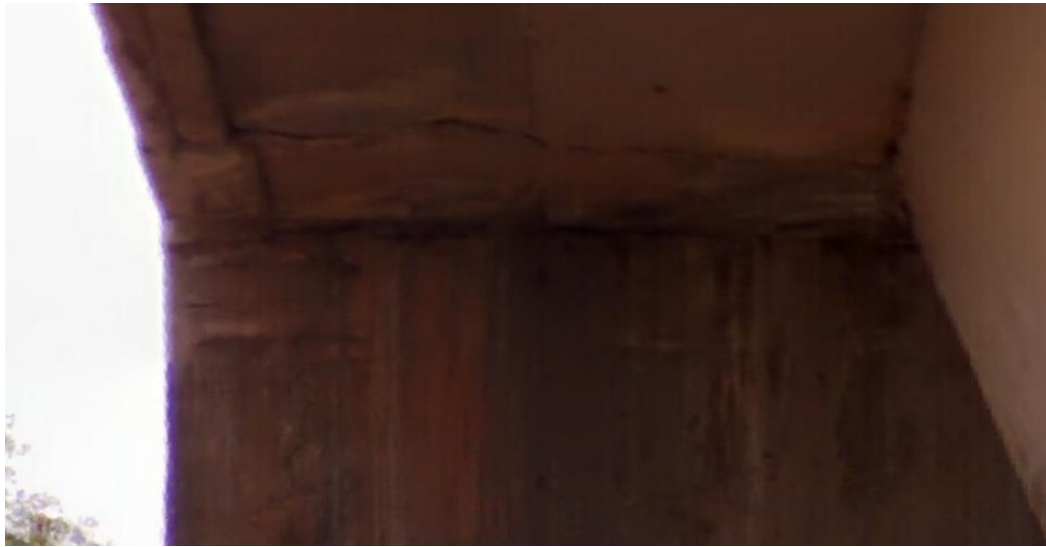
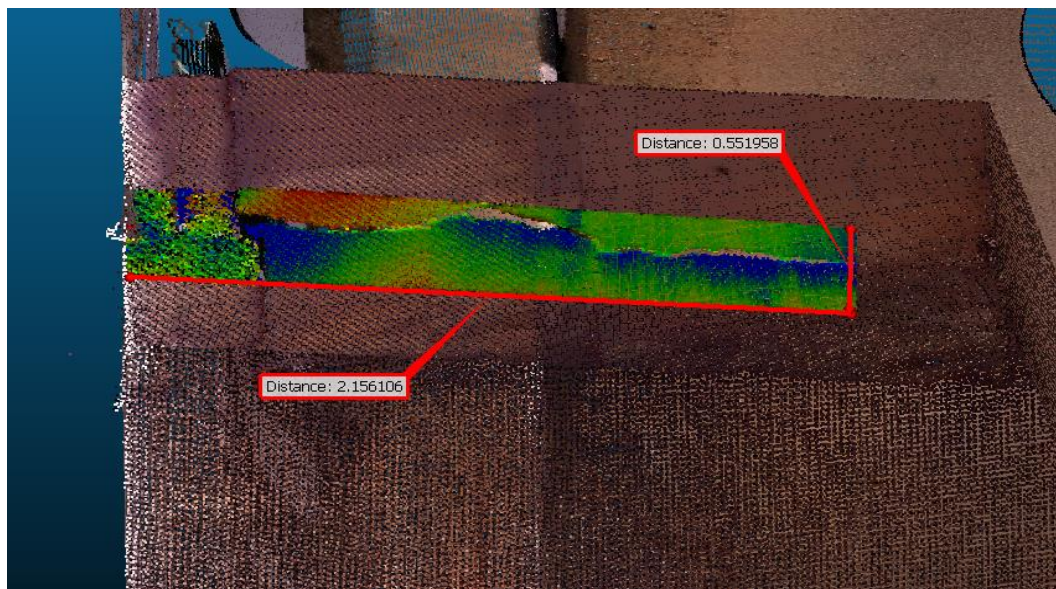
| Element Name | Observation | Location of Distress | Photo No. | Units | Distress Details | | | Area of Repair (Sq.m/ RMT/ m3) |
|---|---|---|---|---|---|---|---|---|
| Slab Bottom | Scaling | | 3 | M | 2.15 | 0.55 | - | 1.1825 |

**3. Scaling observed on Abutment 2 LHS Dirt Wall Slab Bottom, measuring 2.15 m in length and 0.55 m in width, covering an area of 1.1825 m<sup>2</sup>.**
