# **LIDAR Inspection Report of VUP ch.897 + 860**

**Bridge Chainage:** 897 + 860 (CKRP)

- **CKRP:** Chittorgarh to kota
- **State:** Rajasthan NH 27
- **Zone:** RJ-06

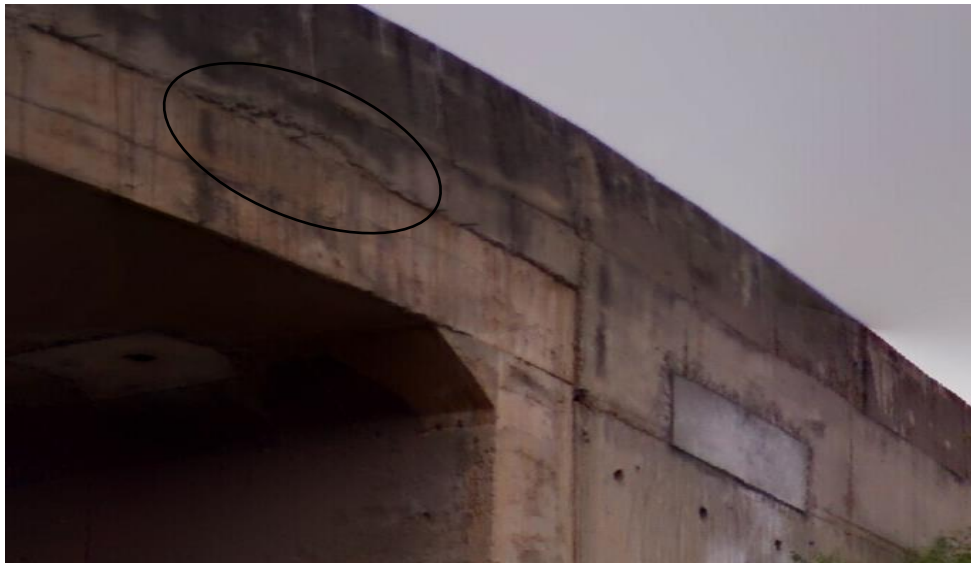
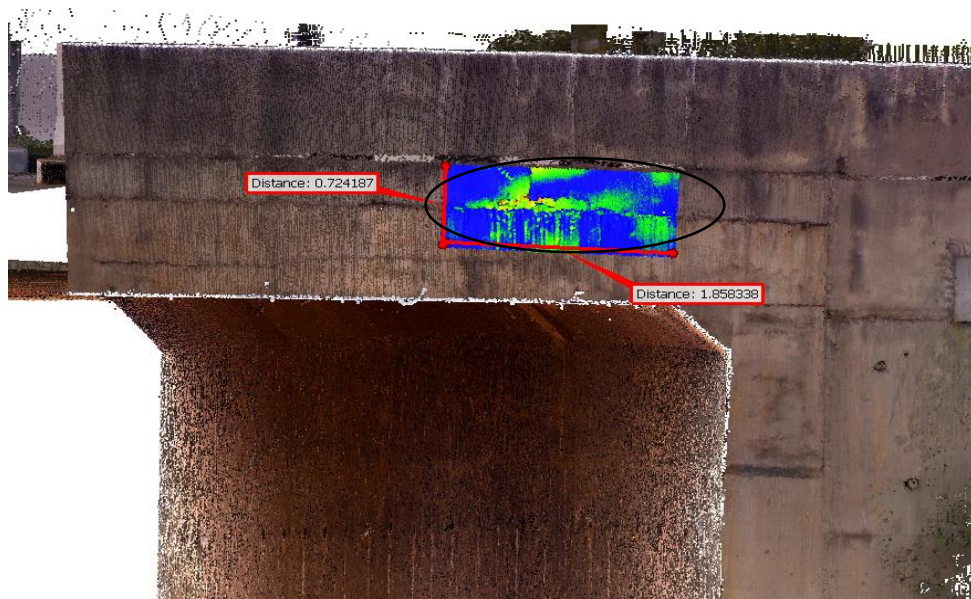
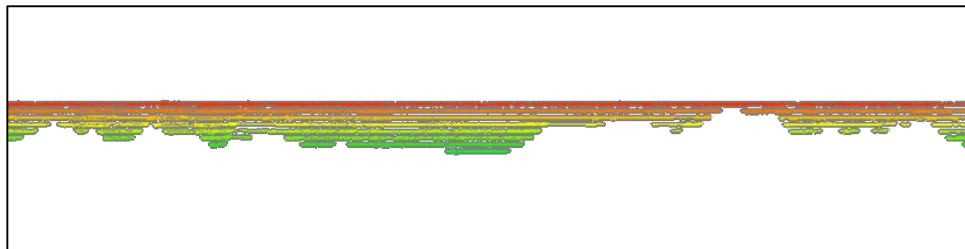
| Element Name | Observation | Location of Distress | Photo No. | Units | Distress Details | | | Area of Repair (Sq.m/R MT/m3) |
|---|---|---|---|---|---|---|---|---|
| Abutment 2 | Scaling | | 1 | M | 1.85 | 0.72 | - | 1.332 |

**1. Scaling observed on Abutment 2 RHS , measuring 1.85 m in length and 0.72 m in width, covering an area of 1.3320 m<sup>2</sup>.**

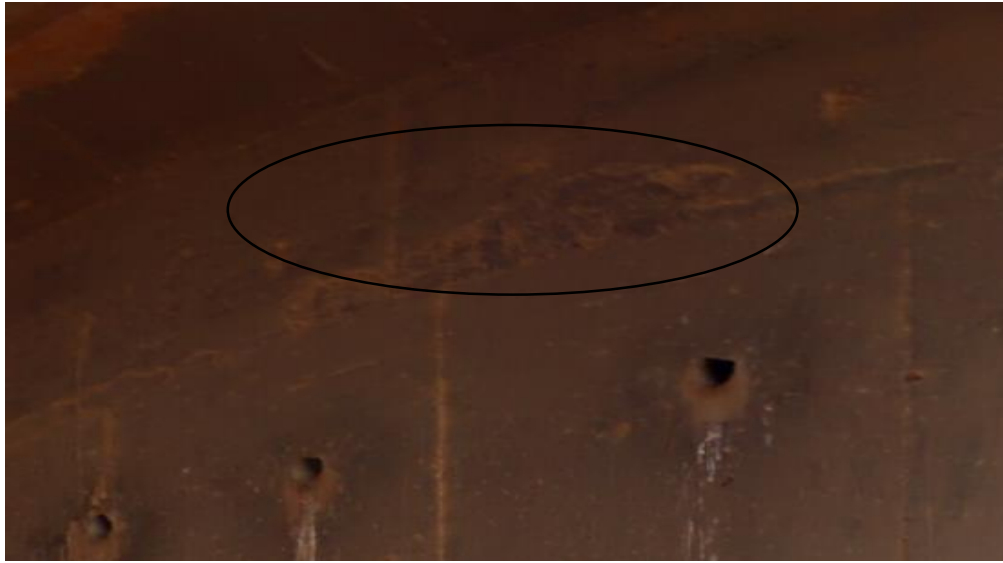
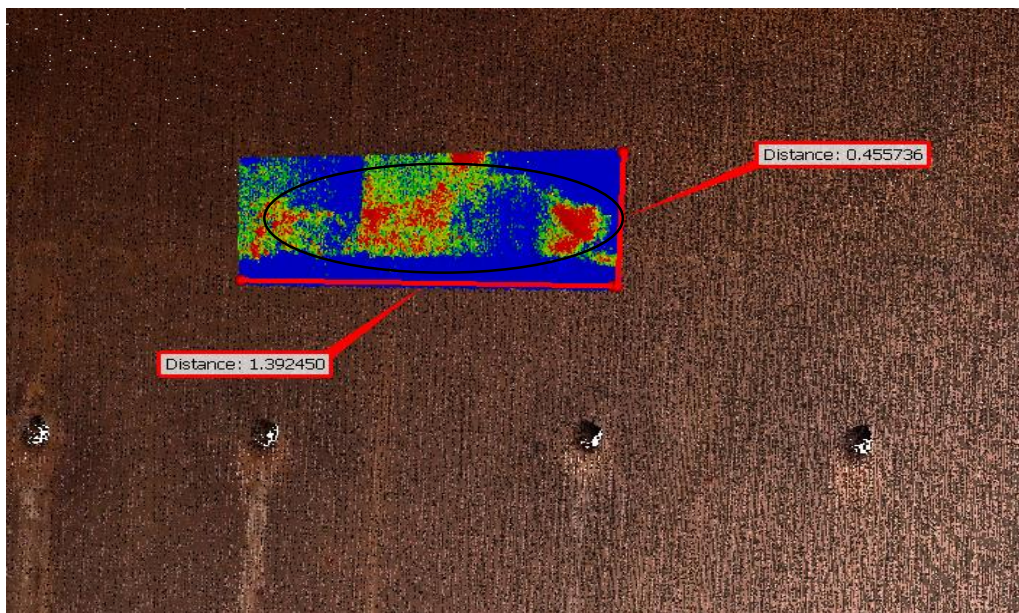
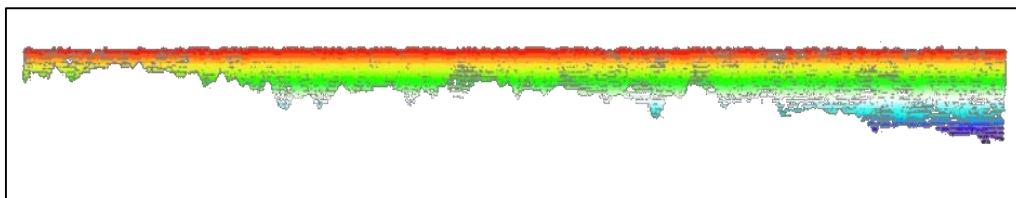
| Element Name | Observation | Location of Distress | Photo No. | Units | Distress Details | | | Area of Repair (Sq.m/R MT/m3) |
|---|---|---|---|---|---|---|---|---|
| Abutment 2 | Scaling | | 2 | M | 1.39 | 0.45 | - | 0.6255 |

**2. Scaling observed on Abutment 2 RHS, measuring 1.39 m in length and 0.45 m in width, covering an area of 0.6255 m<sup>2</sup>.**

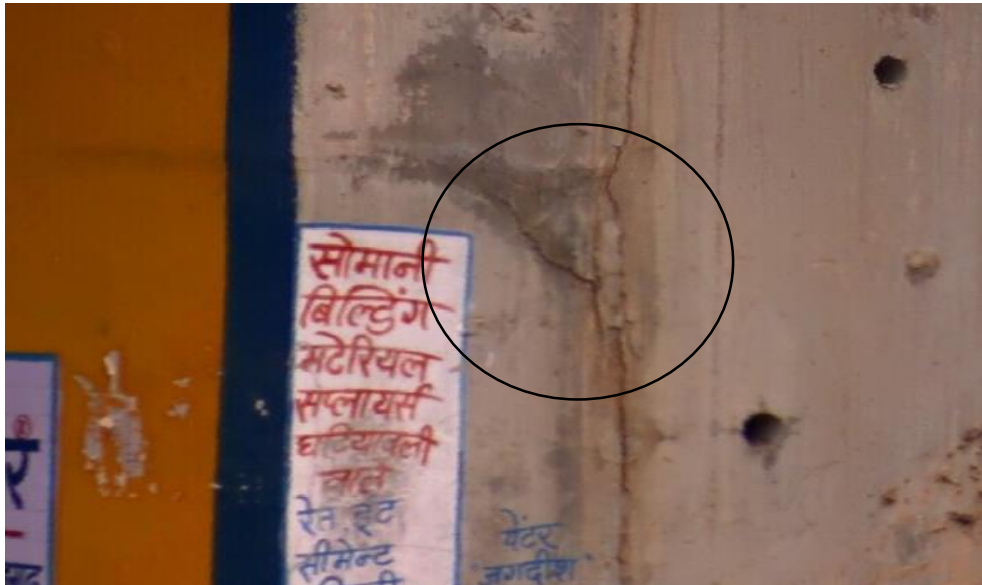
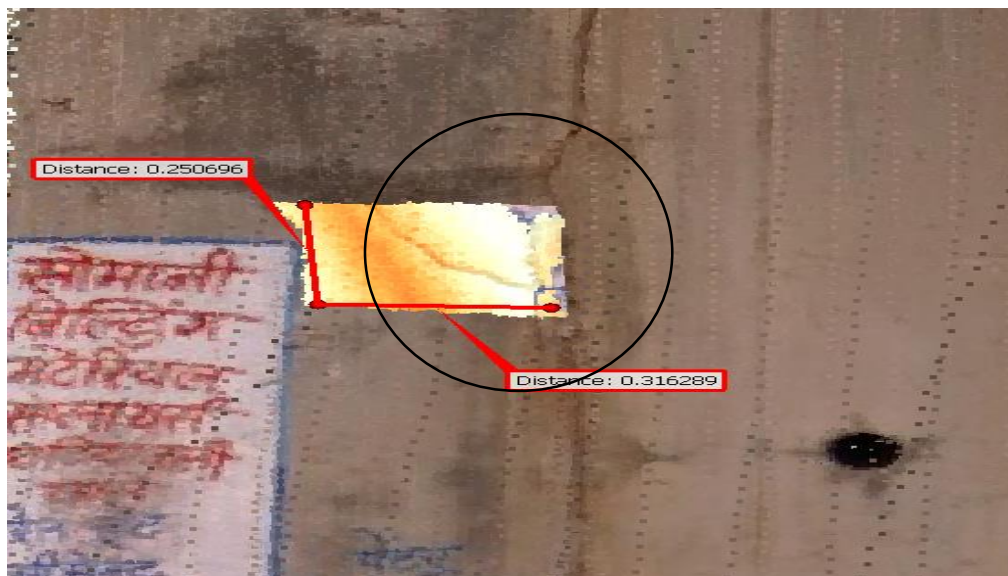
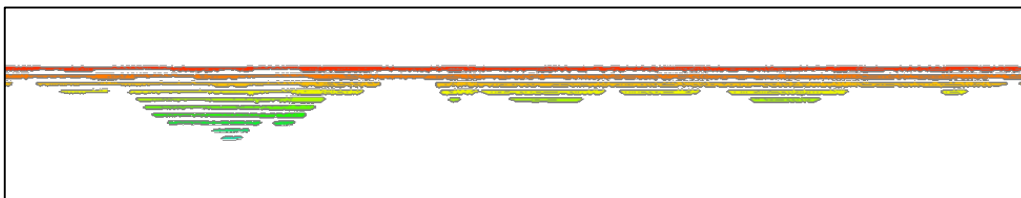
| Element Name | Observation | Location of Distress | Photo No. | Units | Distress Details | | | Area of Repair (Sq.m/R MT/m3) |
|---|---|---|---|---|---|---|---|---|
| Abutment 1 | Scaling | | 3 | M | 0.31 | 0.25 | - | 0.0775 |

**3. Scaling observed on Abutment 1 LHS , measuring 0.31 m in length and 0.25 m in width, covering an area of 0.0775 m<sup>2</sup>**

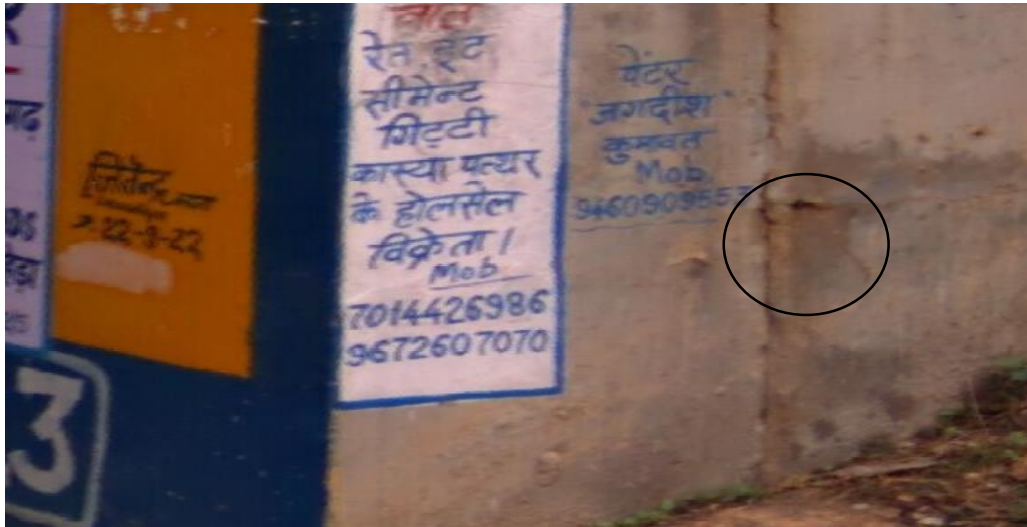
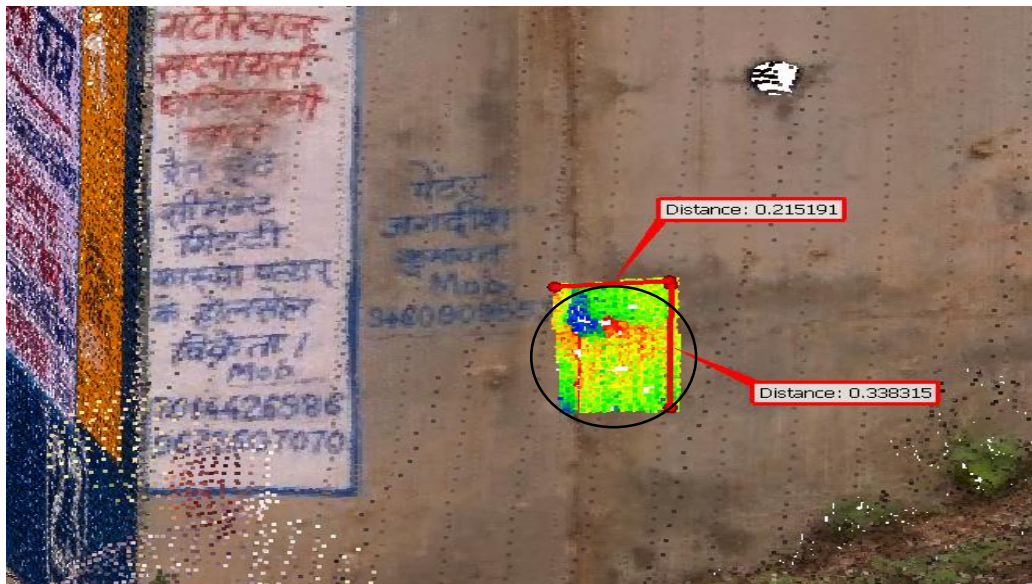
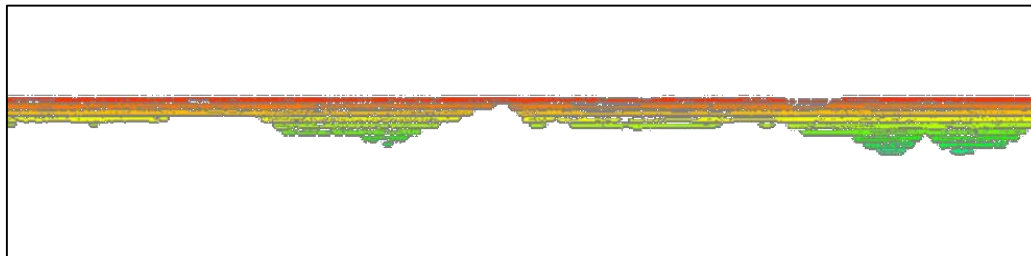
| Element Name | Observation | Location of Distress | Photo No. | Units | Distress Details | | | Area of Repair (Sq.m/R MT/m3) |
|---|---|---|---|---|---|---|---|---|
| Abutment 1 | Scaling | | 4 | M | 0.33 | 0.21 | - | 0.0693 |

**4. Scaling observed on Abutment 1 LHS , measuring 0.33 m in length and 0.21 m in width, covering an area of 0.0693 m<sup>2</sup>.**

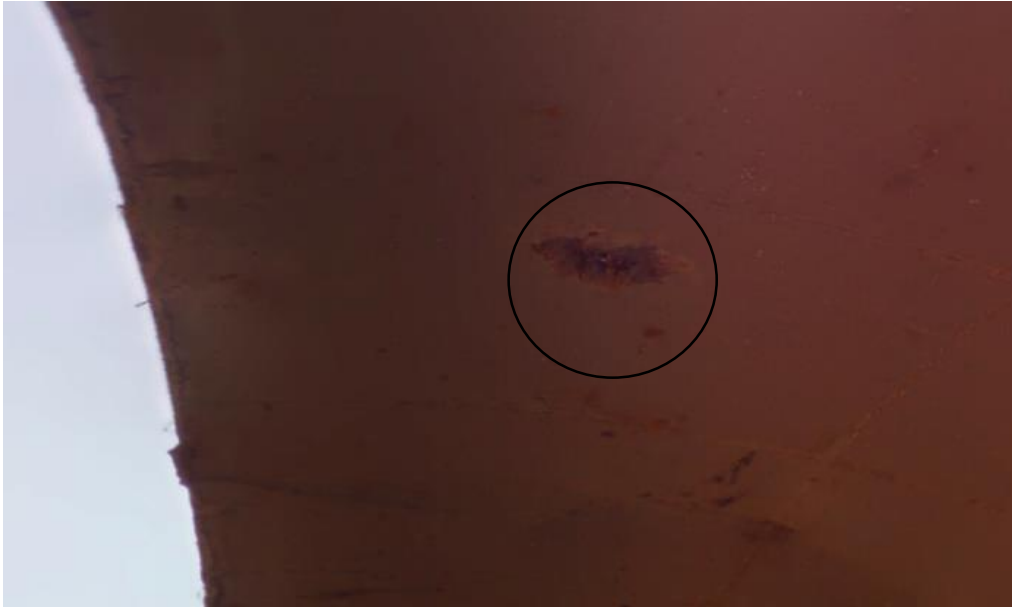
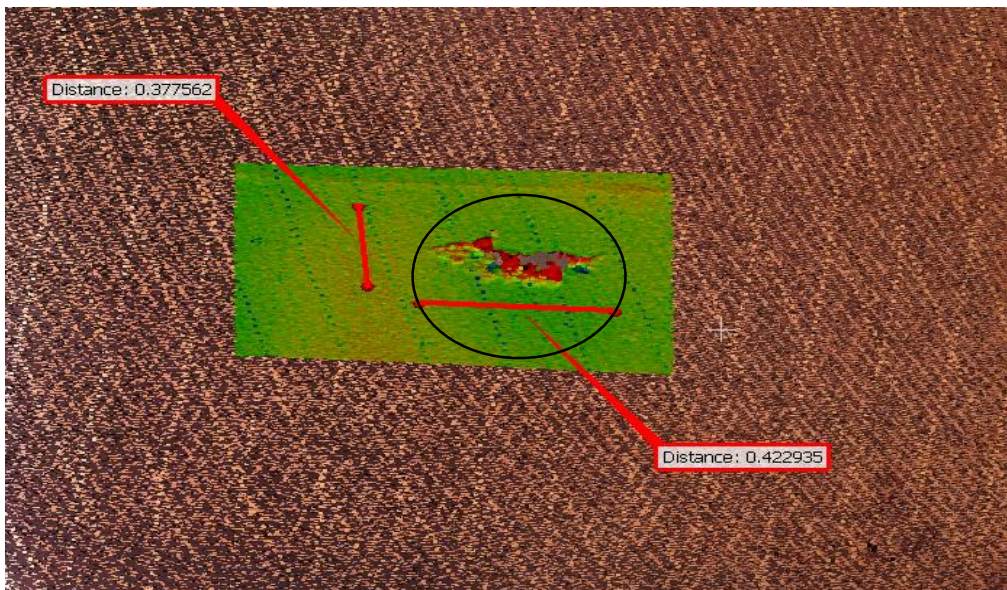
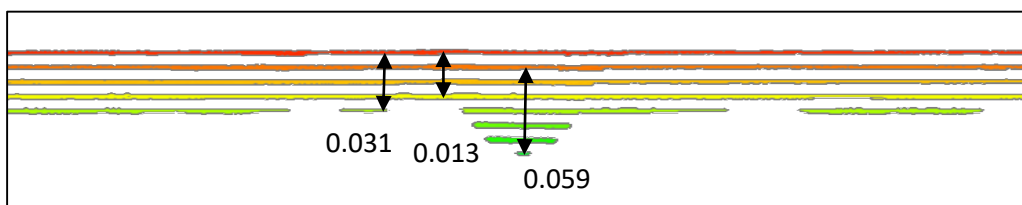
| Element Name | Observation | Location of Distress | Photo No. | Units | Distress Details | | | Area of Repair (Sq.m/R MT/m3) |
|---|---|---|---|---|---|---|---|---|
| Slab Bottom | Damage | | 5 | M | 0.42 | 0.37 | 0.031 | 0.0048 |

**5. Damage observed on Slab Bottom, measuring 0.42 m in length and 0.37 m in width, Depth ranges from 0.013 m (min) to 0.059 m (max), with an average depth of 0.031 m. The calculated volume of the distress is 0.0048 m<sup>3</sup>.**
