# **LIDAR Inspection Report of MNB ch.898+780**

**Bridge No:** MNB - 899/1

**Bridge Chainage:** 898+780 (CKRP)

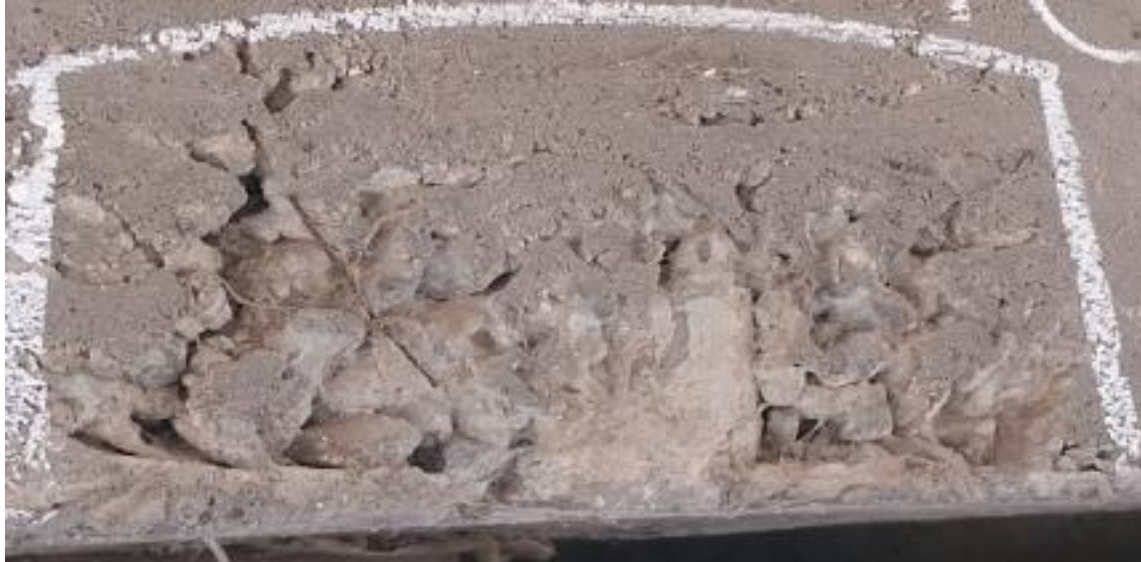
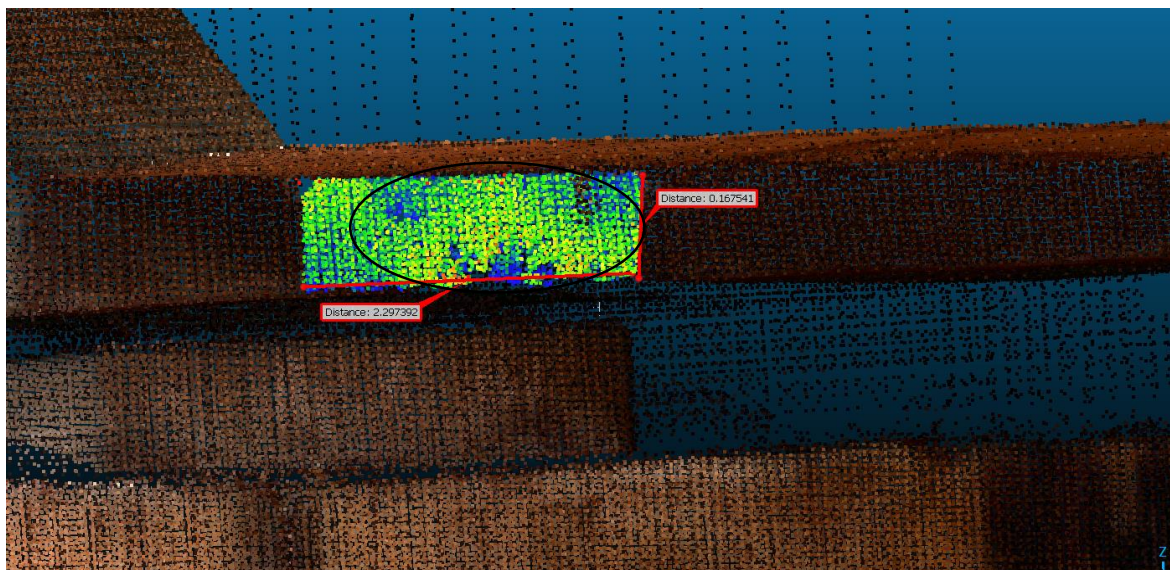
| Element Name | Observation | Location of Distress | Photo No. | Units | Distress Details | | | Area of Repair (Sq./RM T/m3) |
|---|---|---|---|---|---|---|---|---|
| Abutment 1 | Honeycombing | | 1 | | 2.29 | 0.16 | | 0.3664 |

**1.Honeycombing observed on LHS abutment 1, measuring 2.29 m in length and 0.16 m in width, covering an area of 0.3664 m<sup>2</sup>.**

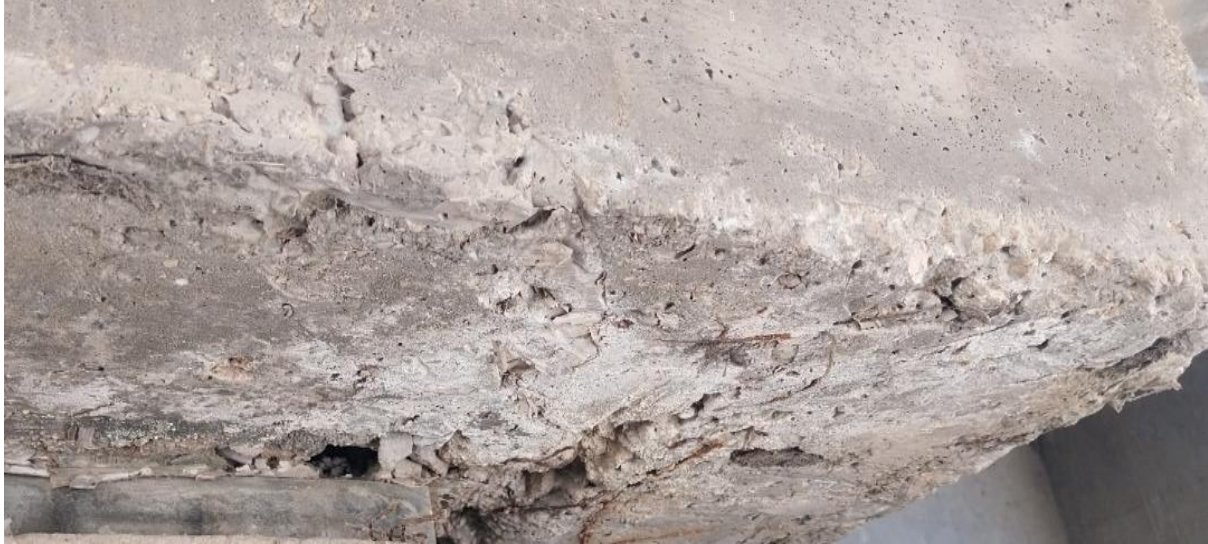
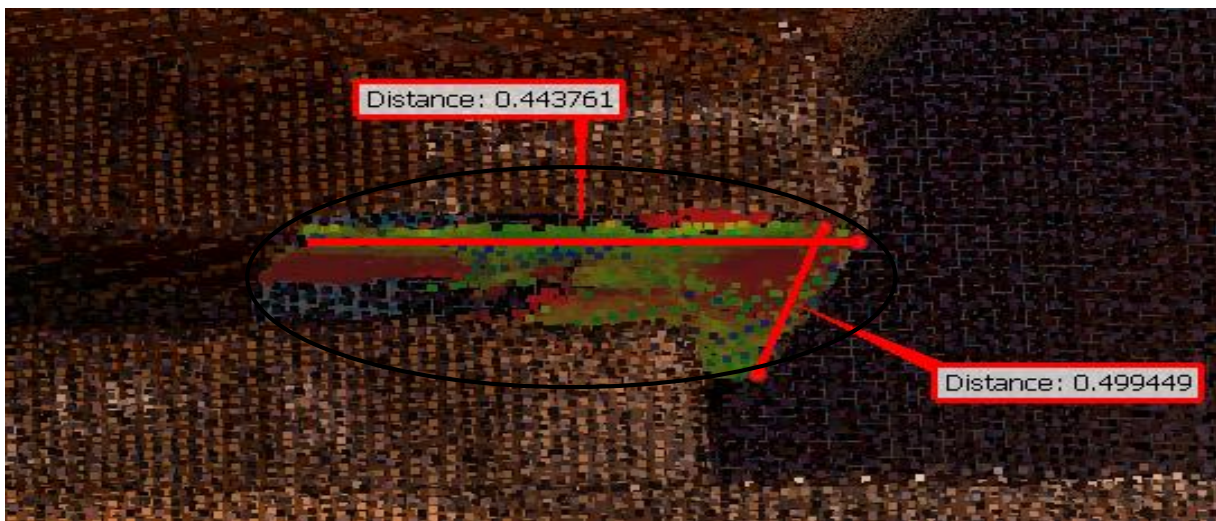
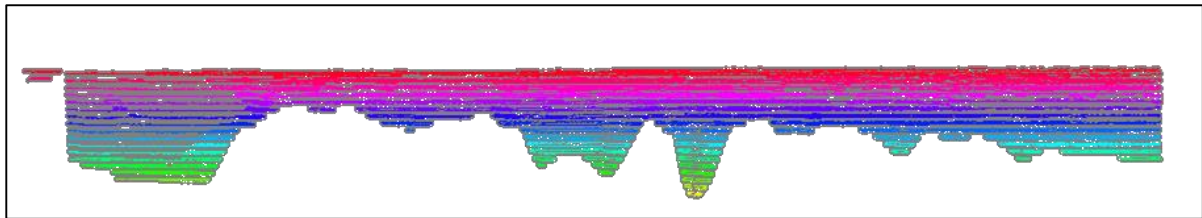
| Element Name | Observation | Location of Distress | Photo No. | Units | Distress Details | | | Area of Repair (Sq./RM T/m3) |
|---|---|---|---|---|---|---|---|---|
| Abutment 2 | Honeycombing | | 2 | | 0.49 | 0.44 | | 0.2156 |

**2. Honeycombing observed on A2 LHS Bearing 1, measuring 0.49 m in length and 0.44 m in width, covering an area of 0.2156 m<sup>2</sup>.**

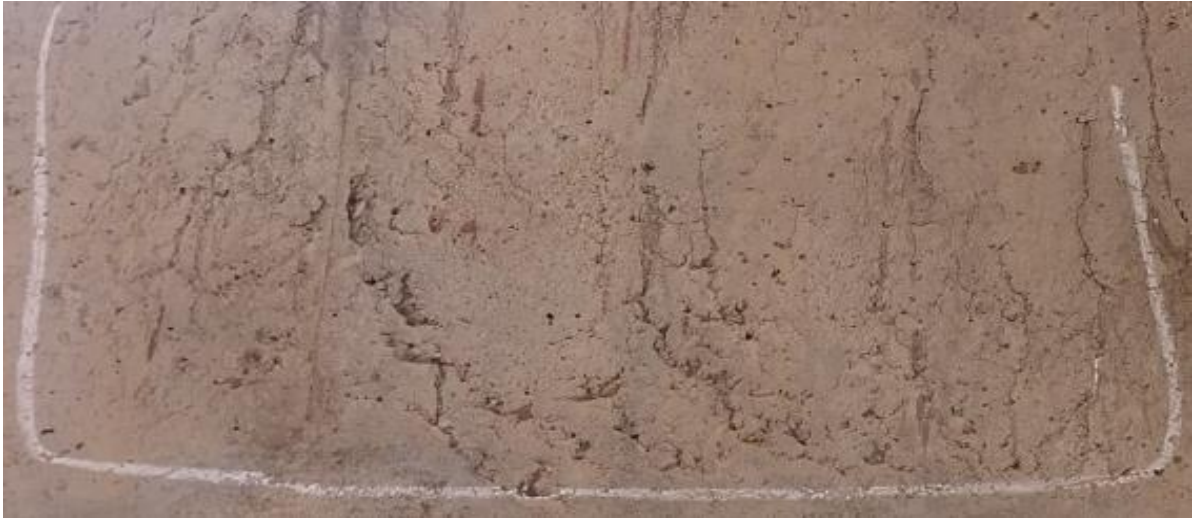
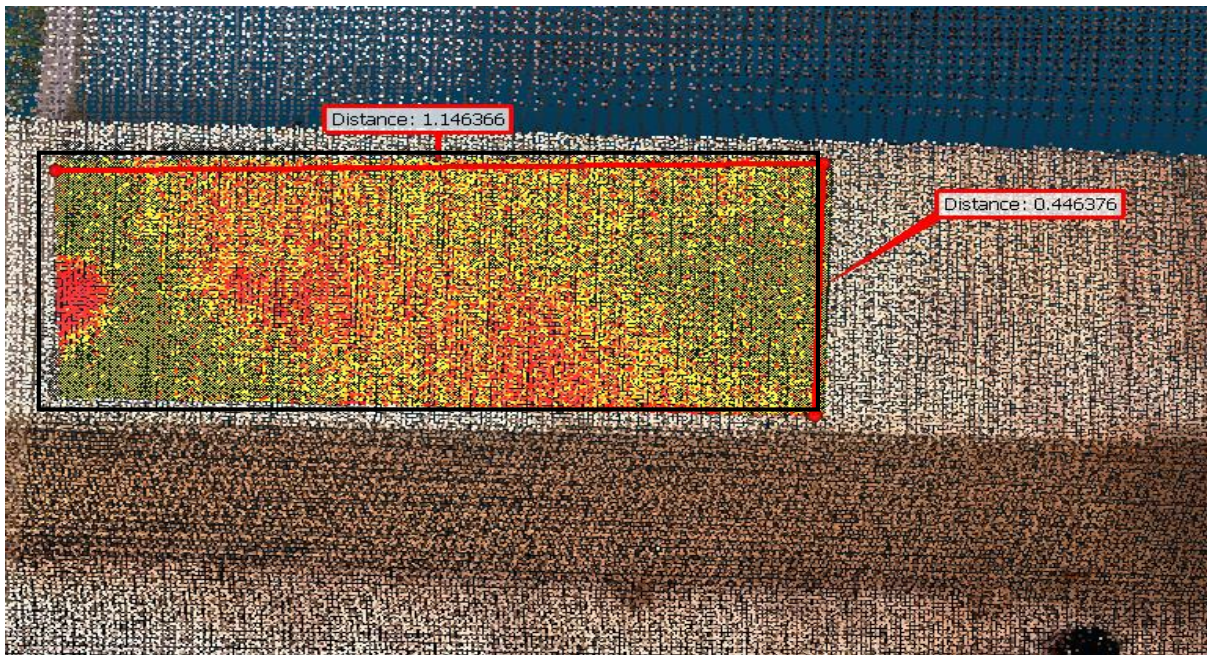
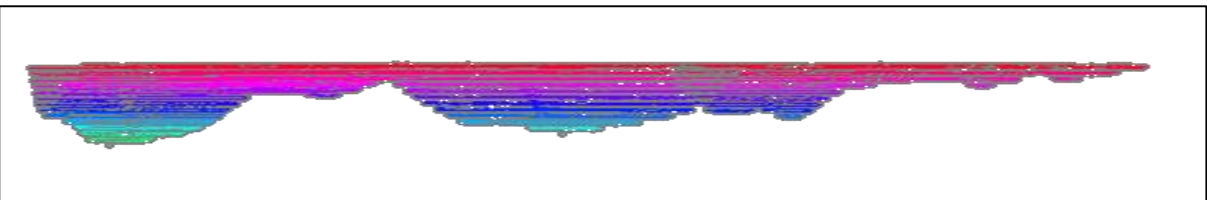
| Element Name | Observation | Location of Distress | Photo No. | Units | Distress Details | | | Area of Repair (Sq./RM T/m3) |
|---|---|---|---|---|---|---|---|---|
| Abutment 2 | Scaling | | 3 | | 0.44 | 1.41 | | 0.633 |

**3. Scaling observed on Abutment 2 LHS, measuring 0.44 m in length and 1.44 m in width, covering an area of 0.633 m<sup>2</sup>.**

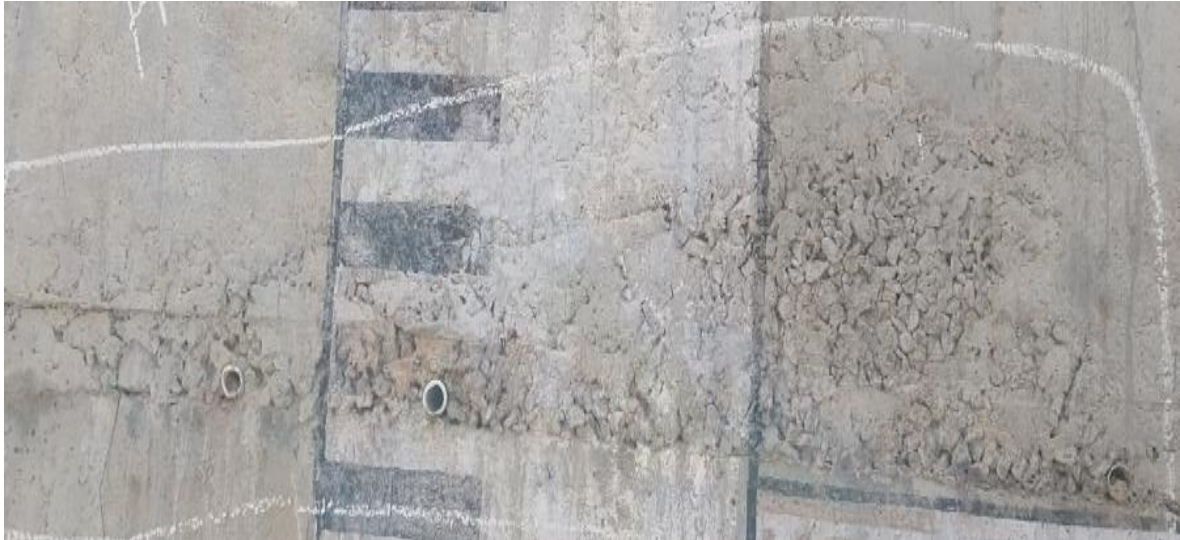
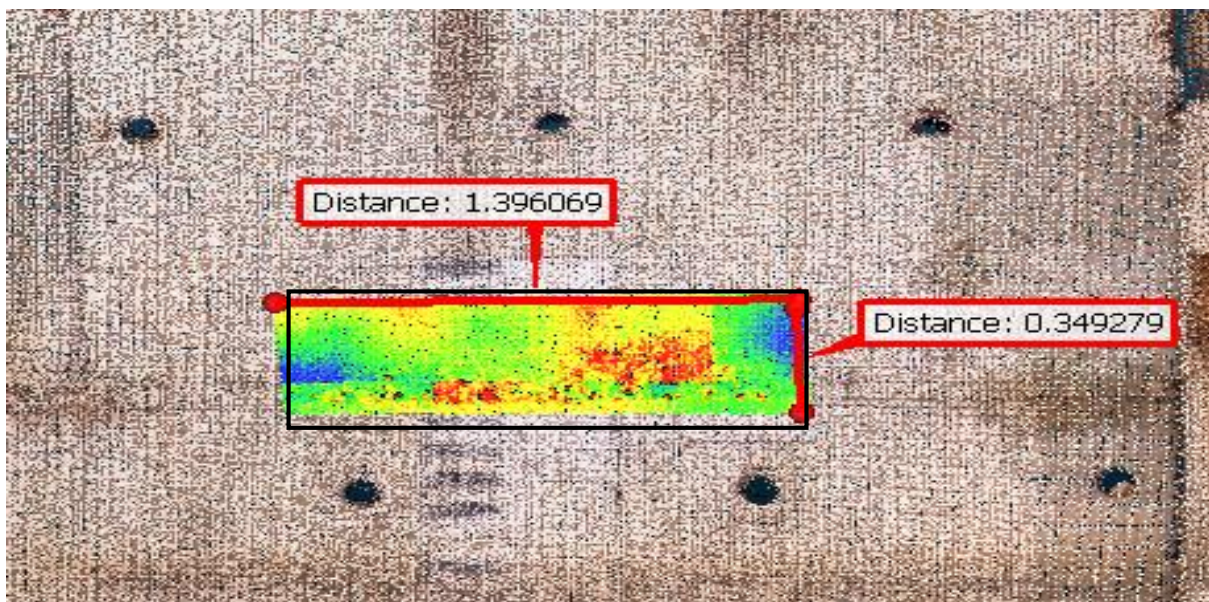
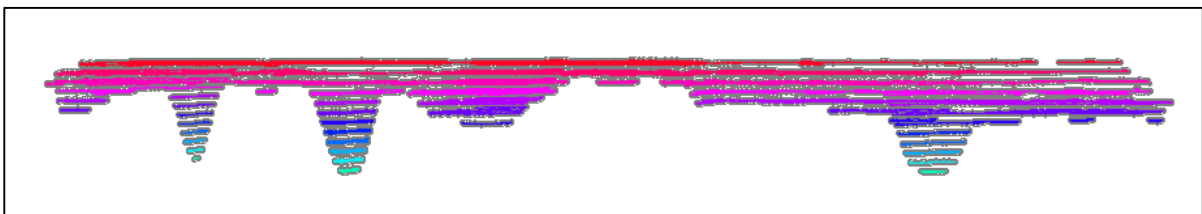
| Element Name | Observation | Location of Distress | Photo No. | Units | Distress Details | | | Area of Repair (Sq./RM T/m3) |
|---|---|---|---|---|---|---|---|---|
| Abutment 2 | Honeycombing | | 4 | | 1.39 | 0.34 | | 0.472 |

**4. Honeycombing observed on A2 LHS median, measuring 1.39 m in length and 0.34 m in width, covering an area of 0.472 m<sup>2</sup>.**

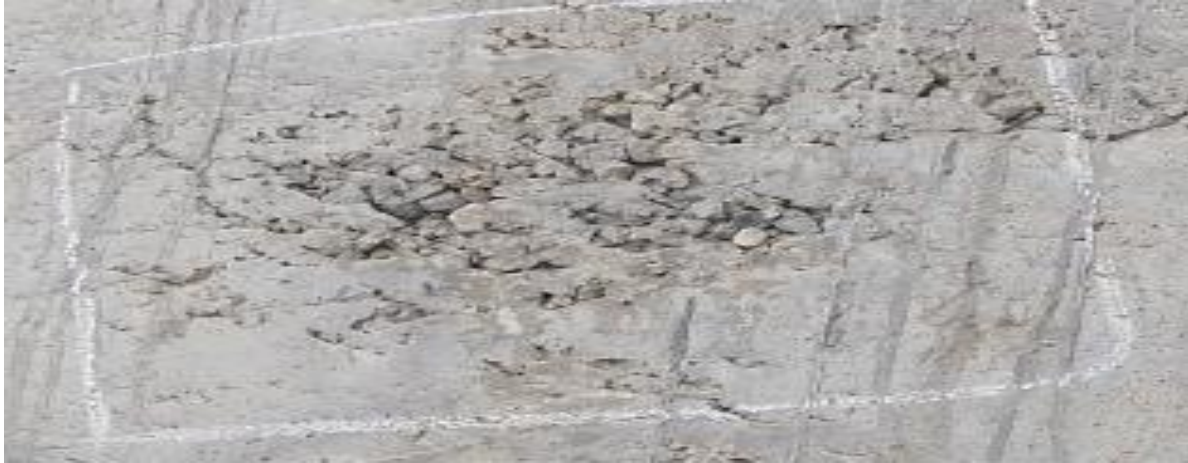
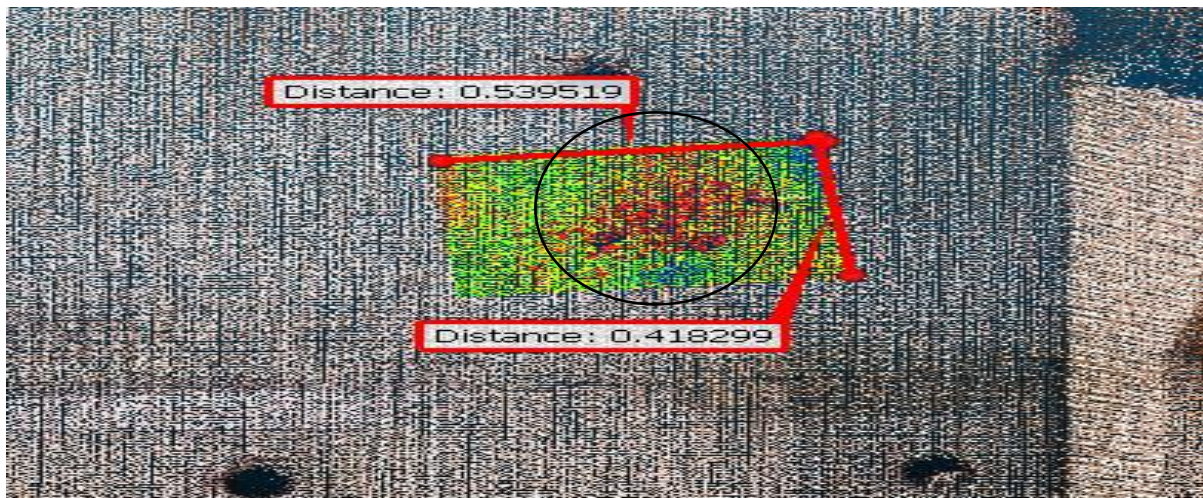
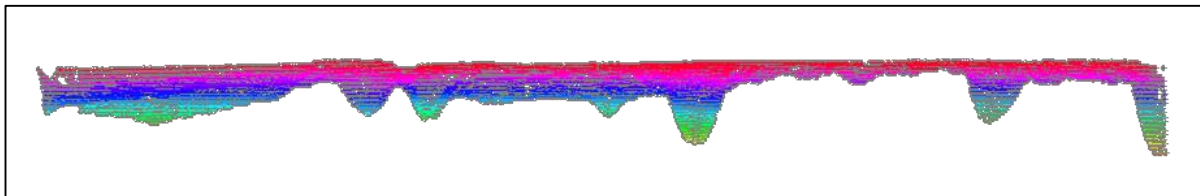
| Element Name | Observation | Location of Distress | Photo No. | Units | Distress Details | | | Area of Repair (Sq./RM T/m3) |
|---|---|---|---|---|---|---|---|---|
| Abutment 2 | Honeycombing | | 5 | | 0.53 | 0.41 | | 0.217 |

**5. Honeycombing observed on A2 LHS median, measuring 0.53 m in length and 0.41 m in width, covering an area of 0.217 m<sup>2</sup>.**

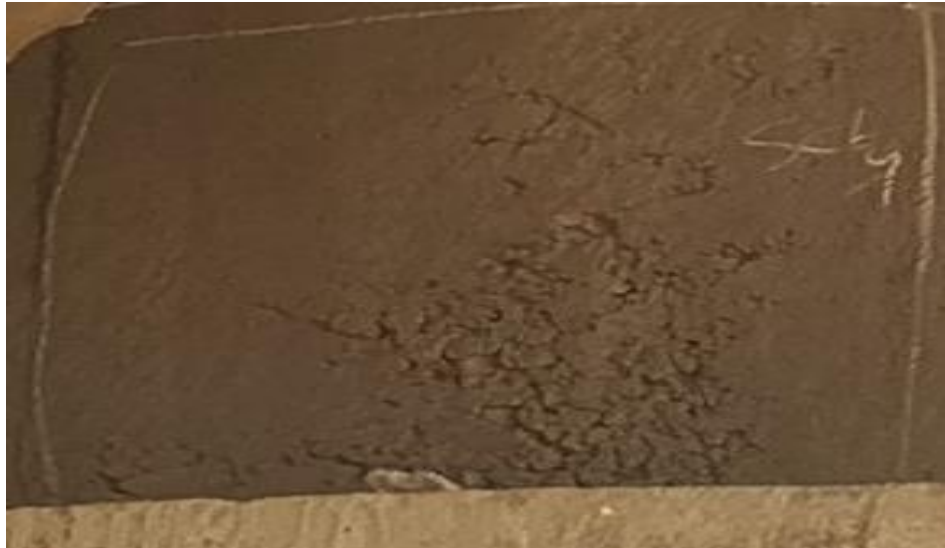
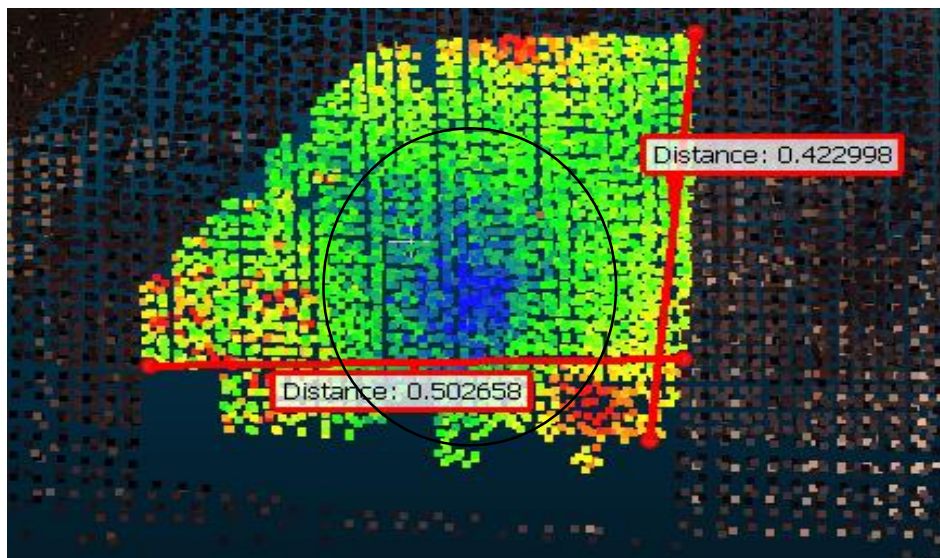
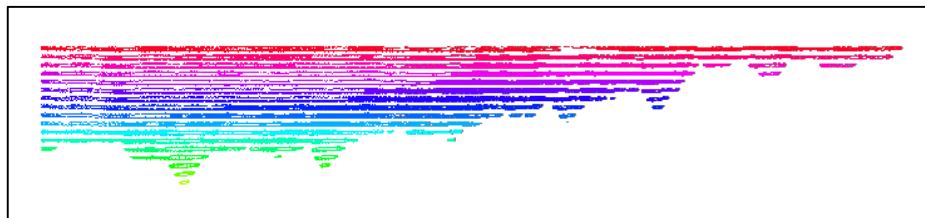
| Element Name | Observation | Location of Distress | Photo No. | Units | Distress Details | | | Area of Repair (Sq./RM T) |
|---|---|---|---|---|---|---|---|---|
| Abutment 2 | Scaling | | 6 | | 0.50 | 0.42 | | 0.21 |

**6. Scaling observed on Abutment 2 RHS, measuring 0.50 m in length and 0.42 m in width, covering an area of 0.21 m<sup>2</sup>.**

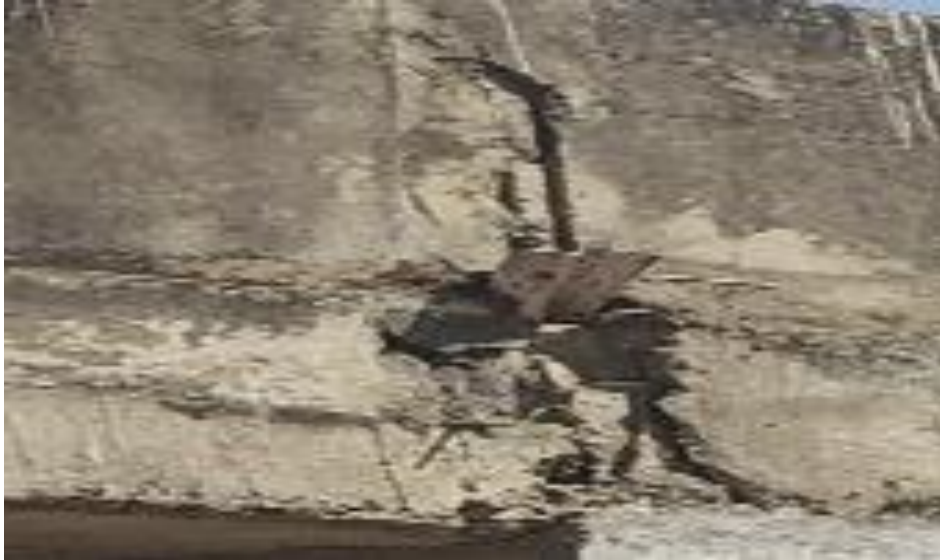
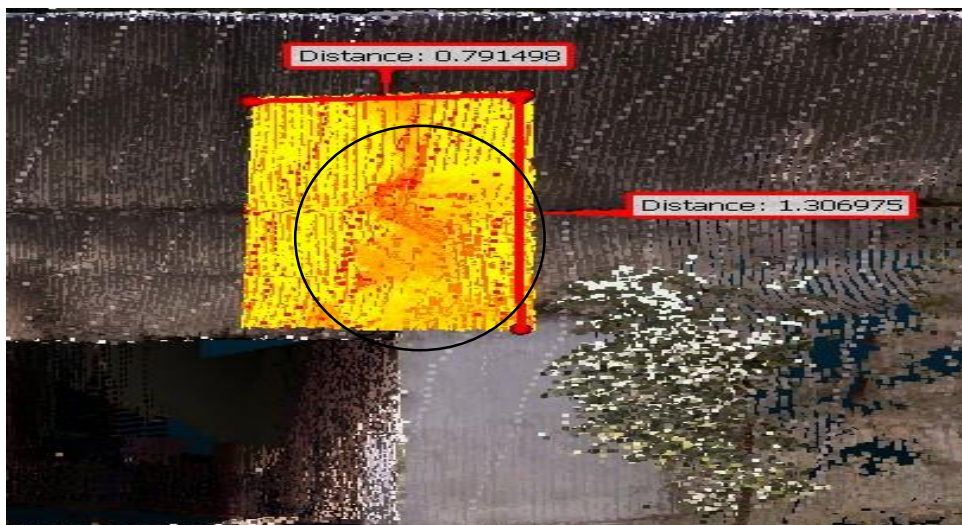
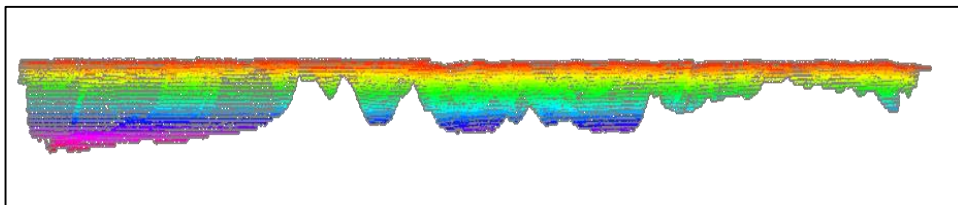
| Element Name | Observation | Location of Distress | Photo No. | Units | Distress Details | | | Area of Repair (Sq./RM T) |
|---|---|---|---|---|---|---|---|---|
| Abutment 2 | Damage | | 7 | | 1.30 | 0.79 | | 1.02 |

**7. Damage observed on Abutment 2 RHS, measuring 1.30 m in length and 0.79 m in width. covering an area of 1.02 m<sup>2</sup>.**

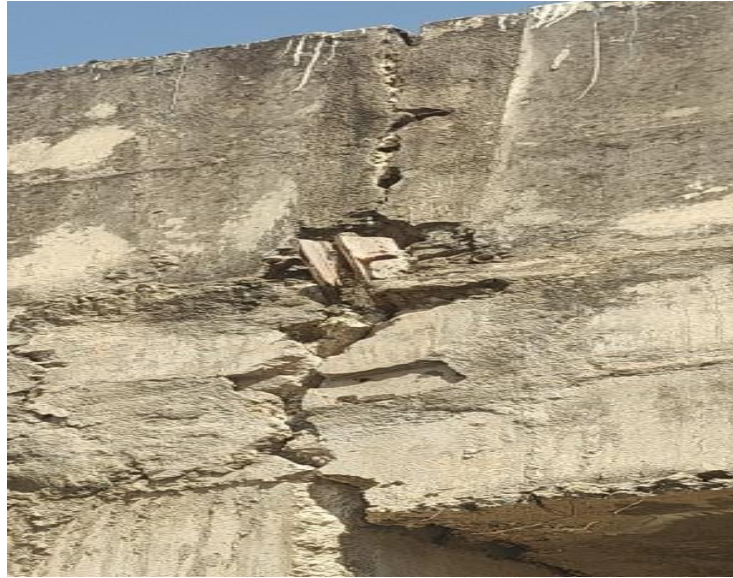
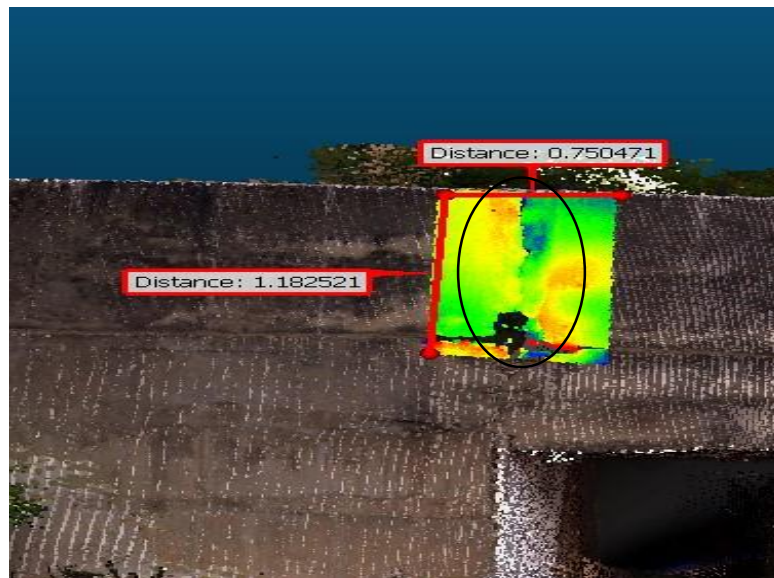
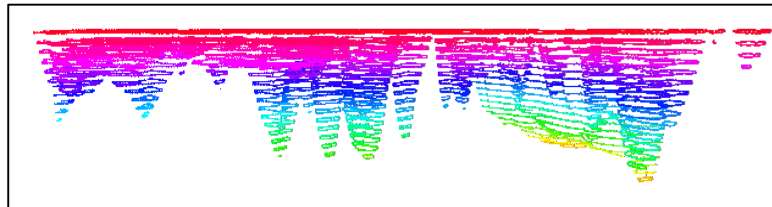
| Element Name | Observation | Location of Distress | Photo No. | Units | Distress Details | | | Area of Repair (Sq./RM T) |
|---|---|---|---|---|---|---|---|---|
| Abutment 1 | Damage | | 8 | | 0.75 | 1.18 | | 0.88 |

**8. Damage observed on Abutment 1 RHS, measuring 0.75 m in length and 1.18 m in width. covering an area of 0.88 m<sup>2</sup>.**

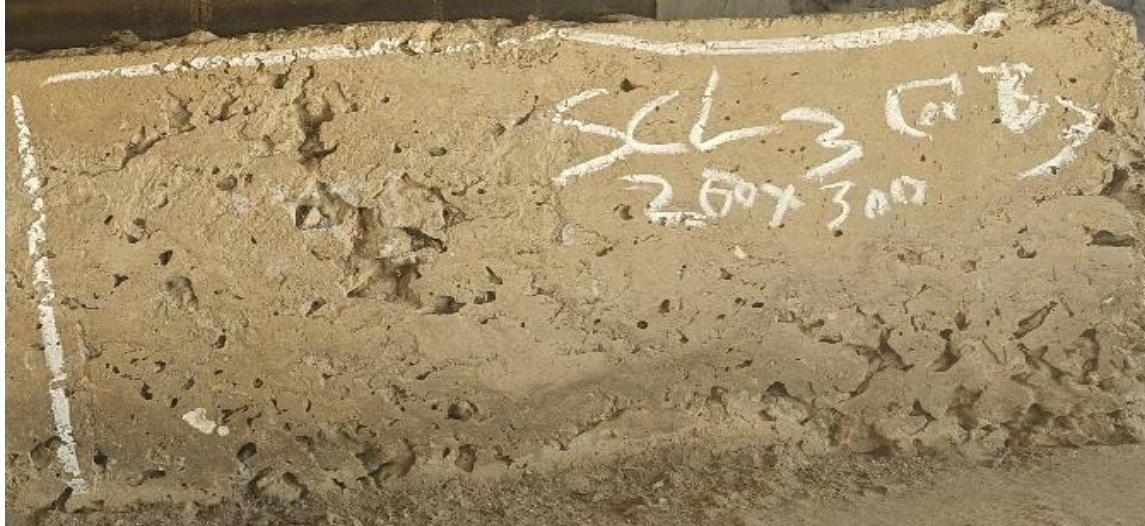
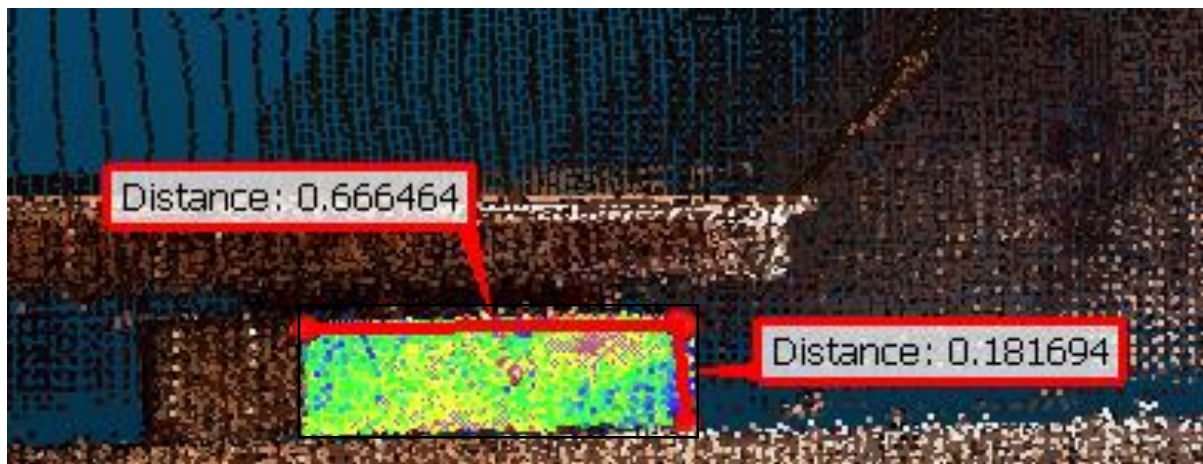
| Element Name | Observation | Location of Distress | Photo No. | Units | Distress Details | | | Area of Repair (Sq./RM T) |
|---|---|---|---|---|---|---|---|---|
| Abutment 2 | Scaling | | 9 | | 0.66 | 0.18 | | 0.11 |

**9. Scaling observed on Abutment 2 Bearing 3 RHS, measuring 0.66 m in length and 0.18 m in width, covering an area of 0.11 m<sup>2</sup>.**
