# **LIDAR Inspection Report of PUP ch.899 + 010**

**Bridge Chainage:** 899 + 010 (CKRP)

- **Bridge No:** -
- **Chainage:** 899 +010
- **Structure type:** PUP

- **CKRP:** Chittorgarh to kota
- **State:** Rajasthan NH 27
- **Zone:** RJ-06

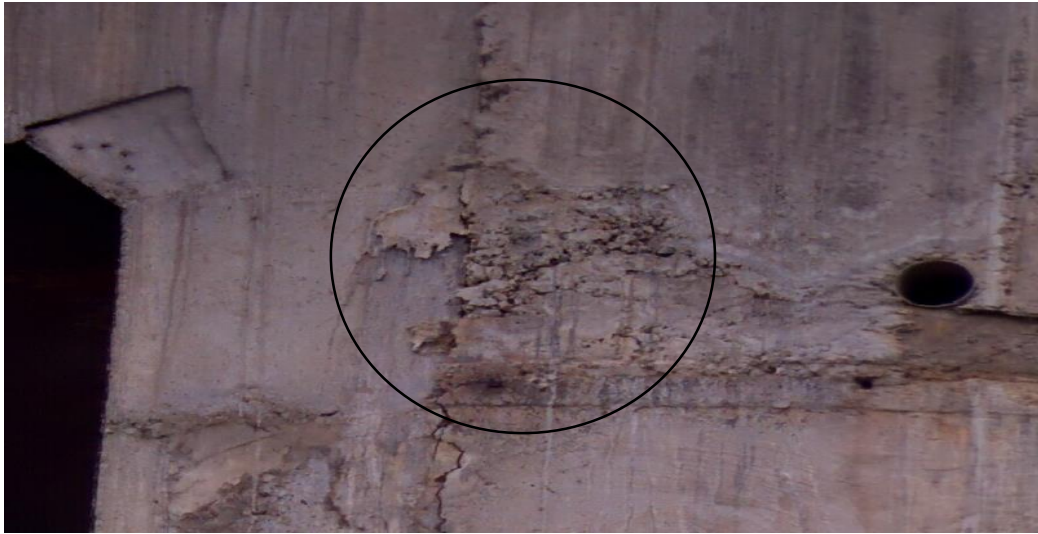
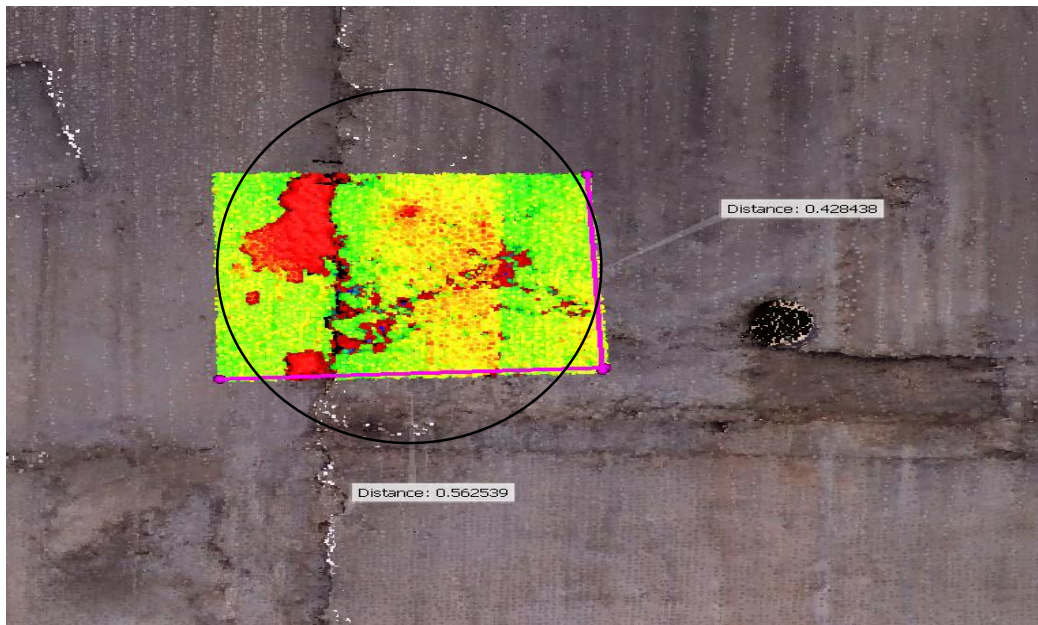
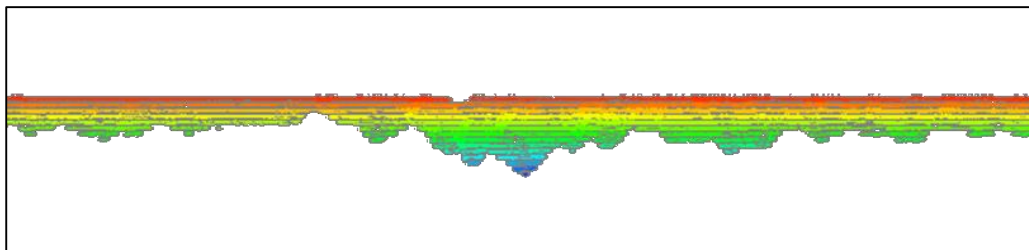
| Element Name | Observation | Location of Distress | Photo No. | Units | Distress Details | | | Area of Repair (Sq.m/RMT/m3) |
|---|---|---|---|---|---|---|---|---|
| Abutment 1 | Scaling | | 1 | M | 0.56 | 0.42 | | 0.2352 |

1. Scaling observed on LHS Abutment 1, measuring 0.56 m in length and 0.42 m in width, covering an area of 0.2352 m<sup>2</sup>.

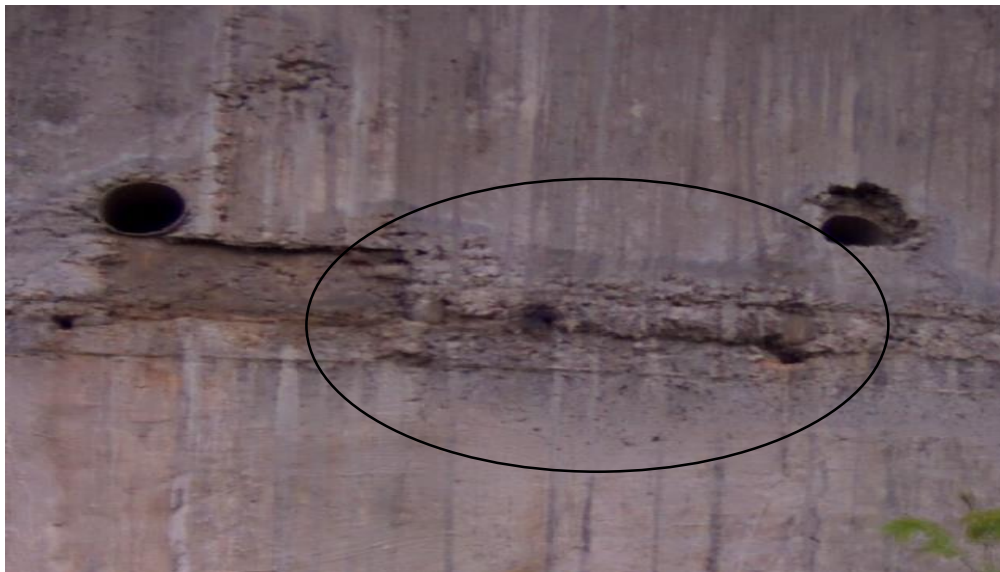
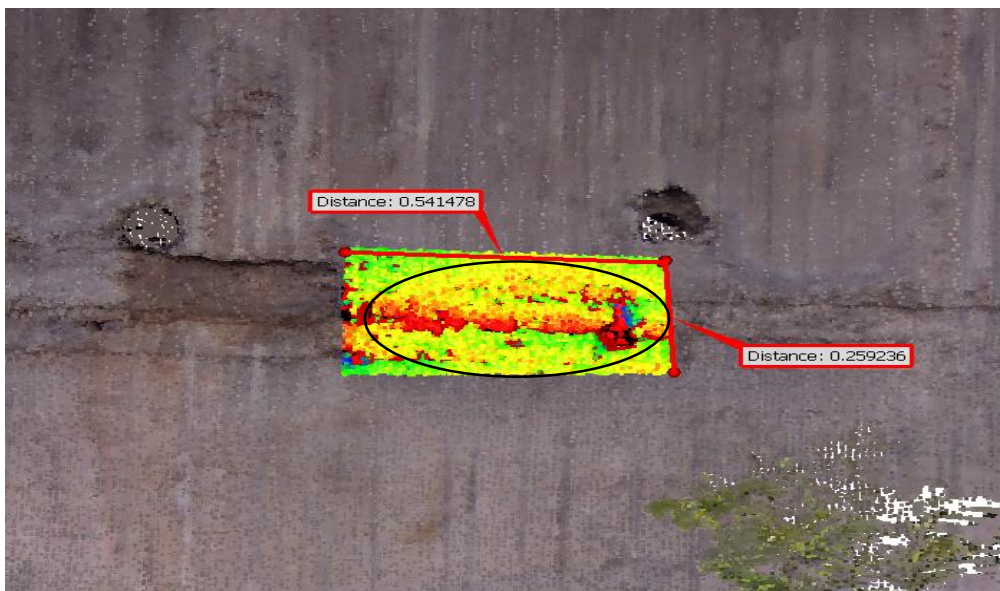
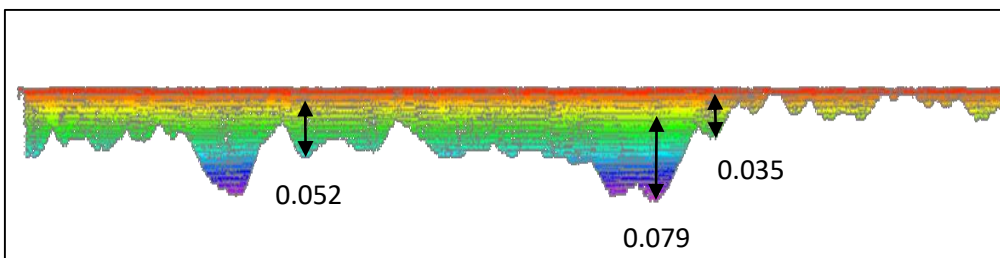
| Element Name | Observation | Location of Distress | Photo No. | Units | Distress Details | | | Area of Repair (Sq.m/RMT/m3) |
|---|---|---|---|---|---|---|---|---|
| Abutment 1 | Damage | | 2 | M | 0.54 | 0.25 | 0.52 | 0.0070 |

- 2. Damage observed on LHS Abutment 1, measuring 0.54 m in length and 0.25 m in width, Depth ranges from 0.035 m (min) to 0.079 m (max), with an average depth of 0.052 m. The calculated volume of the distress is 0.0070 m<sup>3</sup>.**

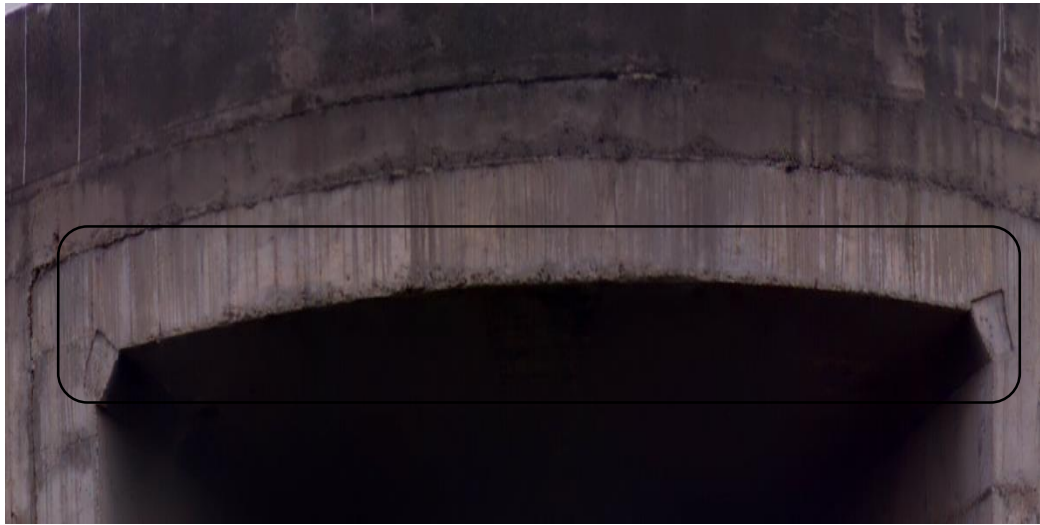
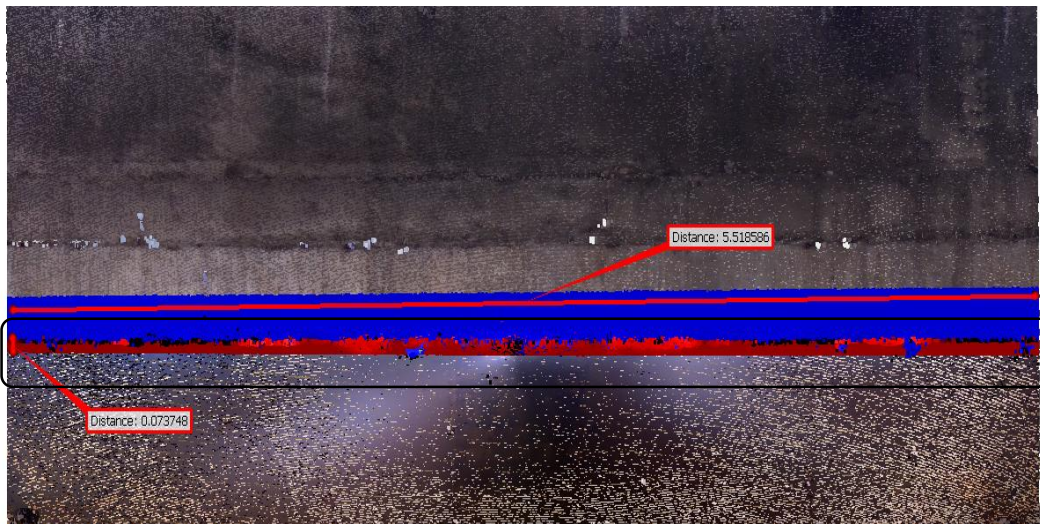
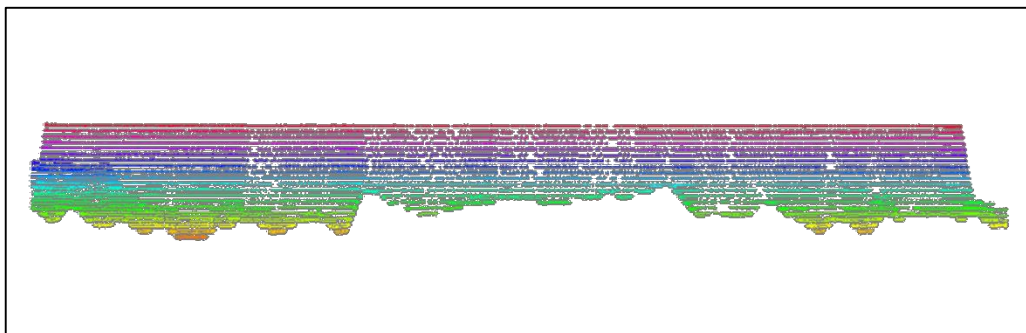
| Element Name | Observation | Location of Distress | Photo No. | Units | Distress Details | | | Area of Repair (Sq.m/RMT/m3) |
|---|---|---|---|---|---|---|---|---|
| Slab Bottom | Honey Combing | | 3 | M | 5.51 | 0.073 | | 0.4022 |

- 3. Damage observed on bottom of LHS slab, measuring 5.51 m in length and 0.073 m in width, covering an area of 0.4022 m<sup>2</sup>.**

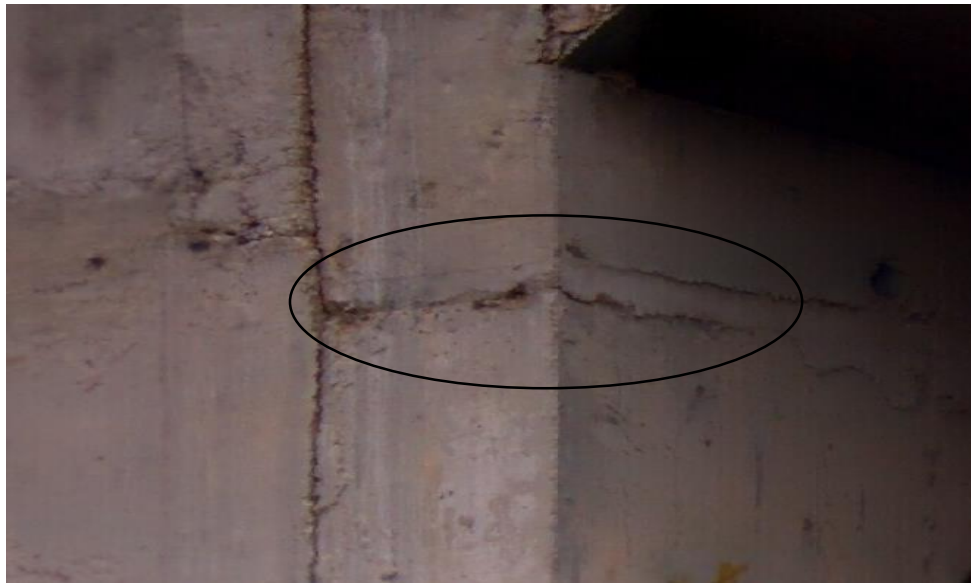
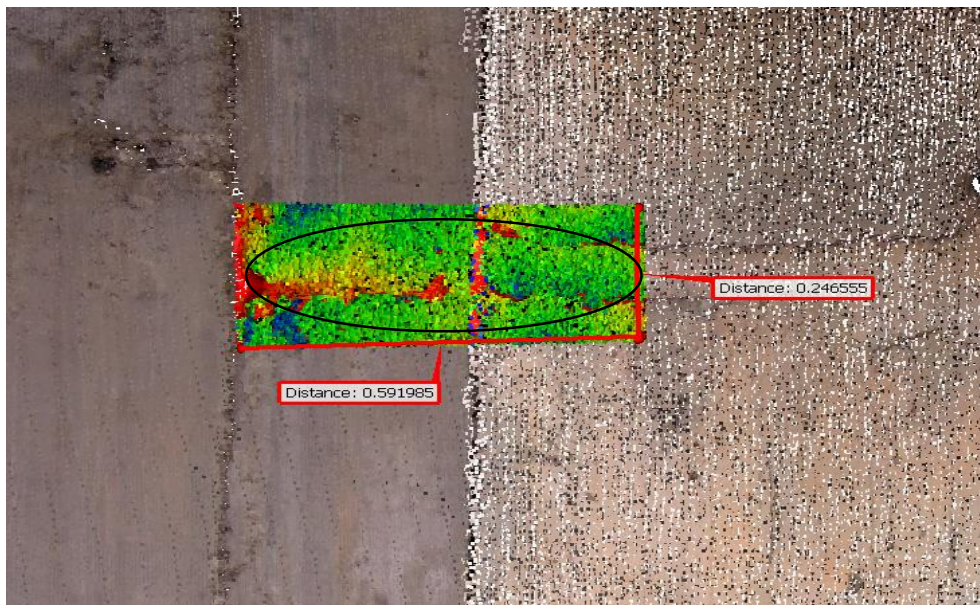
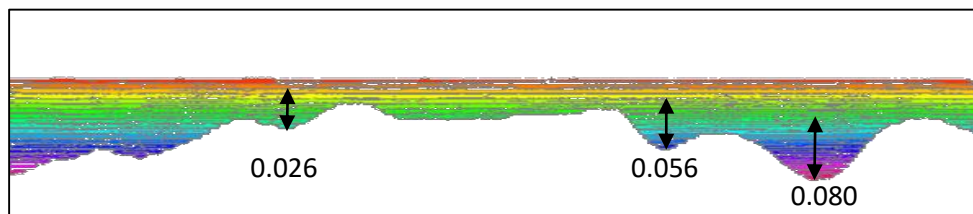
| Element Name | Observation | Location of Distress | Photo No. | Units | Distress Details | | | Area of Repair (Sq.m/RMT/m3) |
|---|---|---|---|---|---|---|---|---|
| Wing Wall | Damage | | 4 | M | 0.59 | 0.24 | 0.56 | 0.0079 |

- 4. Wing wall damage observed on RHS Abutment 1 , measuring 0.59 m in length and 0.24 m in width, Depth ranges from 0.026 m (min) to 0.080 m (max), with an average depth of 0.056 m. The calculated volume of the distress is 0.0079 m<sup>3</sup>.**

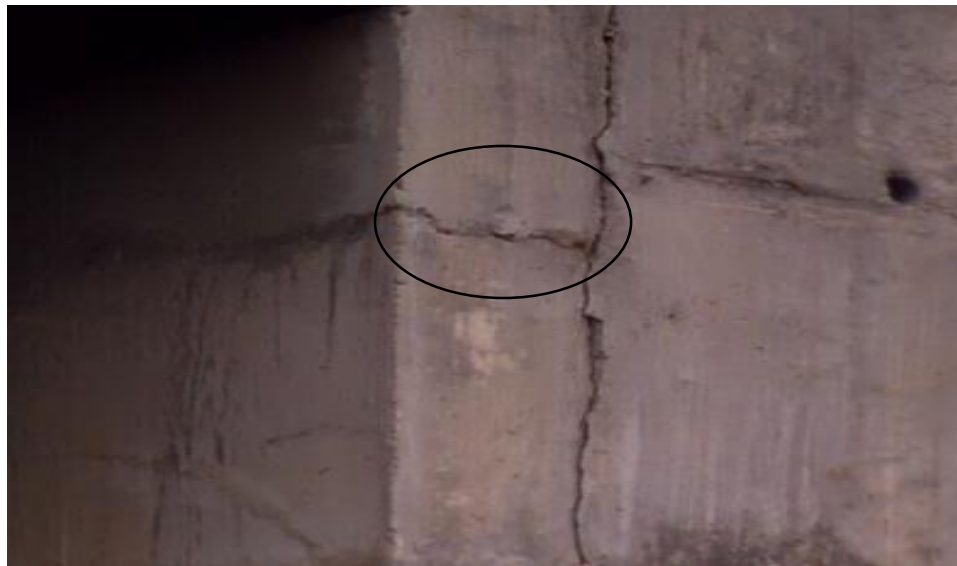
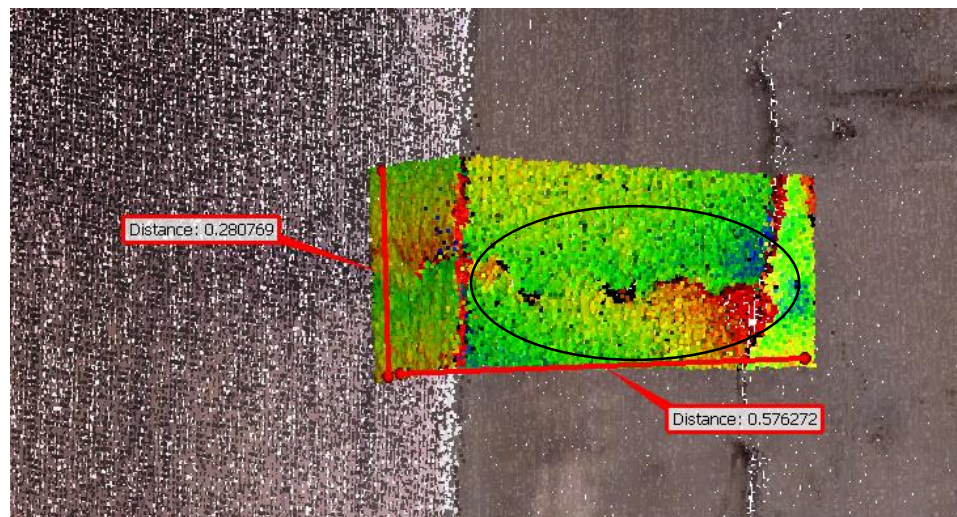
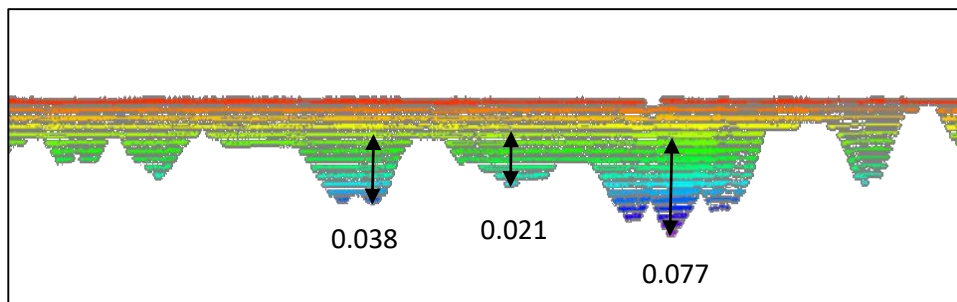
| Element Name | Observation | Location of Distress | Photo No. | Units | Distress Details | | | Area of Repair (Sq.m/RMT/m3) |
|---|---|---|---|---|---|---|---|---|
| Wing Wall | Damage | | 5 | M | 0.57 | 0.28 | 0.38 | 0.0060 |

5. Wing wall damage observed on RHS Abutment 2, measuring 0.57 m in length and 0.28 m in width, Depth ranges from 0.021 m (min) to 0.077 m (max), with an average depth of 0.038 m. The calculated volume of the distress is 0.0060 m<sup>3</sup>.
