# **LIDAR Inspection Report of VUP ch.900+315**

**Bridge Chainage:** 900+315 (CKRP)

- **Bridge No:** -
- **Chainage:** 900+315
- **Structure type:** VUP

- **CKRP:** Chittorgarh to kota
- **State:** Rajasthan NH 27
- **Zone:** RJ-06

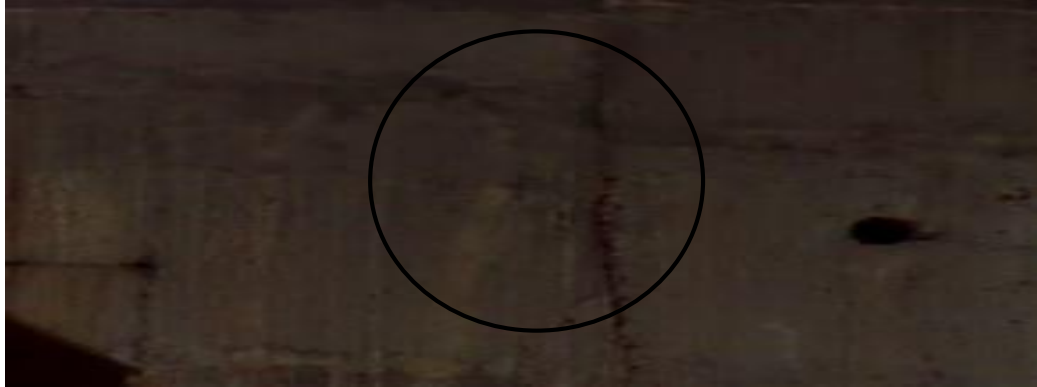
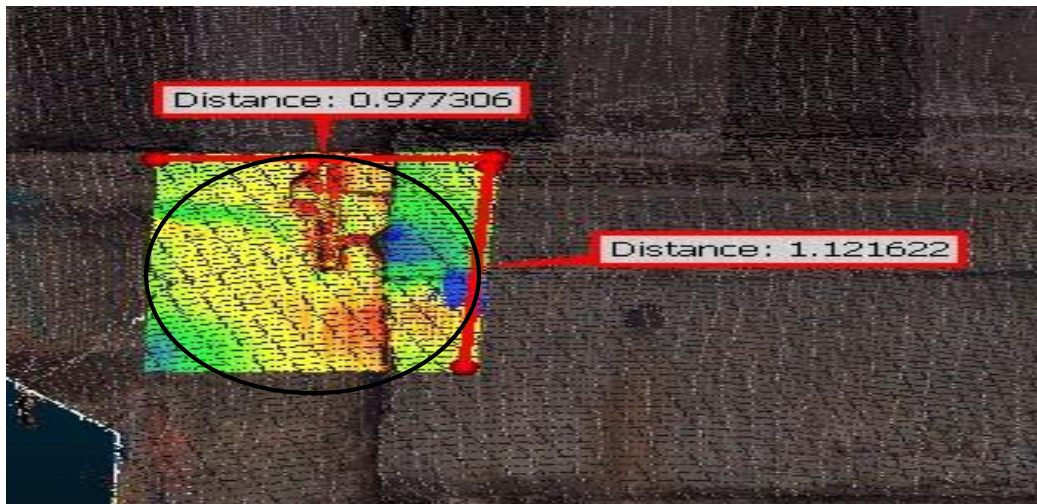
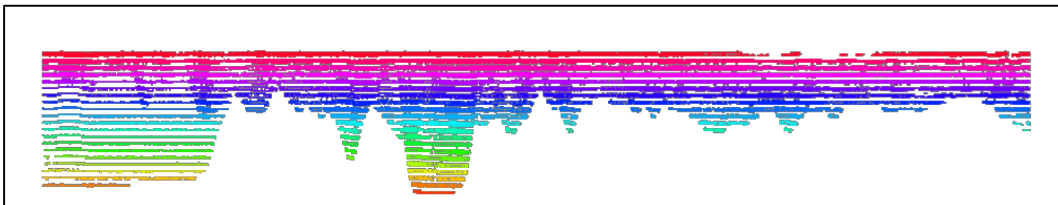
| Element Name | Observation | Location of Distress | Photo No. | Units | Distress Details | | | Area of Repair (Sq.m /RMT/ m3) |
|---|---|---|---|---|---|---|---|---|
| Abutment 1 | Scaling | - | 1 | M | 0.97 | 1.12 | | 1.08 |

**1. Scaling observed on LHS Abutment 1, measuring 0.97 m in length and 1.12 m in width, covering an area of 1.08 m<sup>2</sup>.**

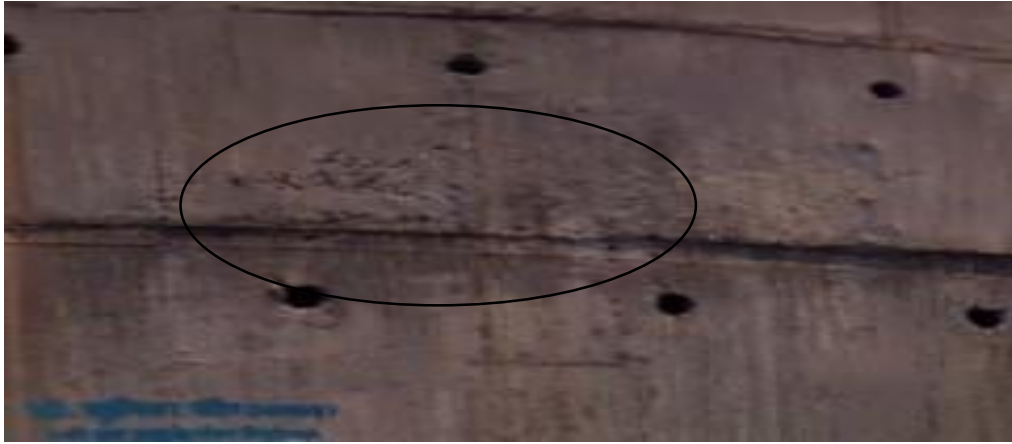
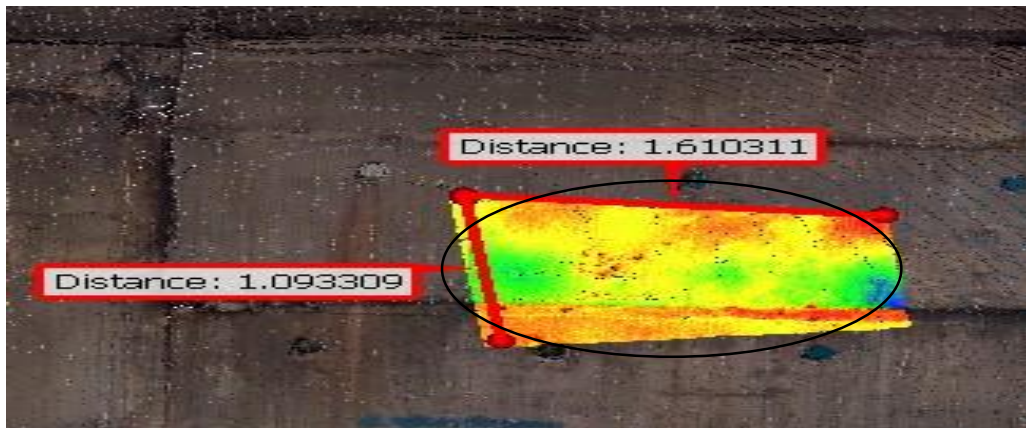
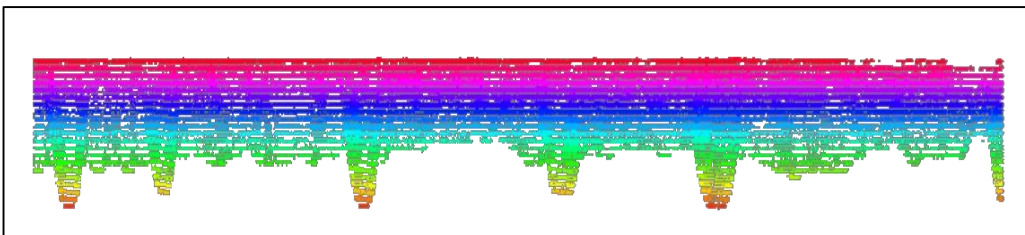
| Element Name | Observation | Location of Distress | Photo No. | Units | Distress Details | | | Area of Repair (Sq.m /RMT/ m3) |
|---|---|---|---|---|---|---|---|---|
| Abutment 1 | Scaling | - | 2 | M | 1.61 | 1.09 | | 1.75 |

**2. Scaling observed on LHS Abutment 1, measuring 1.61 m in length and 1.09 m in width, covering an area of 1.75 m<sup>2</sup>.**

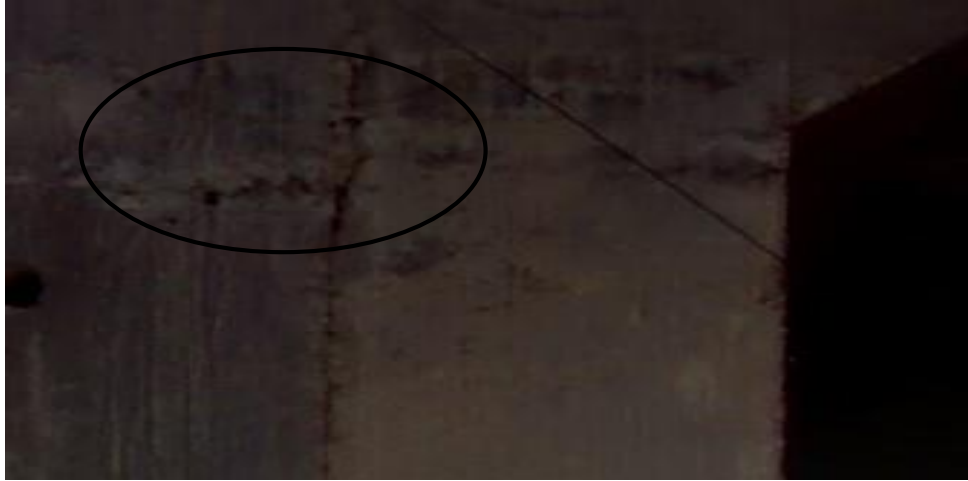
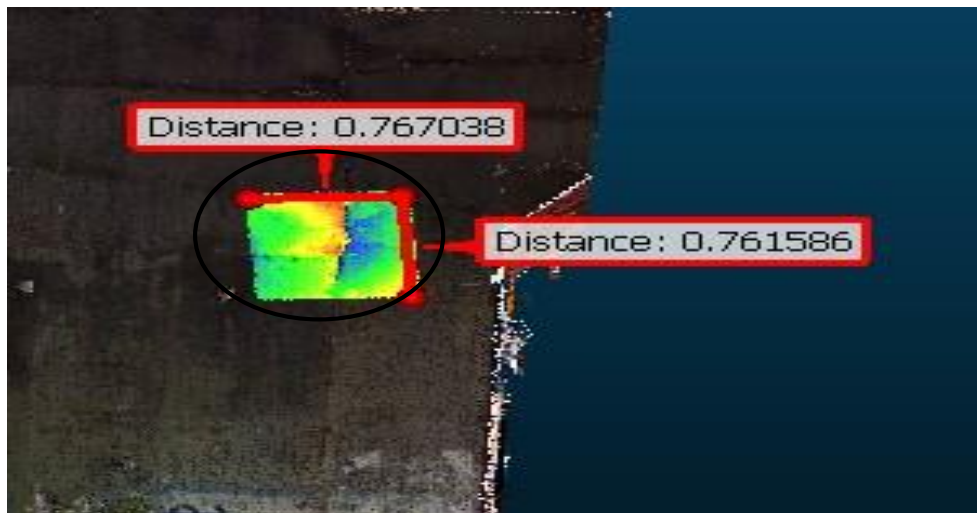
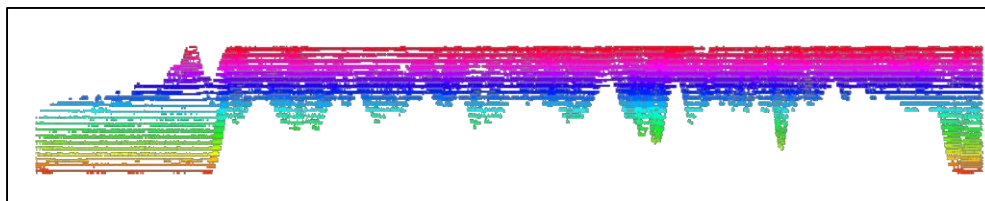
| Element Name | Observation | Location of Distress | Photo No. | Units | Distress Details | | | Area of Repair (Sq.m/ RMT/ m3) |
|---|---|---|---|---|---|---|---|---|
| Abutment 1 | Damage | - | 3 | M | 0.76 | 0.76 | | 0.5776 |

**3. Damage observed on RHS Abutment 1, measuring 0.76 m in length and 0.76 m in width, covering an area of 0.5776 m<sup>2</sup>**
