# **LIDAR Inspection Report of MNB ch.901+270**

**Bridge No:** MNB – 902/2

**Bridge Chainage:** 901+270 (CKRP)

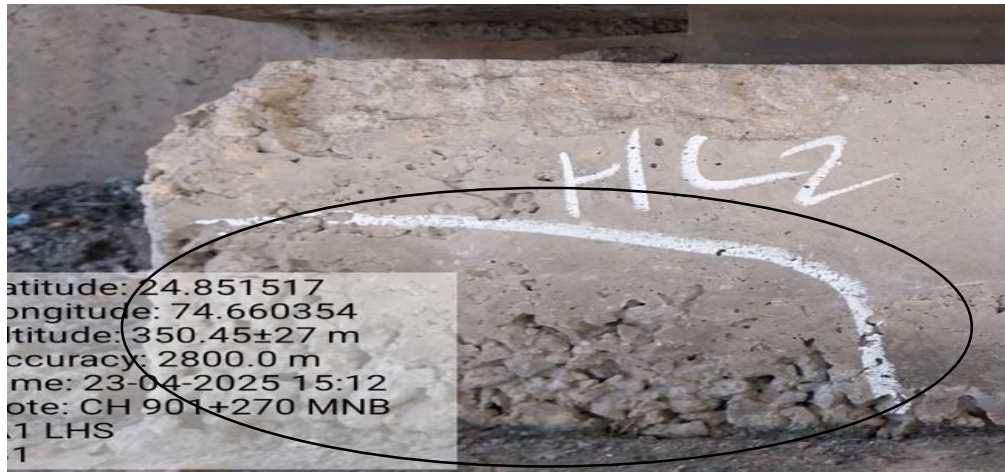
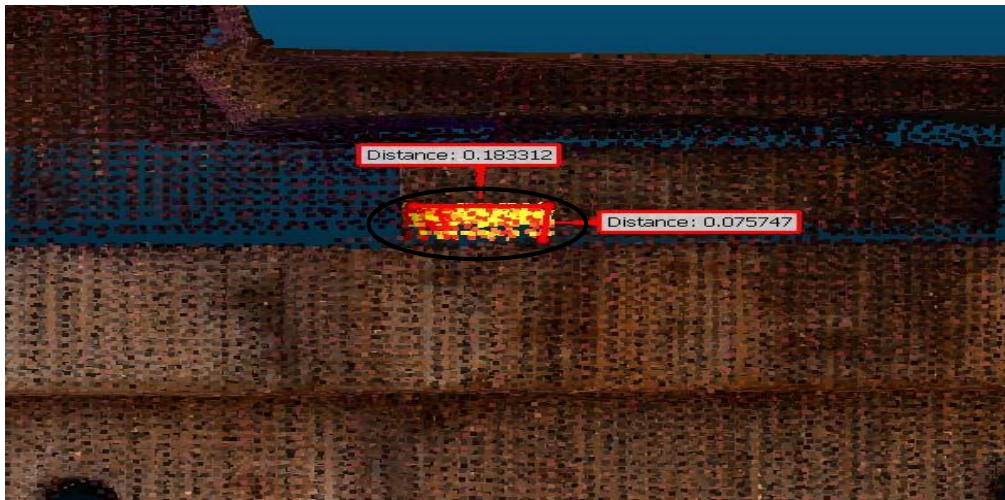
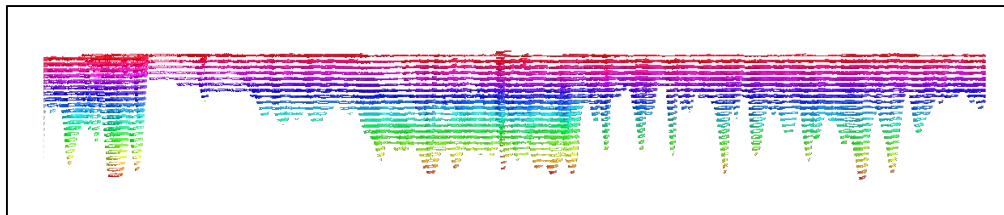
| Element Name | Observation | Location of Distress | Photo No. | Units | Distress Details | | | Area of Repair (Sq./RM T/m3) |
|---|---|---|---|---|---|---|---|---|
| Abutment 1 (B1) | Honeycombing | | 1 | | 0.18 | 0.07 | | 0.012 |

**1.Honeycombing observed on Abutment 1, Bearing 1 LHS, measuring 0.18 m in length and 0.07 m in width, covering an area of 0.012m<sup>2</sup>**

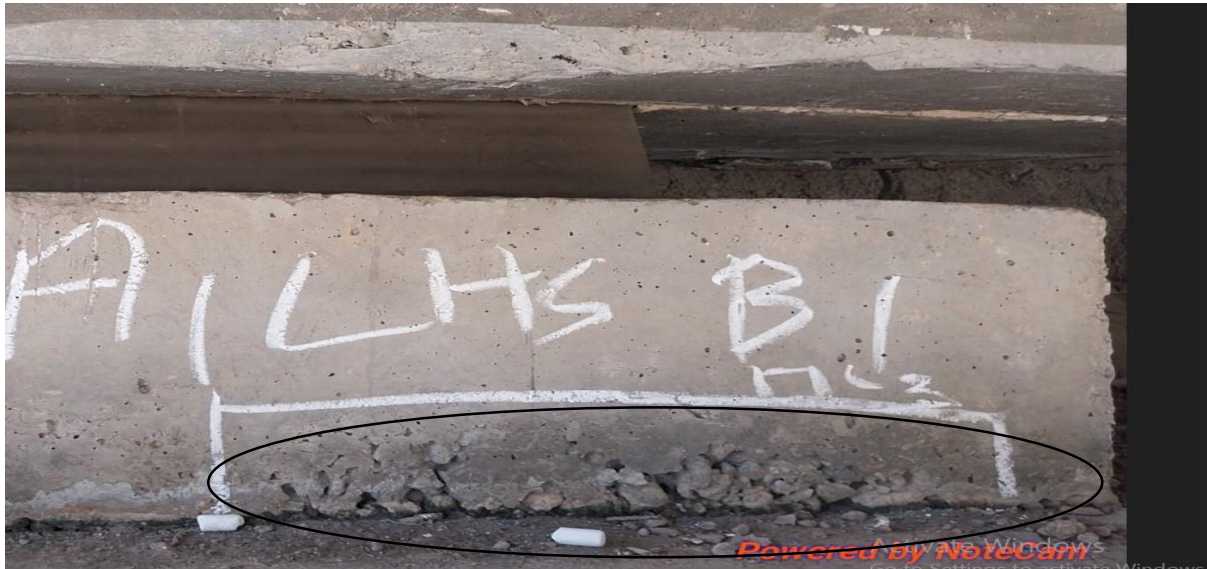
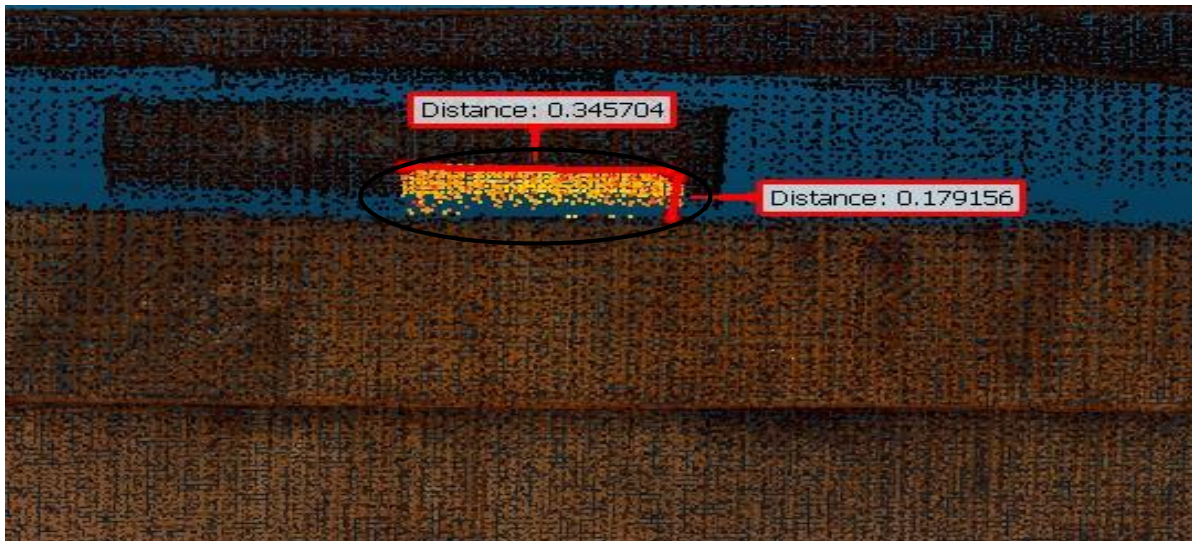
| Element Name | Observation | Location of Distress | Photo No. | Units | Distress Details | | | Area of Repair (Sq./RM T/m3) |
|---|---|---|---|---|---|---|---|---|
| Abutment 1 (B1) | Honeycombing | | 2 | | 0.34 | 0.17 | | 0.0578 |

**2. Honeycombing observed on Abutment 1 Bearing 1 LHS, measuring 0.34 m in length and 0.17 m in width, covering an area of 0.0578m<sup>2</sup>**

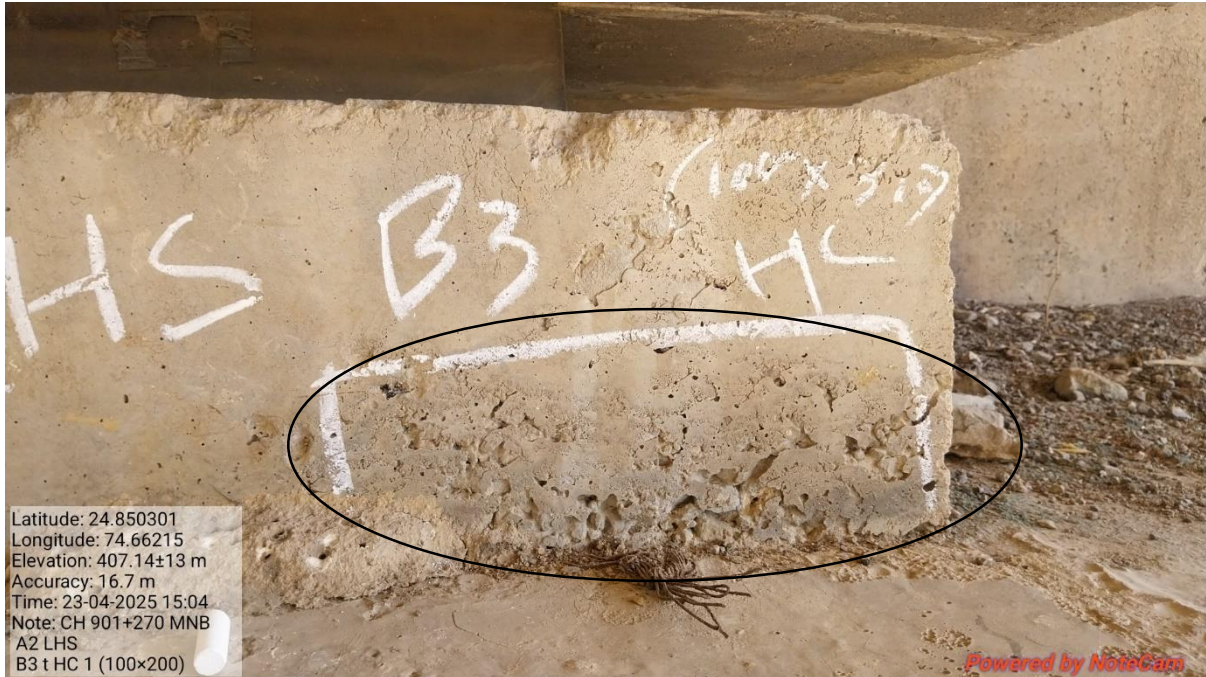
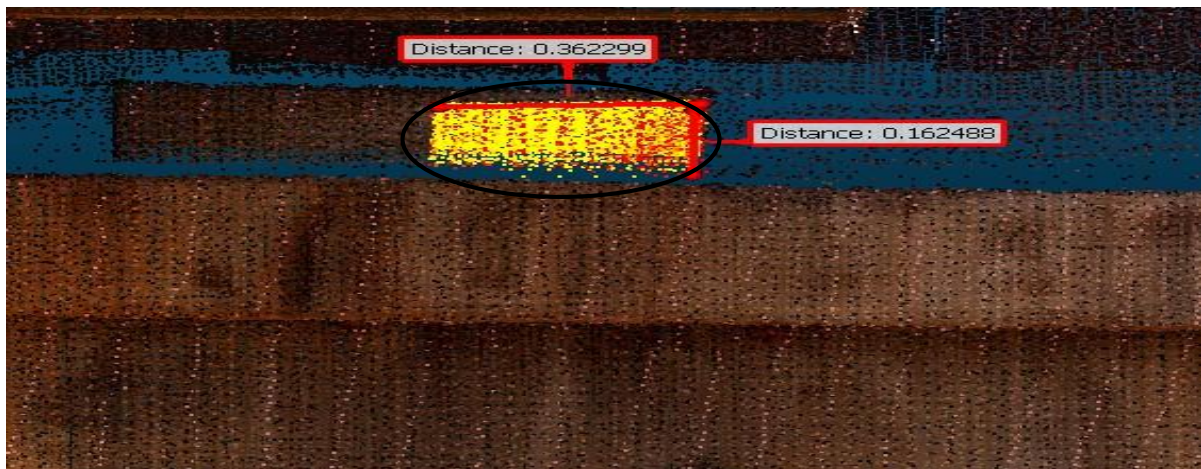
| Element Name | Observation | Location of Distress | Photo No. | Units | Distress Details | | | Area of Repair (Sq./RM T/m3) |
|---|---|---|---|---|---|---|---|---|
| Abutment 2 (B3) | Honeycombing | | 3 | | 0.36 | 0.16 | | 0.057 |

**3.Honeycombing observed on Abutment 2 Bearing 3 LHS, measuring 0.36 m in length and 0.16 m in width, covering an area of 0.057 m<sup>2</sup>**

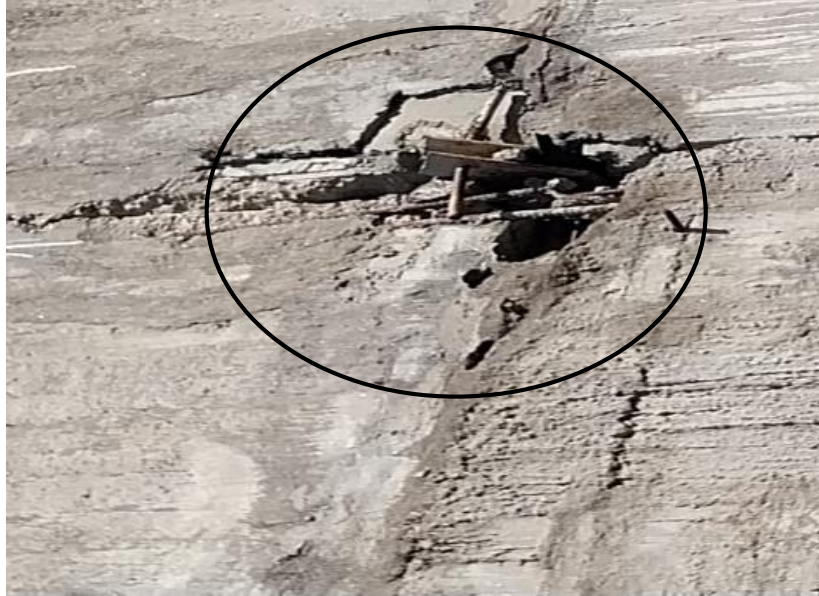
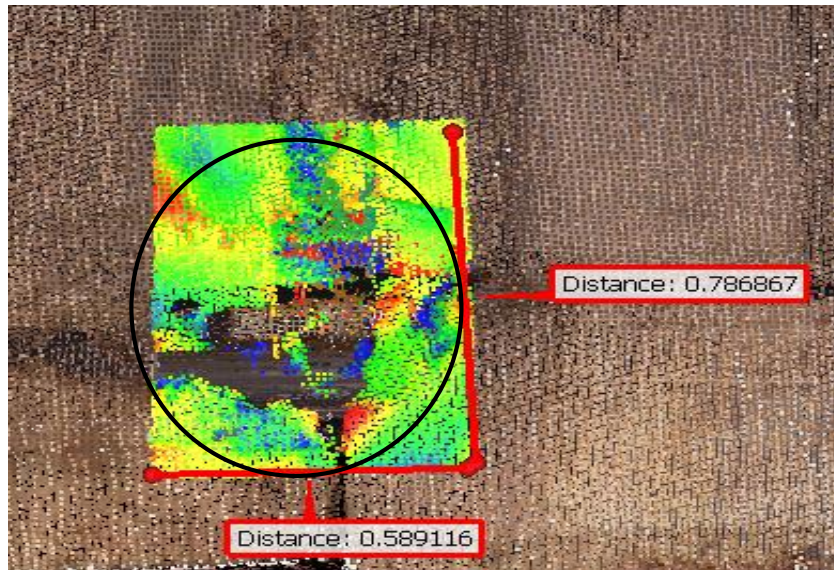
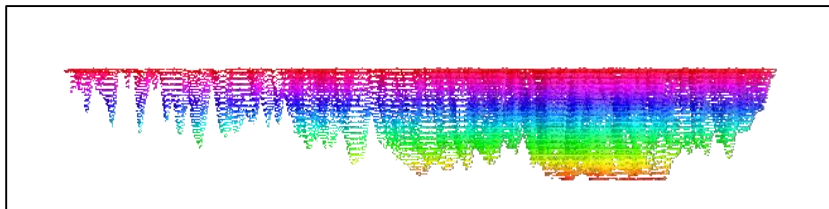
| Element Name | Observation | Location of Distress | Photo No. | Units | Distress Details | | | Area of Repair (Sq./RM T/m3) |
|---|---|---|---|---|---|---|---|---|
| Abutment 1 | Steel Expose | | 4 | | 0.58 | 0.78 | | 0.4524 |

**4. Steel Expose observed on Abutment 1 LHS, measuring 0.58 m in length and 0.78 m in width, covering an area of 0.4524 m<sup>2</sup>.**

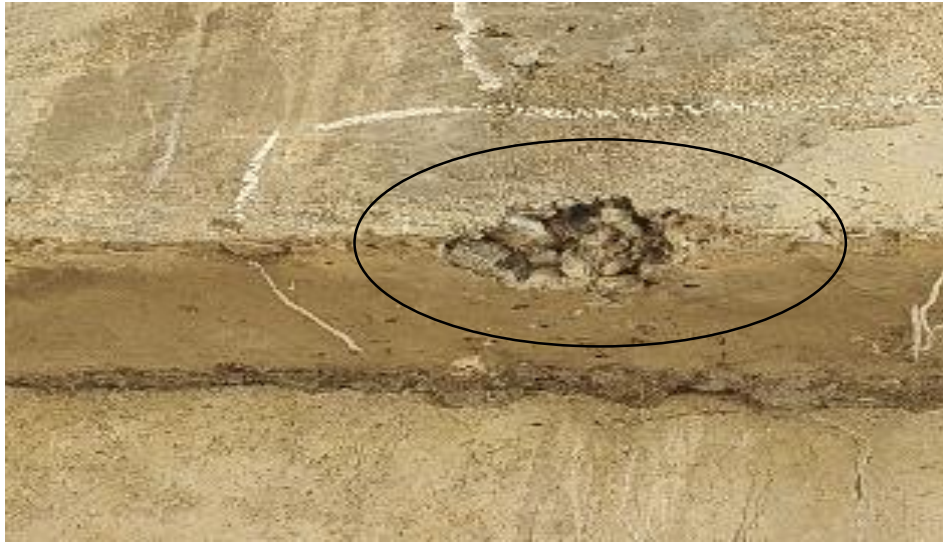
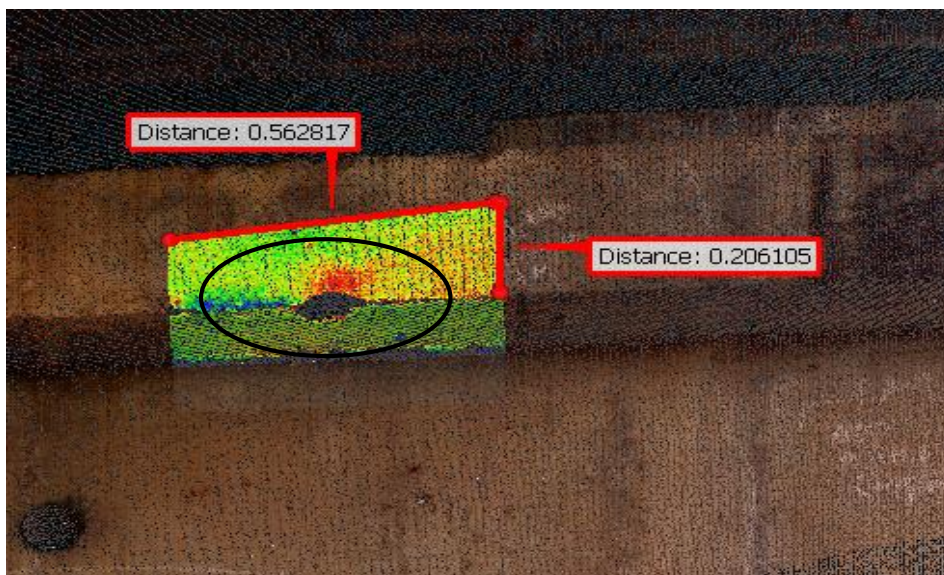
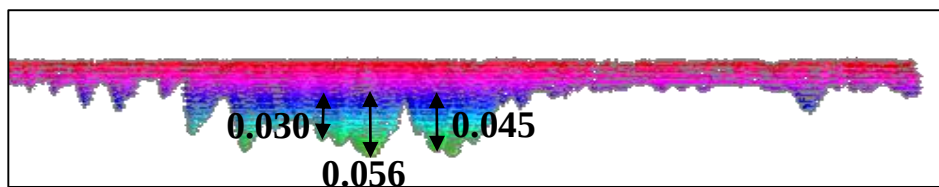
| Element Name | Observation | Location of Distress | Photo No. | Units | Distress Details | | | Area of Repair (Sq./RM T) |
|---|---|---|---|---|---|---|---|---|
| Abutment 2 | Hollow Section | | 5 | | 0.56 | 0.20 | 0.045 | 0.005 |

**5. Hollow Section observed on Abutment 2 RHS, measuring 0.56 m in length and 0.20 m in width, Depth ranges from 0.030 (min) to 0.056 m (max), with an average depth of 0.45 m. The calculated volume of the distress is 0.005 m<sup>3</sup>.**

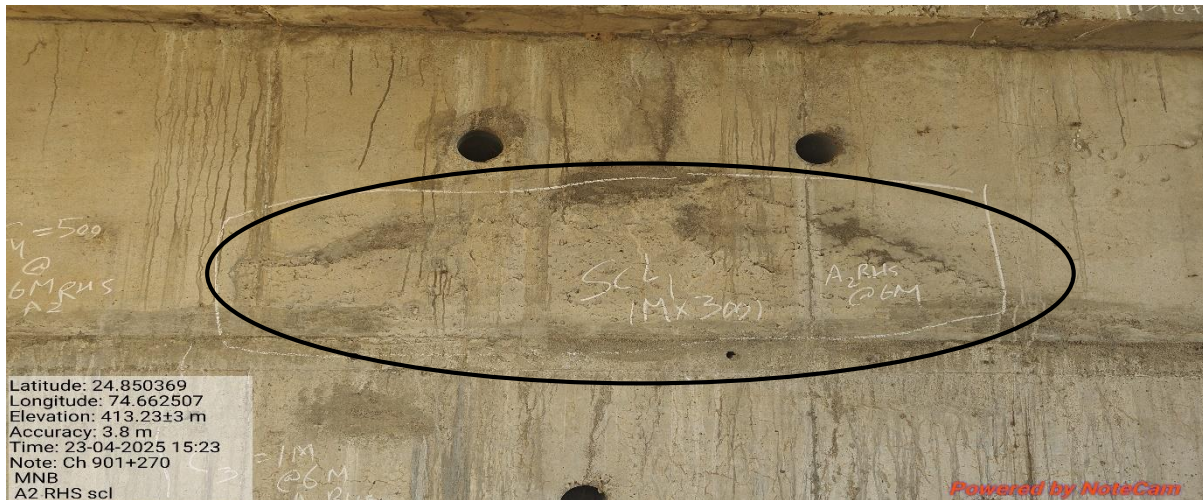
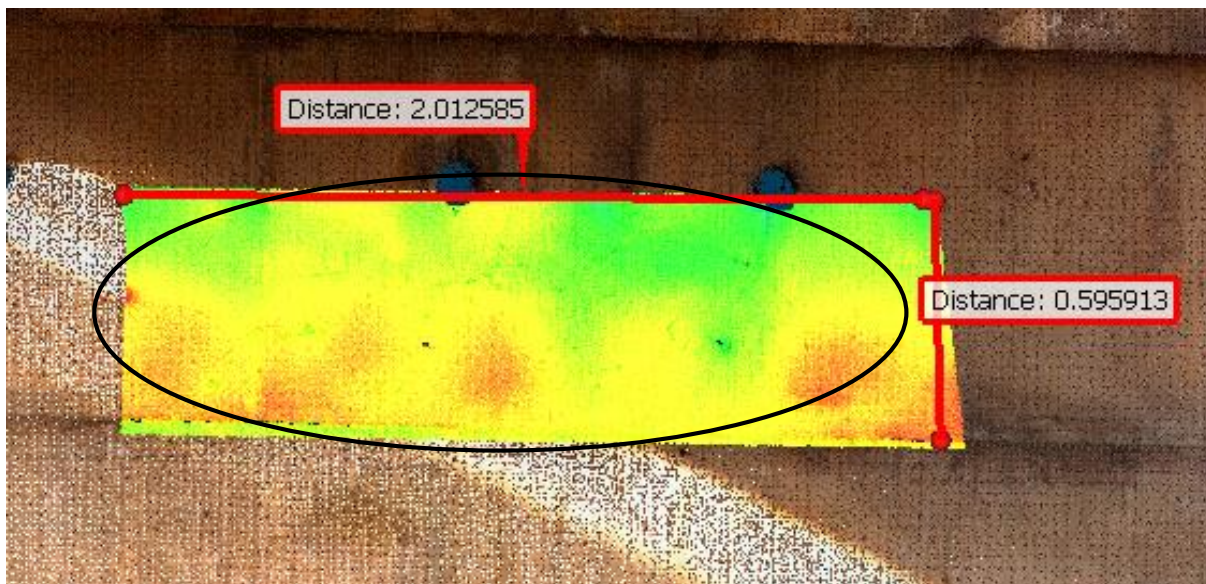
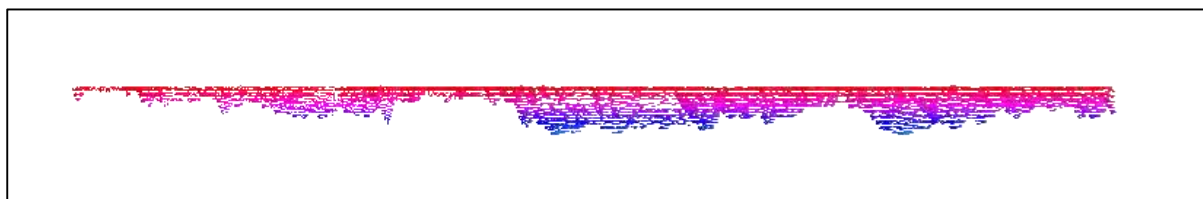
| Element Name | Observation | Location of Distress | Photo No. | Units | Distress Details | | | Area of Repair (Sq./RM T) |
|---|---|---|---|---|---|---|---|---|
| Abutment 2 | Scaling | | 6 | | 2.01 | 0.59 | | 1.18 |

**6. Scaling observed on Abutment 2 RHS, measuring 2.01 m in length and 0.59 m in width, covering an area of 1.18 m<sup>2</sup>**

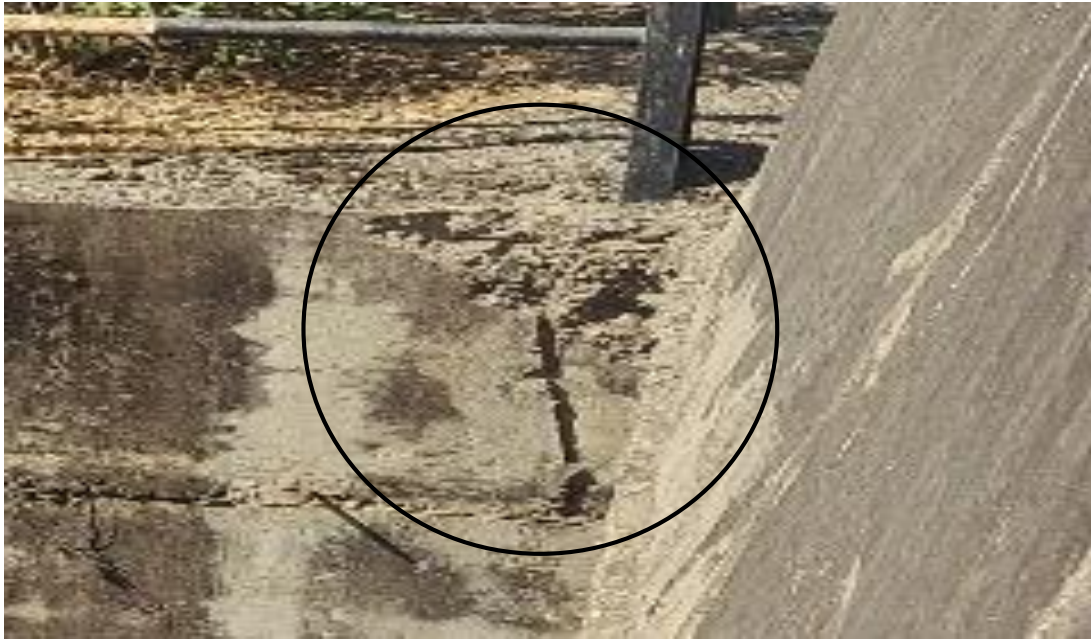
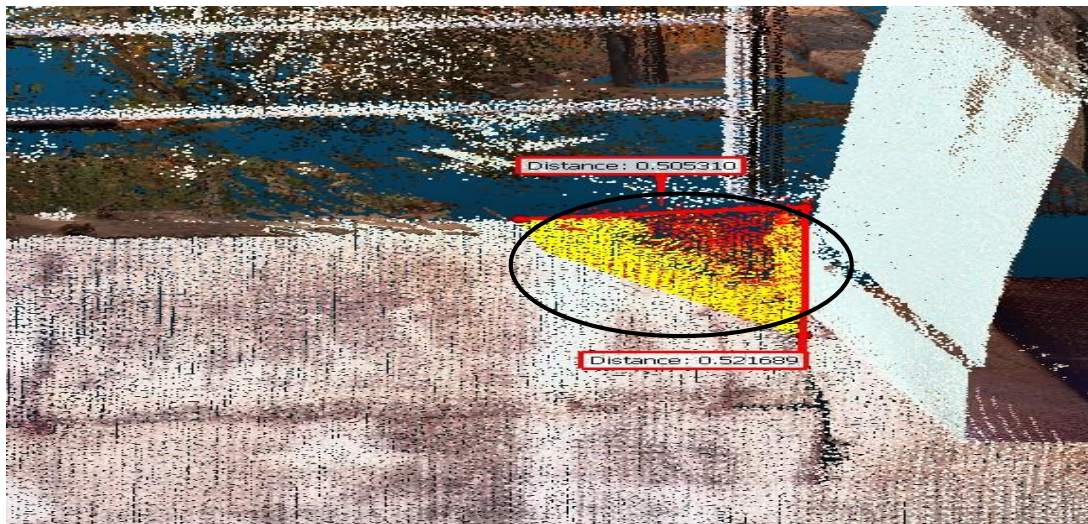
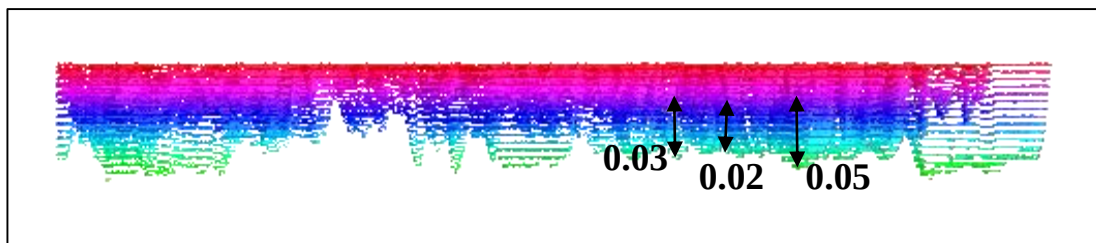
| Element Name | Observation | Location of Distress | Photo No. | Units | Distress Details | | | Area of Repair (Sq./RM T) |
|---|---|---|---|---|---|---|---|---|
| Abutment 2 | Damage | | 7 | | 0.50 | 0.52 | 0.03 | 0.007 |

**7. Damaged area observed on Abutment 2 RHS, measuring 0.50 m in length and 0.52 m in width, Depth ranges from 0.02 (min) to 0.05 m (max), with an average depth of 0.03 m. The calculated volume of the distress 0.007 m<sup>3</sup>.**
