# LIDAR Inspection Report of **Box Culvert** ch.901+935

**Bridge No:** Box Culvert

**Bridge Chainage:** 901 + 935 (CKRP)

- **CKRP:** Chittorgarh to kota
- **State:** Rajasthan NH 27
- **Zone:** RJ-06

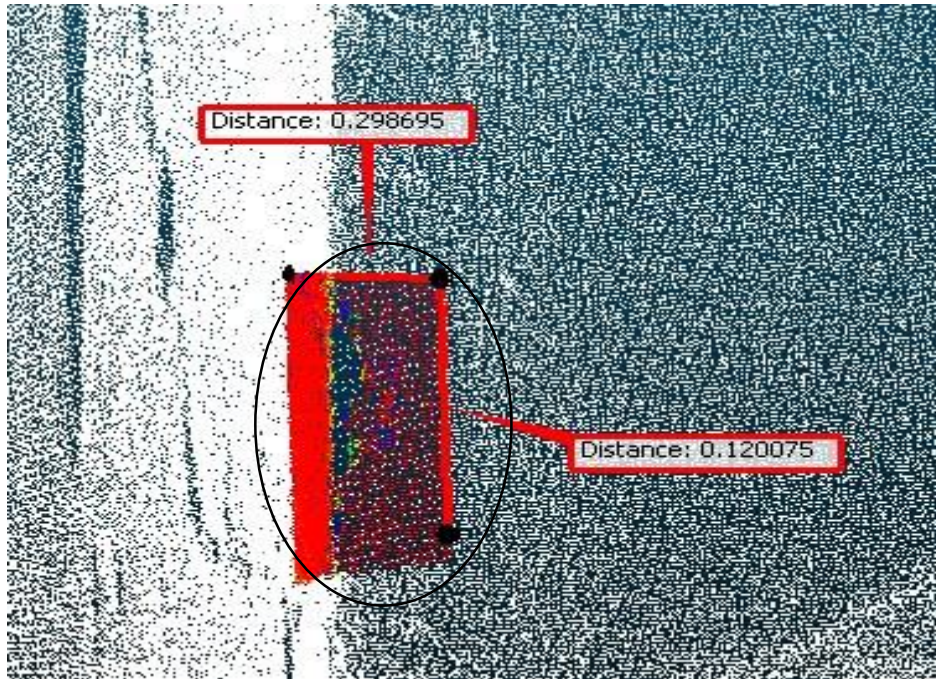
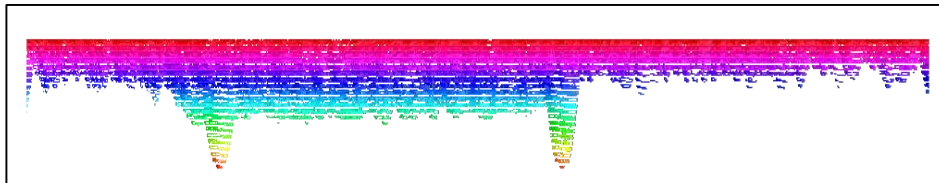
| Element Name | Observation | Location of Distress | Photo No. | Units | Distress Details | | | Area of Repair (Sq.m/ RMT/ m3) |
|---|---|---|---|---|---|---|---|---|
| Wing Wall | Damage | - | 1 | M | 0.29 | 0.12 | | 0.034 |

**1. Joint damage observed on Wing Wall, measuring 0.29 m in length and 0.12 m in width, covering an area of 0.034 m<sup>2</sup>."**

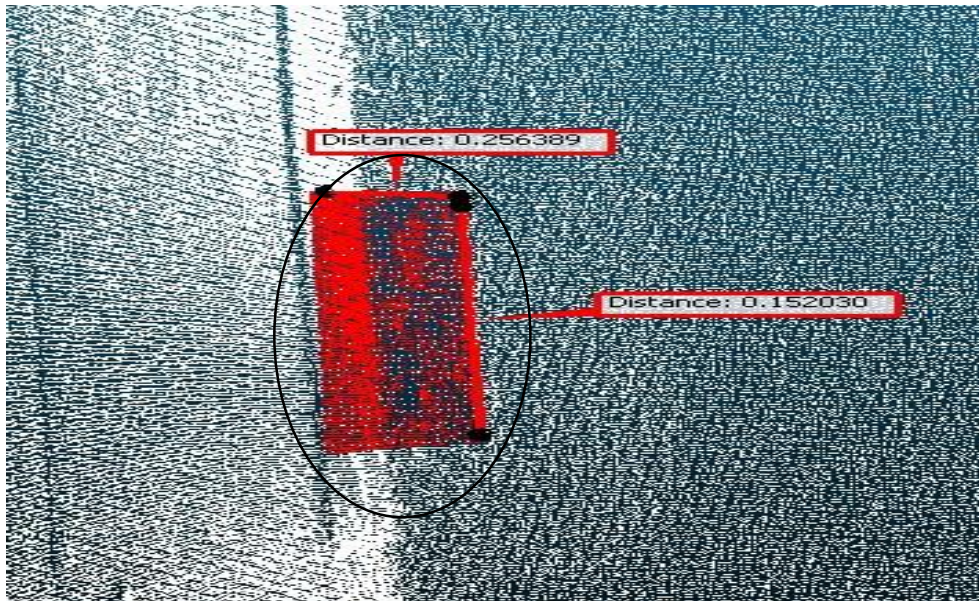
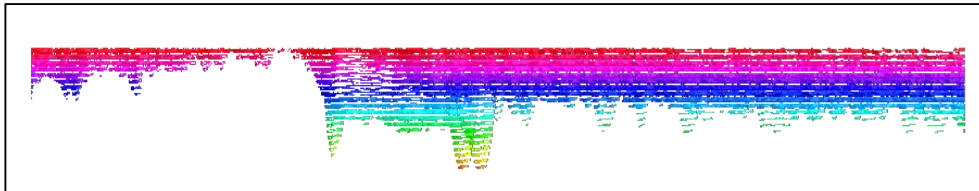
| Element Name | Observation | Location of Distress | Photo No. | Units | Distress Details | | | Area of Repair (Sq.m/ RMT/ m3) |
|---|---|---|---|---|---|---|---|---|
| Wing Wall | Damage | - | 2 | M | 0.25 | 0.15 | | 0.037 |

**2."Joint damage observed on Wing Wall, measuring 0.25 m in length and 0.15 m in width, covering an area of 0.037 m<sup>2</sup>."**

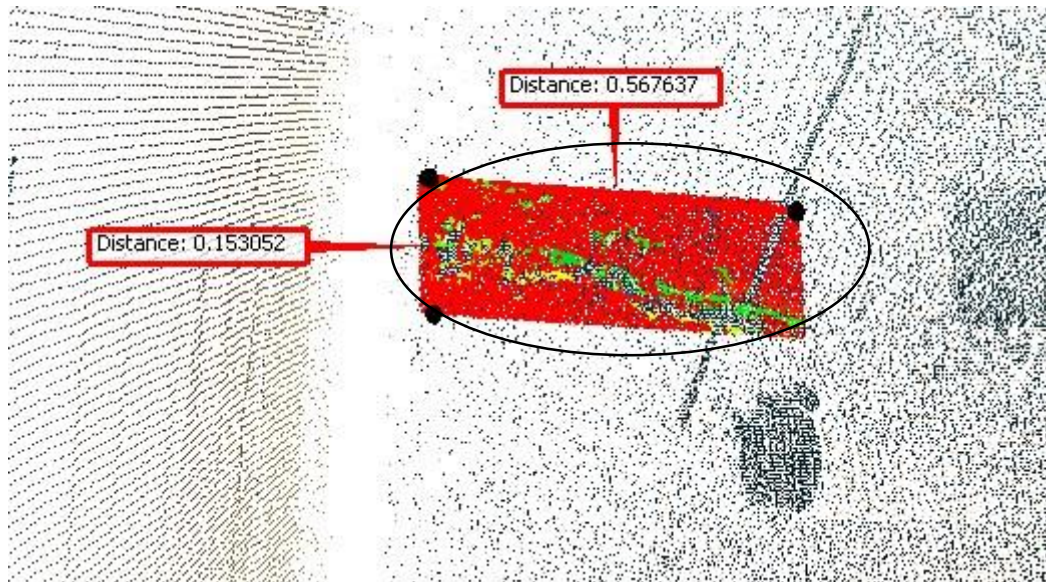
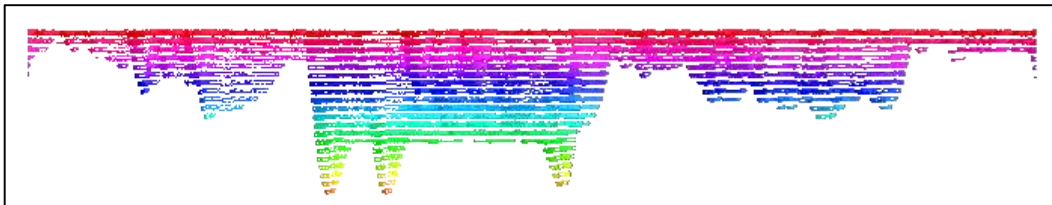
| Element Name | Observation | Location of Distress | Photo No. | Units | Distress Details | | | Area of Repair (Sq.m/ RMT/ m3) |
|---|---|---|---|---|---|---|---|---|
| Wing Wall | scaling | - | 3 | M | 0.56 | 0.15 | | 0.084 |

**3. "Scaling observed on Wing Wall, measuring 0.56 m in length and 0.15 m in width, covering an area of 0.084 m<sup>2</sup>."**

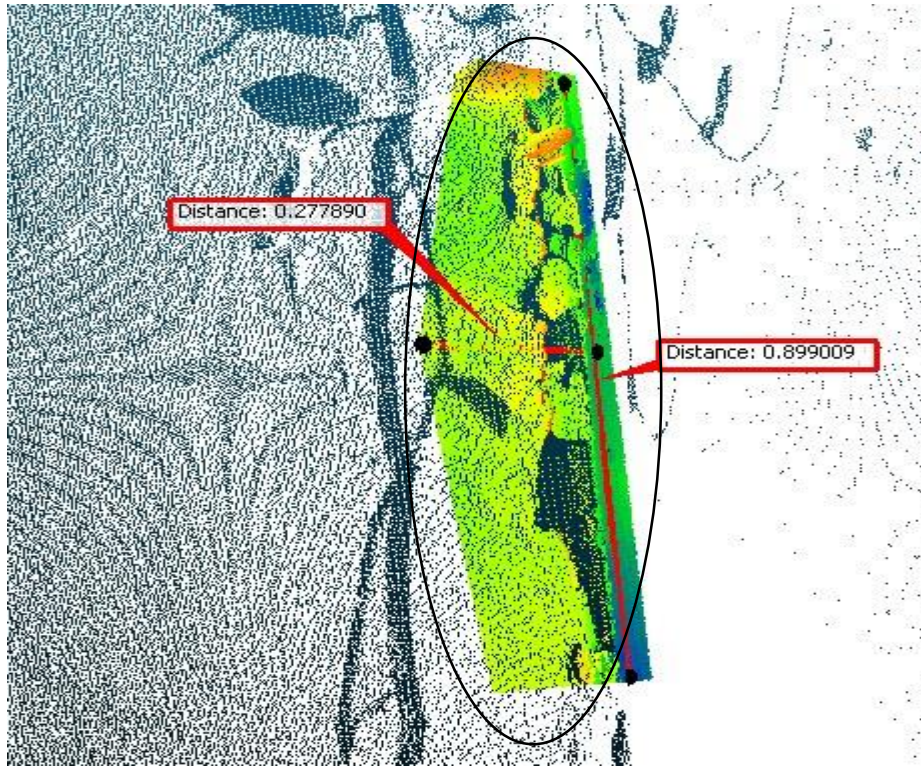
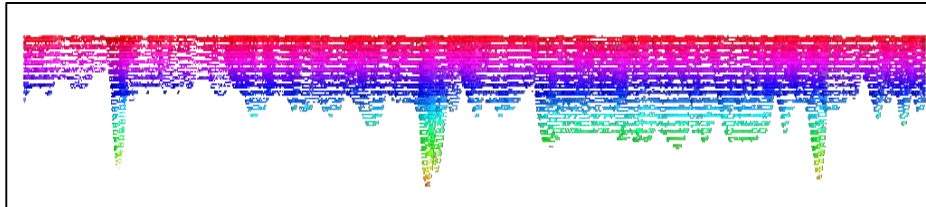
| Element Name | Observation | Location of Distress | Photo No. | Units | Distress Details | | | Area of Repair (Sq.m/ RMT/ m3) |
|---|---|---|---|---|---|---|---|---|
| Wing Wall | Damage | - | 4 | M | 0.27 | 0.89 | | 0.240 |

**4. "Damage observed on Wing Wall, measuring 0.27 m in length and 0.89 m in width, covering an area of 0.240 m<sup>2</sup>."**

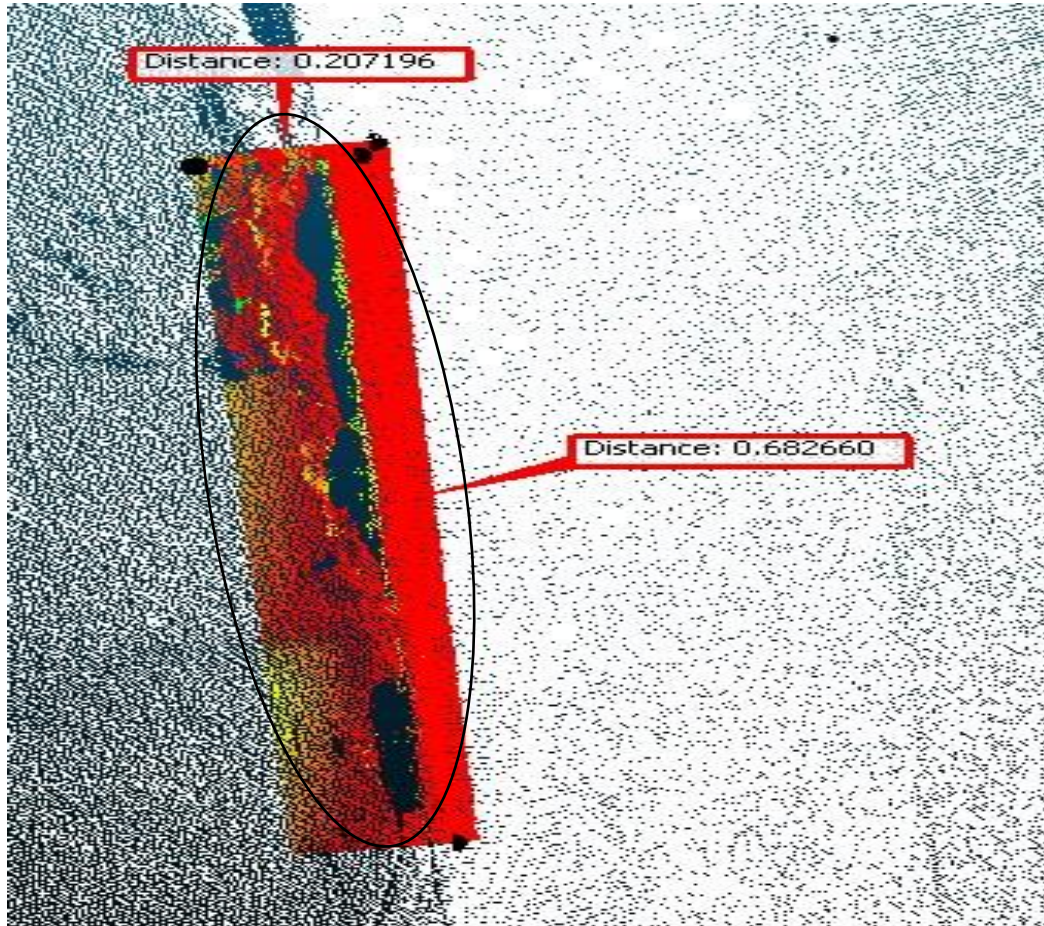
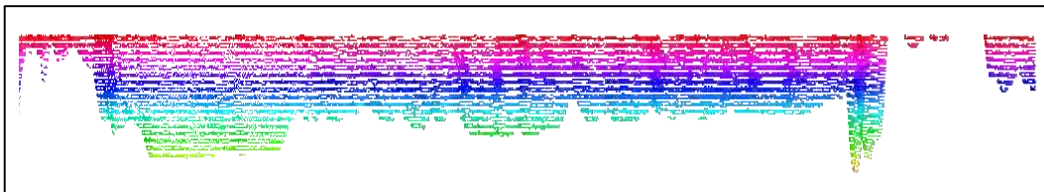
| Element Name | Observation | Location of Distress | Photo No. | Units | Distress Details | | | Area of Repair (Sq.m/ RMT/ m3) |
|---|---|---|---|---|---|---|---|---|
| Wing Wall | Damage | - | 5 | M | 0.20 | 0.68 | | 0.136 |

**5."Damage observed on Wing Wall, measuring 0.20 m in length and 0.68 m in width, covering an area of 0.136 m<sup>2</sup>."**

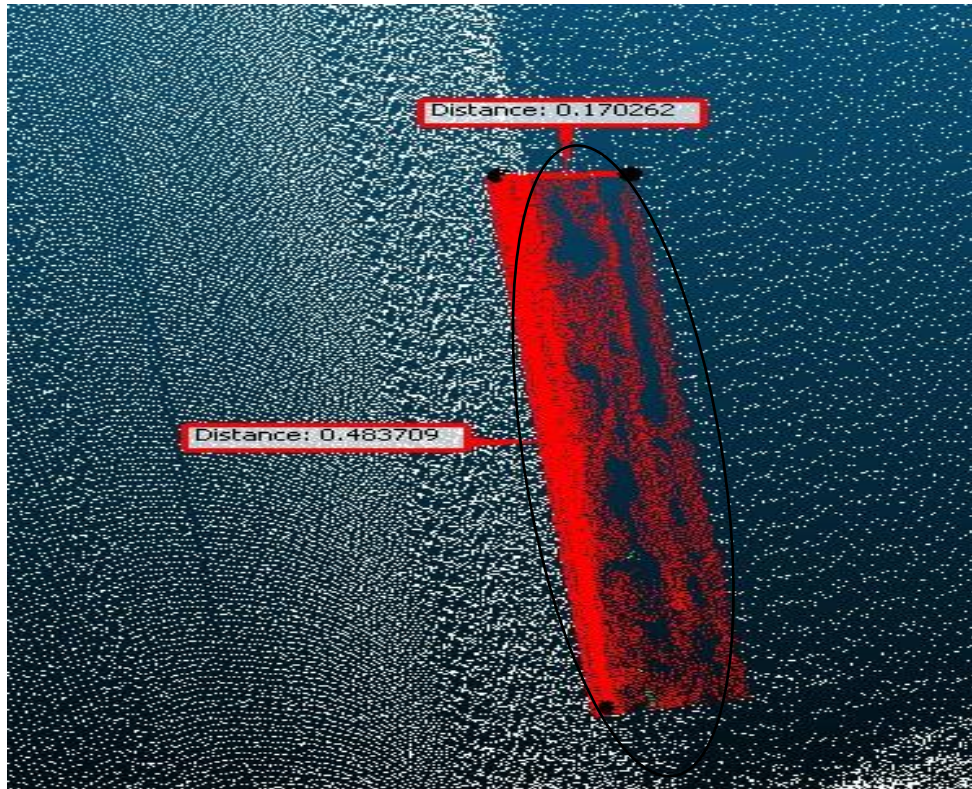
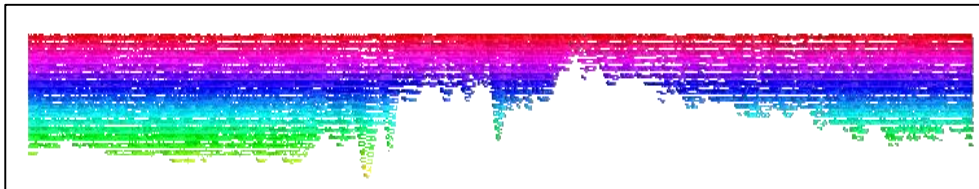
| Element Name | Observation | Location of Distress | Photo No. | Units | Distress Details | | | Area of Repair (Sq.m/ RMT/ m3) |
|---|---|---|---|---|---|---|---|---|
| Wing Wall | Damage | - | 6 | M | 0.17 | 0.48 | | 0.081 |

**6."Damage observed on Wing Wall, measuring 0.17 m in length and 0.48 m in width, covering an area of 0.081 m<sup>2</sup>."**

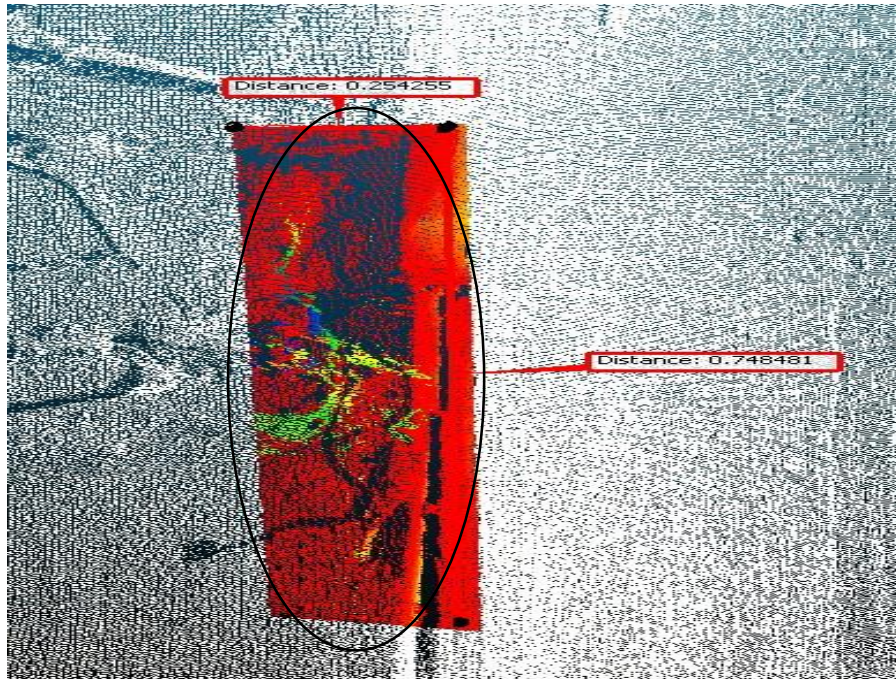
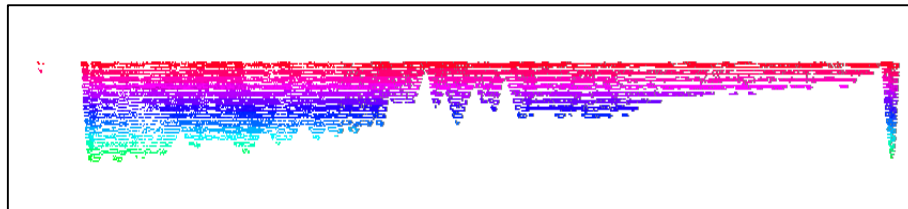
| Element Name | Observation | Location of Distress | Photo No. | Units | Distress Details | | | Area of Repair (Sq.m/ RMT/ m3) |
|---|---|---|---|---|---|---|---|---|
| Wing Wall | Damage | - | 7 | M | 0.25 | 0.78 | | 0.195 |

**7."Damage observed on Wing Wall, measuring 0.25 m in length and 0.78 m in width, covering an area of 0.195 m<sup>2</sup>."**

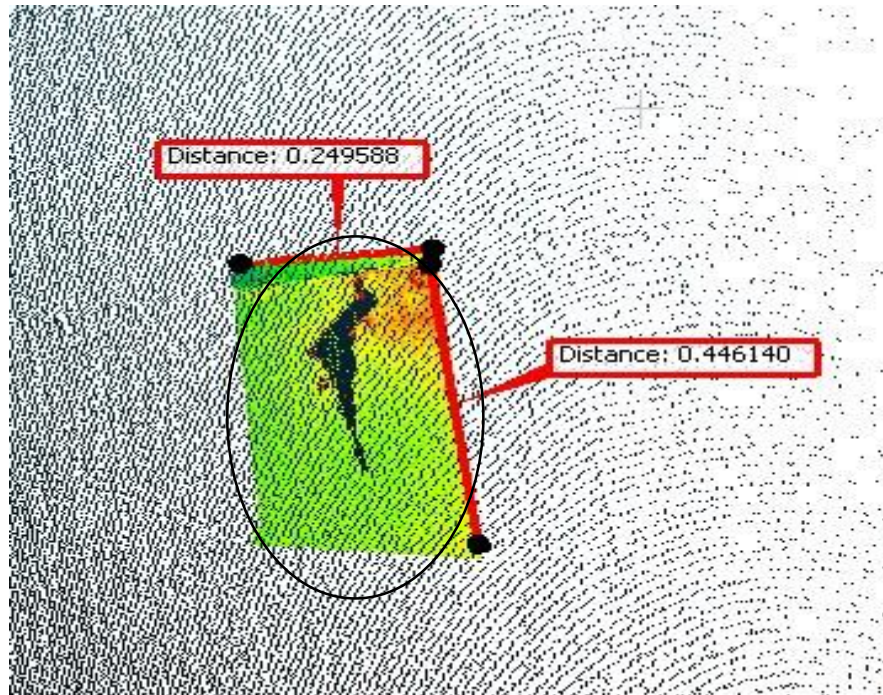
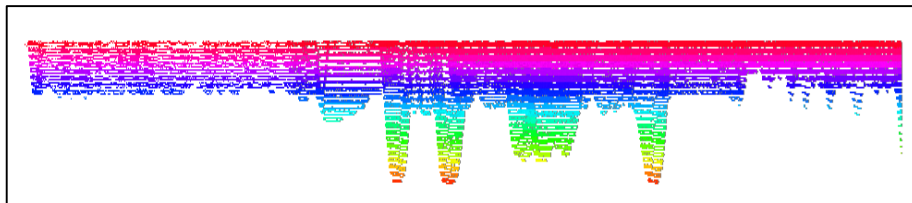
| Element Name | Observation | Location of Distress | Photo No. | Units | Distress Details | | | Area of Repair (Sq.m/ RMT/ m3) |
|---|---|---|---|---|---|---|---|---|
| Wall | Damage | - | 8 | M | 0.24 | 0.44 | | 0.105 |

**8. "Damage observed on Wall, measuring 0.24 m in length and 0.44 m in width, covering an area of 0.105 m<sup>2</sup>."**
