# **LIDAR Inspection Report of VUP ch.902 + 200**

**Bridge Chainage:** 902 + 200 (CKRP)

- **Bridge No:** -
- **Chainage:** 902 +200
- **Structure type:** VUP

- **CKRP:** Chittorgarh to kota
- **State:** Rajasthan NH 27
- **Zone:** RJ-06

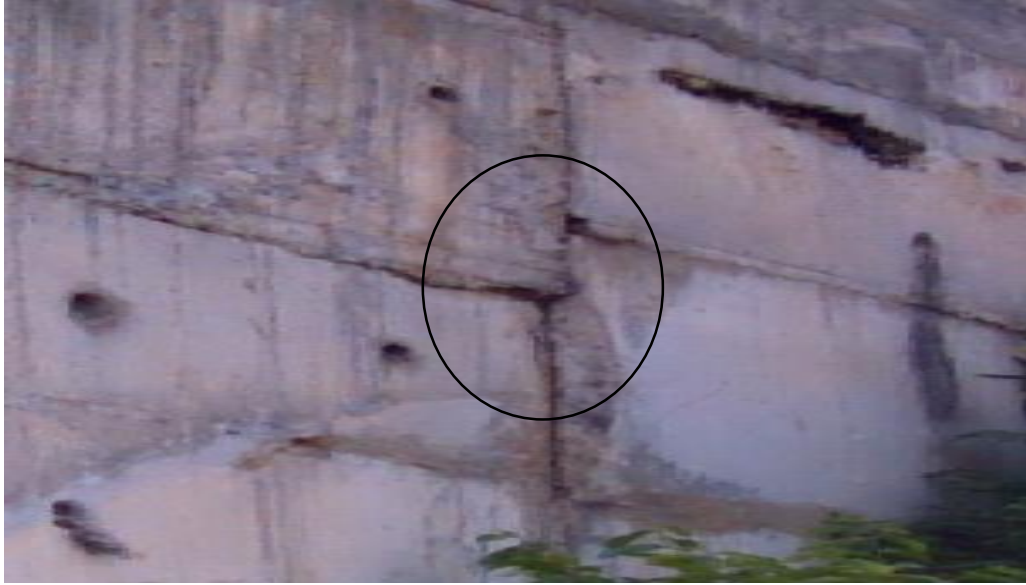
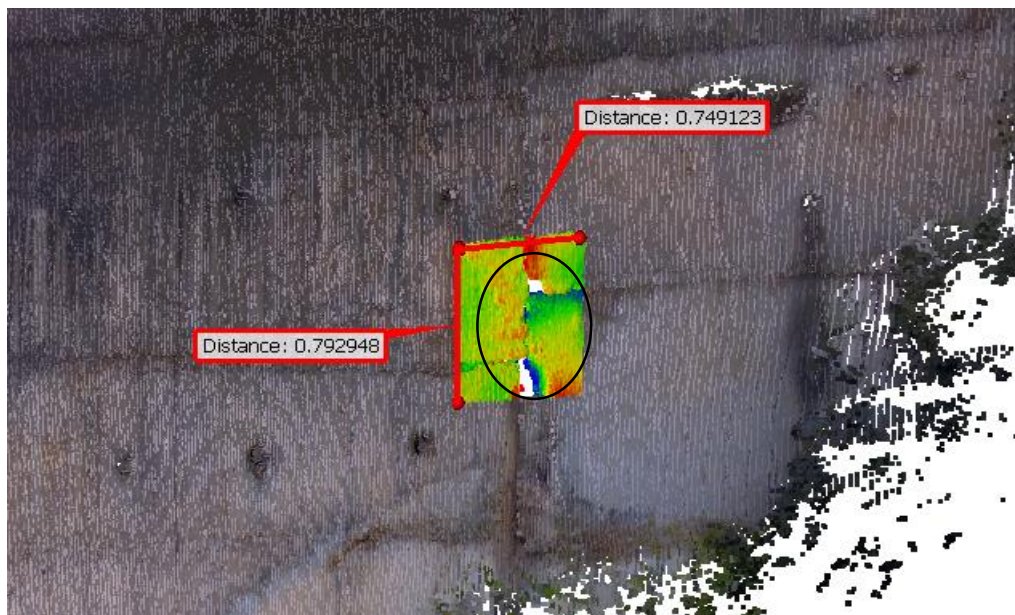
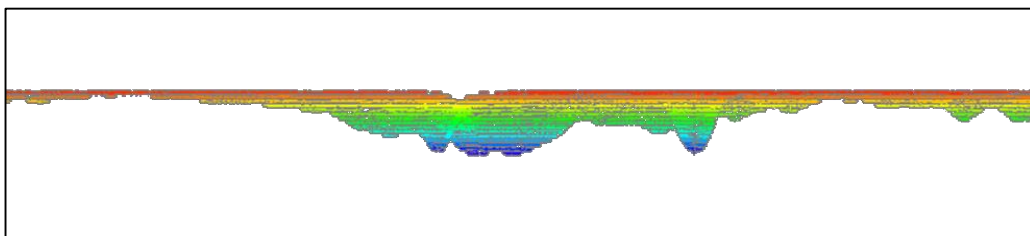
| Element Name | Observation | Location of Distress | Photo No. | Units | Distress Details | | | Area of Repair (Sq.m/R MT/m3) |
|---|---|---|---|---|---|---|---|---|
| Abutment 2 | Scaling | | 1 | M | 0.79 | 0.74 | | 0.5846 |

**1. Scaling observed on Abutment 2 RHS , measuring 0.79 m in length and 0.74 m in width, covering an area of 0.5846 m<sup>2</sup>.**

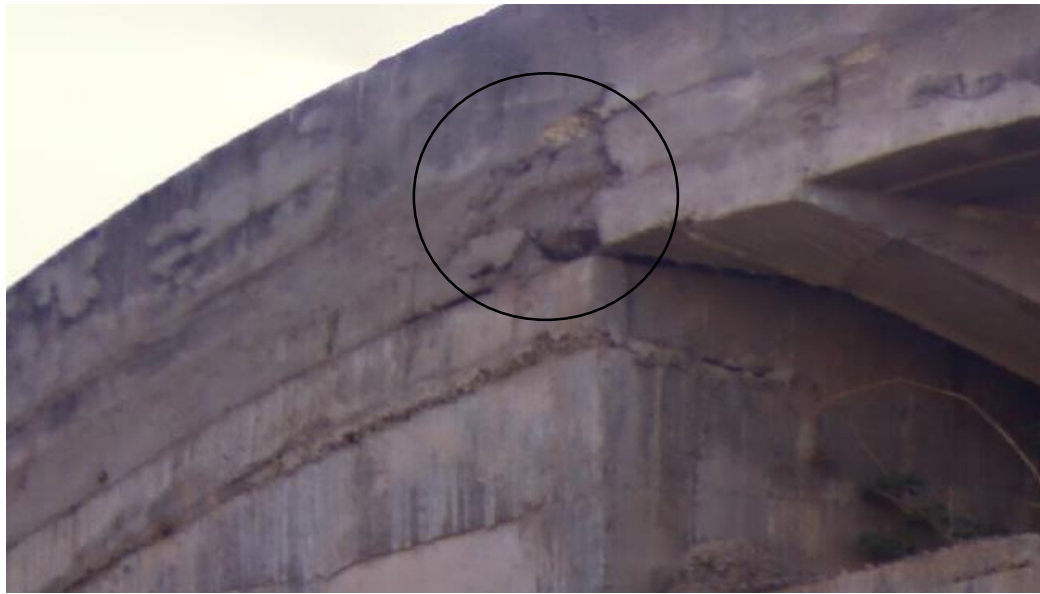
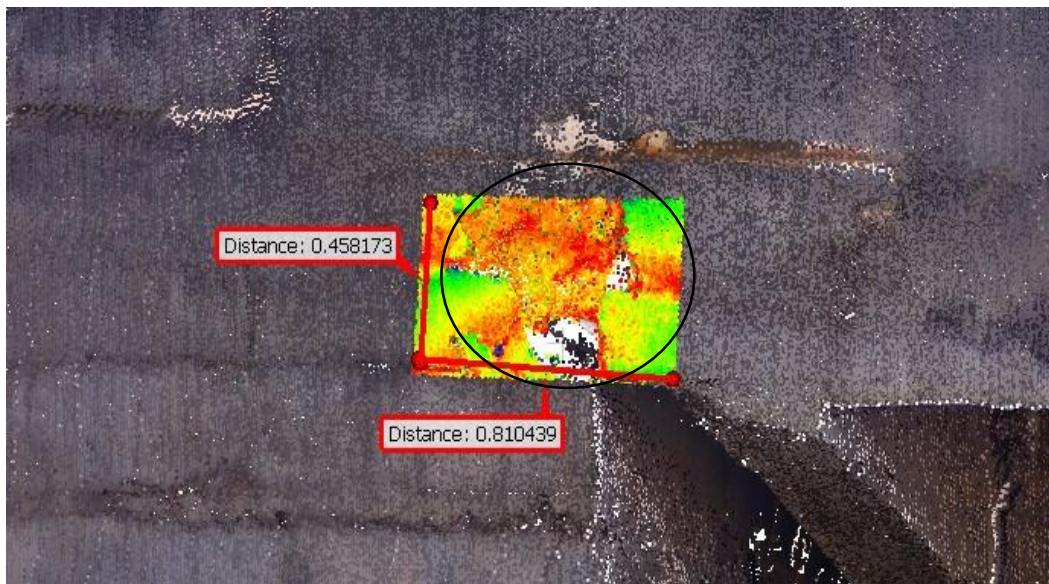
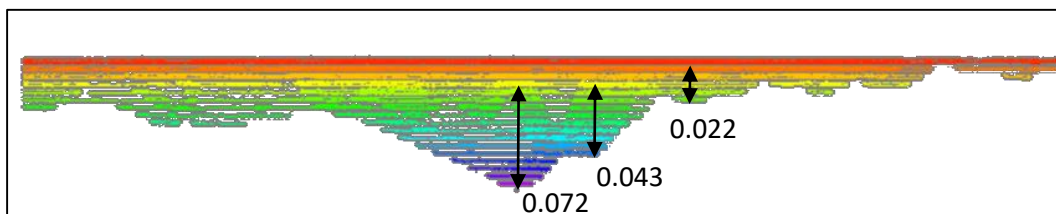
| Element Name | Observation | Location of Distress | Photo No. | Units | Distress Details | | | Area of Repair (Sq.m/R MT/m3) |
|---|---|---|---|---|---|---|---|---|
| Dirt Wall | Damage | | 2 | M | 0.81 | 0.45 | 0.043 | 0.0156 |

**2. Damage observed on Abutment 1 RHS Dirt Wall, measuring 0.81 m in length and 0.45 m in width, Depth ranges from 0.022 m (min) to 0.072 m (max), with an average depth of 0.043 m. The calculated volume of the distress is 0.0156 m<sup>3</sup>.**

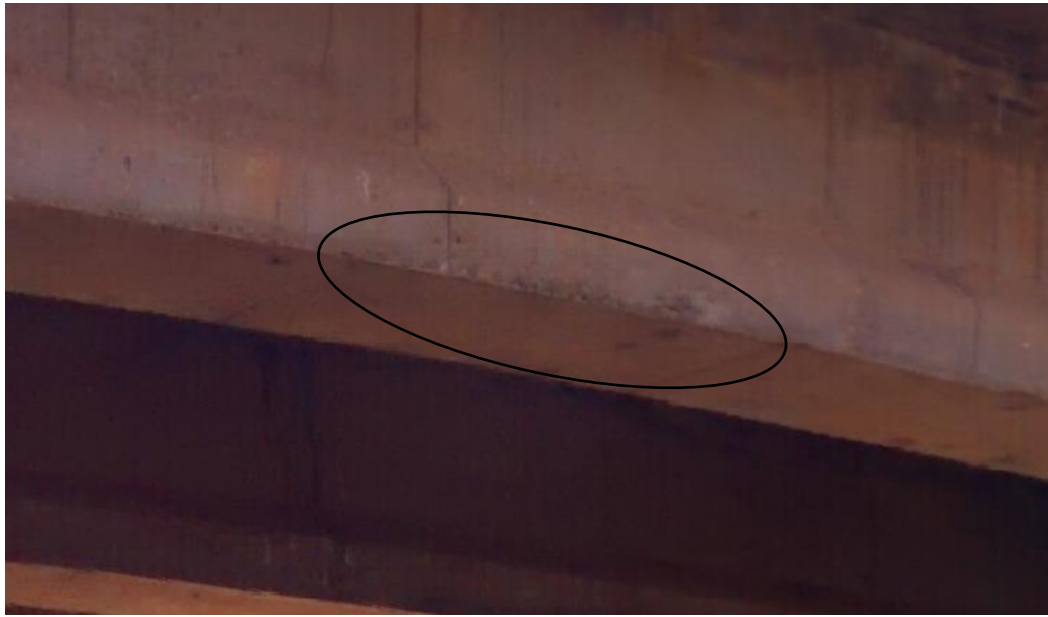
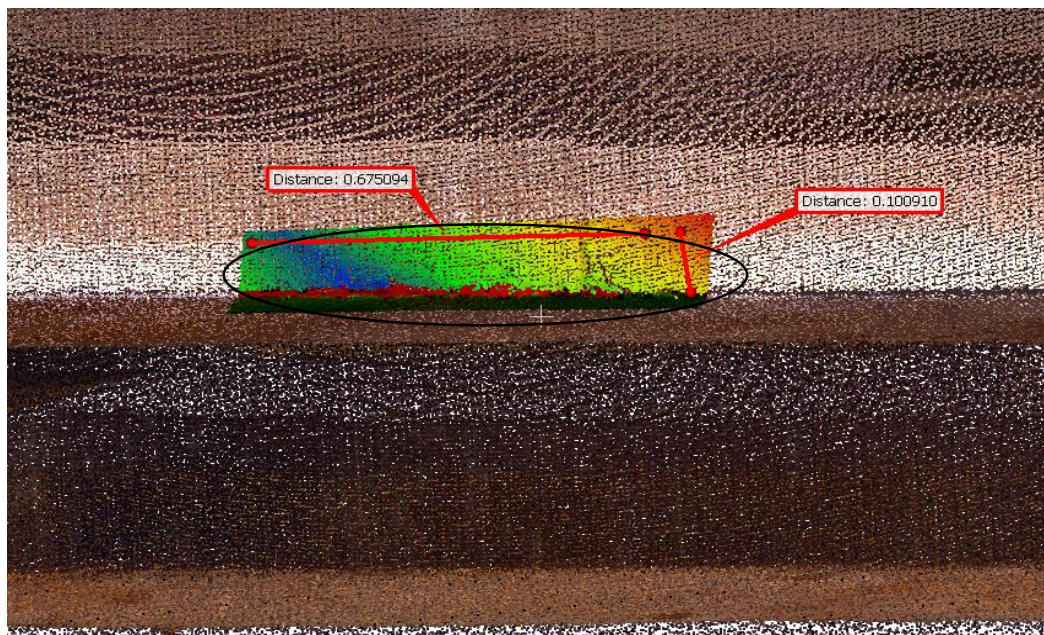
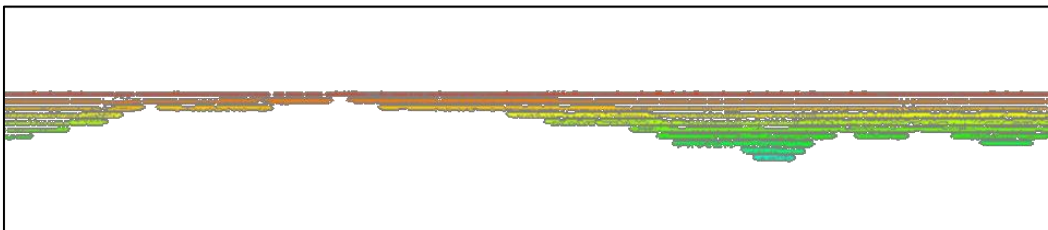
| Element Name | Observation | Location of Distress | Photo No. | Units | Distress Details | | | Area of Repair (Sq.m/R MT/m3) |
|---|---|---|---|---|---|---|---|---|
| Girder | Scaling | | 3 | M | 0.67 | 0.10 | | 0.0670 |

**3. Scaling observed on Girder, measuring 0.67 m in length and 0.10 m in width, covering an area of 0.0670 m<sup>2</sup>**
