# **LIDAR Inspection Report of Box Culvert ch.902+050**

**Bridge Chainage:** 902+050

- **Bridge No:** -
- **Chainage:** 902+050
- **Structure type:** Box Culvert

- **CKRP:** Chittorgarh to kota
- **State:** Rajasthan NH 27
- **Zone:** RJ-20

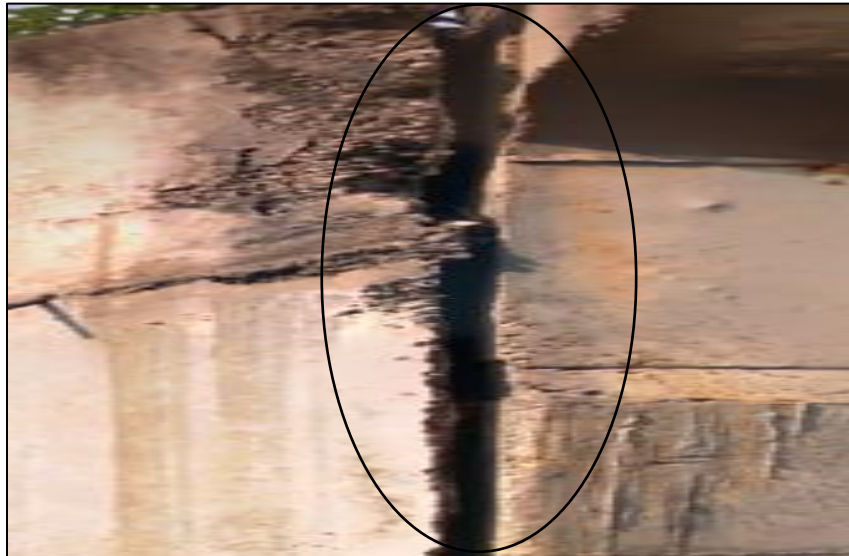
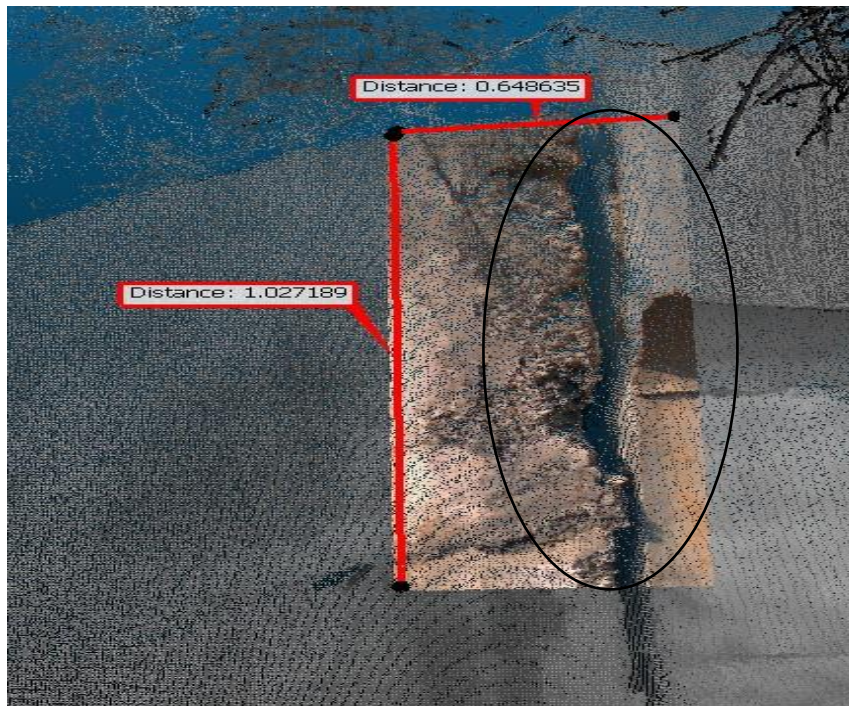
| Element Name | Observation | Location of Distress | Photo No. | Units | Distress Details | | | Area of Repair<br>(Sq.m/R MT/m3) |
|---|---|---|---|---|---|---|---|---|
| Abutment 2 | Hollow Pocket | - | 1 | Sq m | 0.38 | 0.36 | - | 0.1368 |

**1.Hollow pocket observed on LHS A1 HP 8, measuring 0.38 m in length and 0.36 m in width, covering an area of 0.1368 m<sup>2</sup>.**
