# LIDAR Inspection Report of **Box Culvert** ch.902+708

**Bridge Chainage:** 902+708 (CKRP)

- **CKRP:** Chittorgarh to kota
- **State:** Rajasthan NH 27
- **Zone:** RJ-06

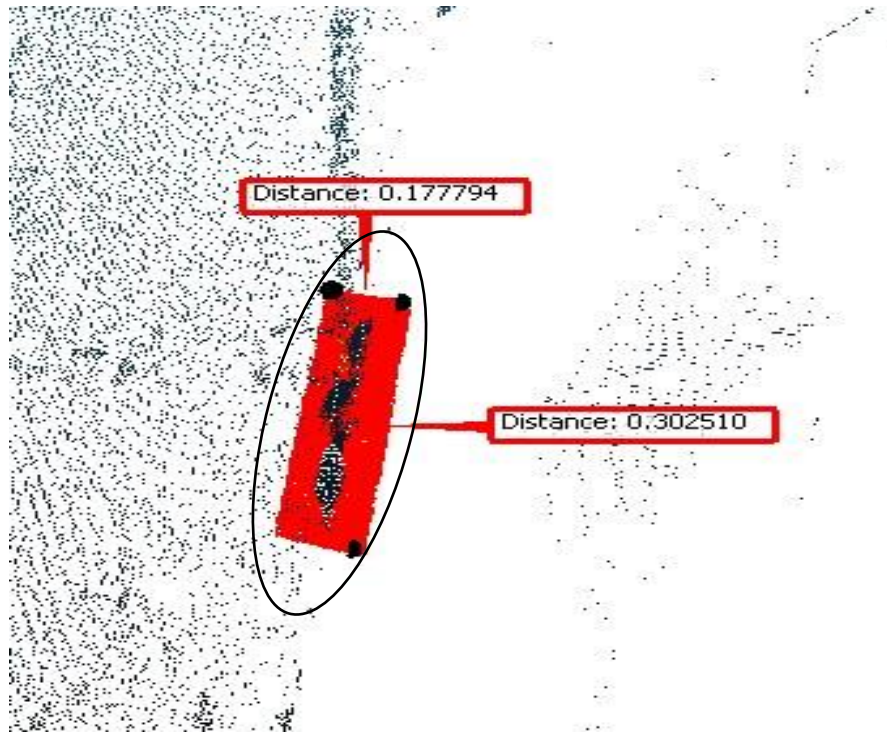
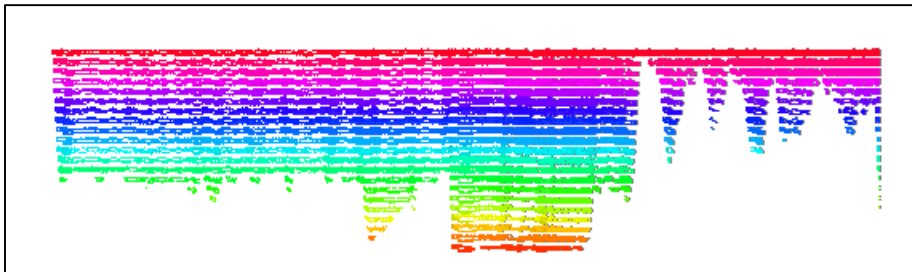
| Element Name | Observation | Location of Distress | Photo No. | Units | Distress Details | | | Area of Repair (Sq.m/ RMT/ m3) |
|---|---|---|---|---|---|---|---|---|
| Wing Wall | Damage | - | 1 | M | 0.17 | 0.0.30 | | 0.051 |

1. "Wing wall joint damage observed, measuring 0.17 m in length and 0.30 m in width, covering an area of 0.051 m<sup>2</sup>."

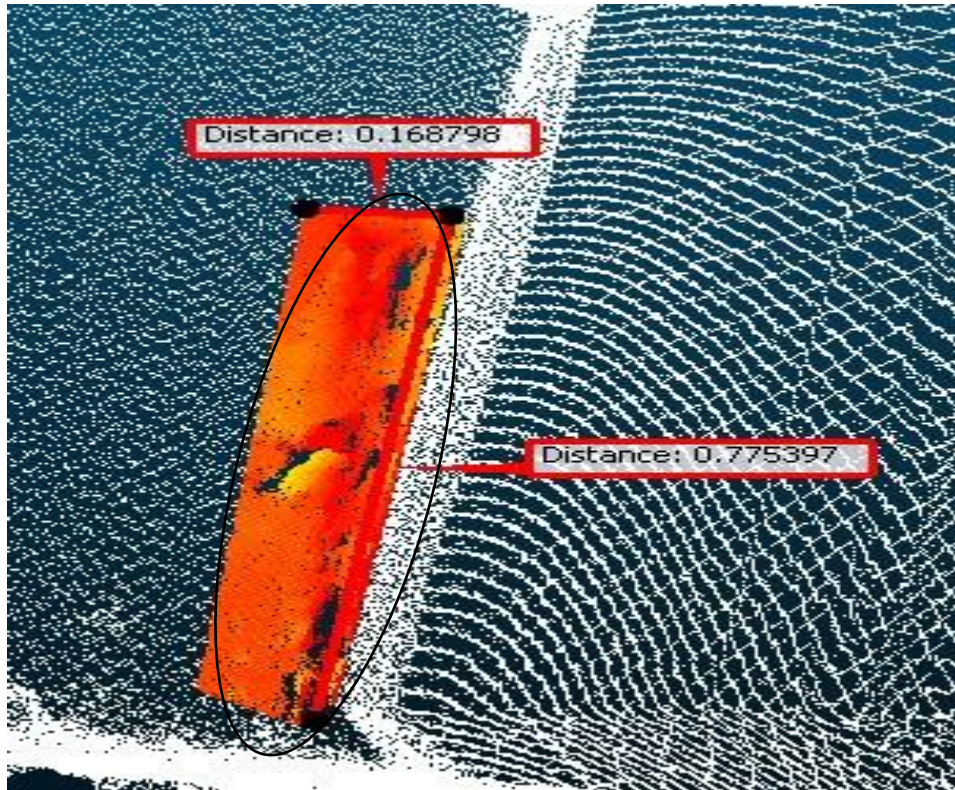
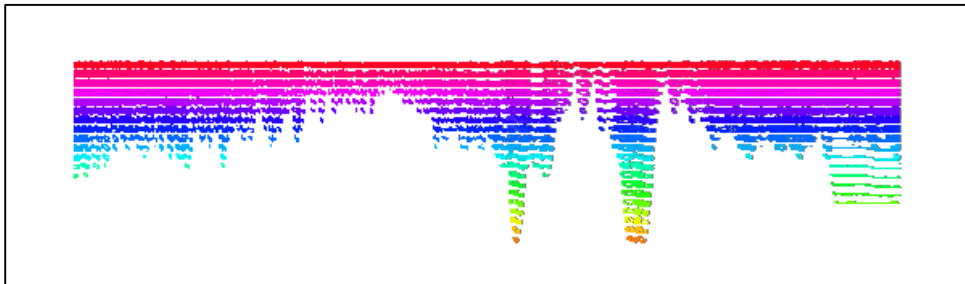
| Element Name | Observation | Location of Distress | Photo No. | Units | Distress Details | | | Area of Repair (Sq.m/ RMT/ m3) |
|---|---|---|---|---|---|---|---|---|
| Wing Wall | Damage | - | 2 | M | 0.16 | 0.77 | | 0.1232 |

**2."Wing wall joint damage observed, measuring 0.16 m in length and 0.77 m in width, covering an area of 0.1232 m<sup>2</sup>."**

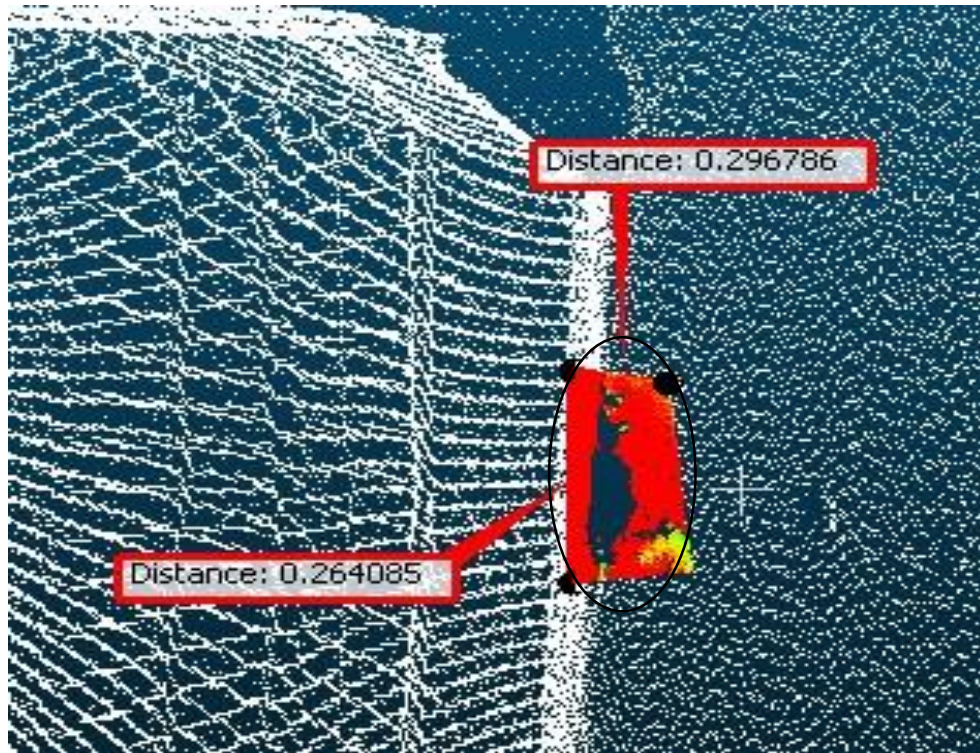
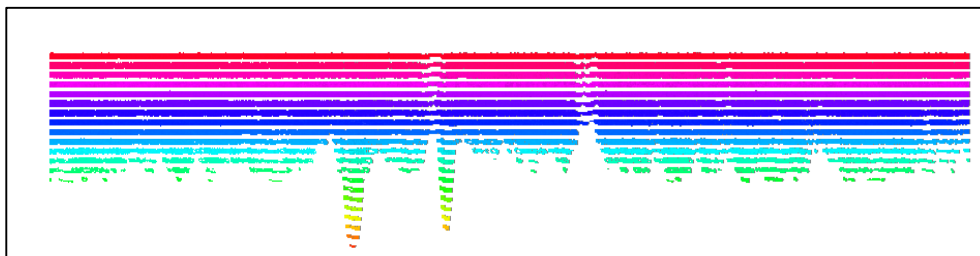
| Element Name | Observation | Location of Distress | Photo No. | Units | Distress Details | | | Area of Repair (Sq.m/ RMT/ m3) |
|---|---|---|---|---|---|---|---|---|
| Wing Wall | Damage | - | 3 | M | 0.29 | 0.26 | | 0.075 |

**3."Wing wall joint damage observed, measuring 0.29 m in length and 0.26 m in width, covering an area of 0.075 m<sup>2</sup>."**

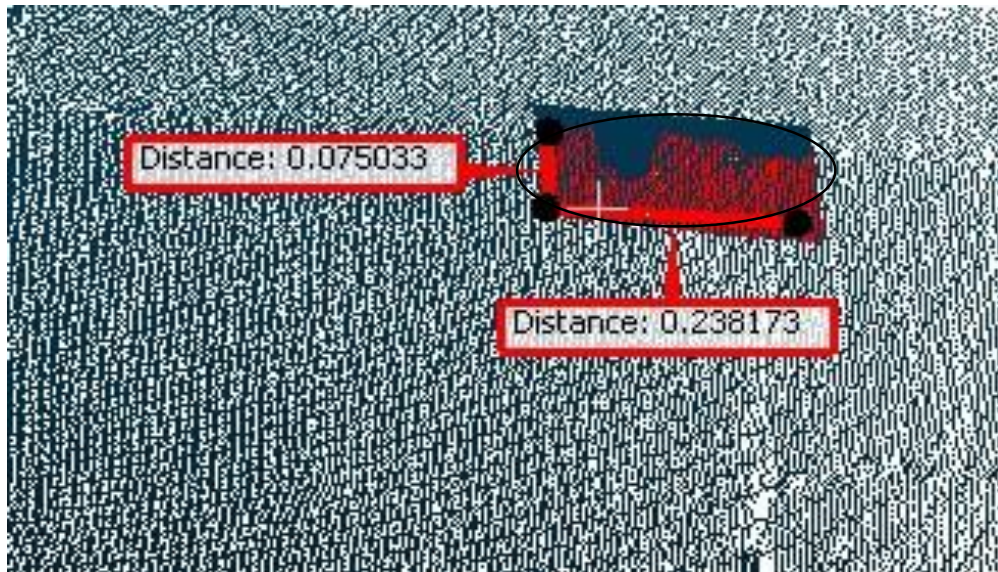
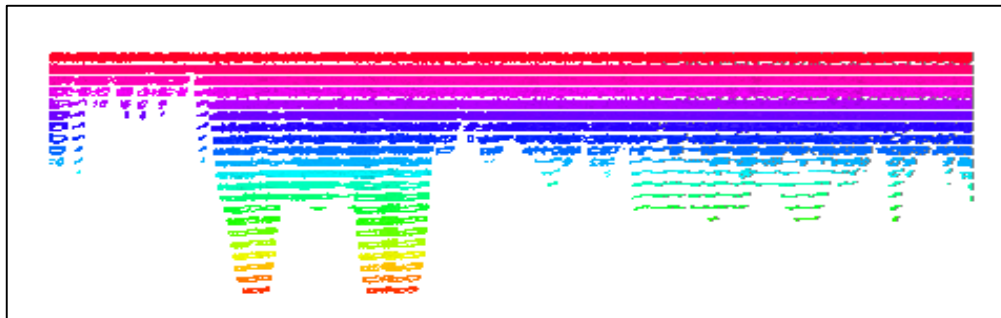
| Element Name | Observation | Location of Distress | Photo No. | Units | Distress Details | | | Area of Repair (Sq.m/ RMT/ m3) |
|---|---|---|---|---|---|---|---|---|
| Abutment Wall | Damage | - | 4 | M | 0.23 | 0.07 | | 0.016 |

**4. "Abutment wall damage observed, measuring 0.23 m in length and 0.07 m in width, covering an area of 0.016 m<sup>2</sup>."**
