# LIDAR Inspection Report of **Box Culvert** ch.904+710

**Bridge Chainage:** 904+710 (CKRP)

- **Bridge No:** -
- **Chainage:** 904+710
- **Structure type:** Box Culvert

- **CKRP:** Chittorgarh to kota
- **State:** Rajasthan NH 27
- **Zone:** RJ-06

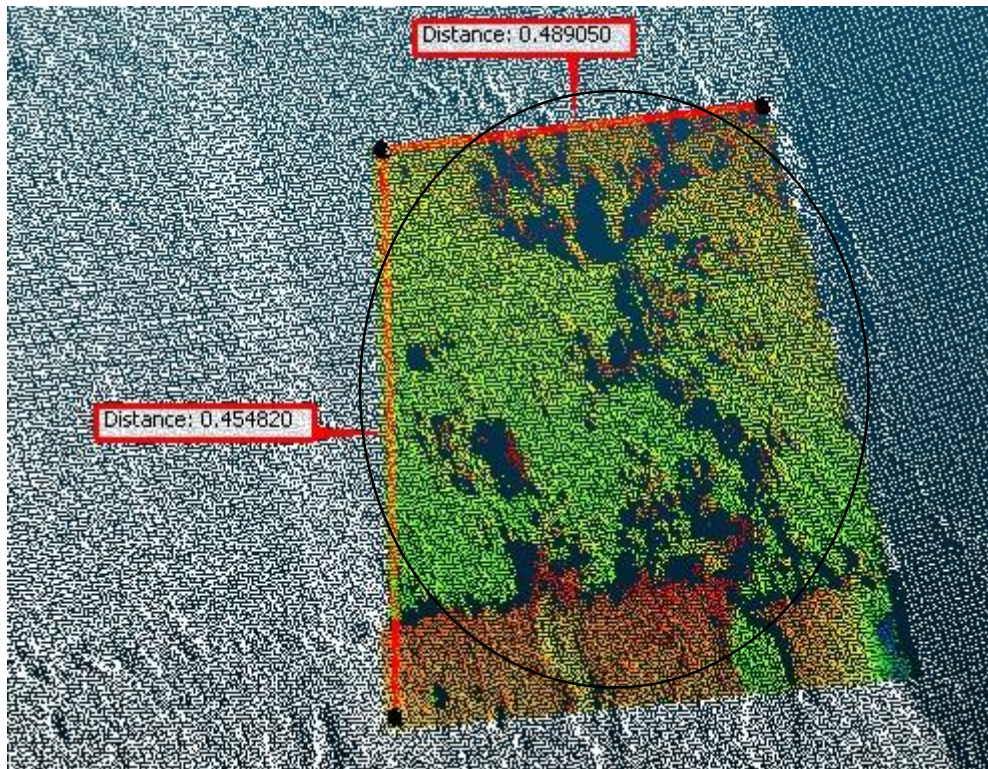
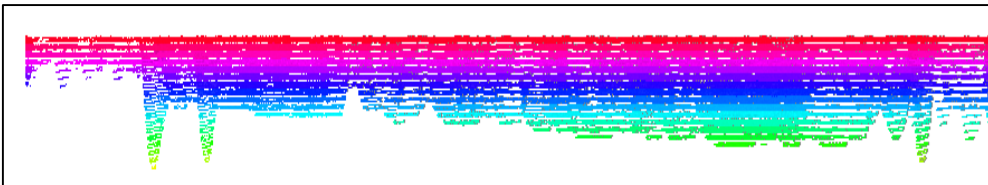
| Element Name | Observation | Location of Distress | Photo No. | Units | Distress Details | | | Area of Repair (Sq.m/ RMT/ m3) |
|---|---|---|---|---|---|---|---|---|
| Abutment Wall | Scaling | - | 1 | M | 0.48 | 0.45 | | 0.216 |

**1. "Scaling observed on LHS Abutment Wall at A1, measuring 0.48 m in length and 0.45 m in width, covering an area of 0.216 m<sup>2</sup>."**

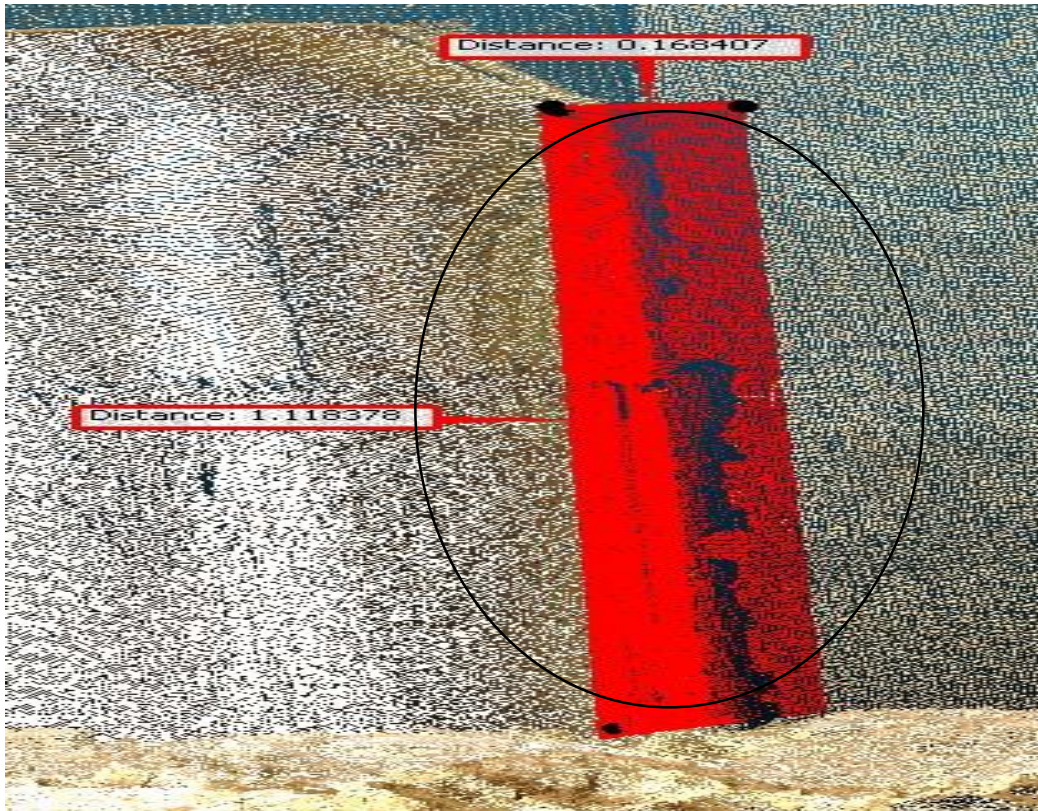
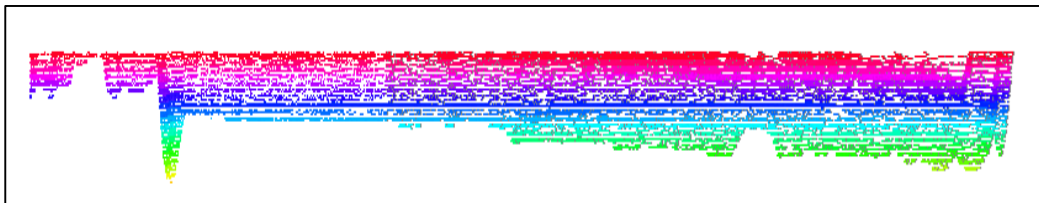
| Element Name | Observation | Location of Distress | Photo No. | Units | Distress Details | | | Area of Repair (Sq.m/ RMT/ m3) |
|---|---|---|---|---|---|---|---|---|
| Wing Wall | Damage | - | 2 | M | 0.16 | 1.11 | | 0.177 |

**2. "Wing Wall damage observed, measuring 0.16 m in length and 1.11 m in width, covering an area of 0.177 m<sup>2</sup>."**

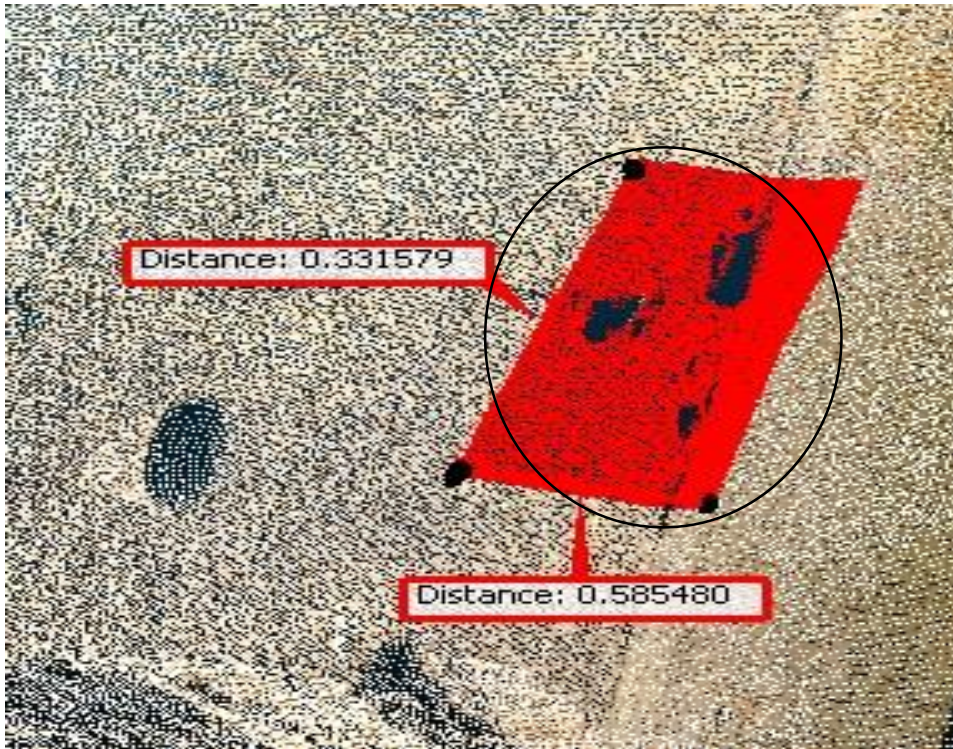
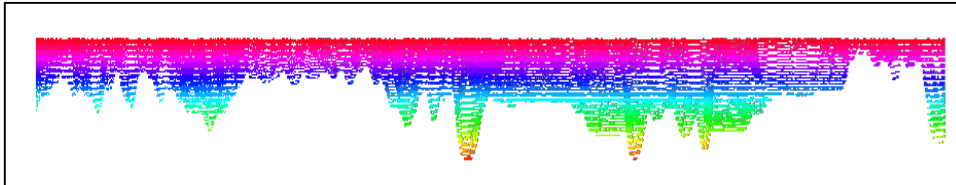
| Element Name | Observation | Location of Distress | Photo No. | Units | Distress Details | | | Area of Repair (Sq.m/ RMT/ m3) |
|---|---|---|---|---|---|---|---|---|
| Wing Wall | Damage | - | 3 | M | 0.33 | 0.58 | | 0.1914 |

**3. "Wing wall damage observed, measuring 0.33 m in length and 0.58 m in width, covering an area of 0.191 m<sup>2</sup>."**

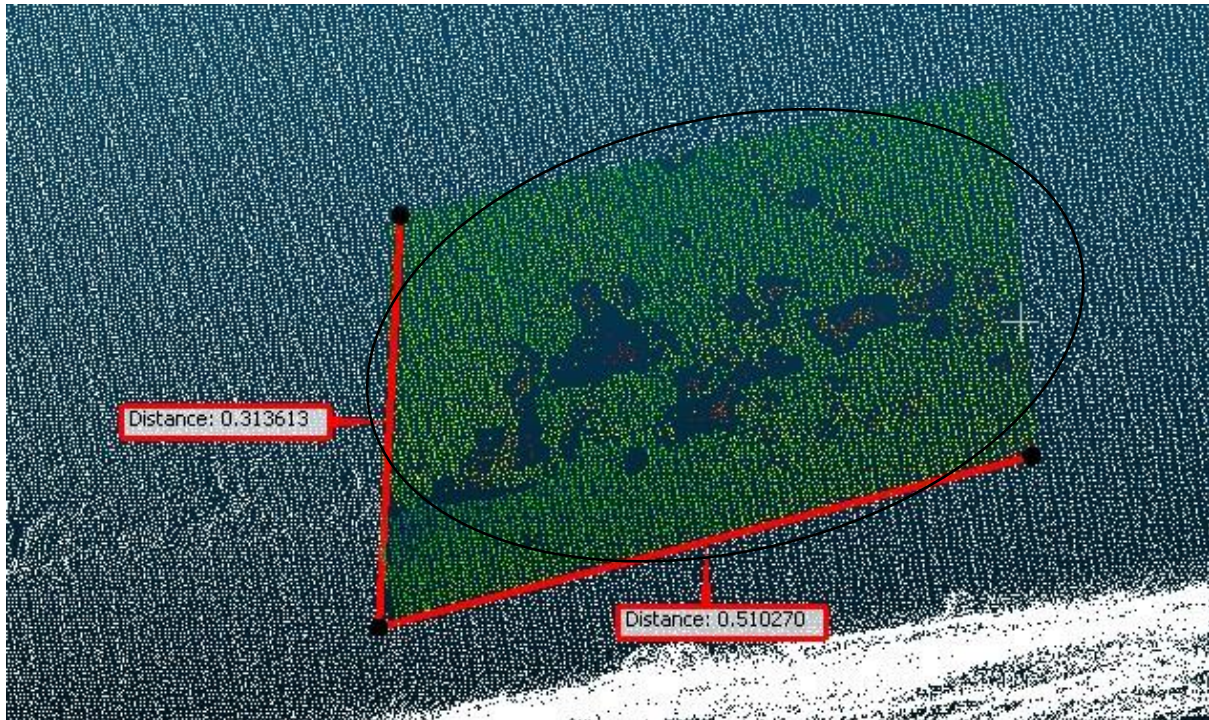
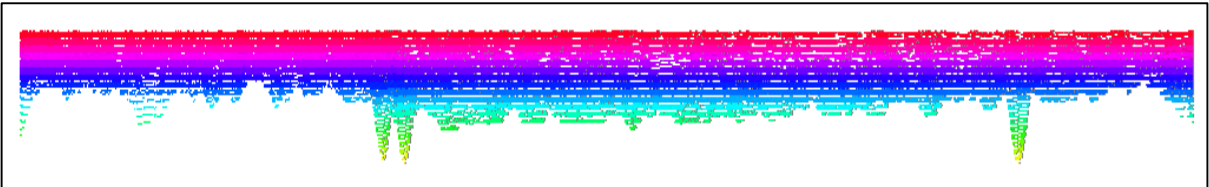
| Element Name | Observation | Location of Distress | Photo No. | Units | Distress Details | | | Area of Repair (Sq.m/ RMT/ m3) |
|---|---|---|---|---|---|---|---|---|
| Abutment Wall | Scaling | - | 4 | M | 0.51 | 0.31 | | 0.1581 |

**4. "Scaling observed on Abutment Wall, measuring 0.51 m in length and 0.31 m in width, covering an area of 0.158 m<sup>2</sup>."**

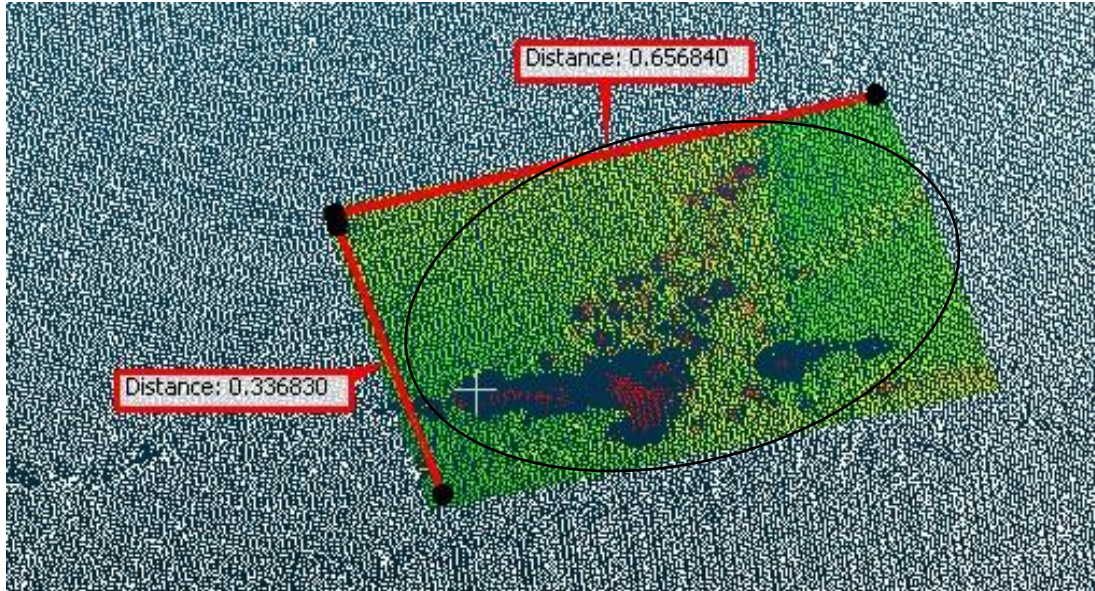
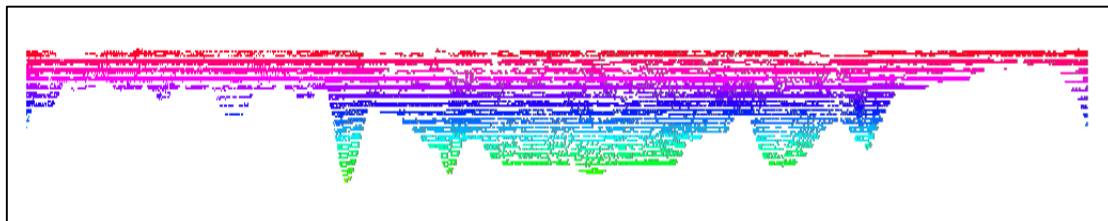
| Element Name | Observation | Location of Distress | Photo No. | Units | Distress Details | | | Area of Repair (Sq.m/ RMT/ m3) |
|---|---|---|---|---|---|---|---|---|
| Abutment Wall | Scaling | - | 5 | M | 0.65 | 0.33 | | 0.214 |

5. "Scaling observed on Abutment Wall, measuring 0.65 m in length and 0.33 m in width, covering an area of 0.214 m<sup>2</sup>."

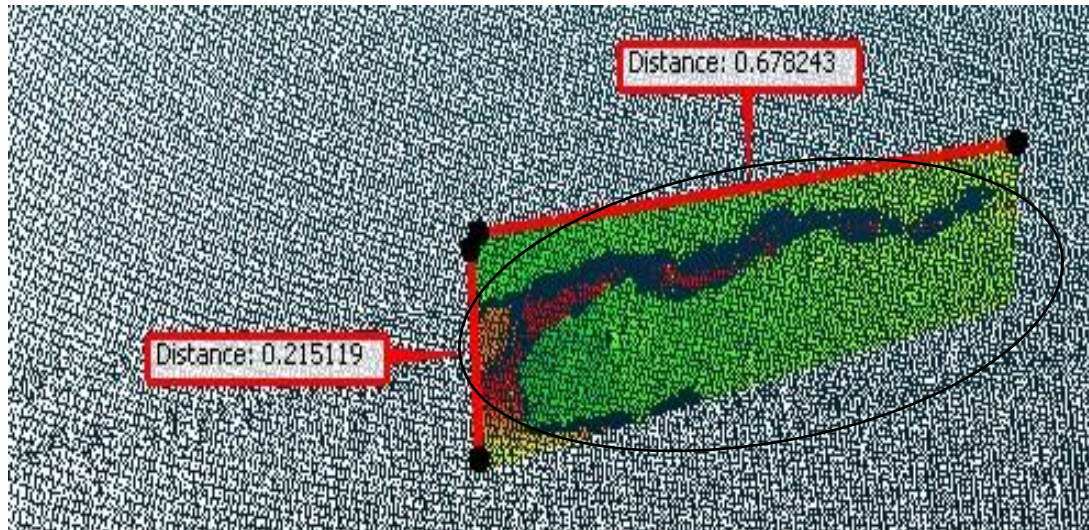
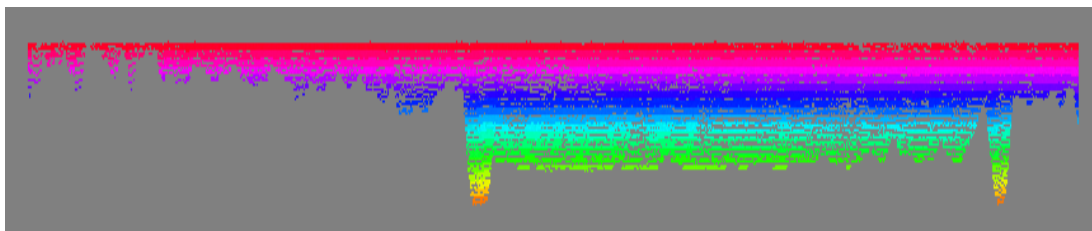
| Element Name | Observation | Location of Distress | Photo No. | Units | Distress Details | | | Area of Repair (Sq.m/ RMT/ m3) |
|---|---|---|---|---|---|---|---|---|
| Abutment Wall | Damage | - | 6 | M | 0.67 | 0.21 | | 0.140 |

**6. "Damage observed on Abutment Wall, measuring 0.67 m in length and 0.21 m in width, covering an area of 0.140 m<sup>2</sup>."**

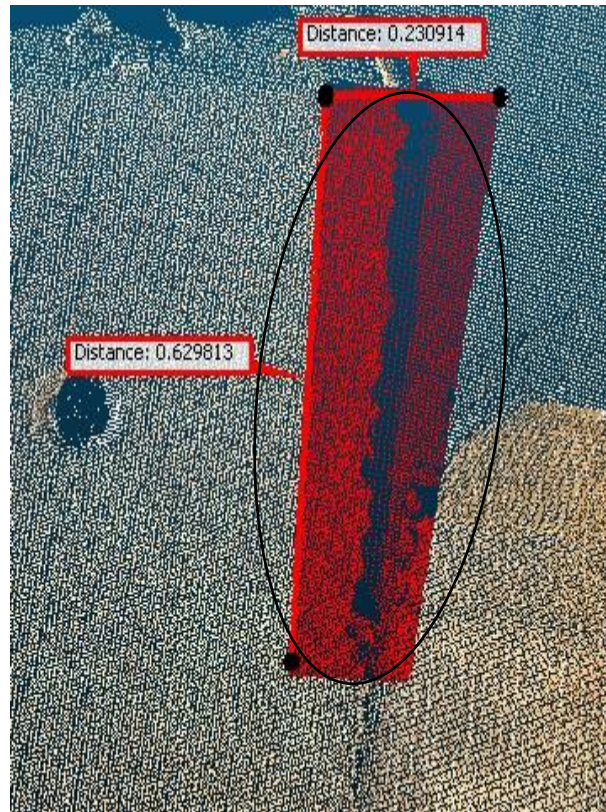
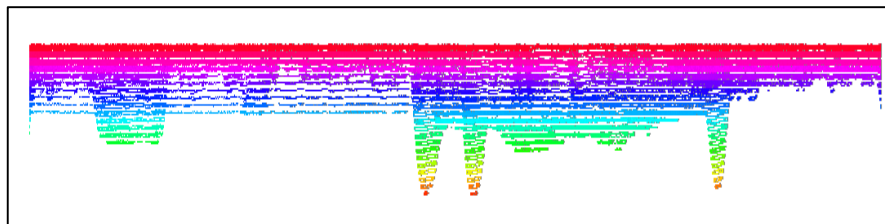
| Element Name | Observation | Location of Distress | Photo No. | Units | Distress Details | | | Area of Repair (Sq.m/ RMT/ m3) |
|---|---|---|---|---|---|---|---|---|
| Wing Wall | Crack | - | 7 | M | 0.23 | 0.62 | | 0.142 |

**7. "Crack observed on Wing Wall, measuring 0.23 m in length and 0.62 m in width, covering an area of 0.143 m<sup>2</sup>."**

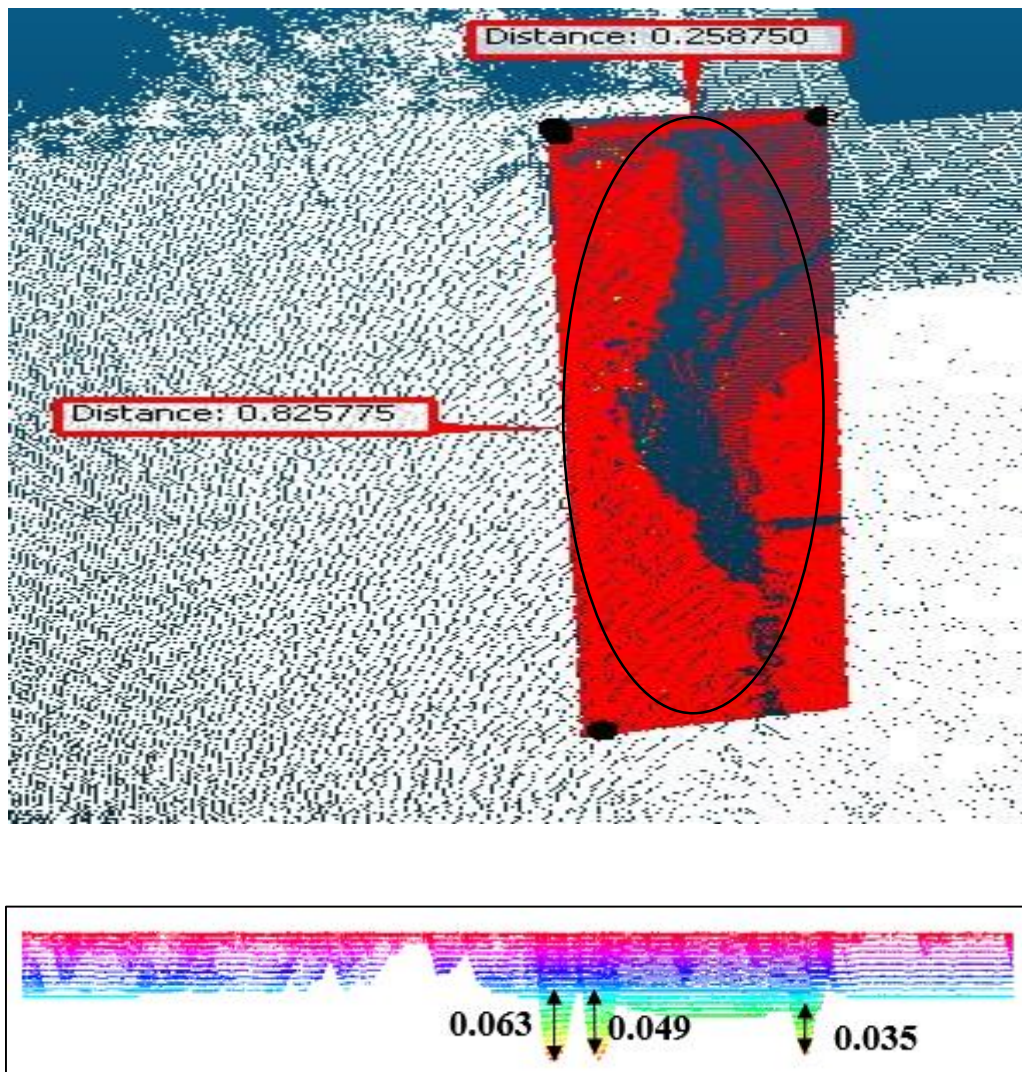
| Element Name | Observation | Location of Distress | Photo No. | Units | Distress Details | | | Area of Repair (Sq.m/ RMT/ m3) |
|---|---|---|---|---|---|---|---|---|
| Wing Wall | Damage | - | 8 | M | 0.25 | 0.82 | 0.049 | 0.010 |

**8. " Damage observed on Wing Wall, measuring 0.25 m in length and 0.82 m in width, Depth ranges from 0.035 m (min) to 0.063 m (max), with an average depth of 0.049 m. The calculated volume of the distress is 0.010 m<sup>3</sup>.**

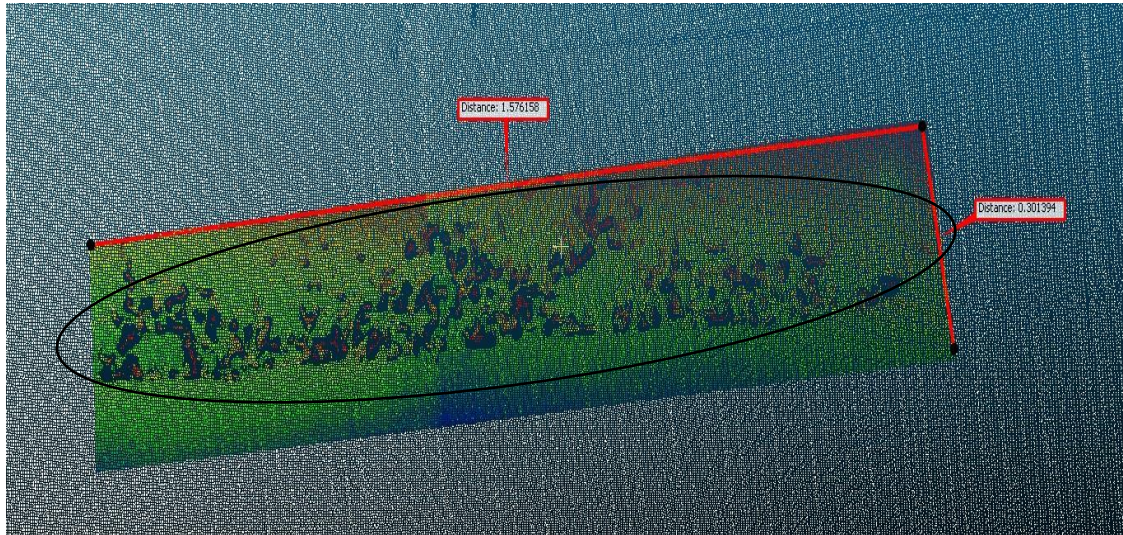
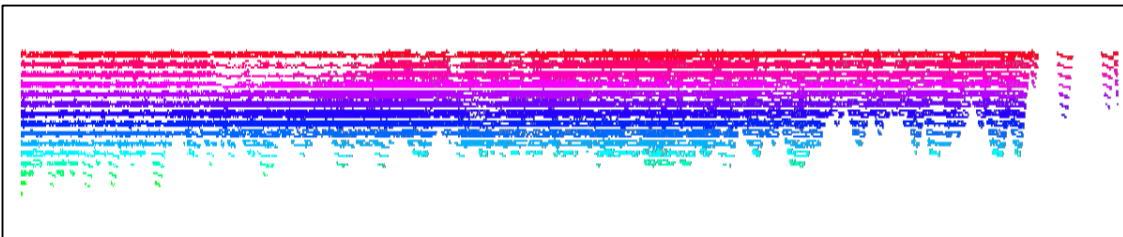
| Element Name | Observation | Location of Distress | Photo No. | Units | Distress Details | | | Area of Repair (Sq.m/ RMT/ m3) |
|---|---|---|---|---|---|---|---|---|
| Abutment Wall | Scaling | - | 9 | M | 1.57 | 0.30 | | 0.471 |

**9. "Scaling observed on Abutment Wall, measuring 1.57 m in length and 0.30 m in width, covering an area of 0.471 m<sup>2</sup>."**
