# **LIDAR Inspection Report of MNB ch.905+300**

**Bridge No:** MNB -906/3

**Bridge Chainage:** 905+300 (CKRP)

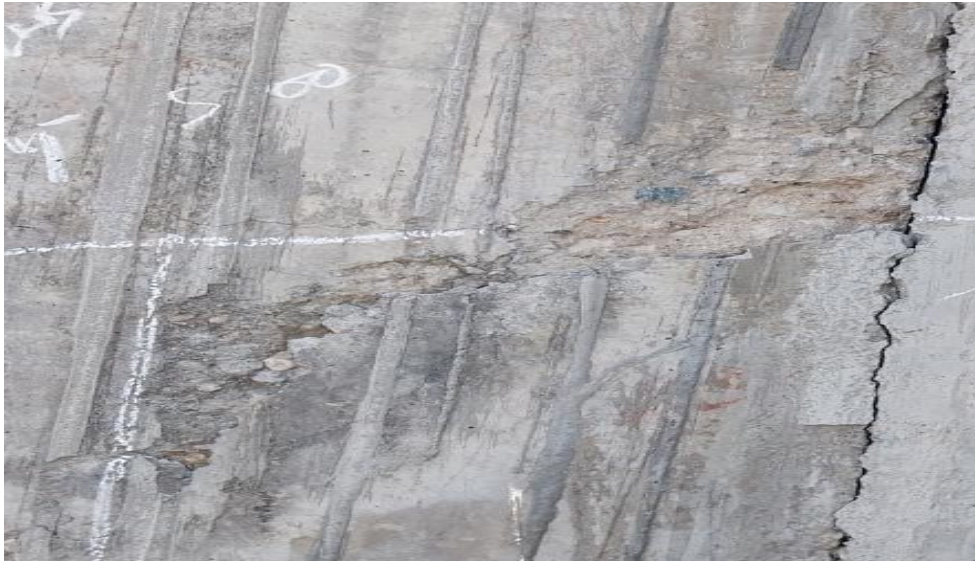
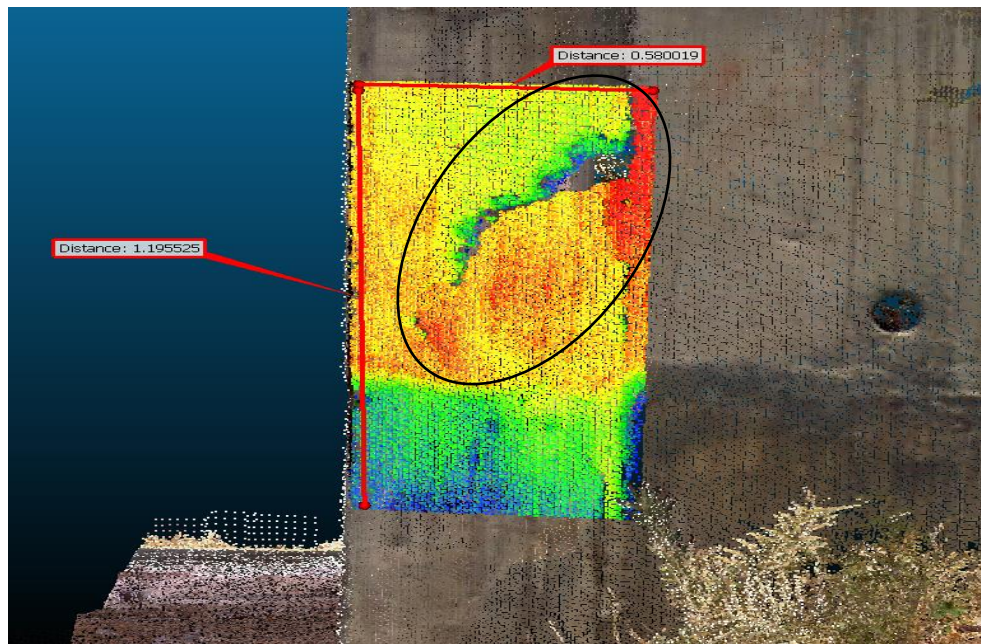
| Element Name | Observation | Location of Distress | Photo No. | Units | Distress Details | | | Area of Repair (Sq./RM T/m3) |
|---|---|---|---|---|---|---|---|---|
| Abutment 1 | Hollow Section | | 1 | | 1.19 | 0.58 | 0.029 | 0.020 |

**1. Hollow section observed on LHS Abutment 1, measuring 1.19 m in length and 0.58 m in width. Depth ranges from 0.019 m (min) to 0.049 m (max), with an average depth of 0.029 m. The calculated volume of the distress is 0.0200 m<sup>3</sup>.**

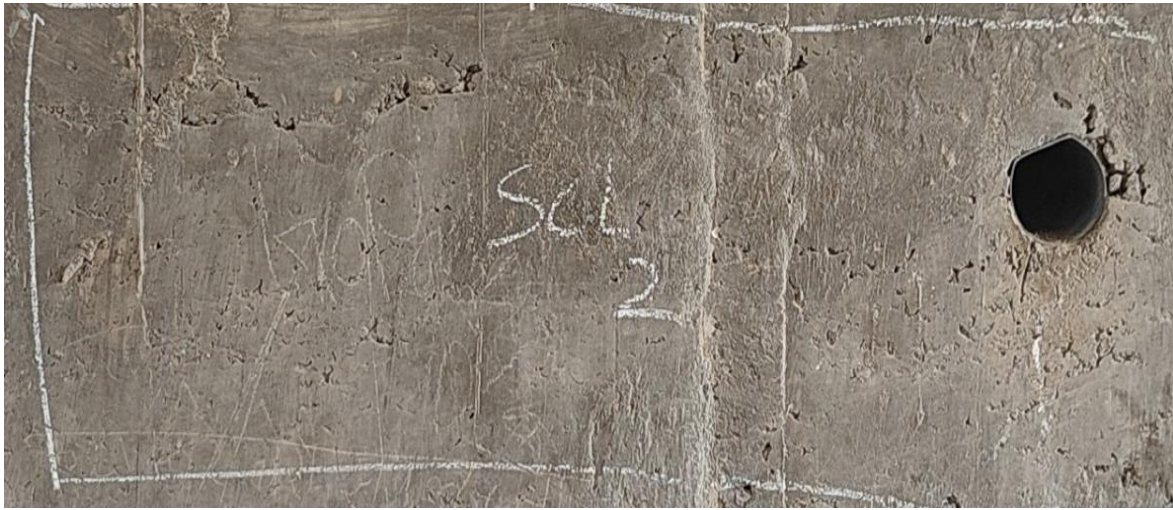
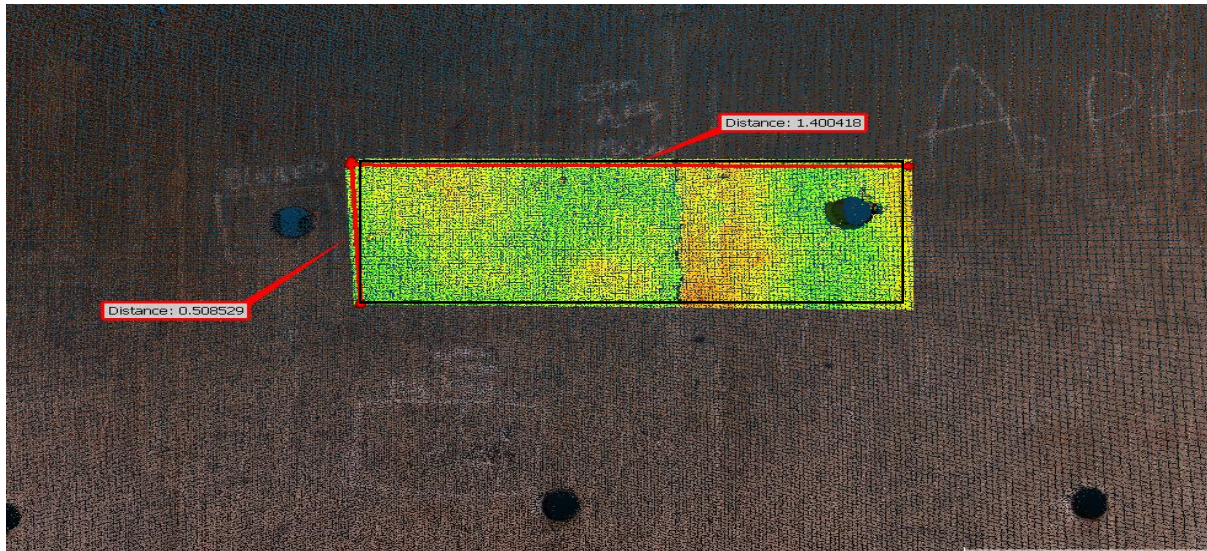
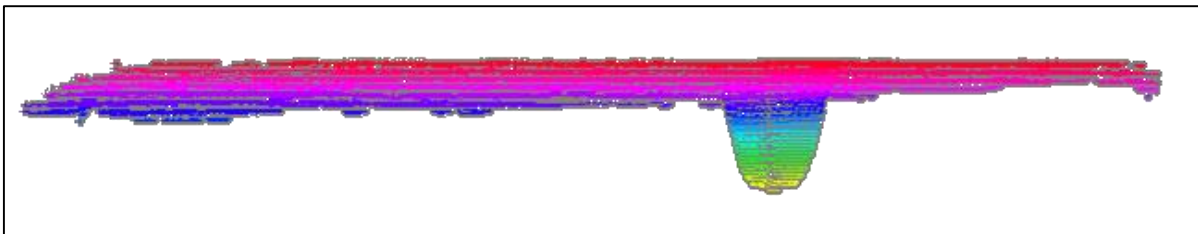
| Element Name | Observation | Location of Distress | Photo No. | Units | Distress Details | | | Area of Repair (Sq./RM T) |
|---|---|---|---|---|---|---|---|---|
| Abutment 2 | Scaling | | 2 | | 1.40 | 0.50 | | 0.70 |

**2. Scaling observed on RHS abutment 2, measuring 1.40 m in length and 0.50 m in width, covering an area of 0.70 m<sup>2</sup>.**

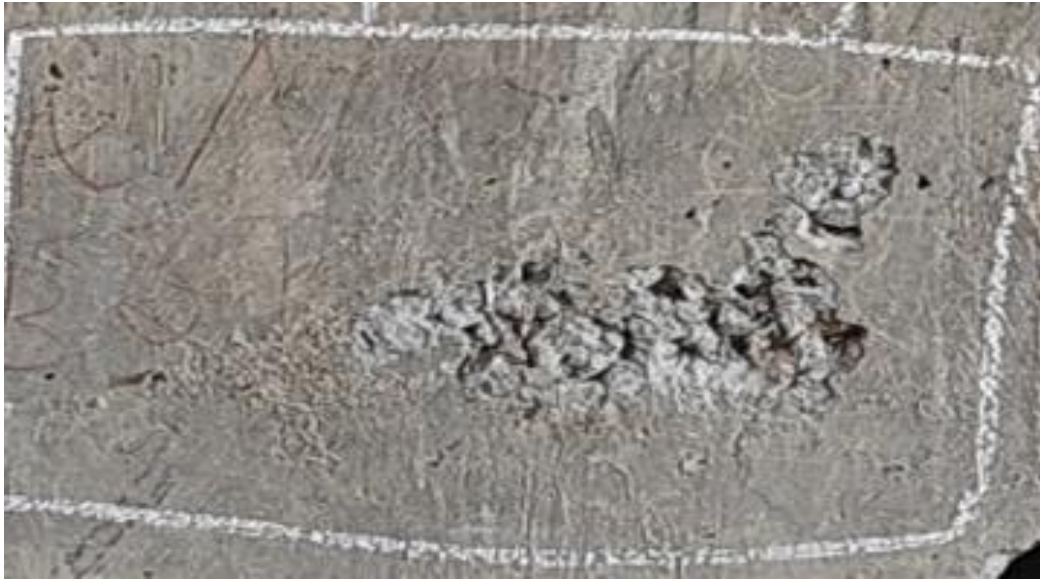
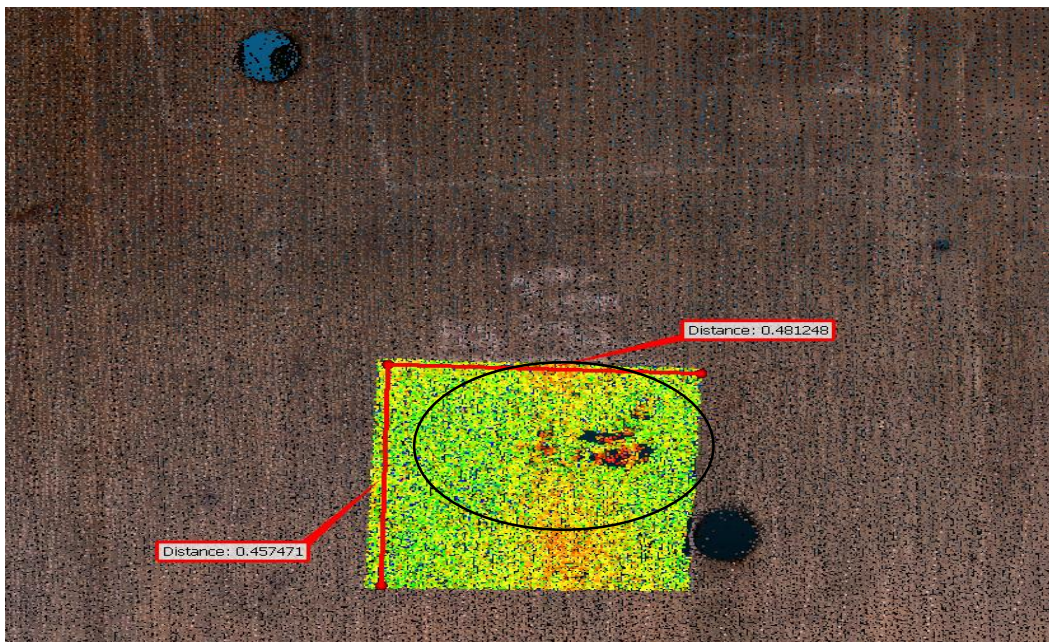
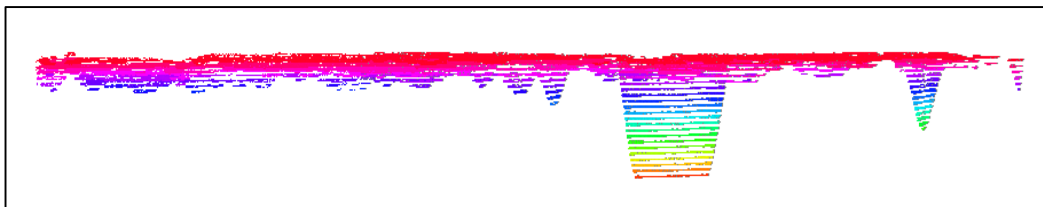
| Element Name | Observation | Location of Distress | Photo No. | Units | Distress Details | | | Area of Repair (Sq./RM T) |
|---|---|---|---|---|---|---|---|---|
| Abutment2 | Hollow Section | | 3 | | 0.48 | 0.45 | | 0.216 |

**3. Scaling observed on RHS abutment 2, measuring 0.48 m in length and 0.45 m in width, covering an area of 0.216 m<sup>2</sup>.**

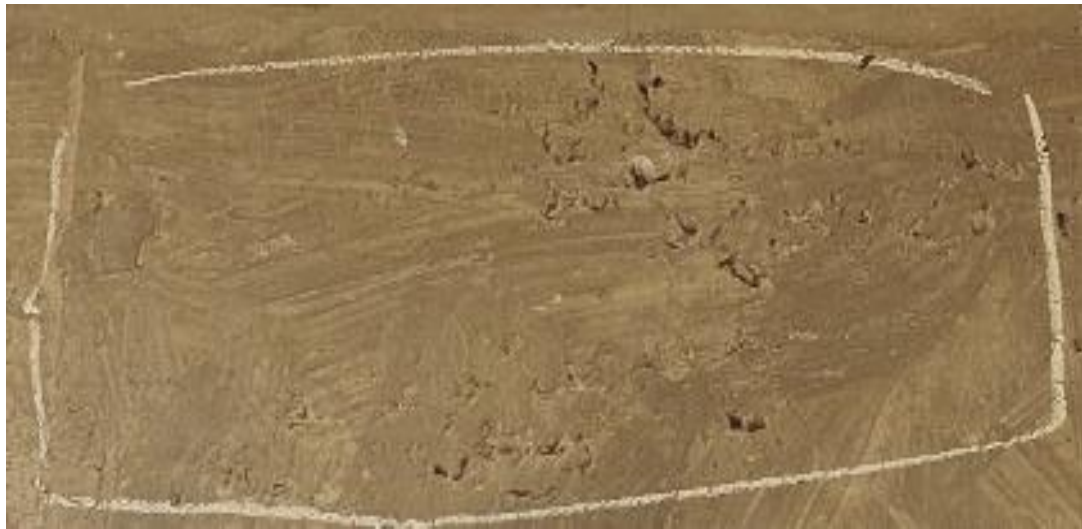
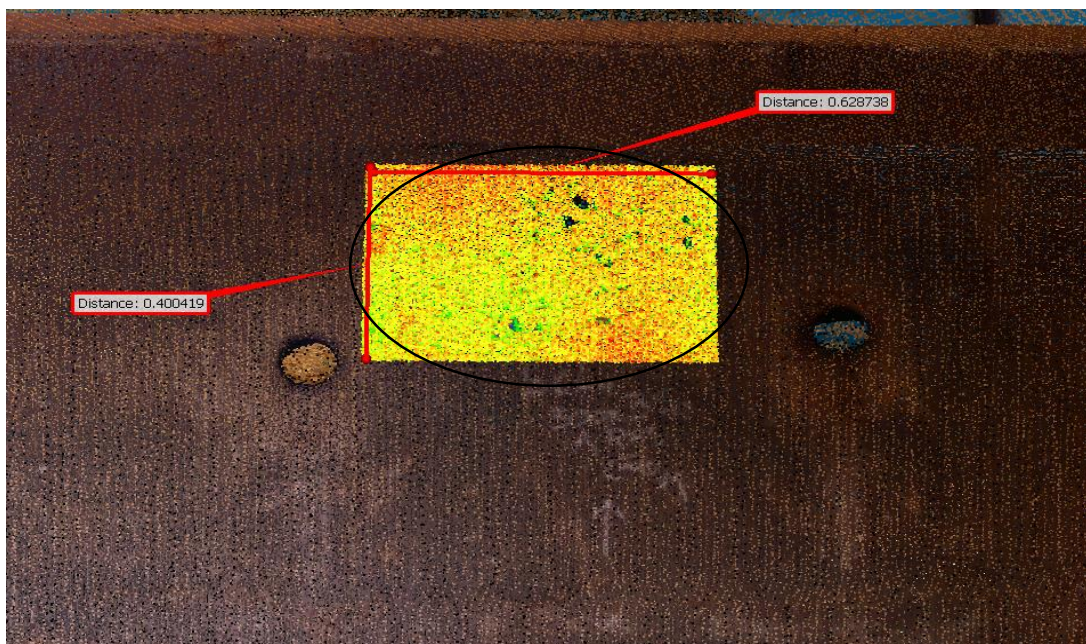
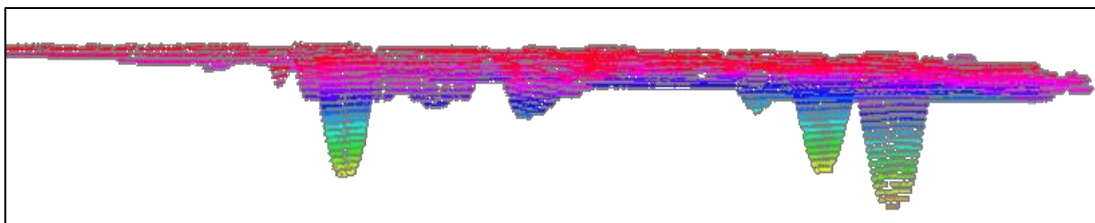
| Element Name | Observation | Location of Distress | Photo No. | Units | Distress Details | | | Area of Repair (Sq./RM T) |
|---|---|---|---|---|---|---|---|---|
| Abutment 2 | Scaling | | 4 | | 0.62 | 0.40 | | 0.248 |

**4. Scaling observed on RHS abutment 2, measuring 0.62 m in length and 0.40 m in width, covering an area of 0.248 m<sup>2</sup>.**
