# LIDAR Inspection Report of **Box Culvert** ch.905+888

**Bridge Chainage:** 905+888 (CKRP)

- **CKRP:** Chittorgarh to kota
- **State:** Rajasthan NH 27
- **Zone:** RJ-06

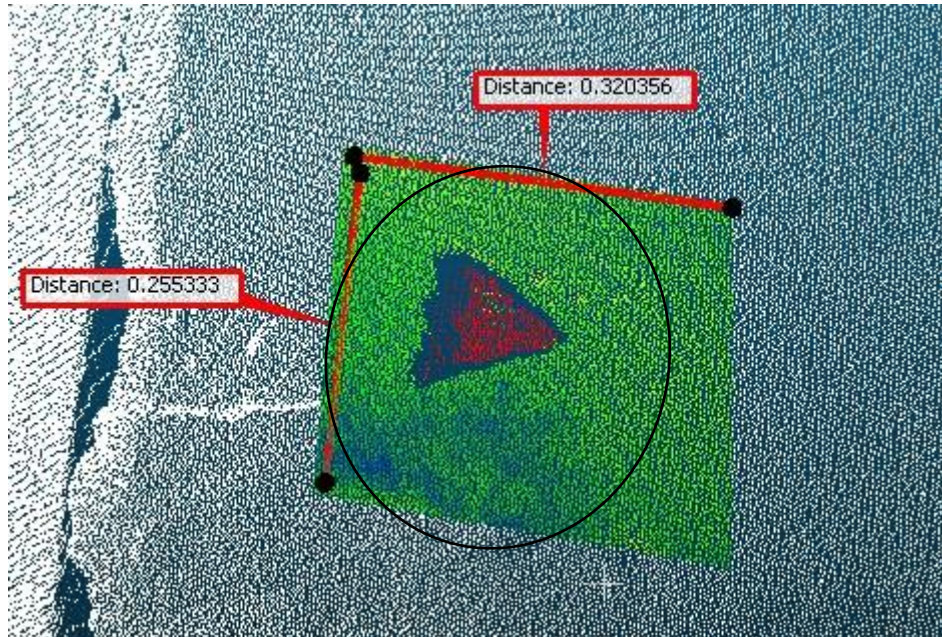
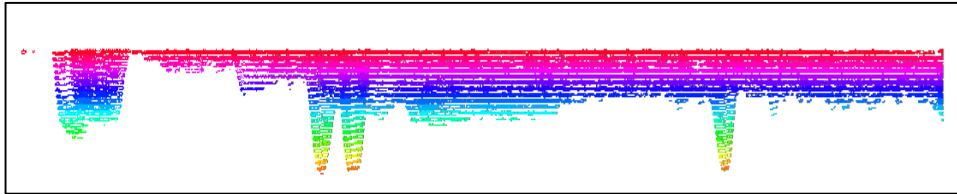
| Element Name | Observation | Location of Distress | Photo No. | Units | Distress Details | | | Area of Repair (Sq.m/ RMT/ m3) |
|---|---|---|---|---|---|---|---|---|
| Wing Wall | Damage | - | 2 | M | 0.32 | 0.25 | | 0.08 |

**2."Damage observed on Wing Wall, measuring 0.32 m in length and 0.25 m in width, covering an area of 0.08 m<sup>2</sup>."**

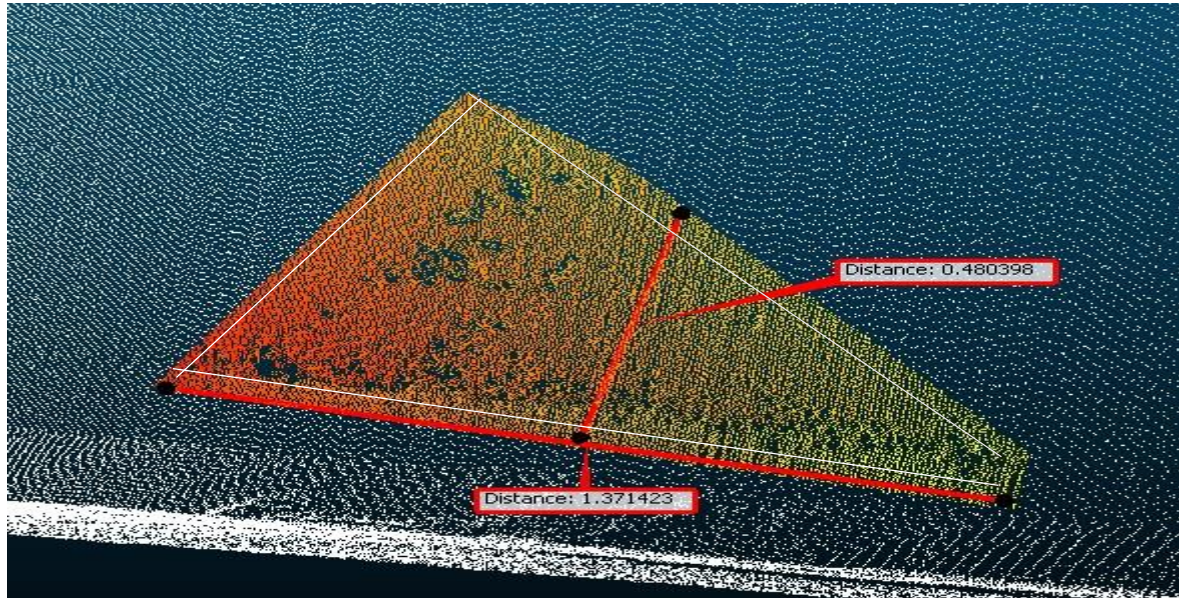
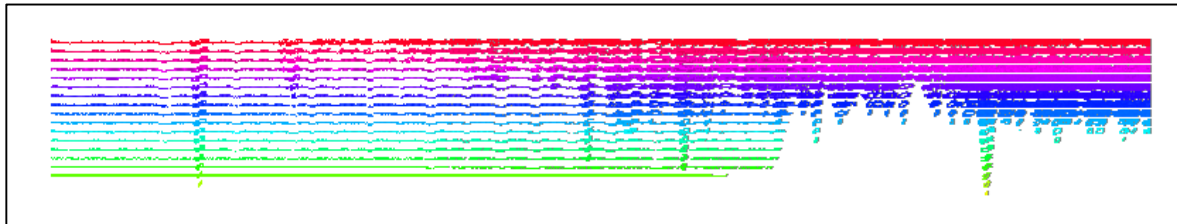
| Element Name | Observation | Location of Distress | Photo No. | Units | Distress Details | | | Area of Repair (Sq.m/ RMT/ m3) |
|---|---|---|---|---|---|---|---|---|
| Abutment Wall | Scaling | - | 3 | M | 1.37 | 0.48 | | 0.6576 |

**3. "Scaling observed on Abutment Wall, measuring 1.37 m in length and 0.48 m in width, covering an area of 0.658 m<sup>2</sup>."**

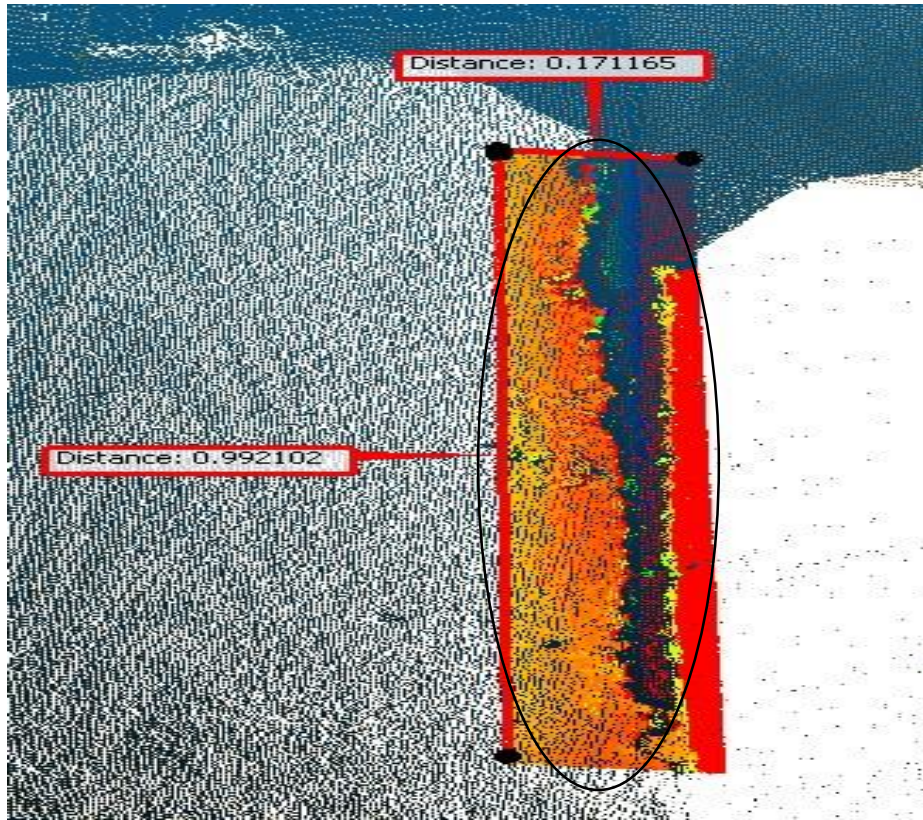
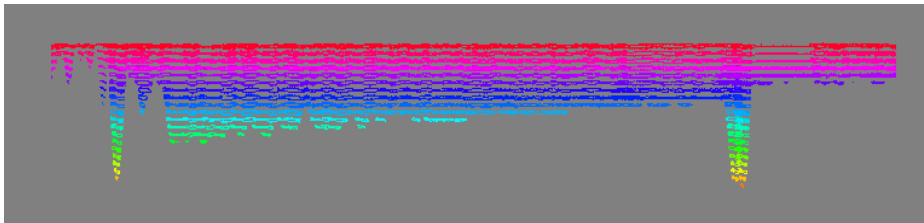
| Element Name | Observation | Location of Distress | Photo No. | Units | Distress Details | | | Area of Repair (Sq.m/ RMT/ m3) |
|---|---|---|---|---|---|---|---|---|
| Wing Wall | Damage | - | 4 | M | 0.17 | 0.99 | | 0.1683 |

**4. "Damage observed on Wing Wall, measuring 0.17 m in length and 0.99 m in width, covering an area of 0.168 m<sup>2</sup>."**

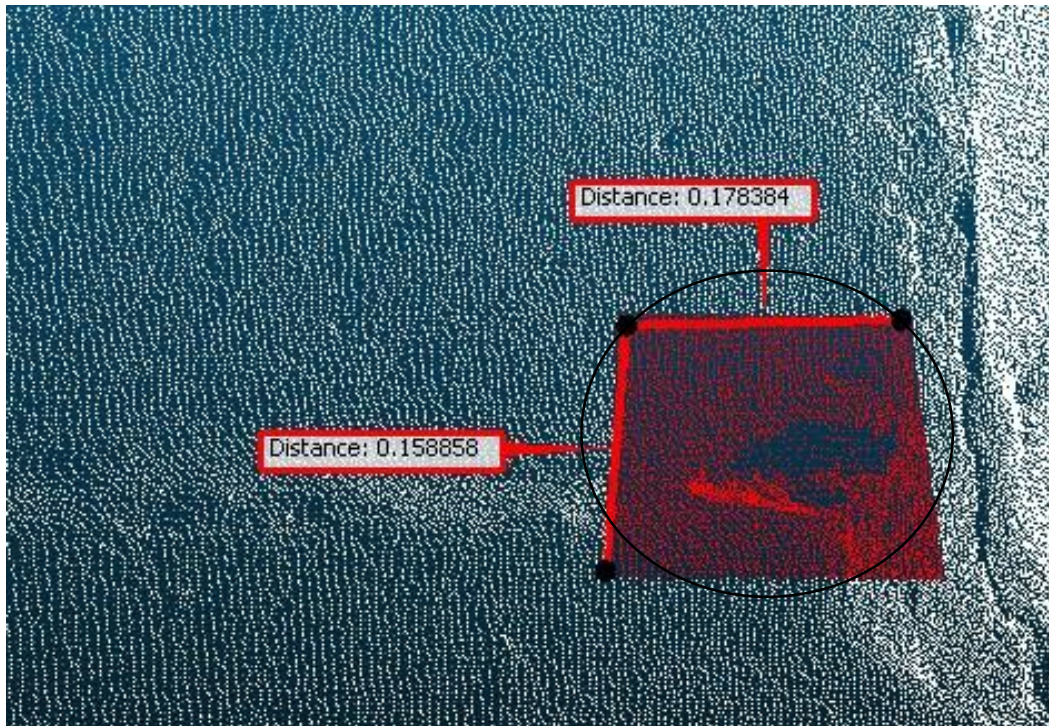
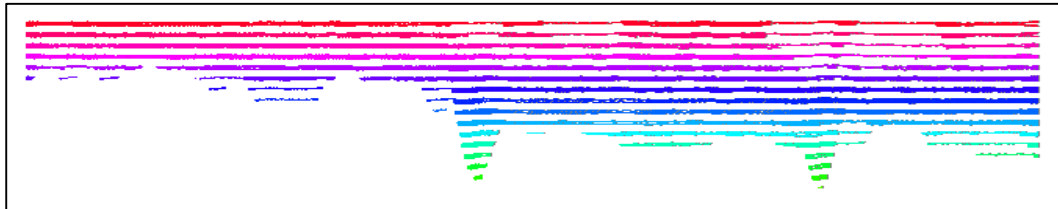
| Element Name | Observation | Location of Distress | Photo No. | Units | Distress Details | | | Area of Repair (Sq.m/ RMT/ m3) |
|---|---|---|---|---|---|---|---|---|
| Wing Wall | Damage | - | 5 | M | 0.17 | 0.15 | | 0.0255 |

**5. "Damage observed on Wing Wall, measuring 0.17 m in length and 0.15 m in width, covering an area of 0.026 m<sup>2</sup>."**

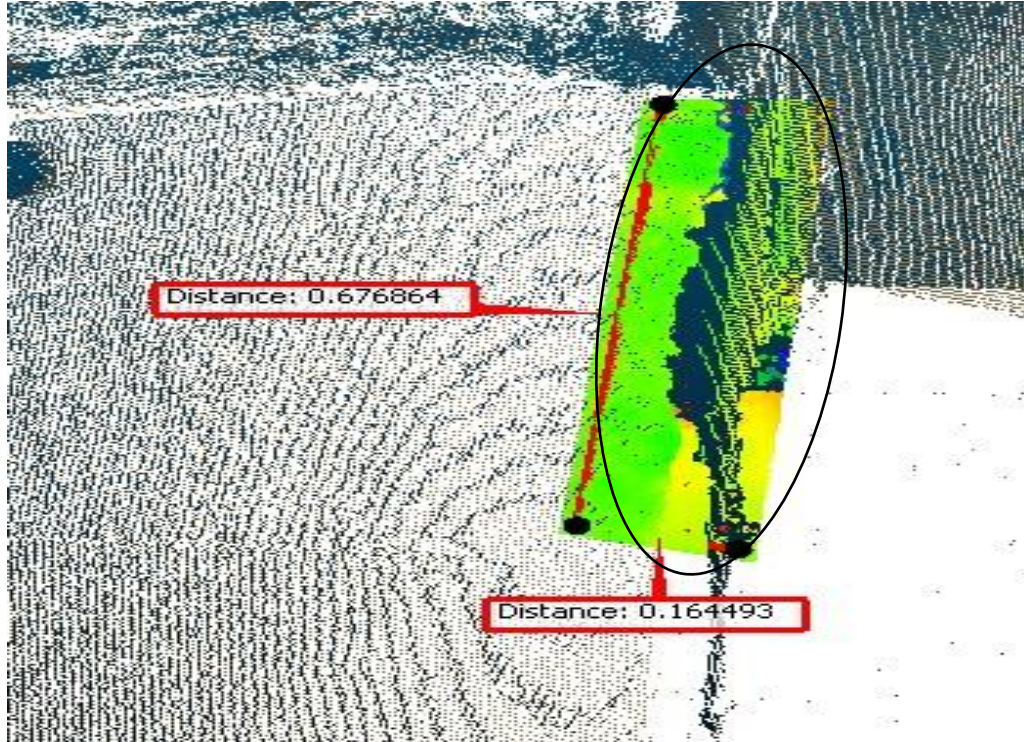
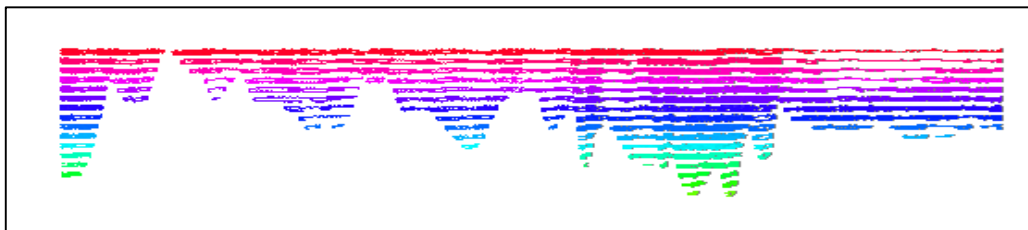
| Element Name | Observation | Location of Distress | Photo No. | Units | Distress Details | | | Area of Repair (Sq.m/ RMT/ m3) |
|---|---|---|---|---|---|---|---|---|
| Wing Wall | Damage | - | 6 | M | 0.16 | 0.67 | | 0.1072 |

**6. "Damage observed on Wing Wall, measuring 0.16 m in length and 0.67 m in width, covering an area of 0.107 m<sup>2</sup>."**

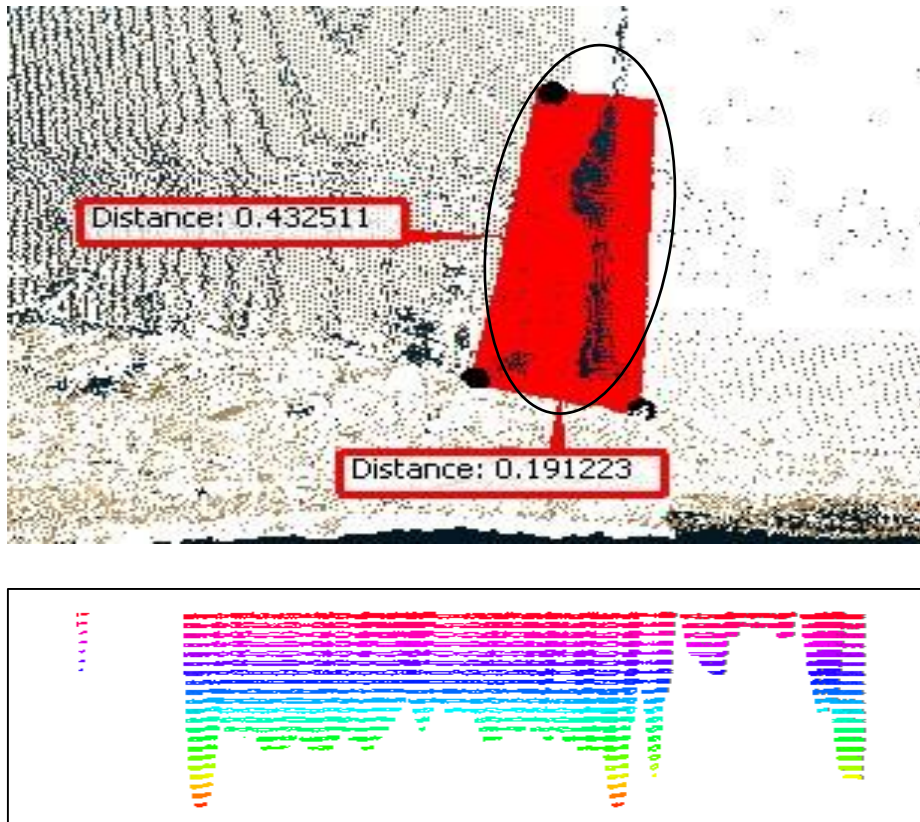
| Element Name | Observation | Location of Distress | Photo No. | Units | Distress Details | | | Area of Repair (Sq.m/ RMT/ m3) |
|---|---|---|---|---|---|---|---|---|
| Wing Wall | Damage | - | 7 | M | 0.19 | 0.43 | | 0.0817 |

**7. "Damage observed on Wing Wall, measuring 0.19 m in length and 0.43 m in width, covering an area of 0.082 m<sup>2</sup>."**

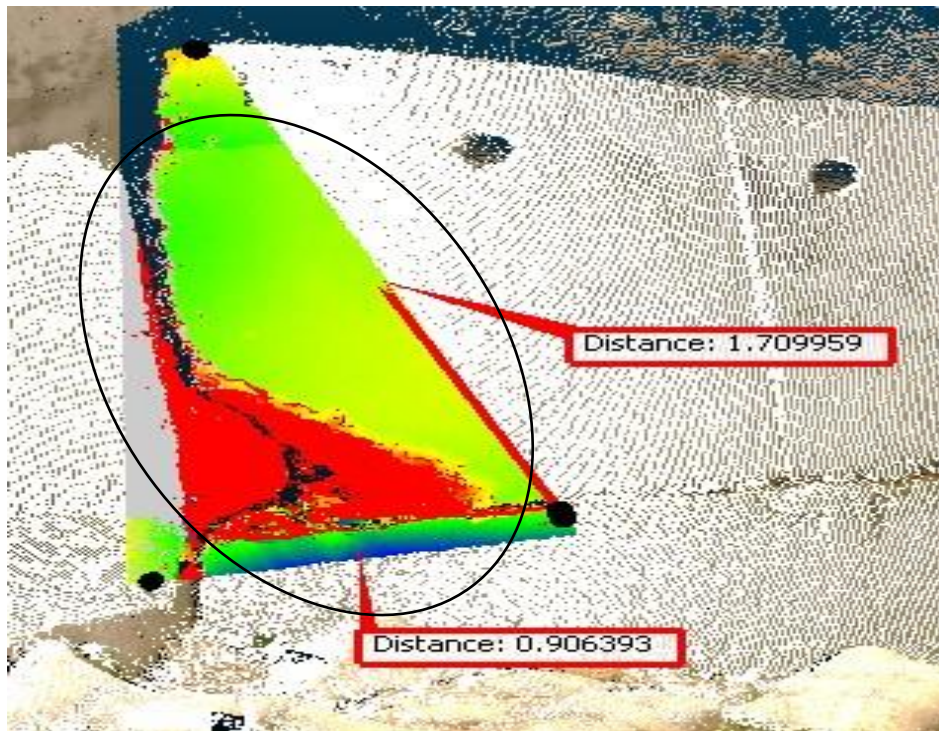
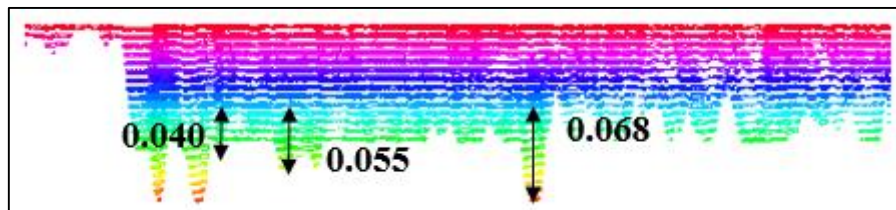
| Element Name | Observation | Location of Distress | Photo No. | Units | Distress Details | | | Area of Repair (Sq.m/ RMT/ m3) |
|---|---|---|---|---|---|---|---|---|
| Wing Wall | Damage | - | 8 | M | 0.90 | 1.70 | 0.055 | 0.084 |

**8. "Damage observed on Wing Wall, measuring 0.90 m in length and 1.70 m in width, Depth ranges from 0.040 m (min) to 0.068 m (max), with an average depth of 0.055 m. The calculated volume of the distress is 0.084 m<sup>3</sup>.**

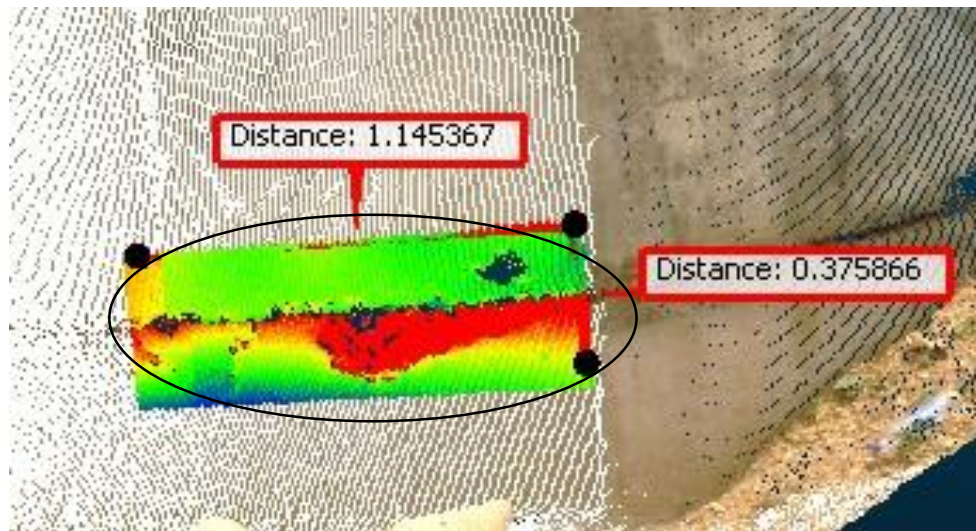
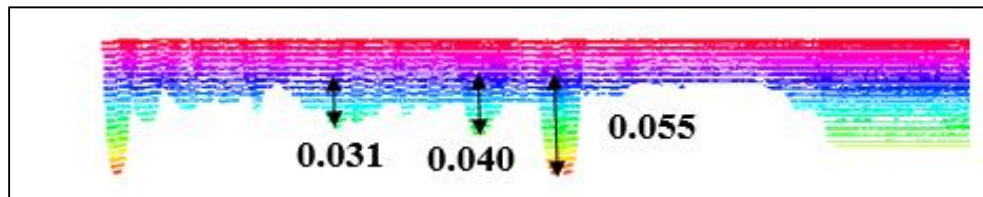
| Element Name | Observation | Location of Distress | Photo No. | Units | Distress Details | | | Area of Repair (Sq.m/ RMT/ m3) |
|---|---|---|---|---|---|---|---|---|
| Wing Wall | Damage | - | 9 | M | 1.14 | 0.37 | 0.040 | 0.016 |

**9. "Damage observed on Wing Wall, measuring 1.14 m in length and 0.37 m in width, Depth ranges from 0.031 m (min) to 0.055 m (max), with an average depth of 0.040m. The calculated volume of the distress is 0.016 m<sup>3</sup>.**

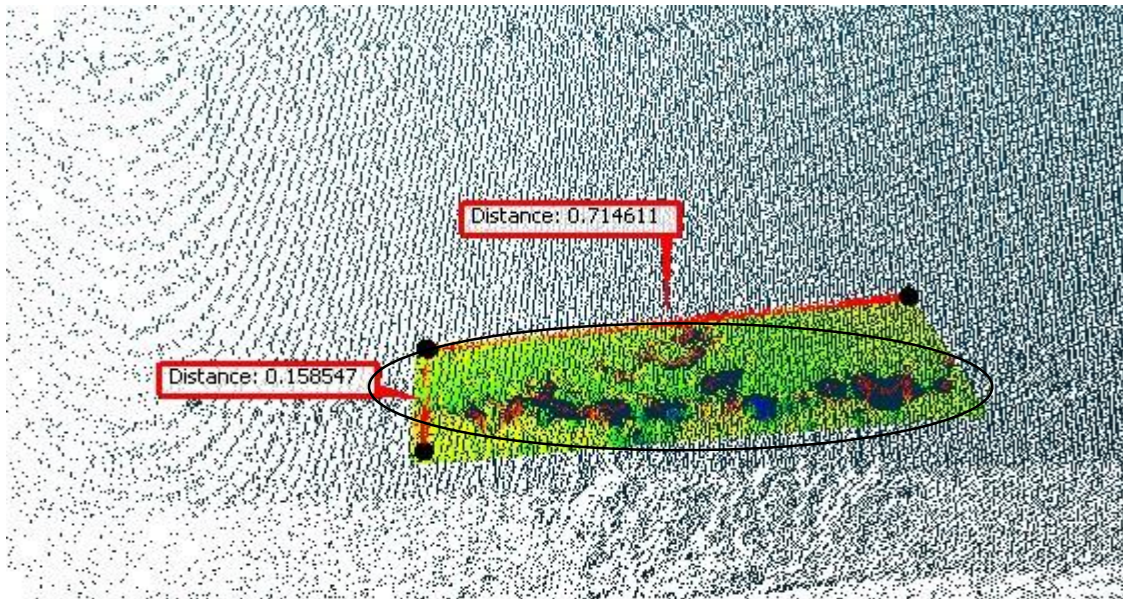
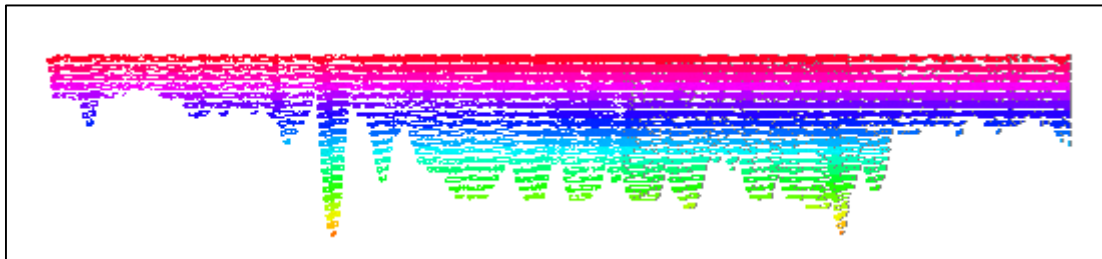
| Element Name | Observation | Location of Distress | Photo No. | Units | Distress Details | | | Area of Repair (Sq.m/ RMT/ m3) |
|---|---|---|---|---|---|---|---|---|
| Abutment Wall | Scaling | - | 10 | M | 0.71 | 0.15 | | 0.1095 |

**10. "Scaling observed on Abutment Wall, measuring 0.71 m in length and 0.15 m in width, covering an area of 0.110 m<sup>2</sup>."**
