# **LIDAR Inspection Report of VUP ch.906+250**

**Bridge Chainage:** 906+250 (CKRP)

- **Bridge No:** -
- **Chainage:** 906+250
- **Structure type:** VUP

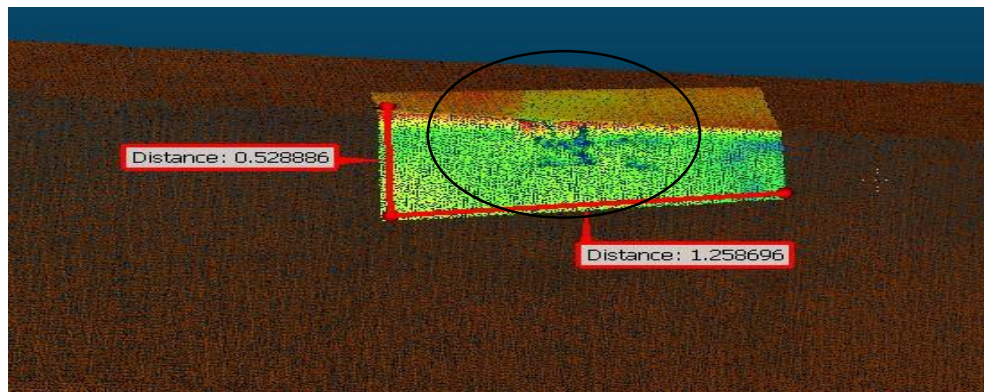
| Element Name | Observation | Location of Distress | Photo No. | Units | Distress Details | | | Area of Repair (Sq.m /RMT/ m3) |
|---|---|---|---|---|---|---|---|---|
| Abutment 2 | Honeycombing | - | 1 | M | 1.25 | 0.52 | | 0.65 |

**1. Honeycombing observed on Abutment 2, measuring 1.25 m in length and 0.52 m in width, covering an area of 0.65 m<sup>2</sup>.**
