# **LIDAR Inspection Report of Box Culvert ch.906+543**

**Bridge Chainage:** 906+543

# **CH: 906+543 BOX CULVERT**

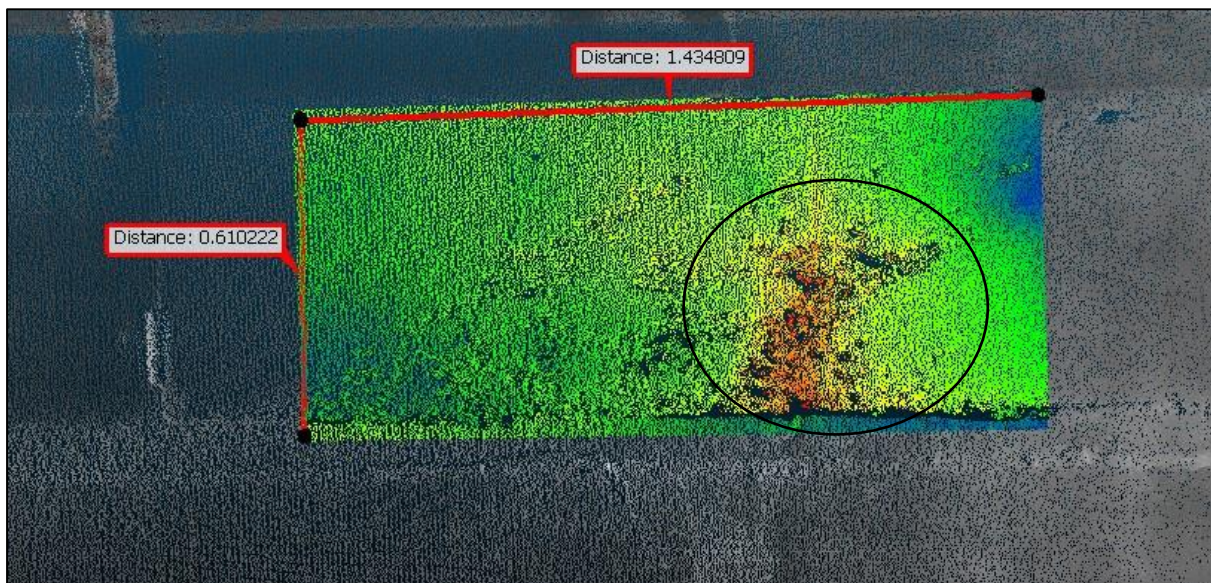
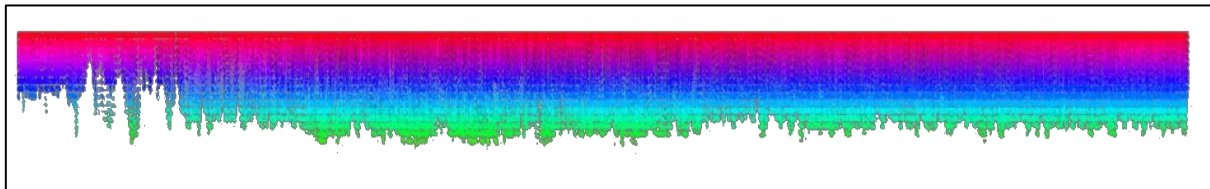
| Element Name | Observation | Location of Distress | Photo No. | Units | Distress Details | | | Area of Repair<br>(Sq.m/R MT/m3) |
|---|---|---|---|---|---|---|---|---|
| Abutment 1 | Scalling | - | 1 | Sq m | 1.43 | 0.61 | - | 0.87 |

**1. Scalling observed on Abutment 1 LHS side, measuring 1.43 m in length and 0.61 m in width, covering an area of 0.87 m<sup>2</sup>.**
