# **LIDAR Inspection Report of MNB ch.906+860**

**Bridge No:** MNB – 907/6

**Bridge Chainage:** 906 + 860 (CKRP)

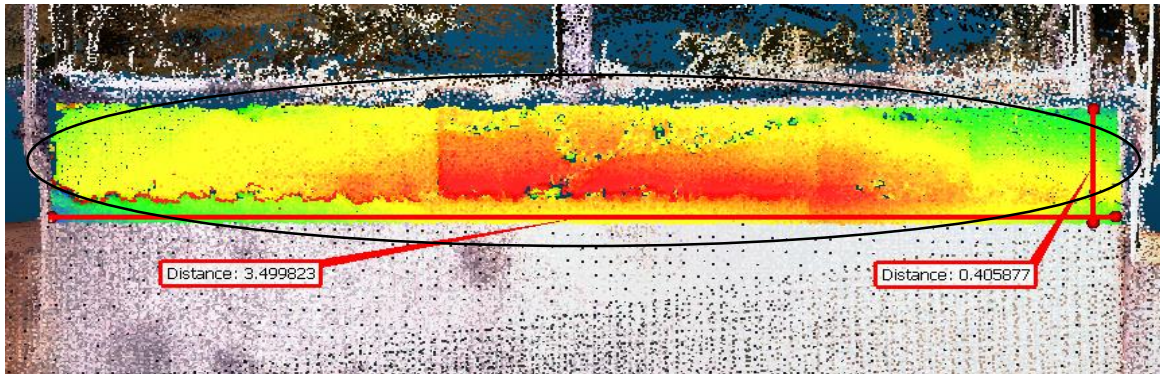
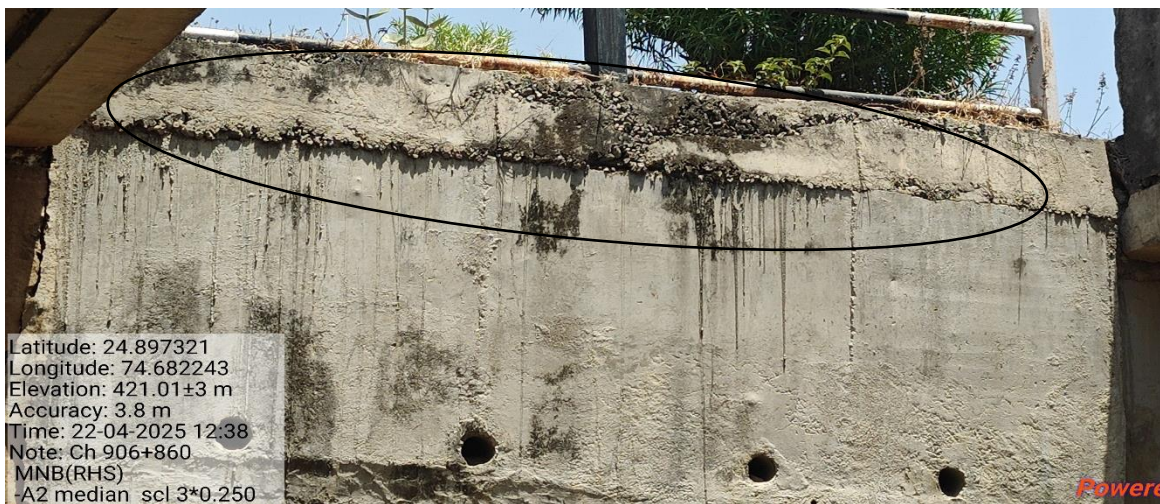
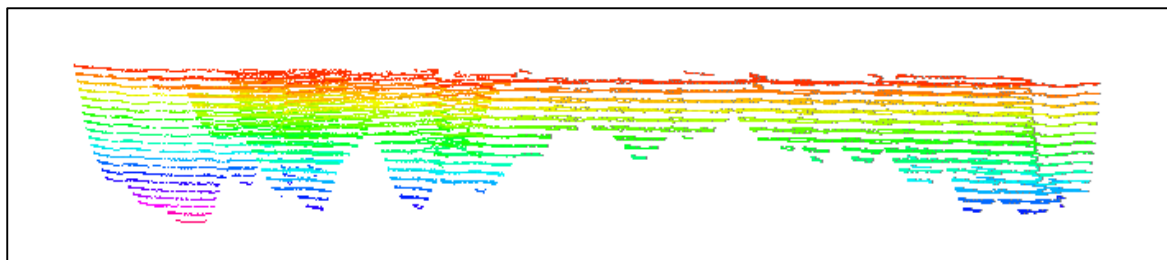
| Element Name | Observation | Location of Distress | Photo No. | Units | Distress Details | | | Area of Repair (Sq.m/R MT) |
|---|---|---|---|---|---|---|---|---|
| Median | Scaling | | 1 | M | 3.49 | 0.40 | | 1.39 |

1. **Scaling Distress** observed at Abutment 2 on the median side , measuring 3.49 m in length and 0.40 m in width, covering an area of 1.39 m<sup>2</sup>.

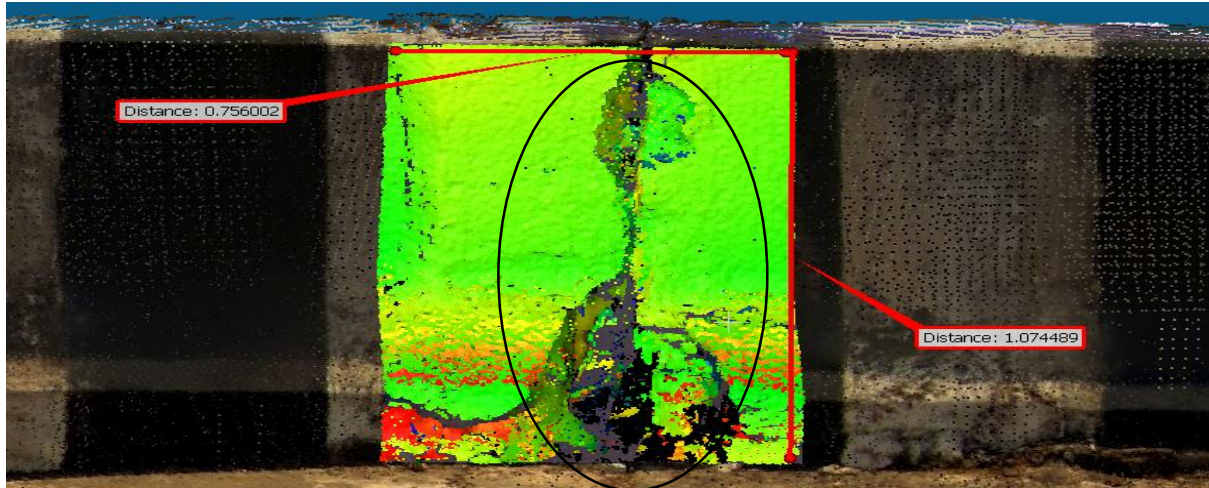
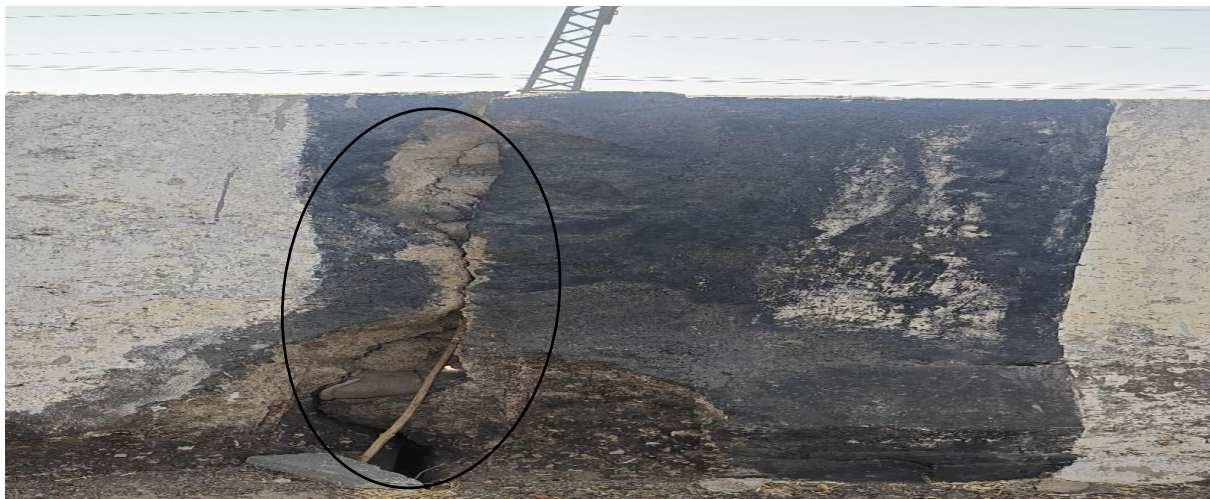
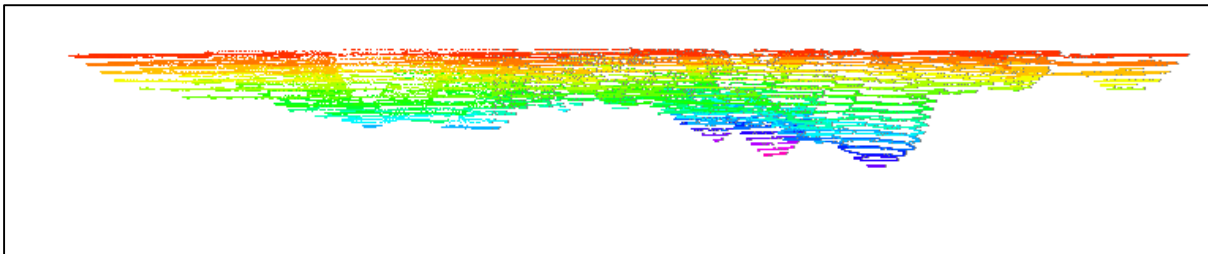
| Element Name | Observation | Location of Distress | Photo No. | Units | Distress Details | | | Area of Repair (Sq.m/R MT) |
|---|---|---|---|---|---|---|---|---|
| Cross barrier | Damage | | 2 | M | 1.07 | 0.75 | | 0.80 |

2. Damage observed on RHS at Abutment 2 near Crash Barrier 1, measuring 1.07 m in length and 0.75 m in width, covering an area of 0.80 m<sup>2</sup>.

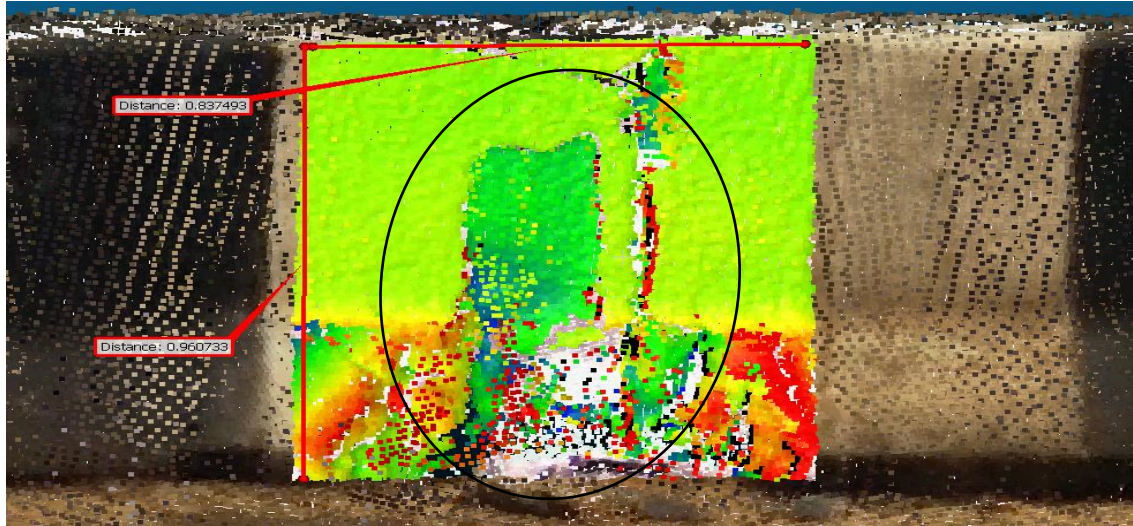
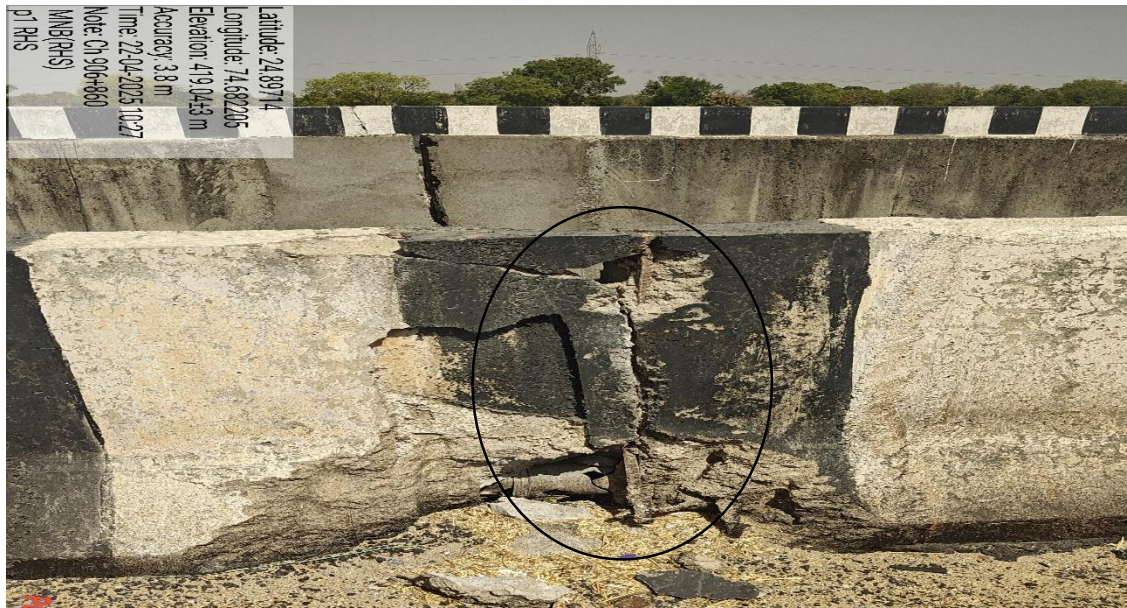
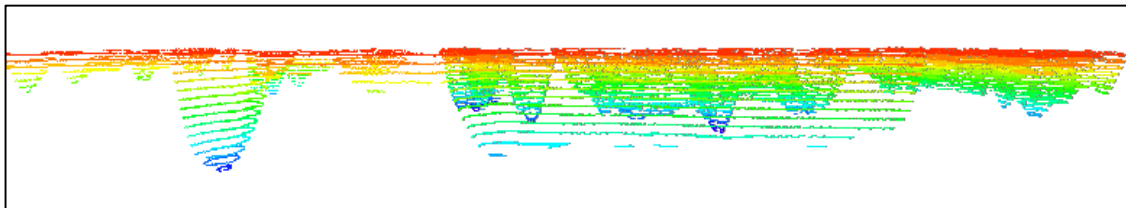
| Element Name | Observation | Location of Distress | Photo No. | Units | Distress Details | | | Area of Repair (Sq.m/R MT) |
|---|---|---|---|---|---|---|---|---|
| Cross barrier | Damage | | 3 | M | 0.96 | 0.83 | | 0.79 |

3. Damage observed on RHS at Pier 1 near Crash Barrier 2, measuring 0.96 m in length and 0.83 m in width, covering an area of 0.79 m<sup>2</sup>.
