# **Satellite Structural Inspection Interferometric Synthetic Aperture Radar (InSAR) Based**

State – Rajasthan  
Bridge No. – 903/2  
Bridge Chainage – 906+860

Project - Chittorgarh to Kota  
Zone – RJ 06  
Structure Type – MNB

MNB- CH-906+860

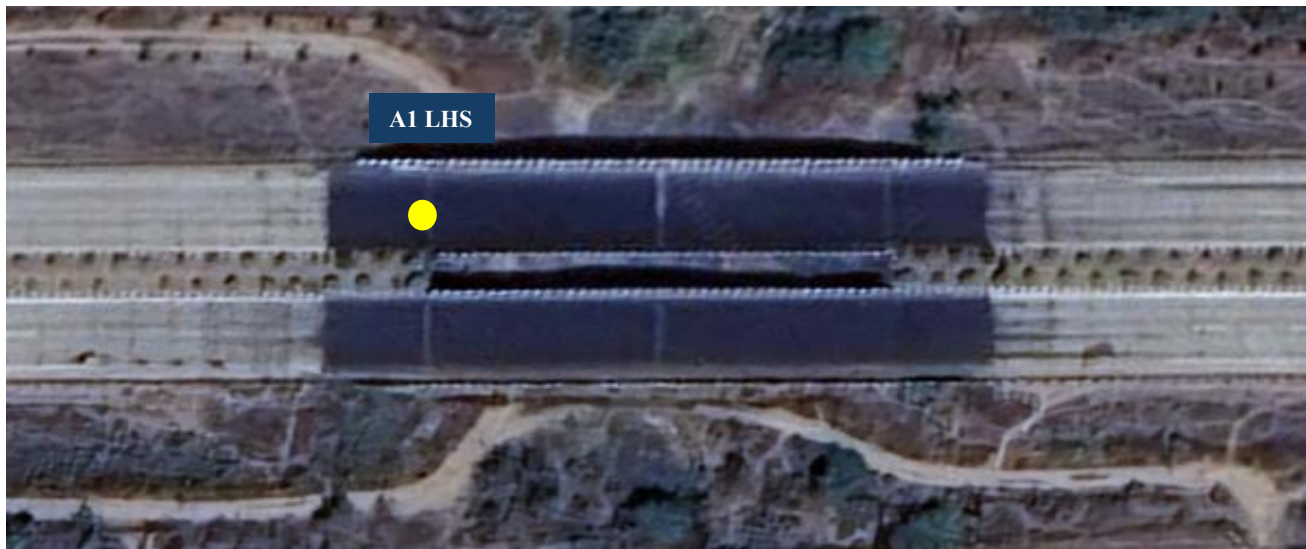
A1 LHS (24.897059132093474, 74.68204439686431)

- **Vertical Displacement (VV)** Vertical displacement exhibits moderate variability with a predominantly negative trend over the monitoring period (Jan–Jun 2025), indicating overall vertical settlement at the A1 LHS location.
- **Horizontal displacement (VH)** Horizontal displacement shows high variability with alternating uplift and settlement phases, ranging roughly between +7 mm and –12 mm.

- **January 2025:** Both VH and VV remain near neutral to slightly positive values, indicating a relatively stable initial deformation phase.
- **May 2025:** VH briefly rebounds to +4 mm, while VV remains negative (–7 mm), indicating a short-lived lateral recovery without vertical relief.
- **June 2025:** Both VH and VV return to negative values (–6 to –11 mm), confirming continued deformation activity with no clear stabilization trend toward the end of the monitoring window.

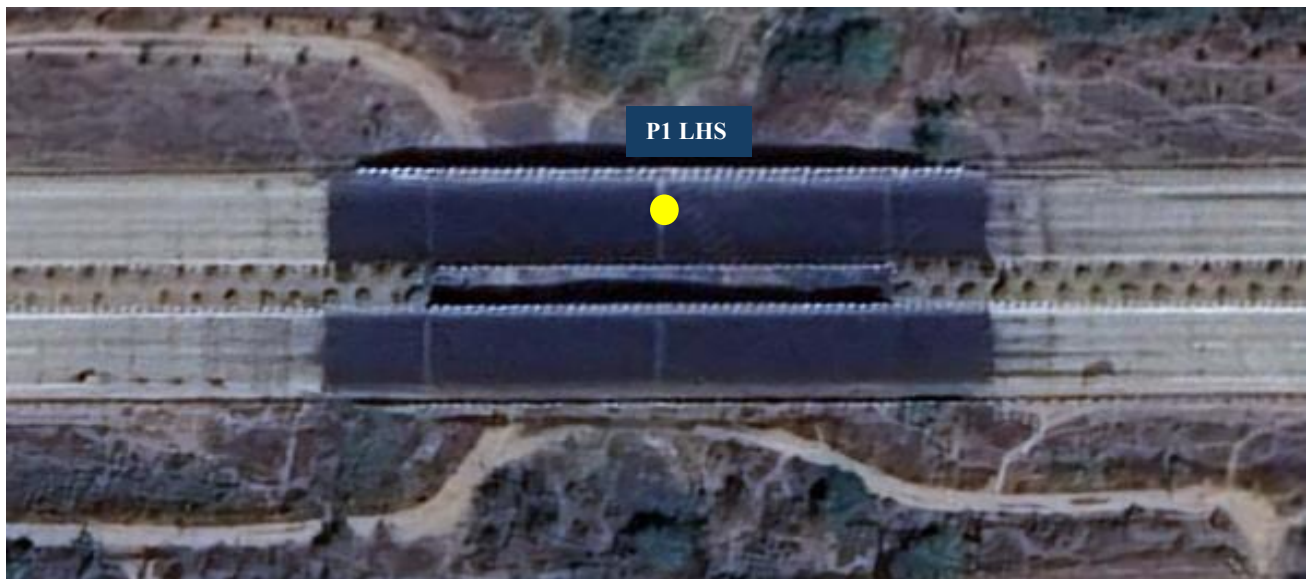
P1 LHS (24.897209751944228, 74.68215935585538)

- **Vertical Displacement (VV)** Vertical displacement shows a predominantly negative trend throughout the monitoring period (Jan–Jun 2025), indicating overall vertical settlement at the P1 LHS location.
- **Horizontal Displacement (VH)** Horizontal displacement exhibits moderate to high variability, ranging roughly between +3 mm and –16 mm.

- **January–February 2025:** VH remains near 0 to +1 mm, while VV is already negative (–3 to –5 mm), indicating early vertical settlement with minimal lateral response.
- **May 2025:** VH reaches –12 to –16 mm, while VV remains between –9 and –10 mm, marking a period of intensified lateral settlement with sustained vertical settlement.
- **June 2025:** VH recovers marginally to –3 mm, while VV drops to its most negative value (–18 mm), confirming severe vertical settlement persisting at the end of the monitoring period.

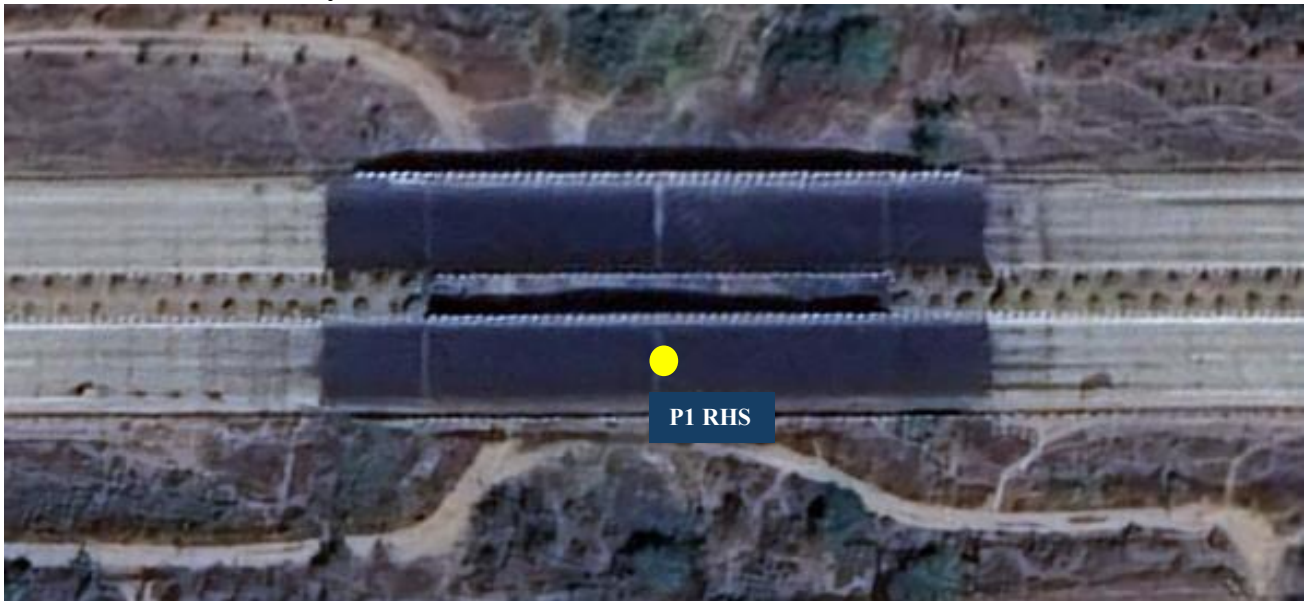
P1 RHS (24.897138304089232, 74.68227218597623)

- **Vertical Displacement (VV)** Vertical displacement remains predominantly negative throughout the monitoring period (Jan–Jun 2025), indicating overall vertical settlement at the P1 RHS location.
- **Horizontal Displacement (VH)** Horizontal displacement exhibits moderate to high variability with a predominantly positive trend, ranging roughly between –2 mm and +22 mm.

- **January 2025:** VH begins near 0 mm, while VV is positive (+5 mm), indicating initial vertical uplift with minimal lateral displacement.
- **April 2025:** VV reaches one of its most negative values (–20 mm), while VH remains positive (+8 mm), representing a highly asymmetric deformation event.
- **June 2025:** VH drops briefly to 0 mm before recovering to +12 mm, while VV remains negative (–18 to –14 mm), confirming continued deformation with no vertical stabilization by the end of the monitoring period.

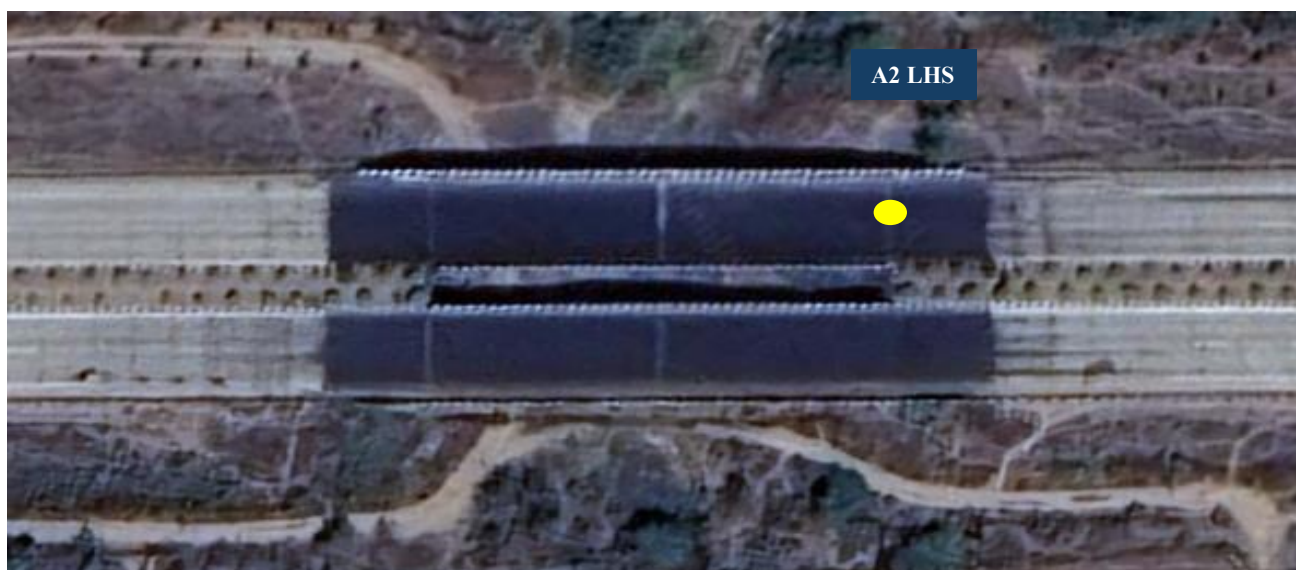
A2 LHS (24.897364233651547, 74.68227750815174)

- **Vertical Displacement (VV)** Vertical displacement exhibits moderate to high variability with a predominantly positive trend over the monitoring period (Jan–Jun 2025), indicating overall vertical uplift at the A2 LHS location.
- **Horizontal Displacement (VH)** Horizontal displacement shows high variability with alternating uplift and settlement phases, ranging roughly between +15 mm and –5 mm.

- **February 2025:** VH reaches a local positive peak (+15 mm), while VV remains modest (+2–3 mm), indicating a lateral-dominant deformation phase with limited vertical participation.
- **June 2025:** VH recovers to +6–14 mm, while VV decreases to +12–14 mm, indicating post-peak vertical relaxation with renewed lateral displacement.

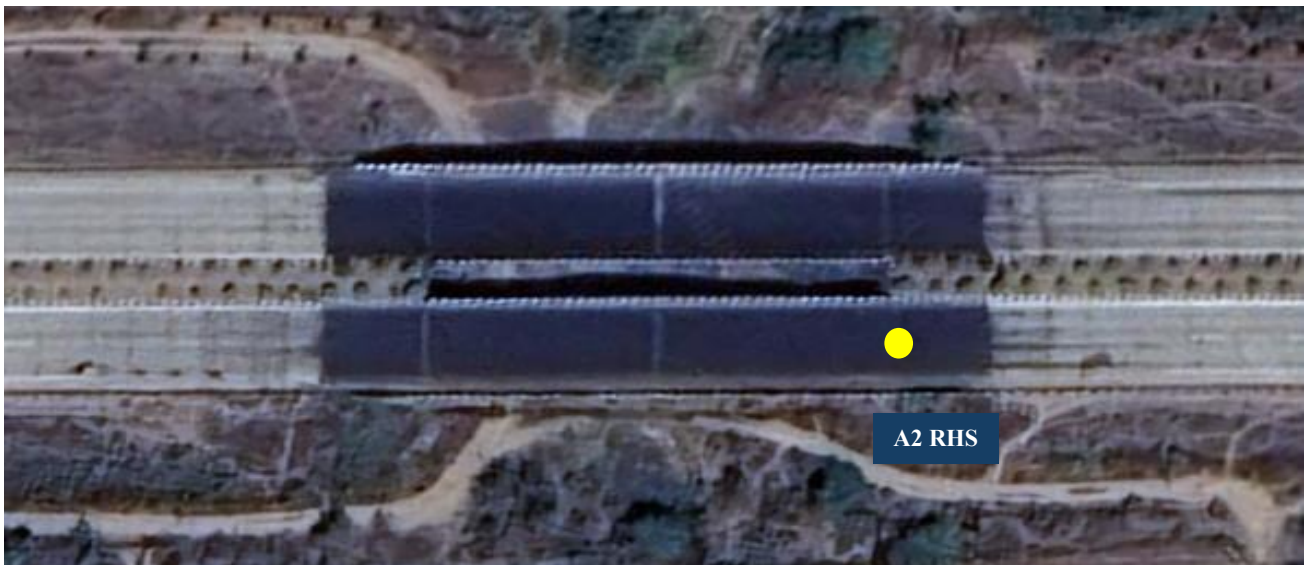
A2 RHS (24.897299544460132, 74.68240098262362)

- Vertical Displacement (VV)** remains predominantly negative throughout the monitoring period, indicating overall vertical settlement at the A2 RHS location.
- Horizontal Displacement (VH)** Horizontal displacement exhibits moderate variability with a clear negative dominance, ranging roughly between  $-3$  mm and  $-18$  mm.

- March 2025:** VH drops to  $-15$  mm, while VV remains around  $-9$  mm, highlighting a lateral-dominant settlement pulse.
- April 2025:** VV reaches one of its most negative values ( $-18$  mm), while VH shows slight improvement ( $-9$  mm), marking a severe vertical settlement event
- May-June 2025:** Both VH and VV deteriorate again (VH  $-18$  mm, VV  $-20$  mm), confirming renewed coupled settlement toward the end of the monitoring period.
