# **LIDAR Inspection Report of VUP ch.907+700**

**Bridge Chainage:** 907+700 (CKRP)

- **Bridge No:** -
- **Chainage:** 907+700
- **Structure type:** VUP

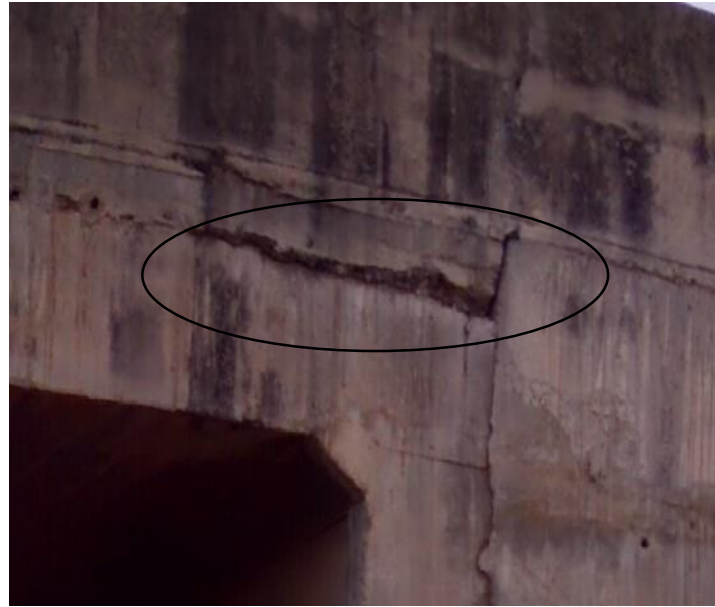
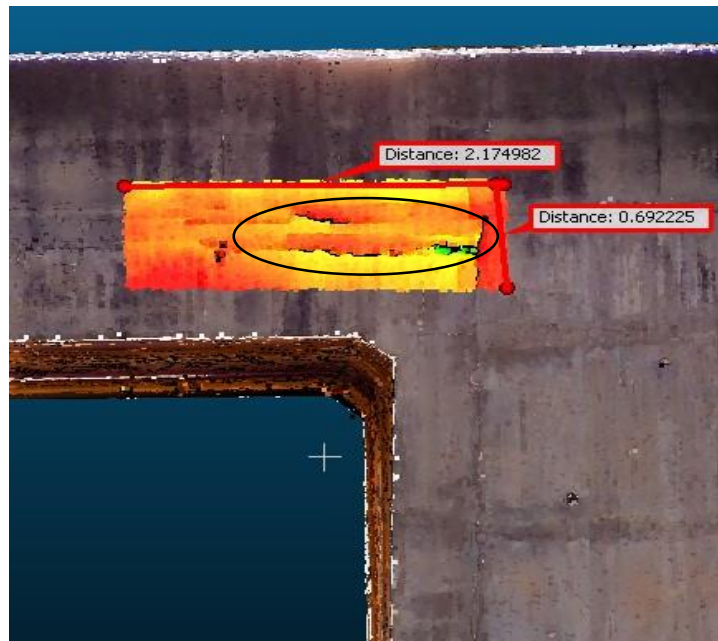
| Element Name | Observation | Location of Distress | Photo No. | Units | Distress Details | | | Area of Repair (Sq.m/RM T/m3) |
|---|---|---|---|---|---|---|---|---|
| Abutment 2 wall | Damage | - | 1 | M | 2.17 | 0.69 | - | 1.497 |

**1. Wing wall damage observed on RHS A2, measuring 2.17 m in length and 0.69 m in width, covering an area of 1.497 m<sup>2</sup>.**

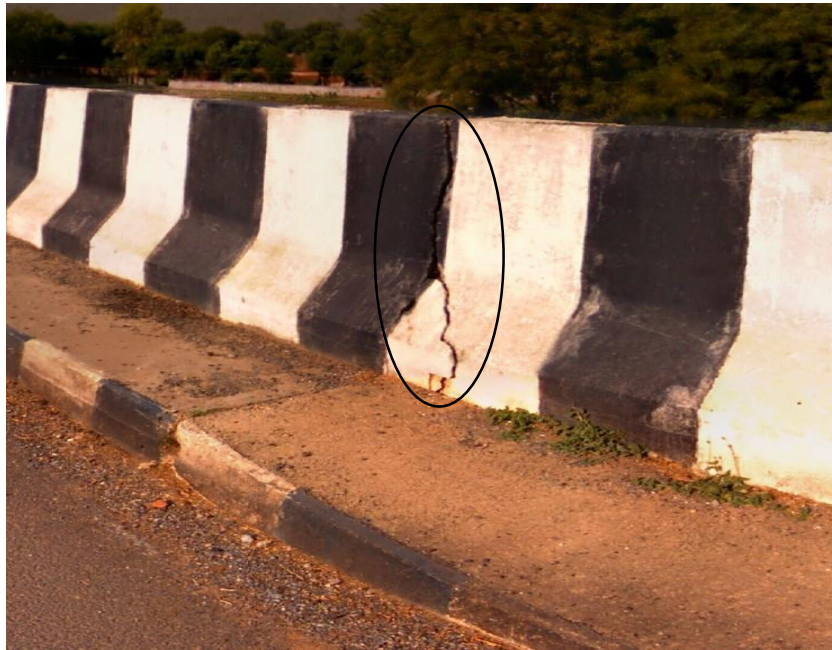
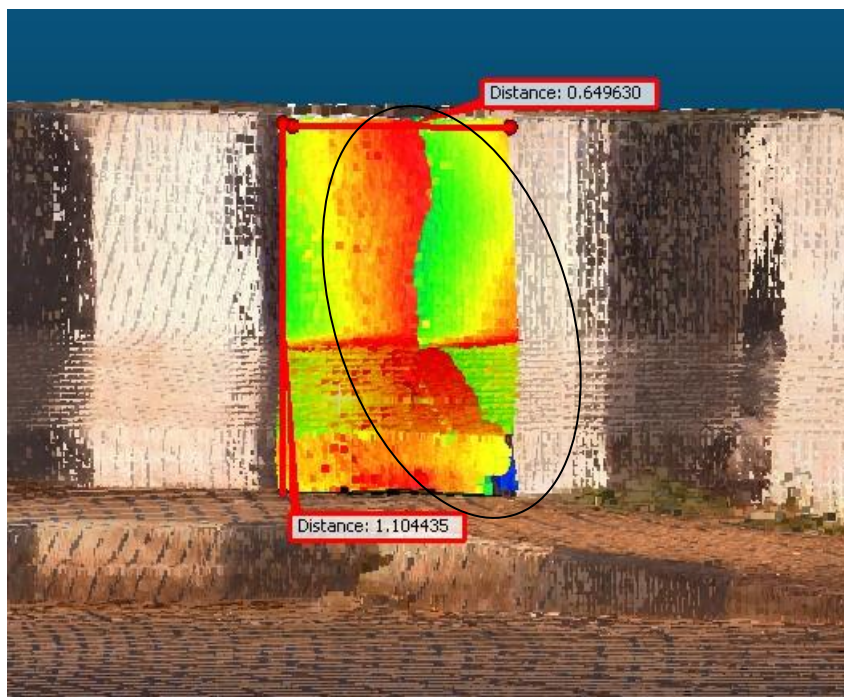
| Element Name | Observation | Location of Distress | Photo No. | Units | Distress Details | | | Area of Repair (Sq.m/RM T/m3) |
|---|---|---|---|---|---|---|---|---|
| Parapet | Damage | - | 2 | M | 0.64 | 1.10 | - | 0.704 |

**2. Wing wall damage observed on RHS, measuring 0.64 m in length and 1.10 m in width, covering an area of 0.704 m<sup>2</sup>.**
