# **LIDAR Inspection Report of Slab Culvert ch.908+863**

**Bridge Chainage :** 908 + 863 (CKRP)

- **Bridge No:** -
- **Chainage:** 908 + 863
- **Structure type:** Slab Culvert

- **CKRP:** Chittorgarh to kota
- **State:** Rajasthan NH 27
- **Zone:** RJ-06

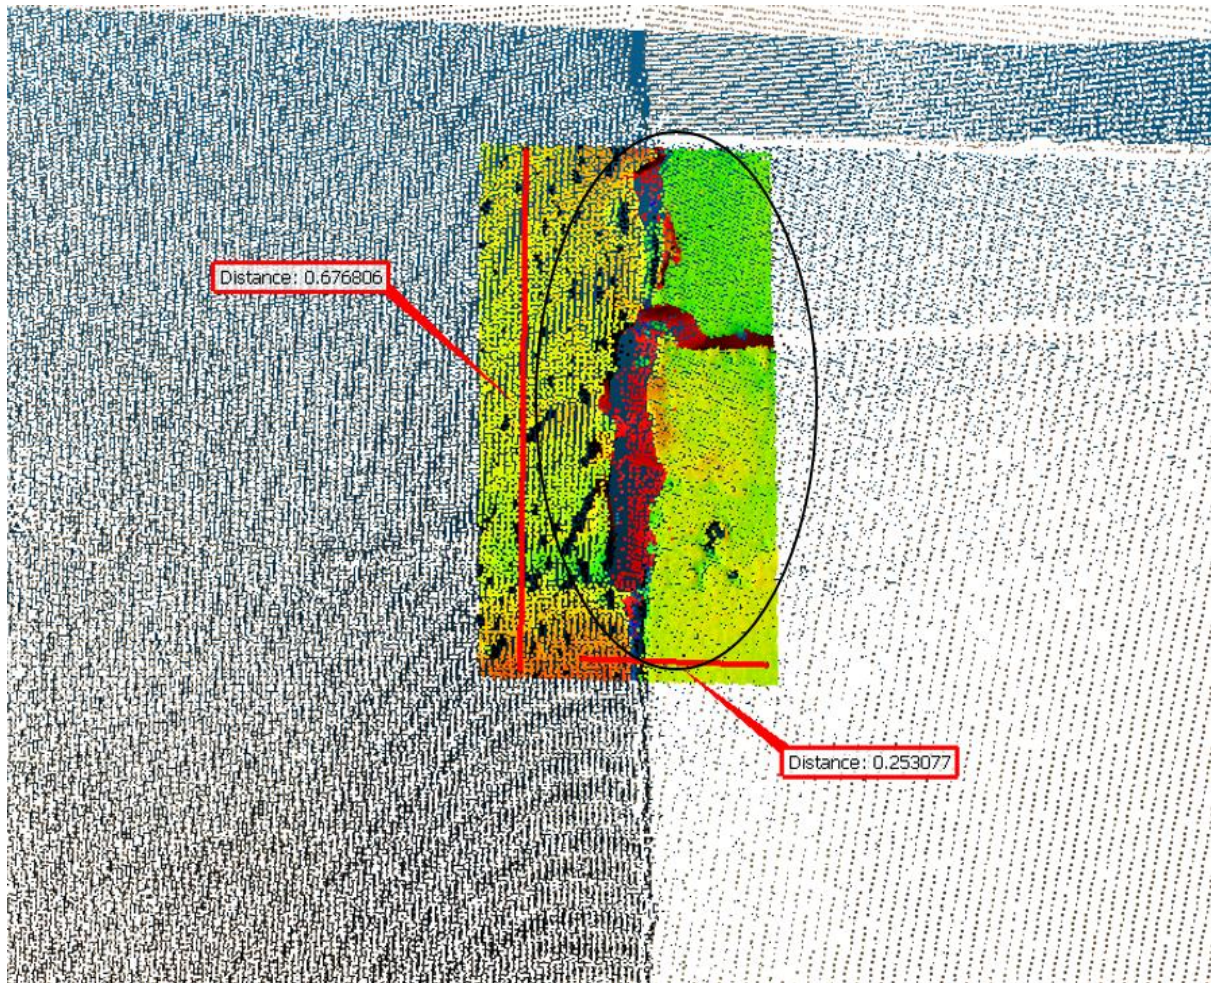
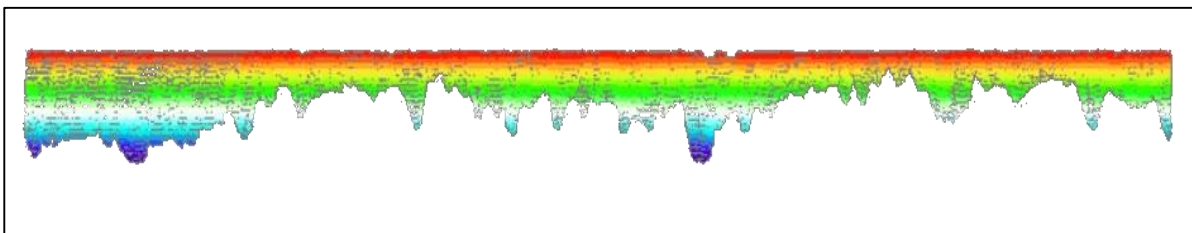
| Sr. No. | Description | Distress Notation | Observation | Location | | Distress Details | | | Area of Repair |
|---|---|---|---|---|---|---|---|---|---|
| 1 | Return wall | | Damaged (LHS/RHS) | | | | | | |

1. Return wall damage observed on LHS, measuring 0.6768 m in length and 0.2530 m in width, covering an area of 0.17 m<sup>2</sup>.

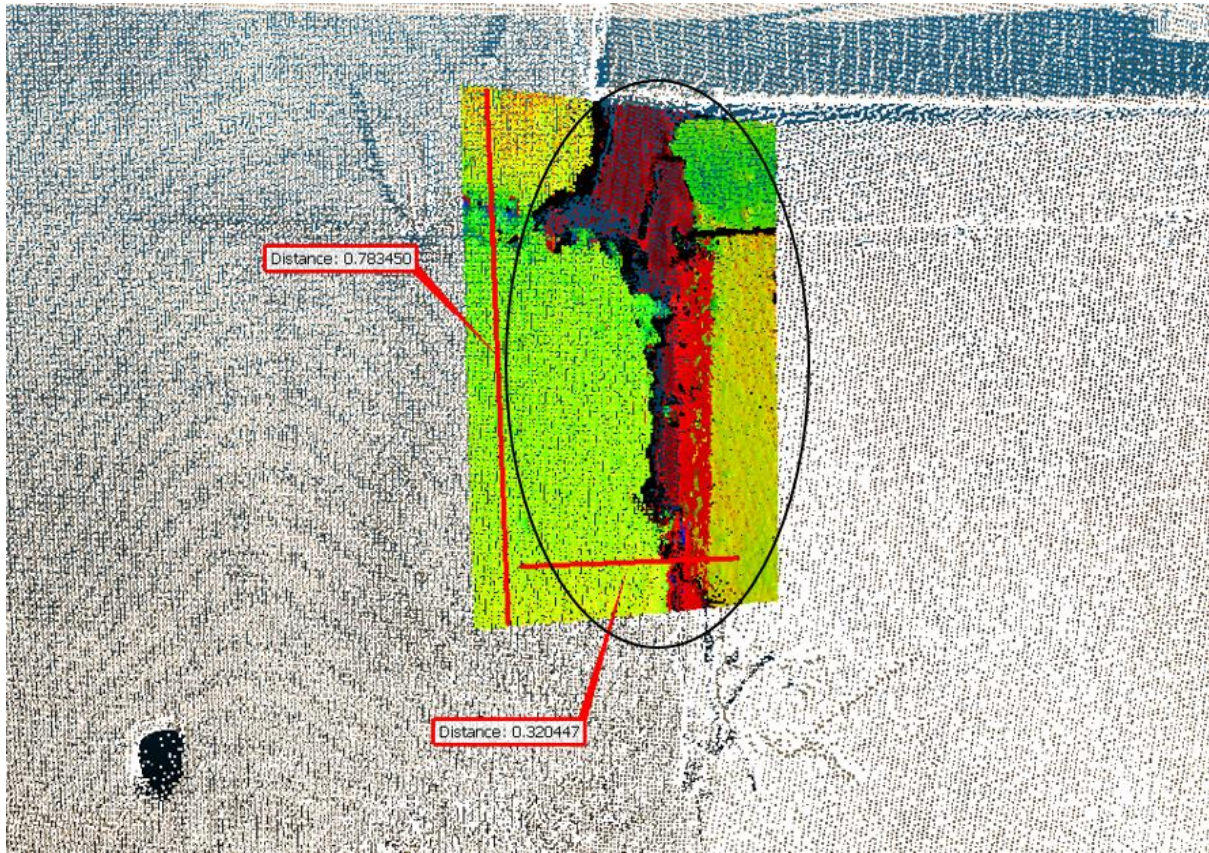
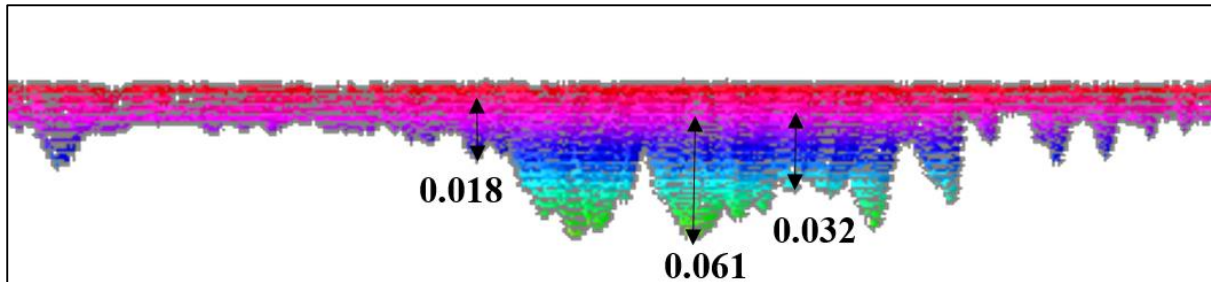
2. Return wall damage observed on RHS, measuring 0.7834 m in length and 0.3204 m in width, Depth ranges from 0.018 (min) to 0.061 m (max), with an average depth of 0.032 m. The calculated volume of the distress is 0.0080 m<sup>3</sup>.
