# **LIDAR Inspection Report of Box Culvert ch.909+490**

**Bridge Chainage:** 909+490

- **CKRP:** Chittorgarh to kota
- **State:** Rajasthan NH 27
- **Zone:** RJ-20

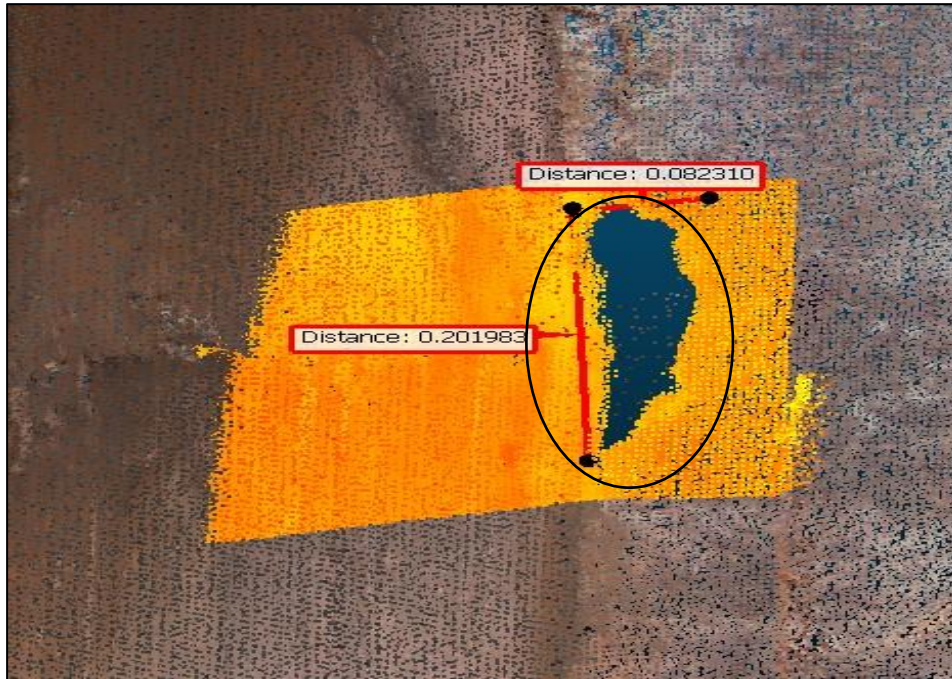
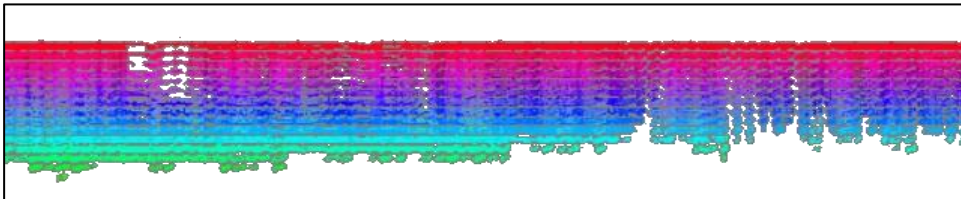
| Element Name | Observation | Location of Distress | Photo No. | Units | Distress Details | | | Area of Repair (Sq.m/R MT/m3) |
|---|---|---|---|---|---|---|---|---|
| Return Wall | Damage | - | 1 | Sq m | 0.20 | 0.08 | - | 0.016 |

**1. Damage observed on return wall corner RHS side, measuring 0.20 m in length and 0.08 m in width, covering an area of 0.016 m<sup>2</sup>.**

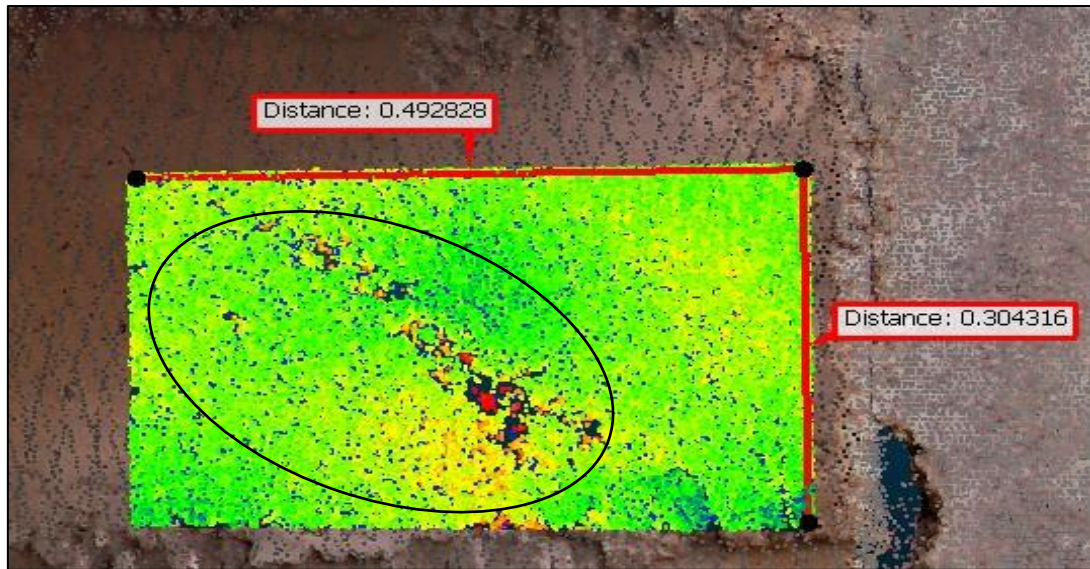
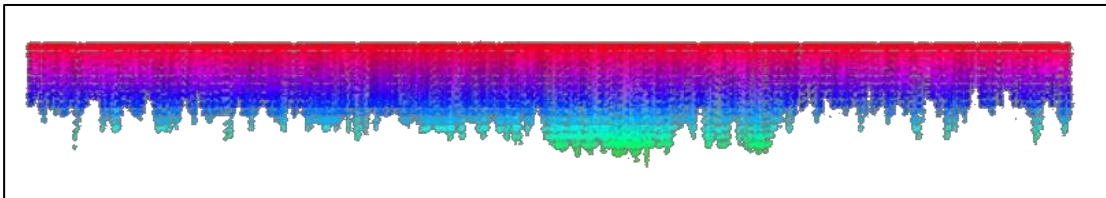
| Element Name | Observation | Location of Distress | Photo No. | Units | Distress Details | | | Area of Repair (Sq.m/R MT/m3) |
|---|---|---|---|---|---|---|---|---|
| Abutment 2 | Scalling | - | 2 | Cu m | 0.49 | 0.30 | - | 0.147 |

**2. Scaling observed on Abutment 2 RHS side, measuring 0.49 m in length and 0.30 m in width, covering an area of 0.147 m<sup>2</sup>.**

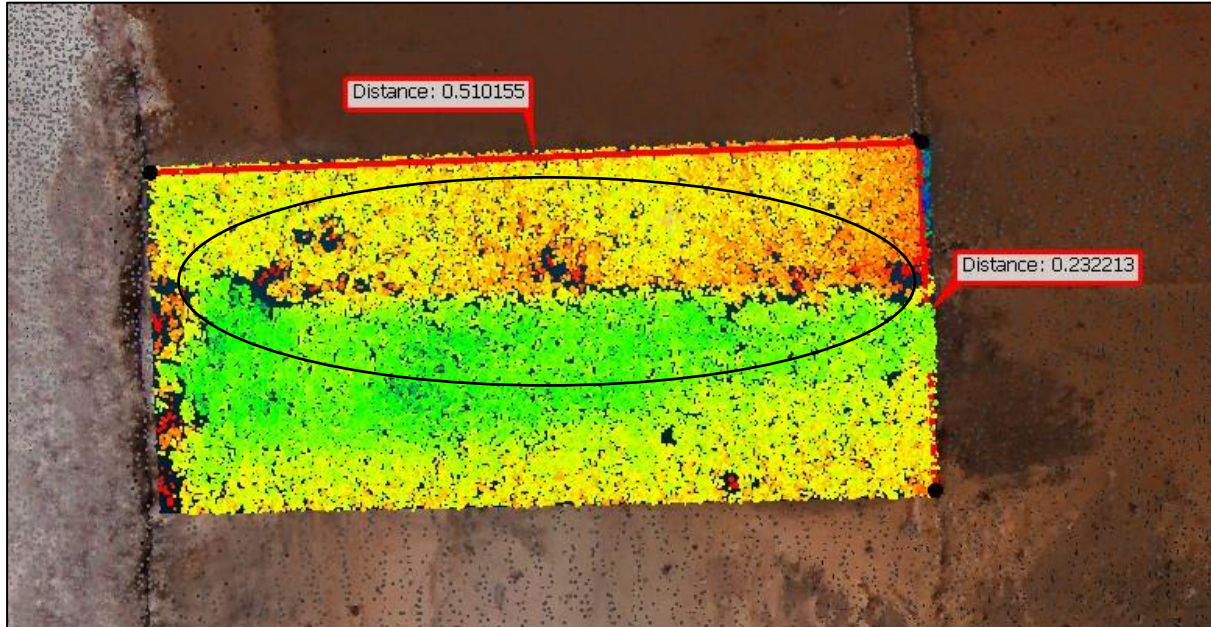
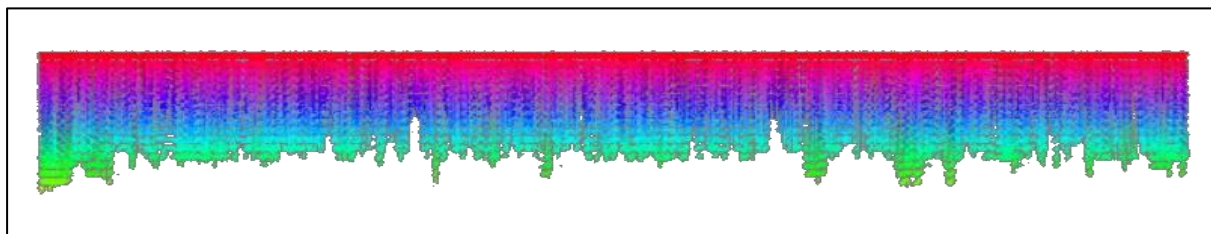
| Element Name | Observation | Location of Distress | Photo No. | Units | Distress Details | | | Area of Repair (Sq.m/R MT/m3) |
|---|---|---|---|---|---|---|---|---|
| Abutment 2 | Scalling | - | 3 | Sq m | 0.51 | 0.23 | - | 0.11 |

**3. Scaling observed on Abutment 2 LHS side, measuring 0.51 m in length and 0.23 m in width, covering an area of 0.11 m<sup>2</sup>.**
