# LIDAR Inspection Report of **Box Culvert** ch.910+198

**Bridge Chainage:** 910+198 (CKRP)

# **CH: 910+198 – Box CULVERT**

**DISTRESS PHOTOS**

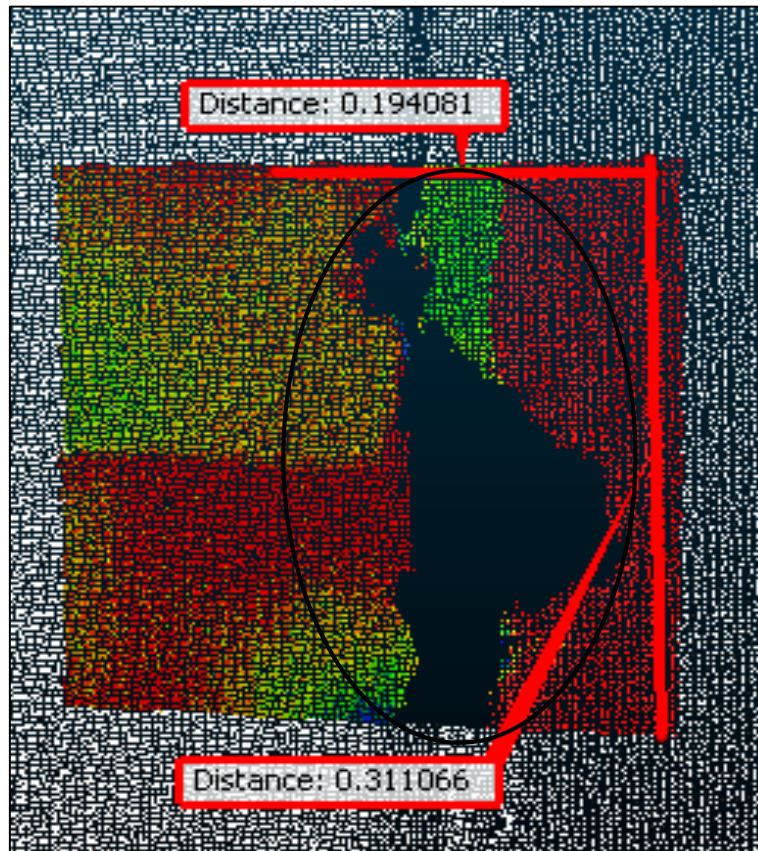
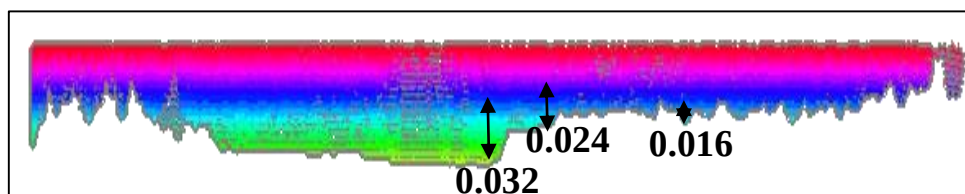
1. Wing wall joint damage observed, measuring 0.19 m in length and 0.31 m in width, covering an area of 0.0589 m<sup>2</sup>. Depth ranges from 0.016 (min) to 0.032 m (max), with an average depth of 0.024 m. The calculated volume of the distress is 0.001m<sup>3</sup>.

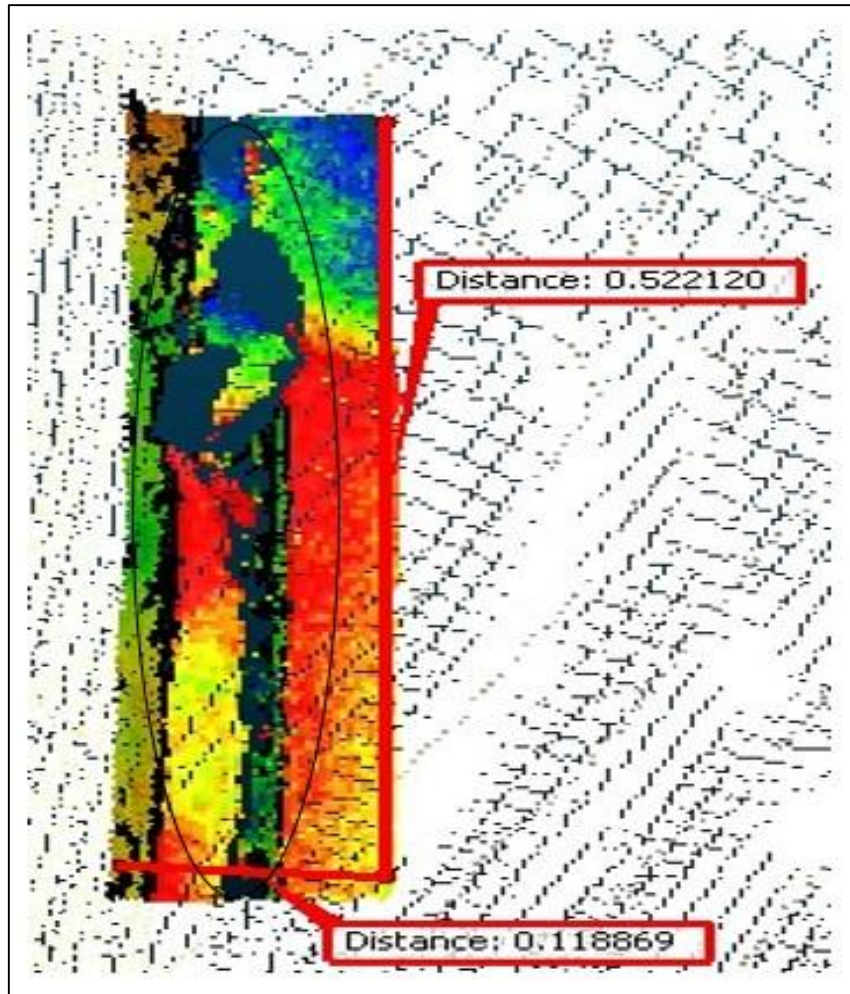
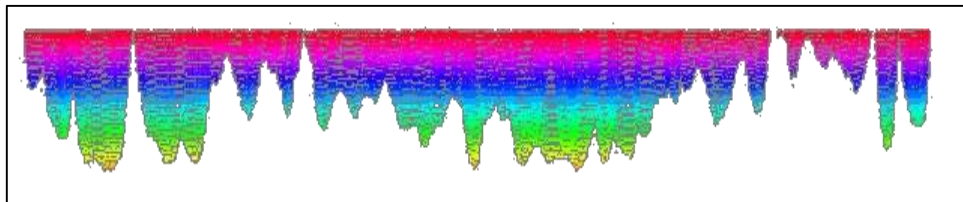
2. Wing wall joint damage observed on LHS, measuring 0.52 m in length and 0.11 m in width, covering an area of 0.0572 m<sup>2</sup>.

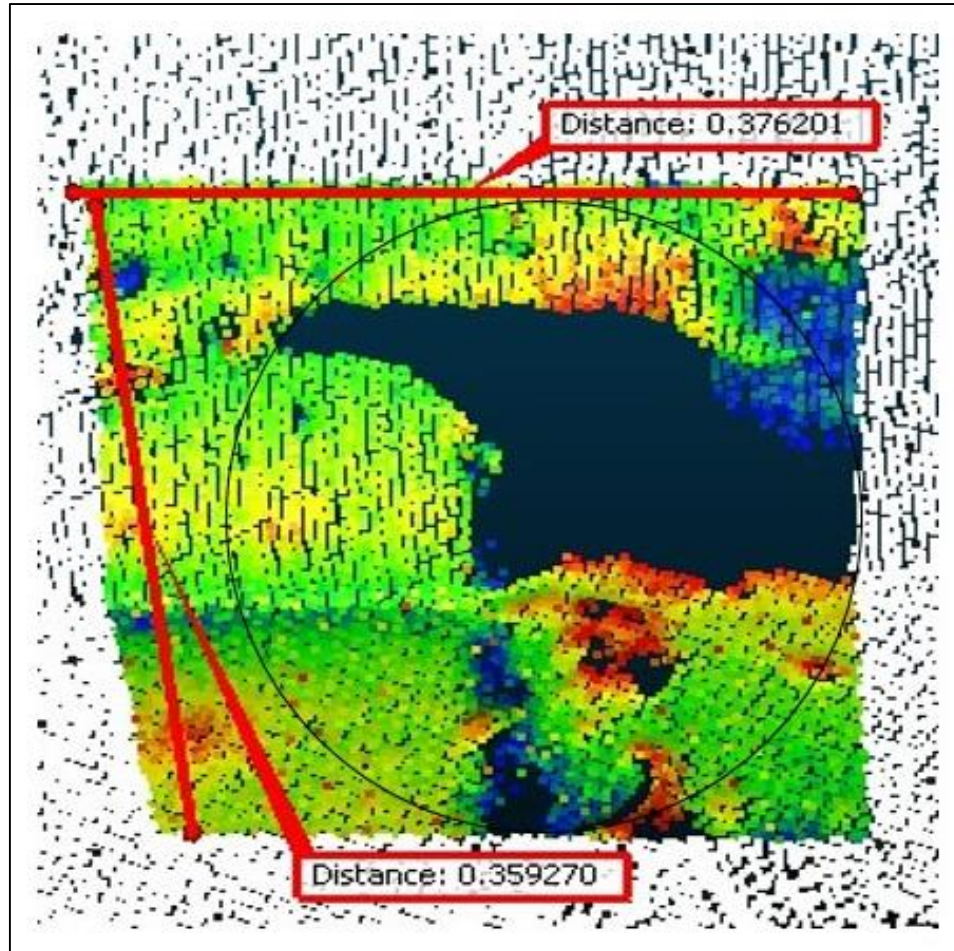
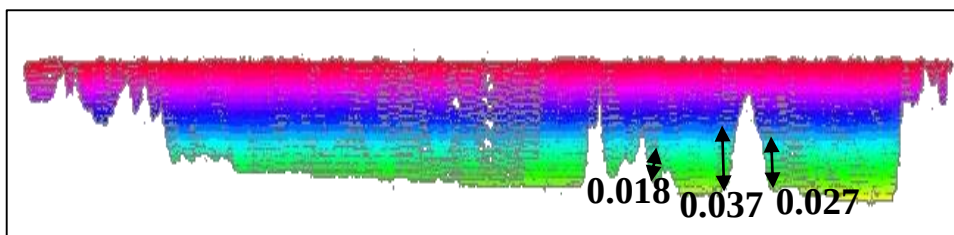
3. Abutment wall damage observed on LHS A1, measuring 0.37 m in length and 0.35 m in width, covering an area of 0.13 m<sup>2</sup>. Depth ranges from 0.018 (min) to 0.037 m (max), with an average depth of 0.027 m. The calculated volume of the distress is 0.003 m<sup>3</sup>.
