# **LIDAR Inspection Report of VUP ch.911+160**

**Bridge Chainage:** 911+160 (CKRP)

**Latitude/Longitude:** 24.934503,74.690150

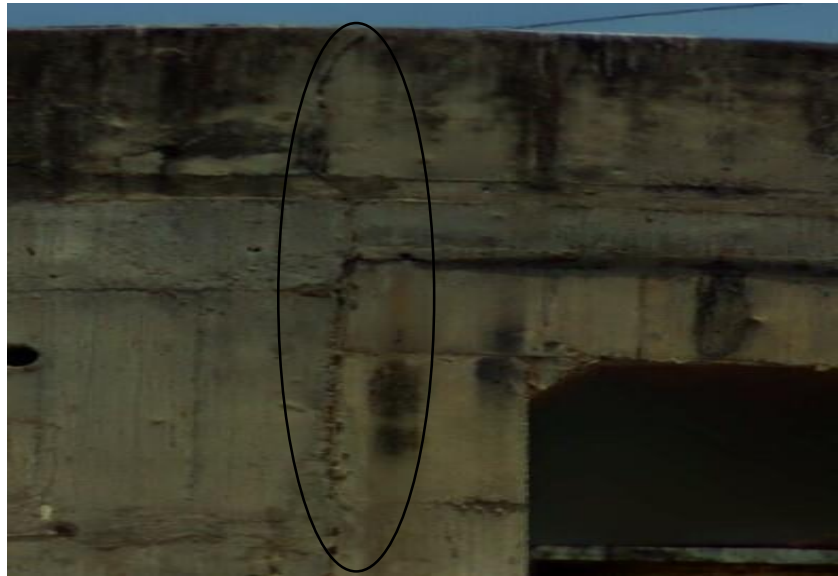
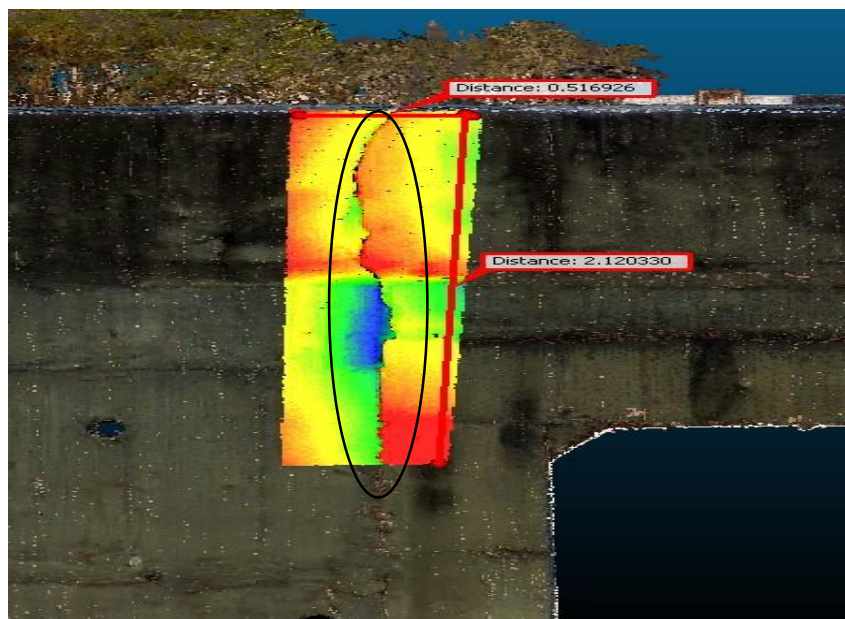
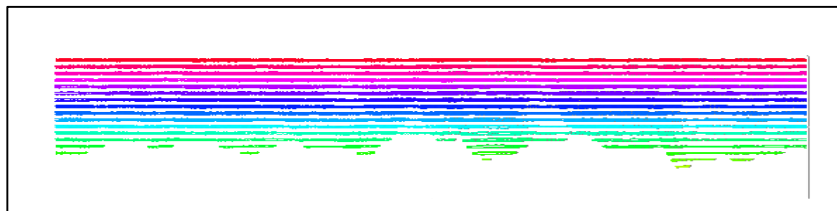
| Element Name | Observation | Location of Distress | Photo No. | Units | Distress Details | | | Area of Repair<br>(Sq.m/R<br>MT/m3) |
|---|---|---|---|---|---|---|---|---|
| Abutment 2 | Damage | - | 1 | M | 2.12 | 0.51 | - | 1.081 |

**1. Wing wall damage observed on LHS A2, measuring 2.12 m in length and 0.51 m in width, covering an area of 1.081 m<sup>2</sup>.**
