# LIDAR Inspection Report of **Box Culvert** ch.911+523

**Bridge Chainage:** 911+523(CKRP)

# **CH: 911+523 – Box CULVERT**

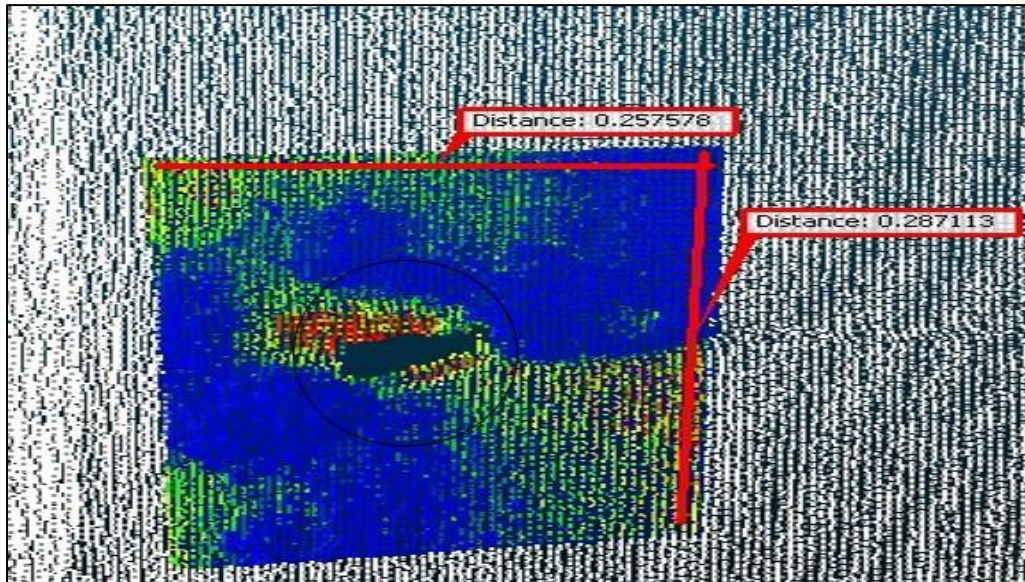
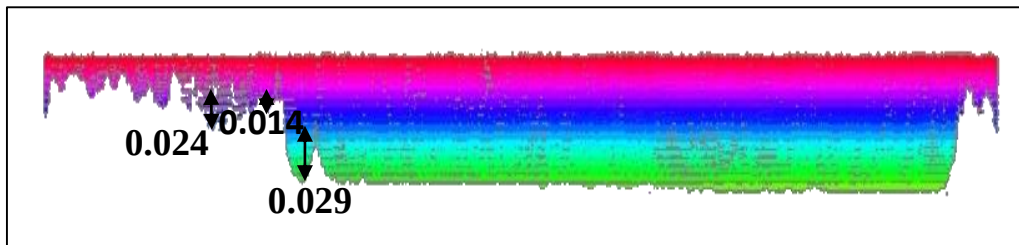
1. Wing wall damage observed on LHS, measuring 0.25 m in length and 0.28 m in width, covering an area of 0.07 m<sup>2</sup>. Depth ranges from 0.014 (min) to 0.029 m (max), with an average depth of 0.024 m. The calculated volume of the distress is 0.001m<sup>3</sup>.

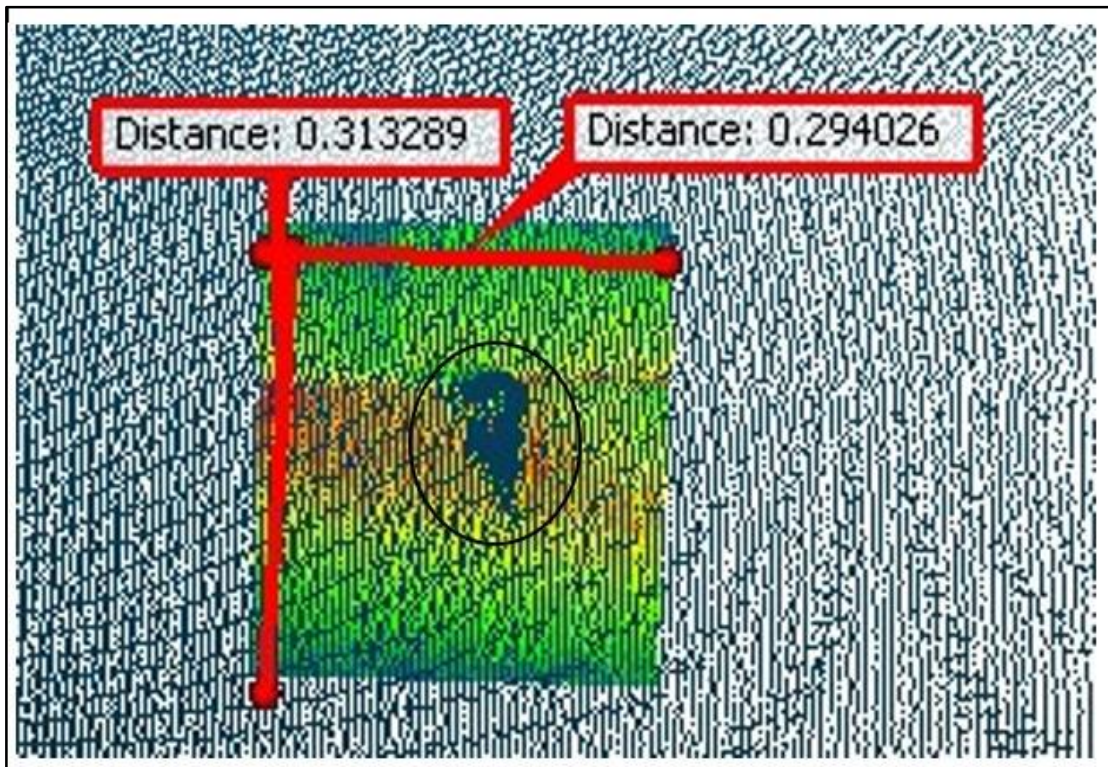
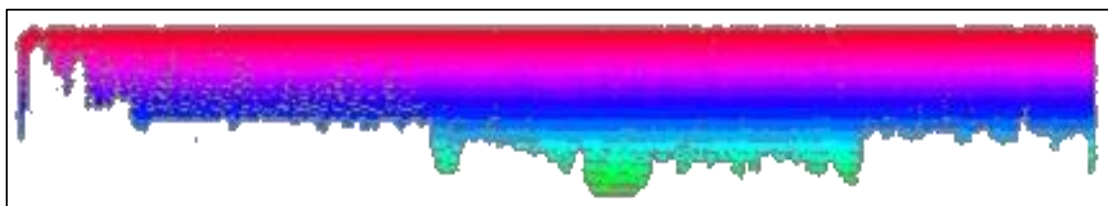
2. Wing wall damage observed on LHS A1 HP 7, measuring 0.31 m in length and 0.29 m in width, covering an area of 0.0899 m<sup>2</sup>.
