# **LIDAR Inspection Report of Box Culvert ch.911+595**

**Bridge Chainage:** 911+595

- **Bridge No:** -
- **Chainage:** 911+595
- **Structure type:** Box Culvert

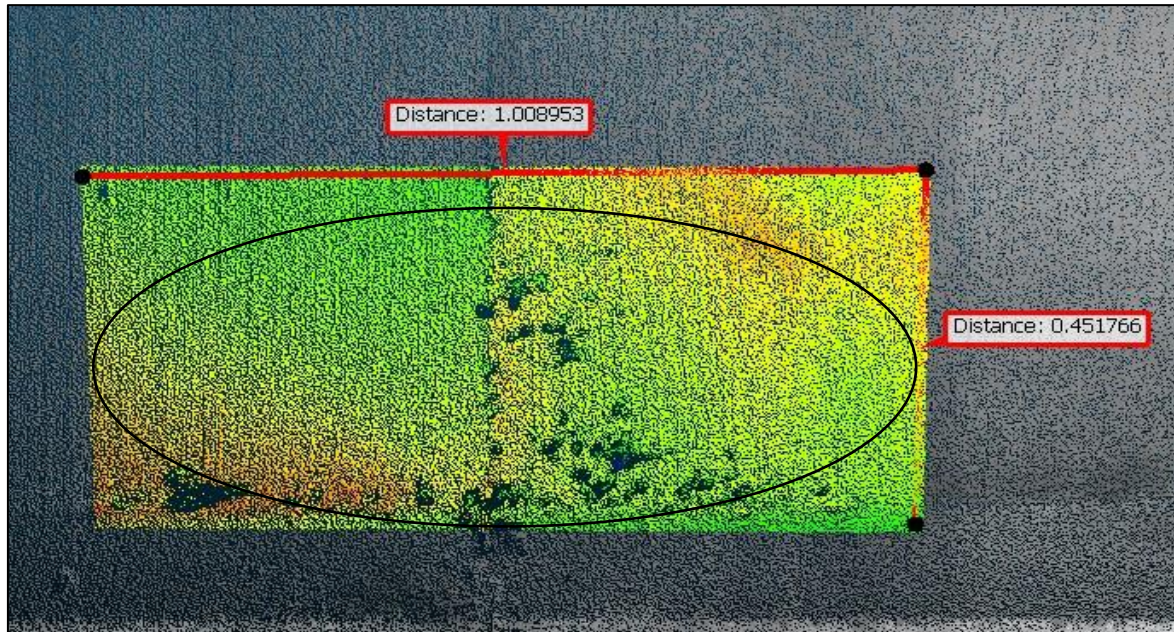
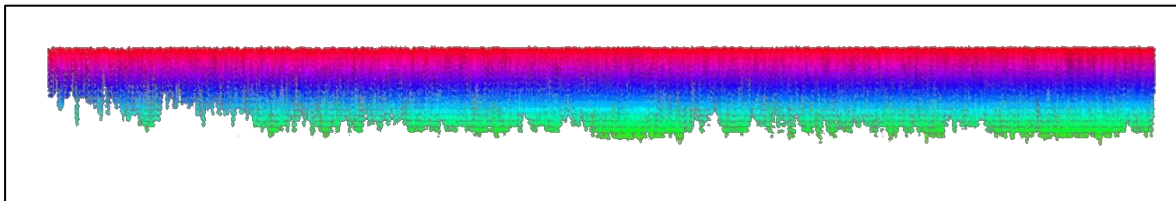
| Element Name | Observation | Location of Distress | Photo No. | Units | Distress Details | | | Area of Repair (Sq.m/R MT/m3) |
|---|---|---|---|---|---|---|---|---|
| Abutment 1 | Scalling | - | 1 | Sq m | 1.008 | 0.45 | - | 0.45 |

**1. Scaling observed on Abutment 1 LHS side, measuring 1.008 m in length and 0.45 m in width, covering an area of 0.45 m<sup>2</sup>.**

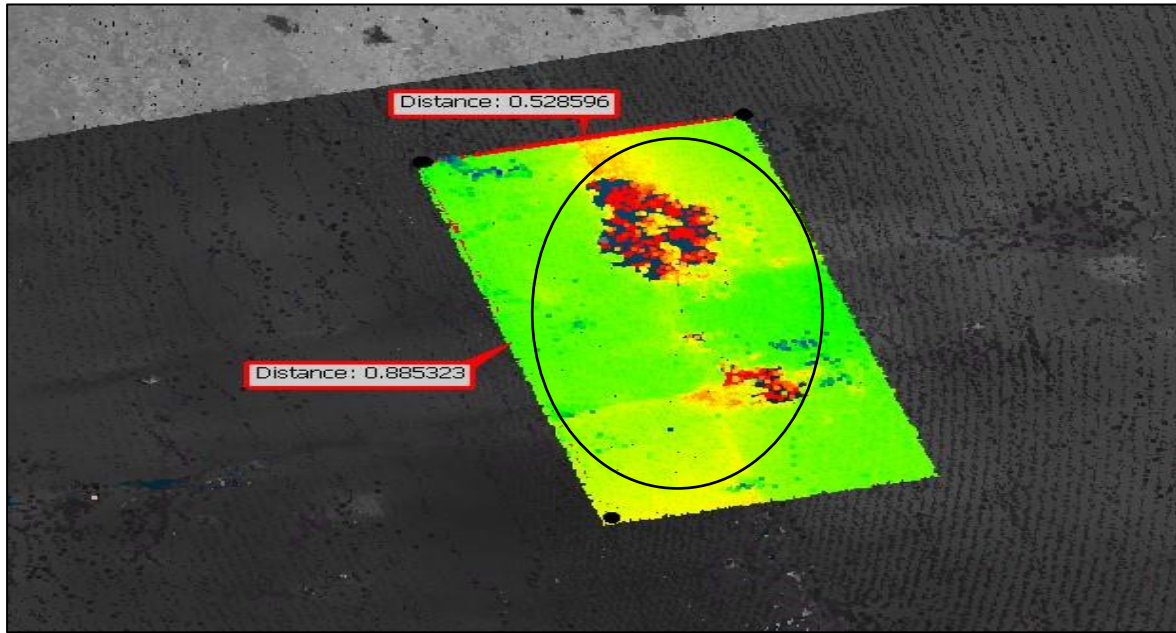
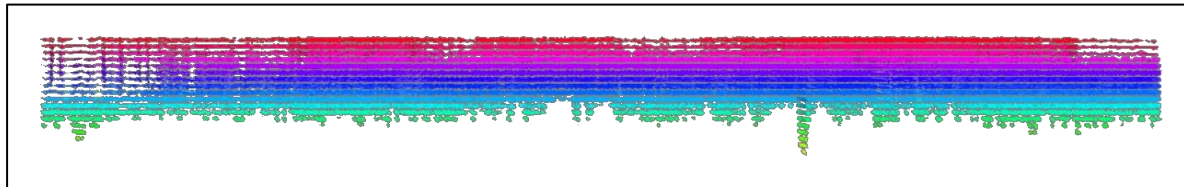
| Element Name | Observation | Location of Distress | Photo No. | Units | Distress Details | | | Area of Repair (Sq.m/R MT/m3) |
|---|---|---|---|---|---|---|---|---|
| Deck Slab | Spalling | - | 2 | Sq m | 0.88 | 0.52 | - | 0.45 |

**2.Spalling observed on deck of slab RHS side, measuring 0.88 m in length and 0.52 m in width, covering an area of 0.45 m<sup>2</sup>.**
