# **LIDAR Inspection Report of VUP ch.913+100**

**Bridge Chainage:** 913+100 (CKRP)

- **Bridge No:** -
- **Chainage:** 913+100
- **Structure type:** VUP

- **CKRP:** Chittorgarh to kota
- **State:** Rajasthan NH 27
- **Zone:** RJ-06

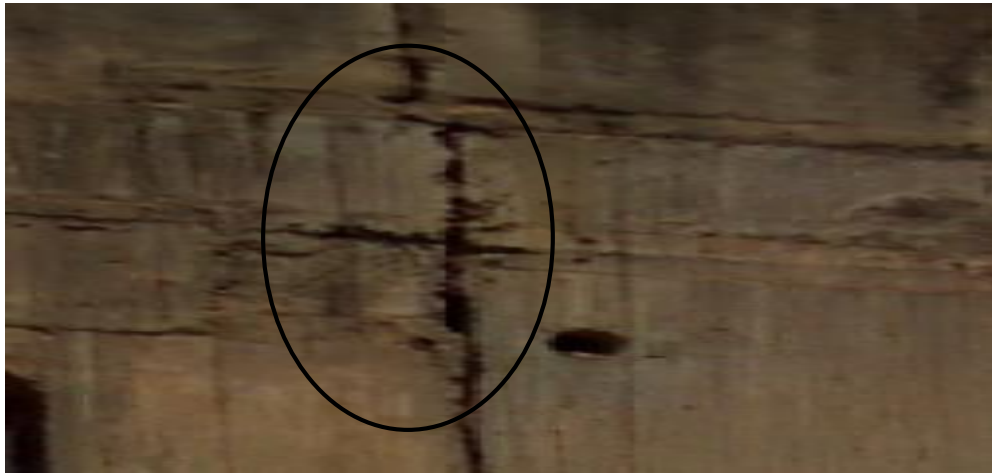
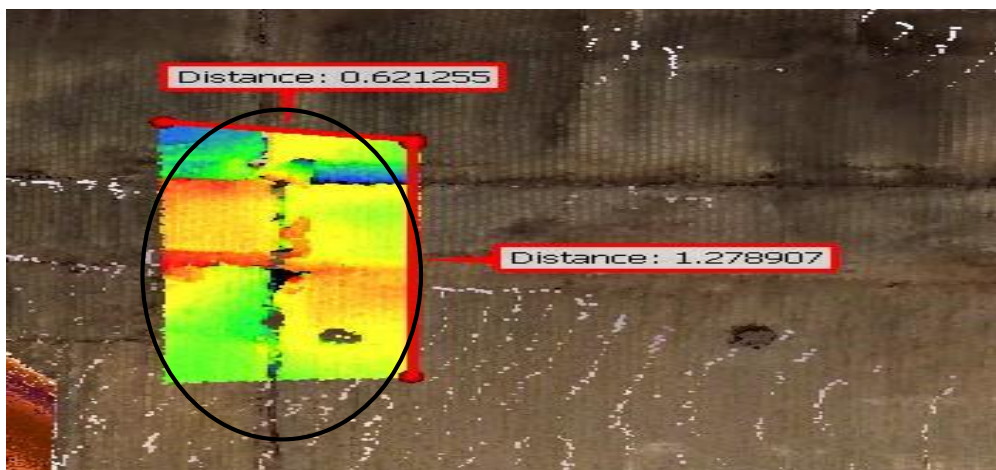
| Element Name | Observation | Location of Distress | Photo No. | Units | Distress Details | | | Area of Repair (Sq.m/ RMT/ m3) |
|---|---|---|---|---|---|---|---|---|
| Abutment 1 | Damage | - | 1 | M | 0.62 | 1.27 | | 0.7874 |

**1. Damage observed on LHS Abutment 1 Wing Wall, measuring 0.62 m in length and 1.27 m in width, covering an area of 0.7874 m<sup>2</sup>.**

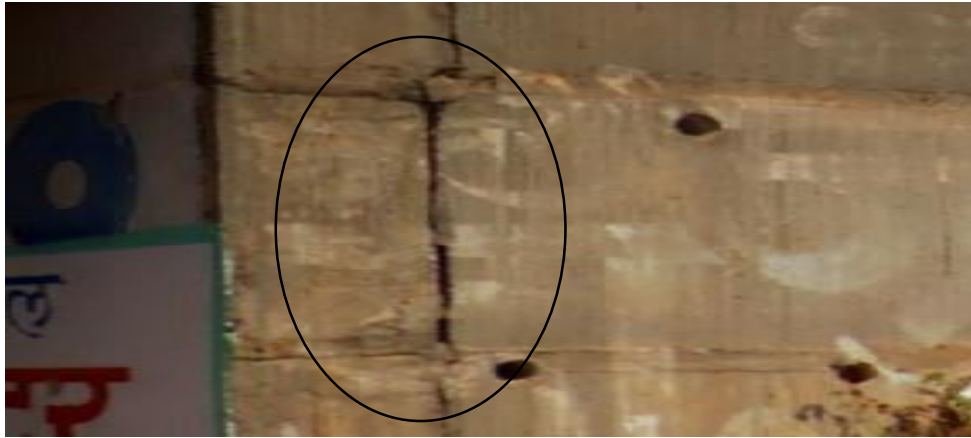
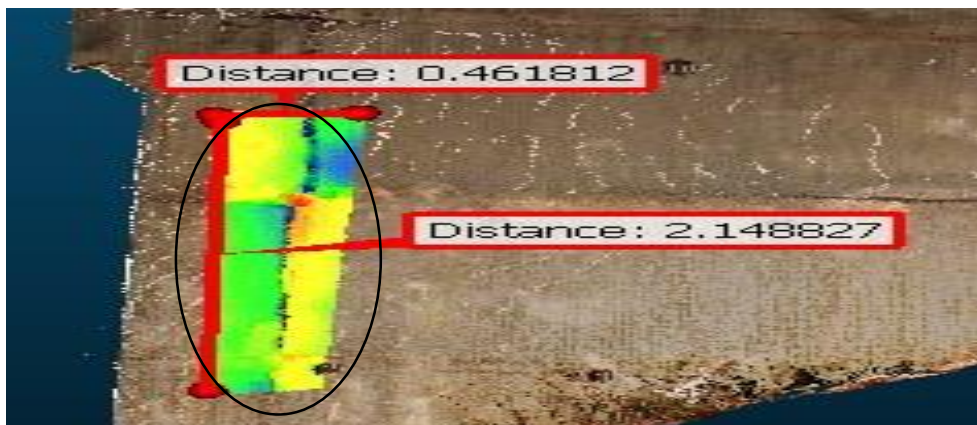
| Element Name | Observation | Location of Distress | Photo No. | Units | Distress Details | | | Area of Repair (Sq.m/ RMT/ m3) |
|---|---|---|---|---|---|---|---|---|
| Abutment 1 | Crack | - | 2 | M | 0.46 | 2.14 | | 0.9844 |

**2. Crack observed on LHS Abutment 1 Wall, measuring 0.46 m in length and 2.14 m in width, covering an area of 0.9844 m<sup>2</sup>.**

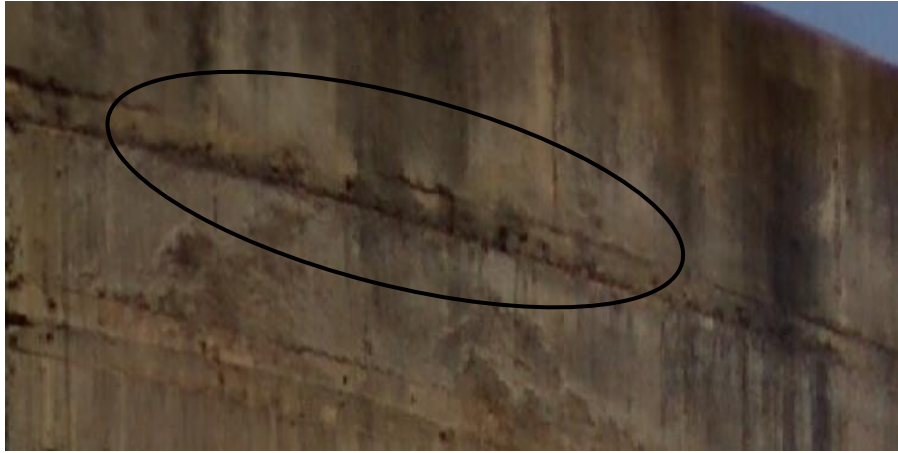
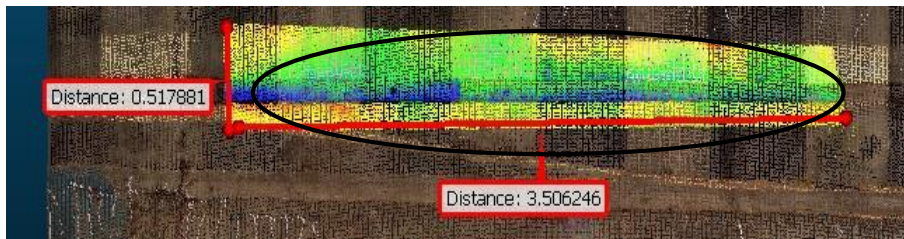
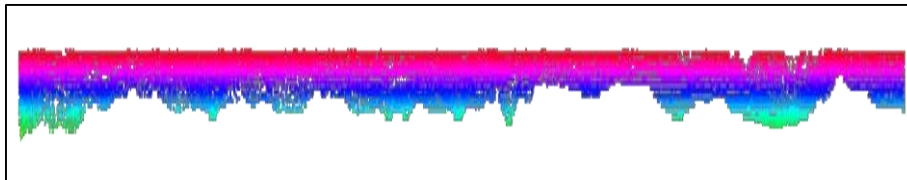
| Element Name | Observation | Location of Distress | Photo No. | Units | Distress Details | | | Area of Repair (Sq.m/ RMT/ m3) |
|---|---|---|---|---|---|---|---|---|
| Abutment 1 | Scaling | | 3 | M | 3.50 | 0.51 | | 1.78 |

**3. Scaling observed on LHS Abutment 1 Wall, measuring 3.50 m in length and 0.51 m in width, covering an area of 1.78 m<sup>2</sup>.**

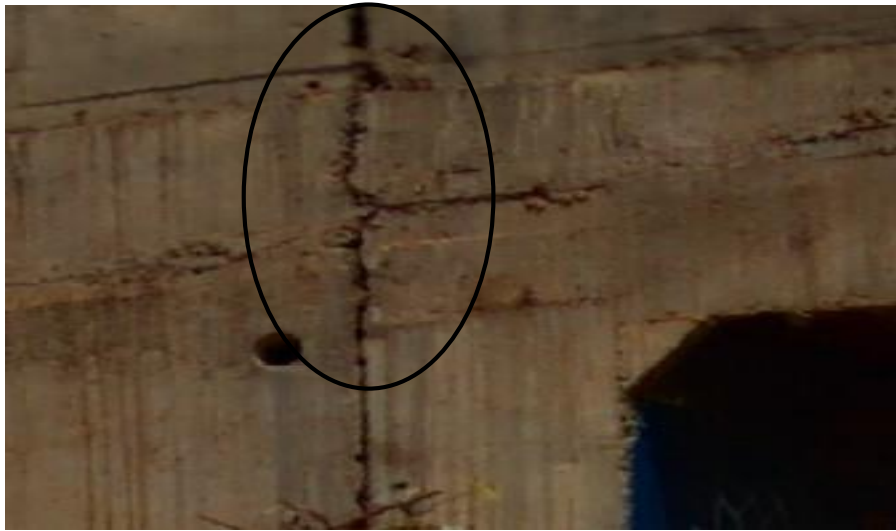
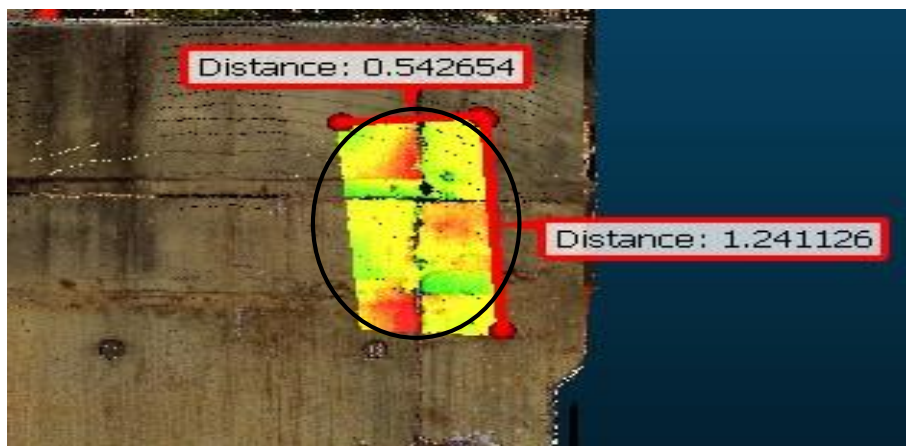
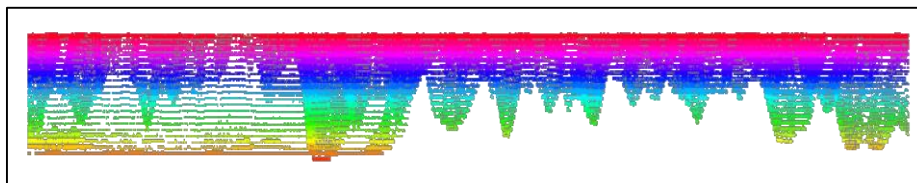
| Element Name | Observation | Location of Distress | Photo No. | Units | Distress Details | | | Area of Repair (Sq.m/ RMT/ m3) |
|---|---|---|---|---|---|---|---|---|
| Abutment 2 | Damage | | 4 | M | 0.54 | 1.24 | | 0.6696 |

**4.Damage observed on LHS Abutment 2 Wing Wall, measuring 0.54 m in length and 1.24 m in width, covering an area of 0.6696 m<sup>2</sup>.**

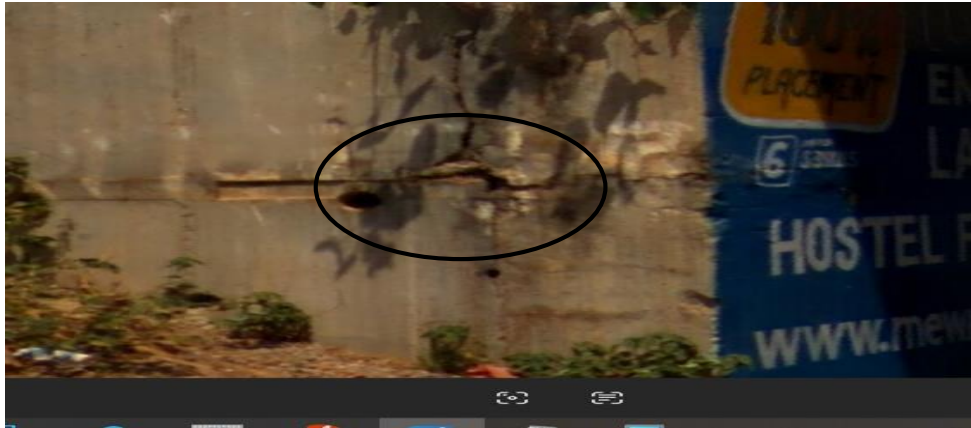
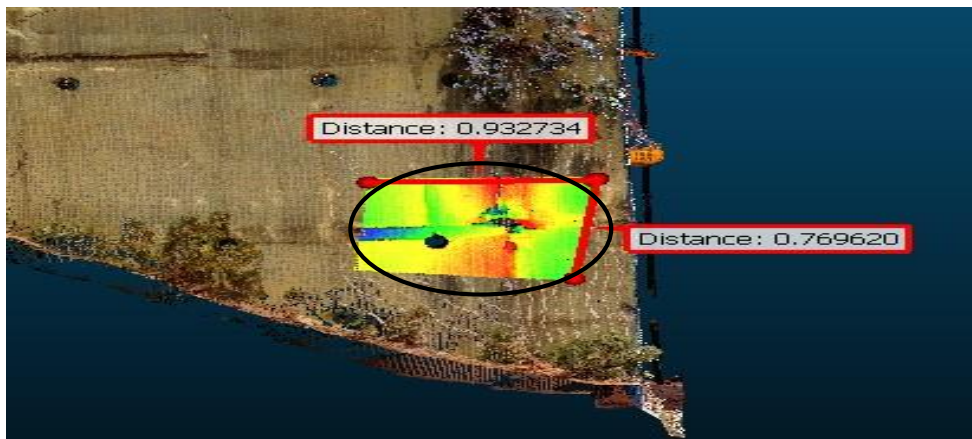
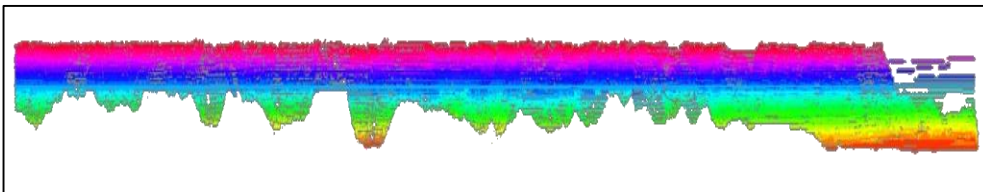
| Element Name | Observation | Location of Distress | Photo No. | Units | Distress Details | | | Area of Repair (Sq.m/ RMT/ m3) |
|---|---|---|---|---|---|---|---|---|
| Abutment 2 | Damage | | 5 | M | 0.93 | 0.76 | | 0.7068 |

**5. Damage observed on LHS Abutment 2 Wing Wall, measuring 0.93 m in length and 0.76 m in width, covering an area of 0.7068 m<sup>2</sup>.**

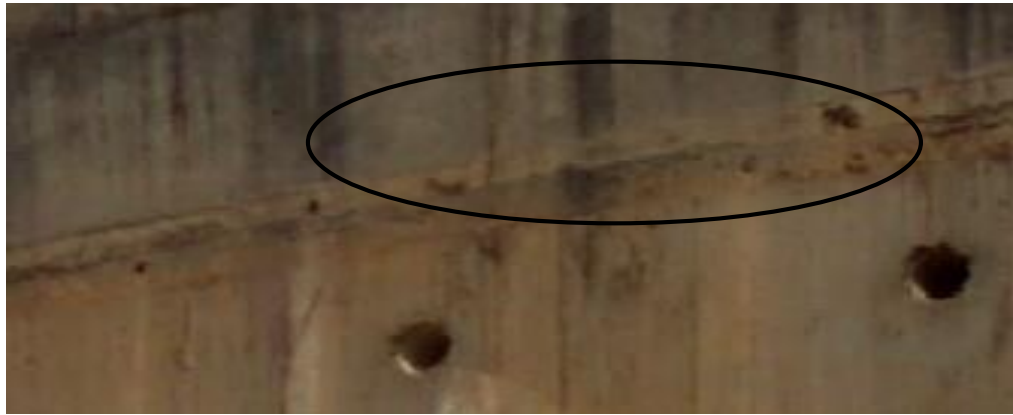
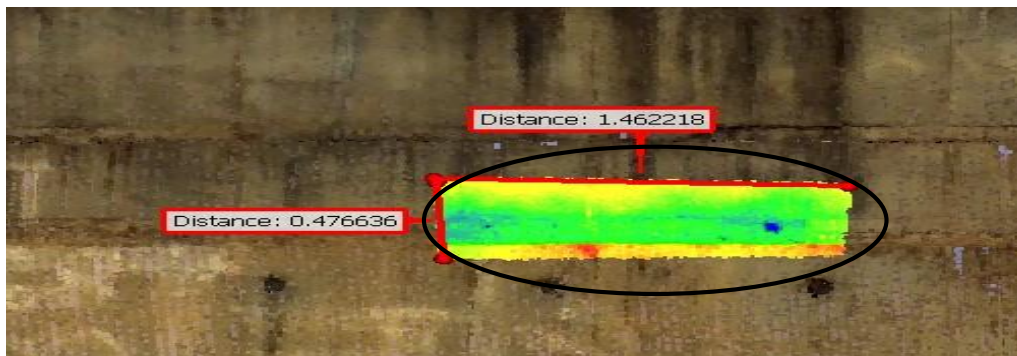
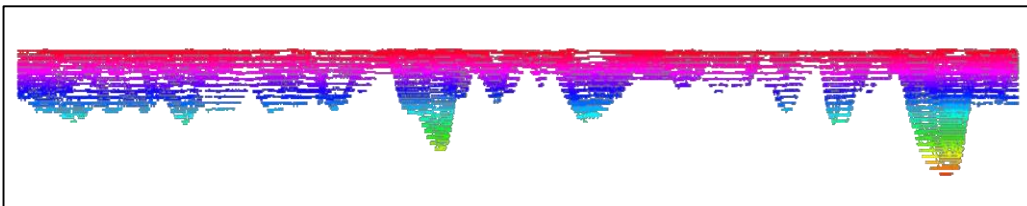
| Element Name | Observation | Location of Distress | Photo No. | Units | Distress Details | | | Area of Repair (Sq.m/ RMT/ m3) |
|---|---|---|---|---|---|---|---|---|
| Abutment 2 | Damage | | 6 | M | 1.46 | 0.47 | | 0.6862 |

**6. Damage observed on LHS Abutment 2 Wall, measuring 1.46 m in length and 0.47 m in width, covering an area of 0.6862 m<sup>2</sup>.**

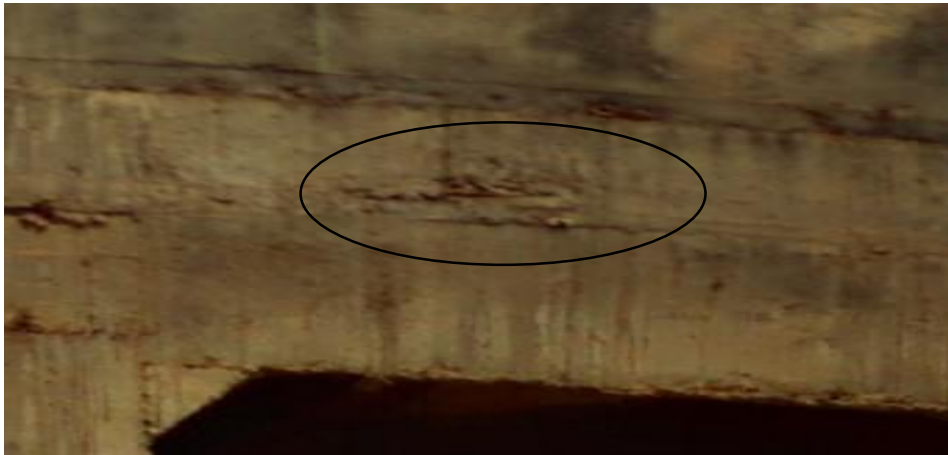
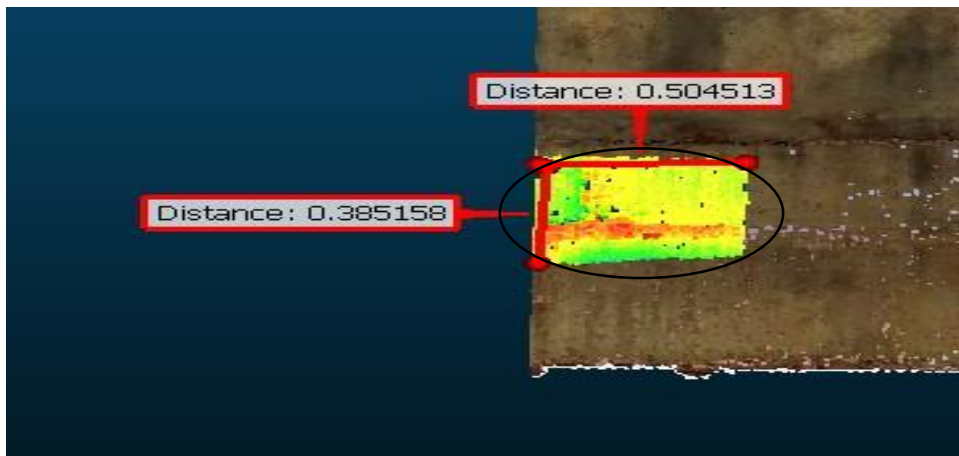
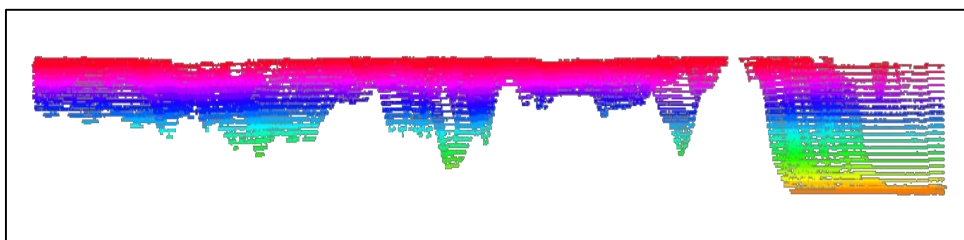
| Element Name | Observation | Location of Distress | Photo No. | Units | Distress Details | | | Area of Repair (Sq.m/ RMT/ m3) |
|---|---|---|---|---|---|---|---|---|
| Deck Slab | Scaling | | 7 | M | 0.50 | 0.38 | | 0.19 |

**7. Scaling observed on LHS deck slab, measuring 0.50 m in length and 0.38 m in width, covering an area of 0.19 m<sup>2</sup>.**

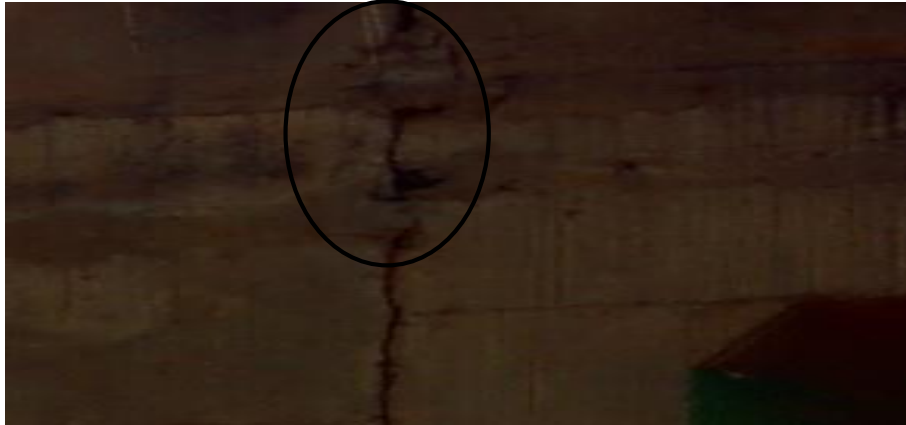
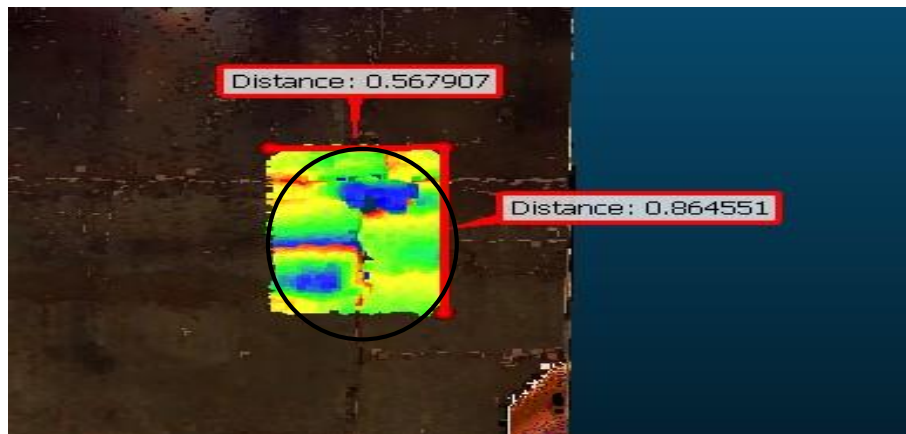
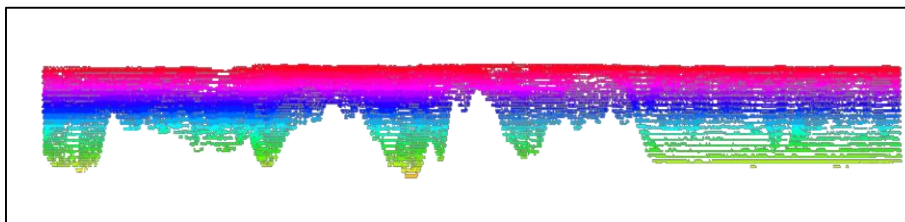
| Element Name | Observation | Location of Distress | Photo No. | Units | Distress Details | | | Area of Repair (Sq.m/ RMT/ m3) |
|---|---|---|---|---|---|---|---|---|
| Abutment 1 | Damage | - | 8 | M | 0.56 | 0.86 | | 0.4816 |

**8. Damage observed on RHS Abutment 1 wing Wall, measuring 0.56 m in length and 0.86 m in width, covering an area of 0.4816 m<sup>2</sup>.**

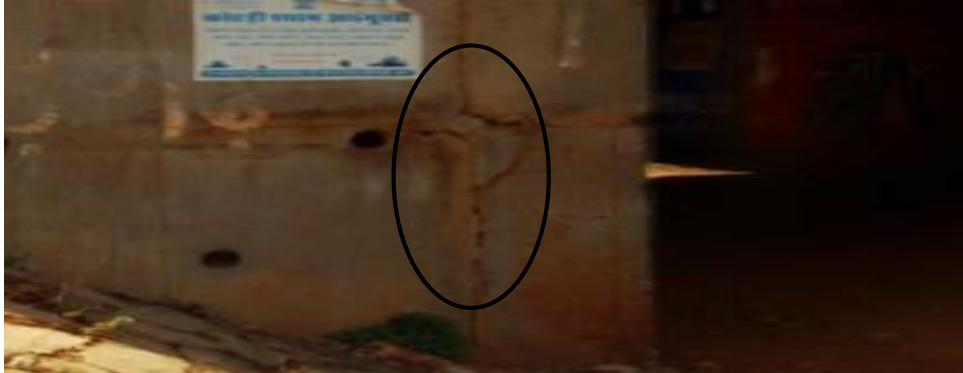
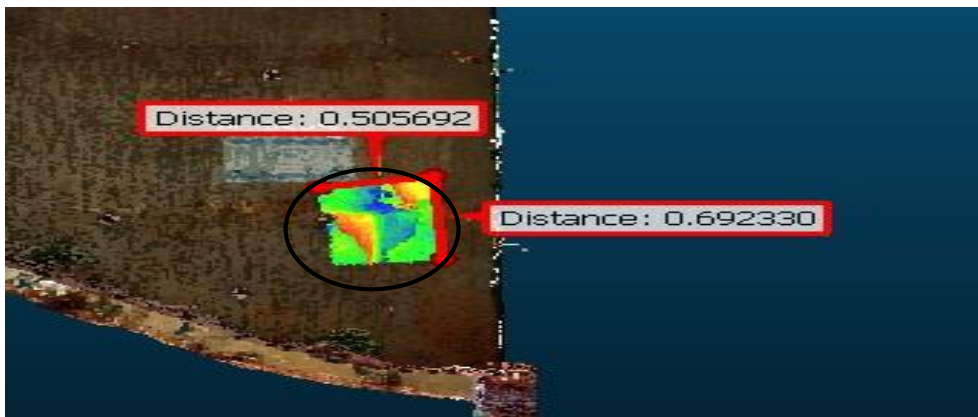
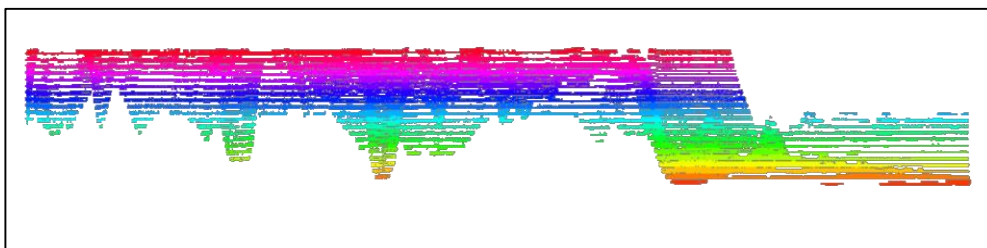
| Element Name | Observation | Location of Distress | Photo No. | Units | Distress Details | | | Area of Repair (Sq.m/ RMT/ m3) |
|---|---|---|---|---|---|---|---|---|
| Abutment 1 | Crack | | 9 | M | 0.50 | 0.69 | | 0.345 |

**9. Crack observed on RHS Abutment 1 Wall, measuring 0.50 m in length and 0.69 m in width, covering an area of 0.345 m<sup>2</sup>.**

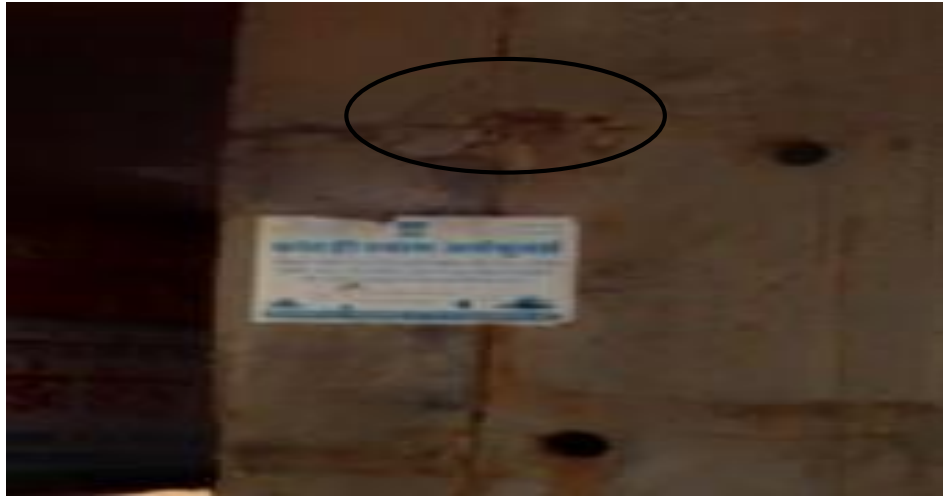
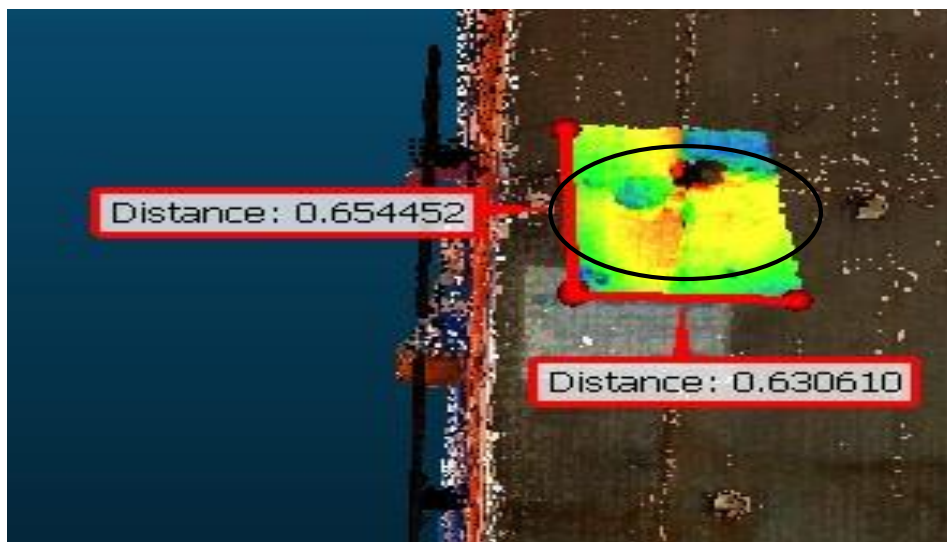
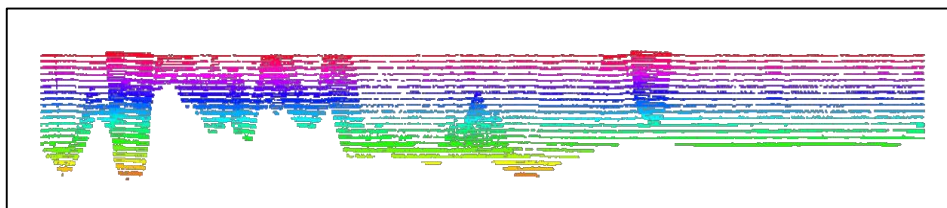
| Element Name | Observation | Location of Distress | Photo No. | Units | Distress Details | | | Area of Repair (Sq.m/ RMT/ m3) |
|---|---|---|---|---|---|---|---|---|
| Abutment 2 | Damage | | 10 | M | 0.63 | 0.65 | | 0.4095 |

**10. Damage observed on RHS Abutment 2 Wall, measuring 0.63 m in length and 0.65 m in width, covering an area of 0.4095 m<sup>2</sup>.**
