# **LIDAR Inspection Report of **Box Culvert** ch.913+196**

**Bridge Chainage:** 913+196(CKRP)

- **CKRP:** Chittorgarh to kota
- **State:** Rajasthan NH 27
- **Zone:** RJ-06

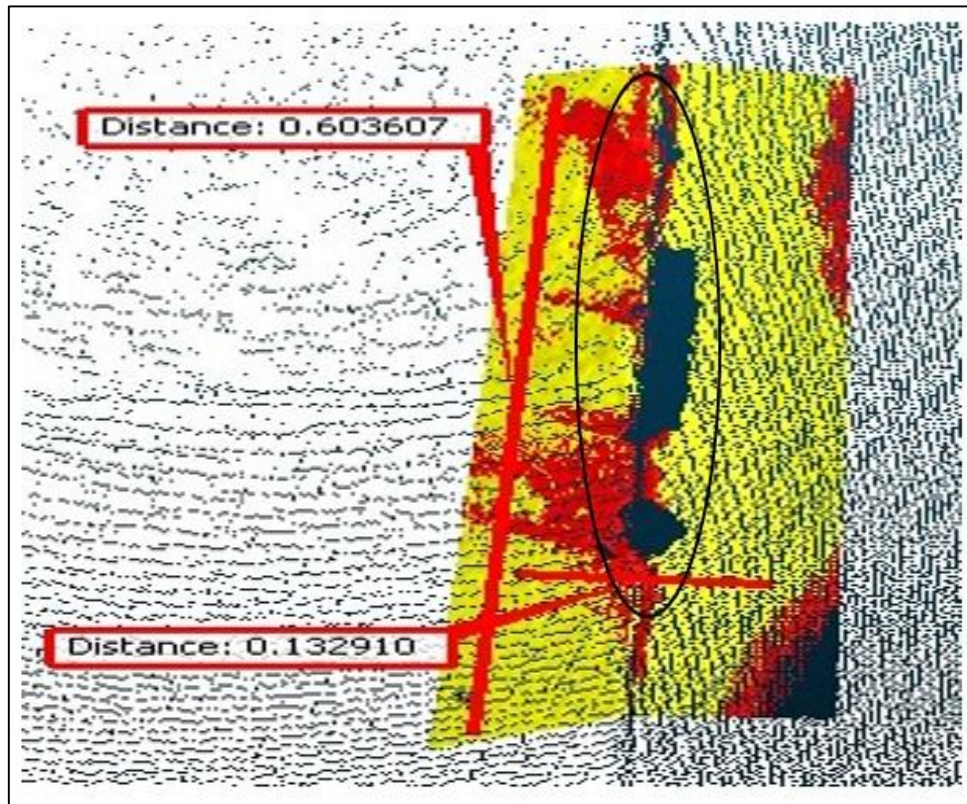
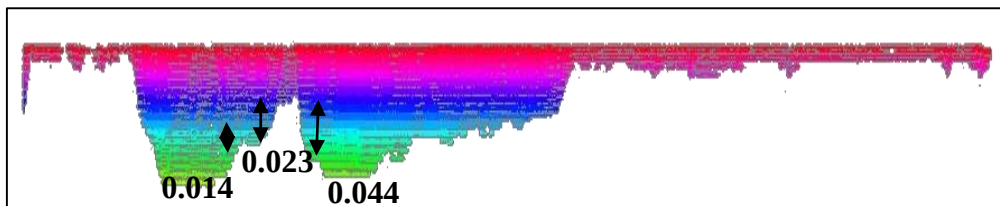
| Sl. No. | Description | Distress Notation | Observation | Location | | Distress Details | | | Area of Repair |
|---|---|---|---|---|---|---|---|---|---|
| 3 | Wing wall | | Damage | | | | | | |

1. Wing wall damage observed on LHS, measuring 0.60 m in length and 0.13 m in width, covering an area of 0.07 m<sup>2</sup>. Depth ranges from 0.014 (min) to 0.044 m (max), with an average depth of 0.023 m. The calculated volume of the distress is 0.0017 m

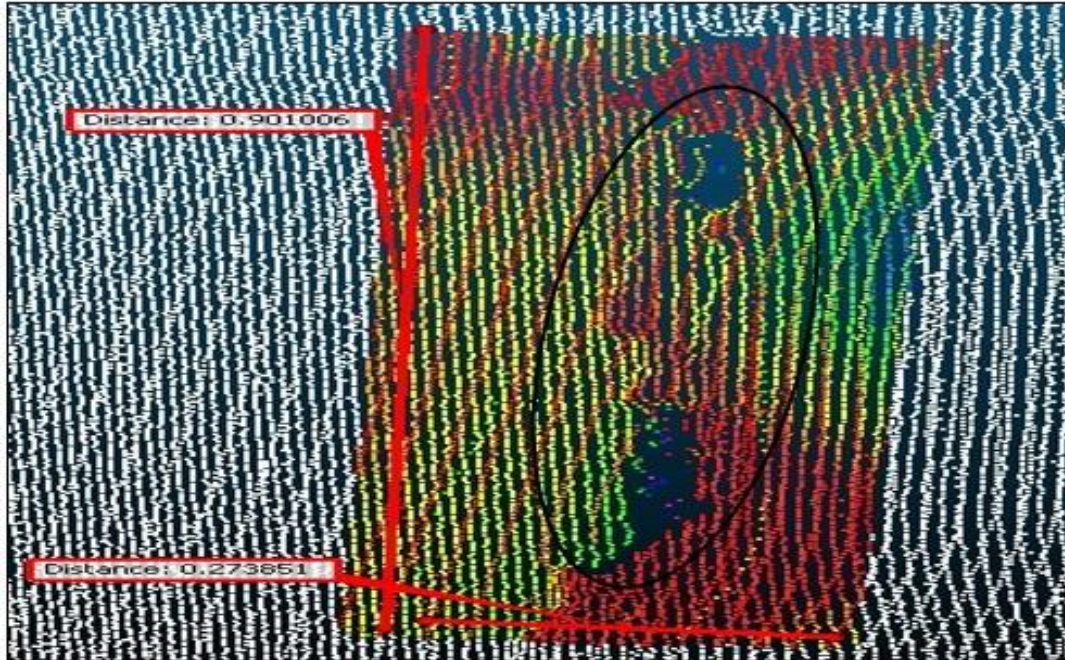
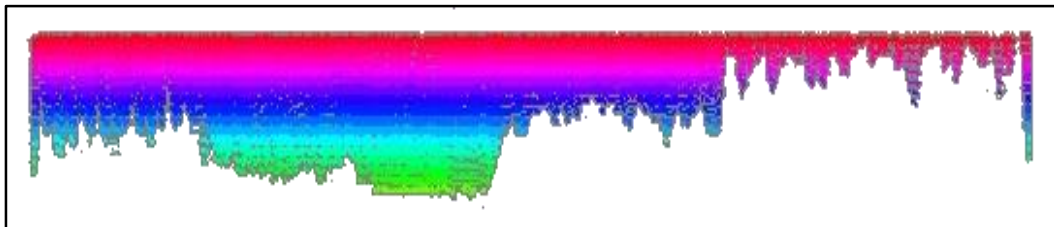
- 2. Abutment wall damage observed on LHS Abutment, measuring 0.90 m in length and 0.27 m in width, covering an area of 0.243 m<sup>2</sup>.**

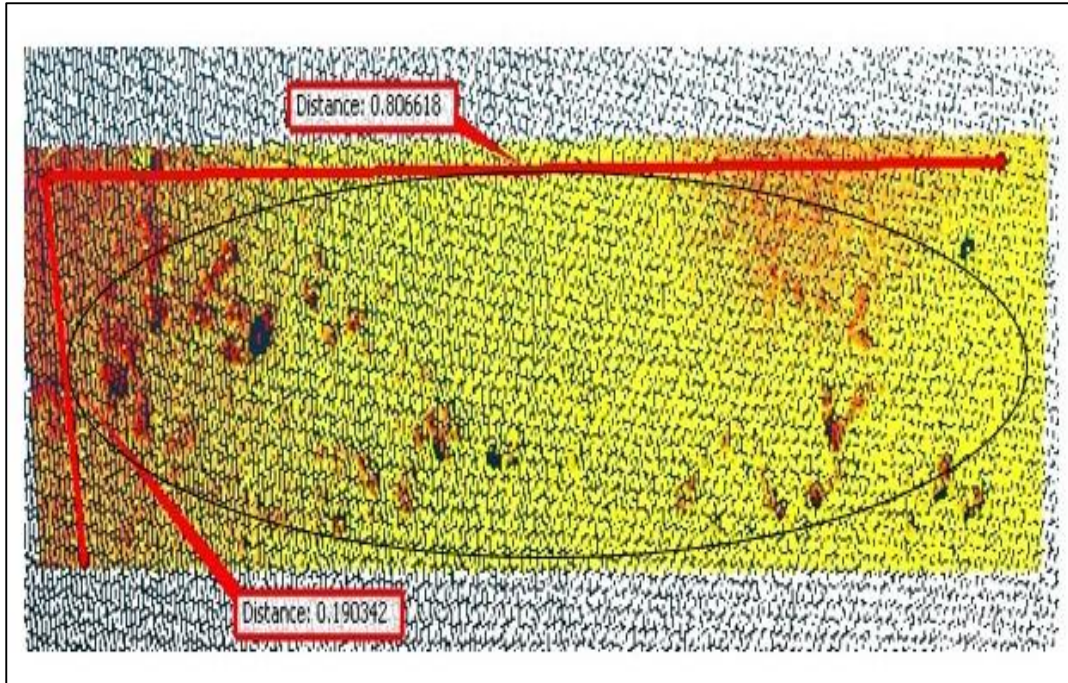
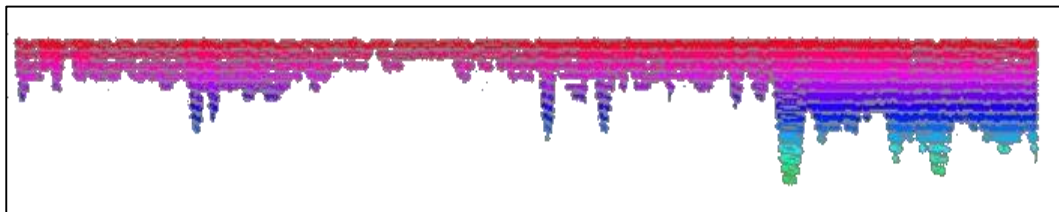
- 3. Abutment wall scaling observed on LHS A1, measuring 0.80 m in length and 0.19 m in width, covering an area of 0.152 m<sup>2</sup>.**
