# **LIDAR Inspection Report of Box Culvert ch.913+599**

**Bridge Chainage:** 913+599

- **Bridge No:** -
- **Chainage:** 913+599
- **Structure type:** Box Culvert

# **CH: 913+599 BOX CULVERT**

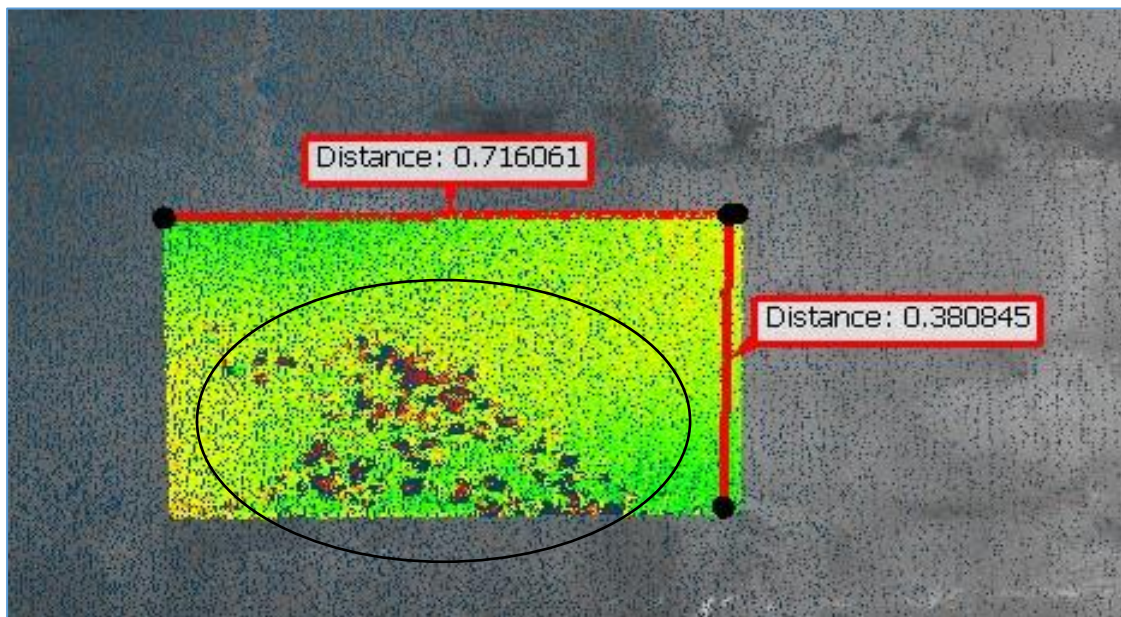
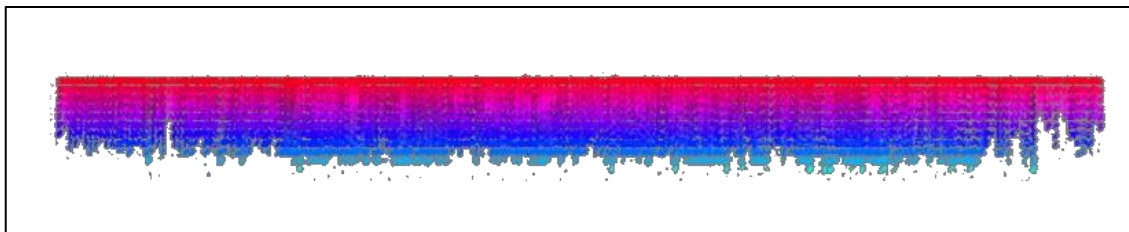
| Element Name | Observation | Location of Distress | Photo No. | Units | Distress Details | | | Area of Repair (Sq.m/R MT/m3) |
|---|---|---|---|---|---|---|---|---|
| Abutment 1 | Scalling | - | 1 | Sq m | 0.71 | 0.38 | - | 0.26 |

**1. Scaling observed on Abutment 1, measuring 0.71 m in length and 0.38 m in width, covering an area of 0.26 m<sup>2</sup>.**

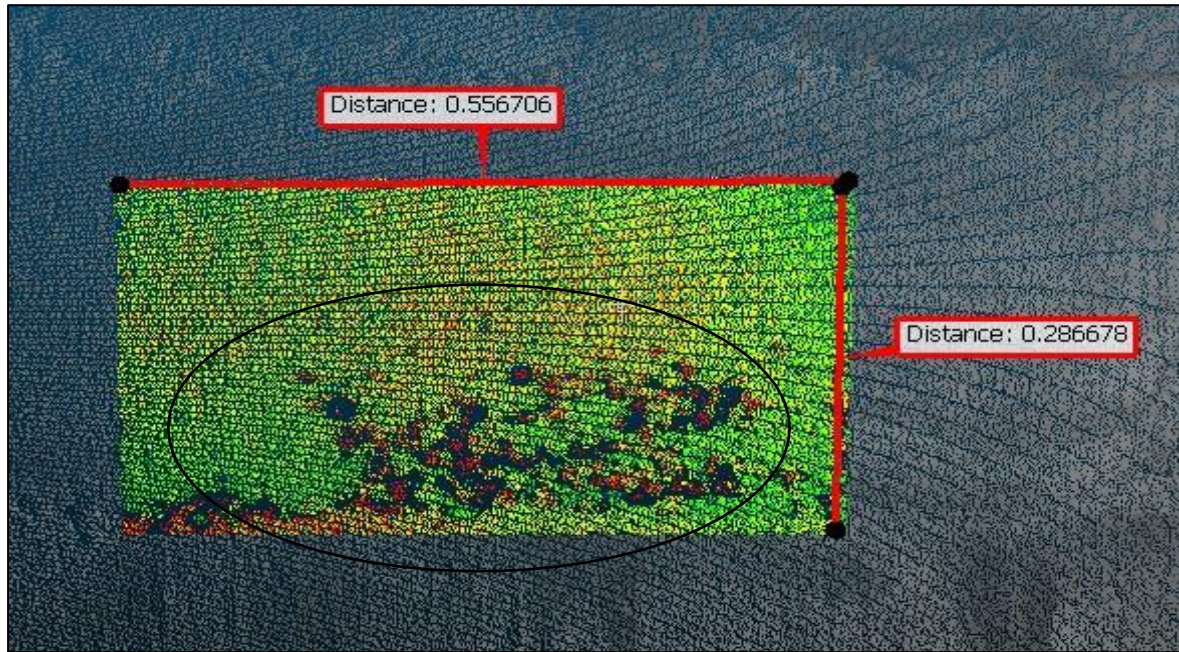
| Element Name | Observation | Location of Distress | Photo No. | Units | Distress Details | | | Area of Repair (Sq.m/R MT/m3) |
|---|---|---|---|---|---|---|---|---|
| Abutment 2 | Scalling | - | 2 | Sq m | 0.55 | 0.28 | - | 0.15 |

**2. Scaling observed on Abutment 2, measuring 0.55 m in length and 0.28 m in width, covering an area of 0.15 m<sup>2</sup>.**
