# LIDAR Inspection Report of **Box Culvert** ch.913+735

**Bridge Chainage:** 913+735(CKRP)

- **CKRP:** Chittorgarh to kota
- **State:** Rajasthan NH 27
- **Zone:** RJ-06

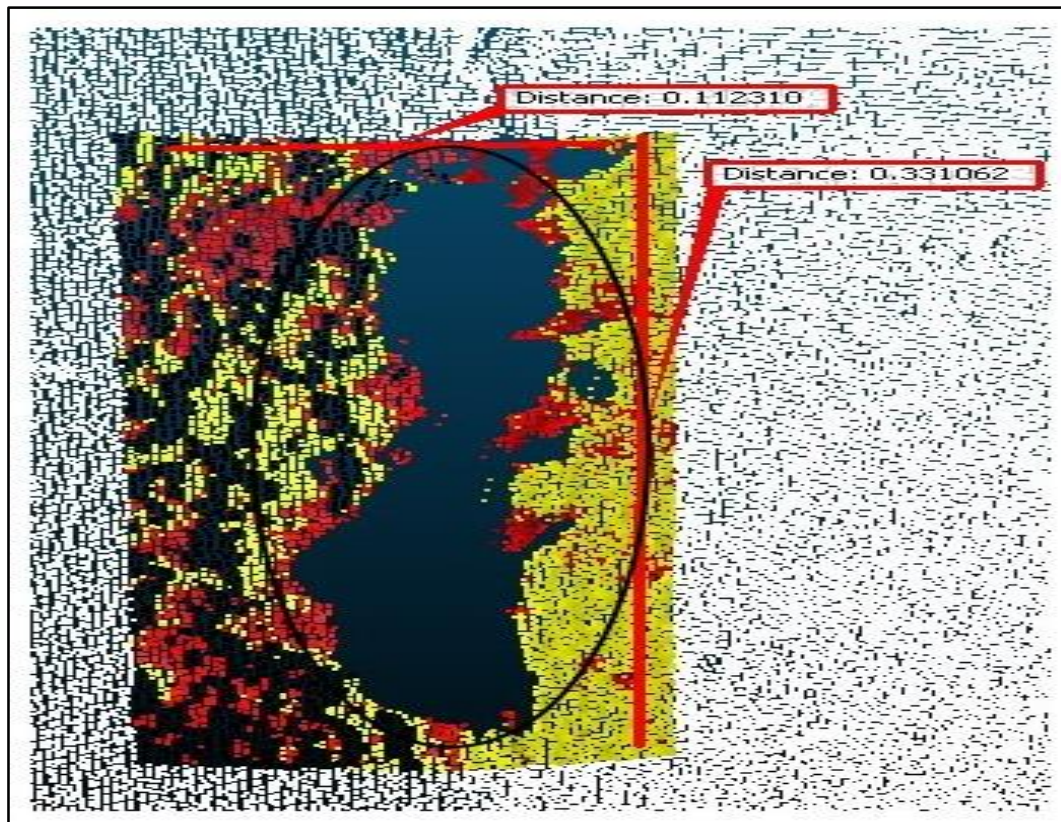
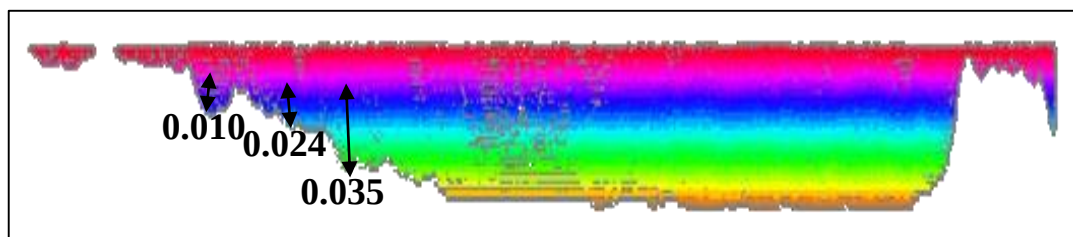
1. Wing wall damage observed on LHS, measuring 0.33 m in length and 0.11 m in width, covering an area of 0.0363 m<sup>2</sup>. Depth ranges from 0.010 (min) to 0.035 m (max), with an average depth of 0.024 m. The calculated volume of the distress is 0.0008 m<sup>3</sup>.

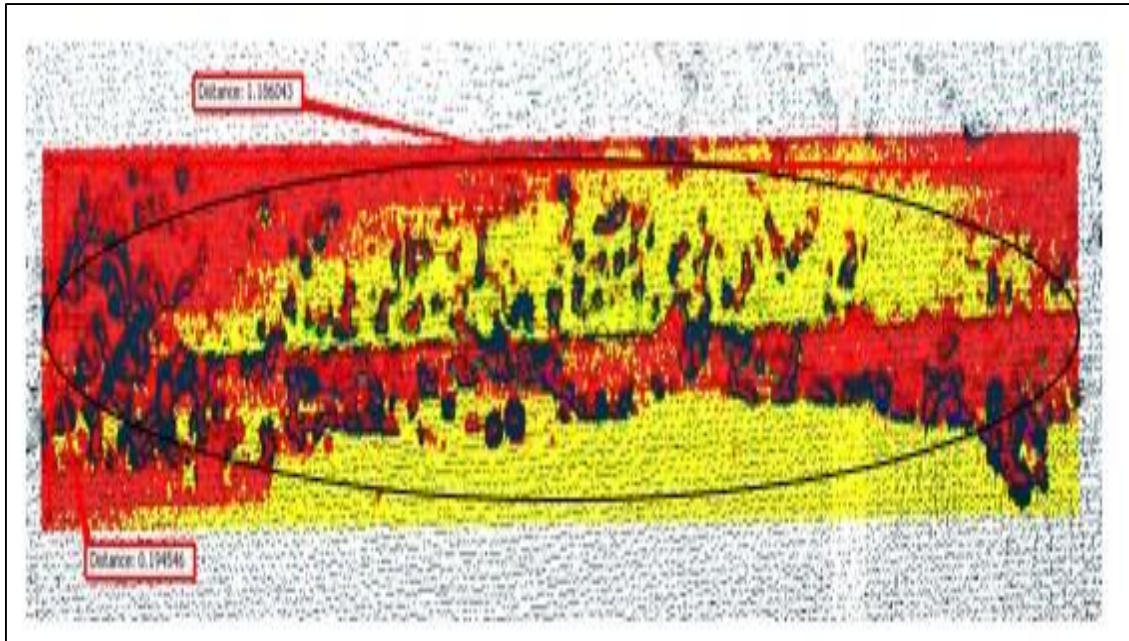
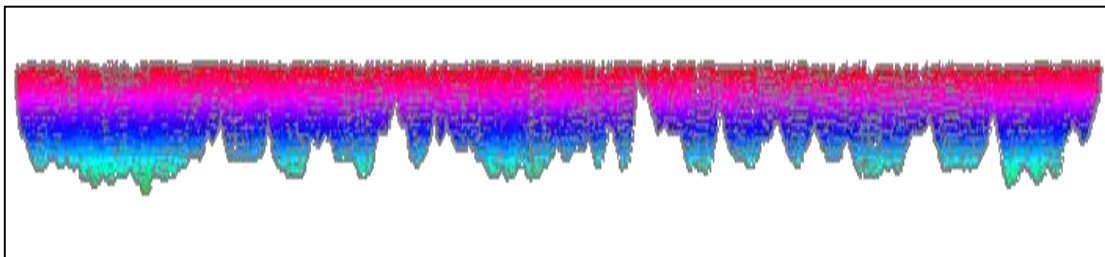
- 2. Abutment wall scaling observed on LHS A1, measuring 1.18 m in length and 0.19 m in width, covering an area of 0.2242 m<sup>2</sup>.**

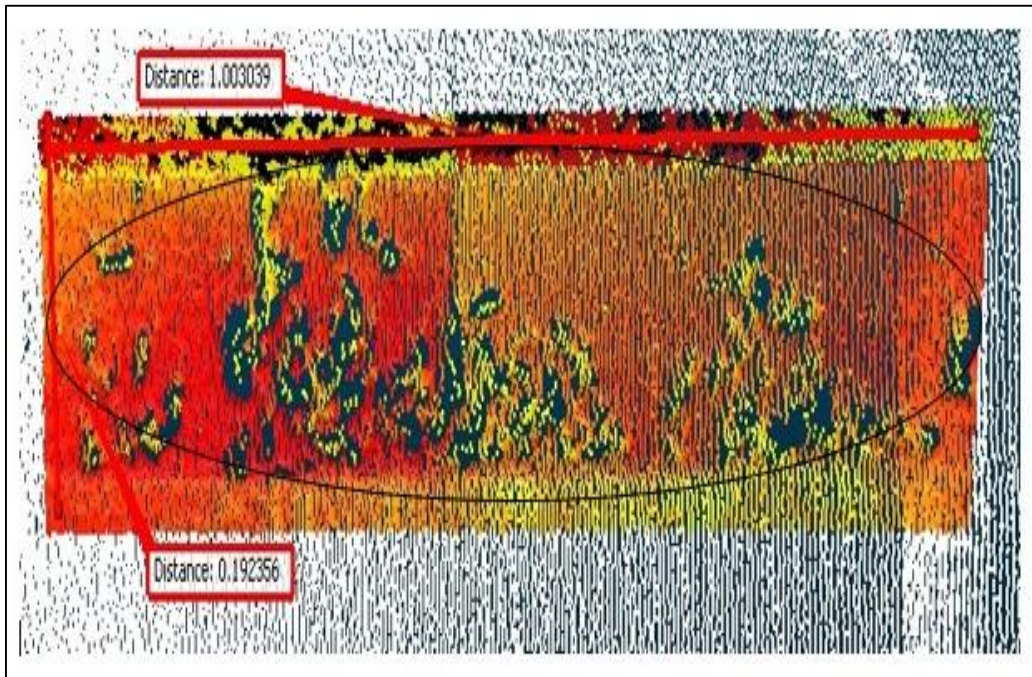
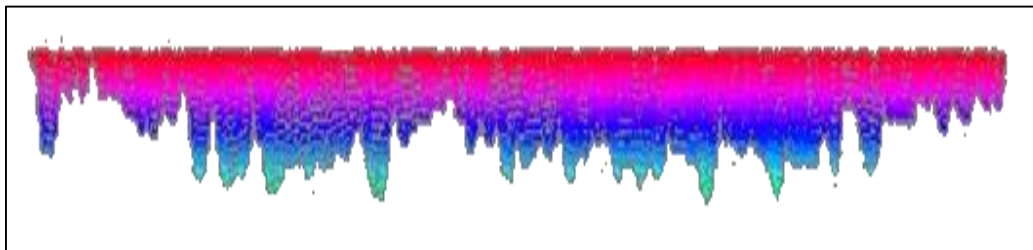
- 3. "Scaling observed on Abutment Wall, measuring 1.00 m in length and 0.19 m in width, covering an area of 0.19 m<sup>2</sup>."**
