# **LIDAR Inspection Report of MNB ch.914 + 260**

**Bridge No:** MNB -915/1

**Bridge Chainage:** 914 + 260 (CKRP)

- **CKRP:** Chittorgarh to kota
- **State:** Rajasthan NH 27
- **Zone:** RJ-06

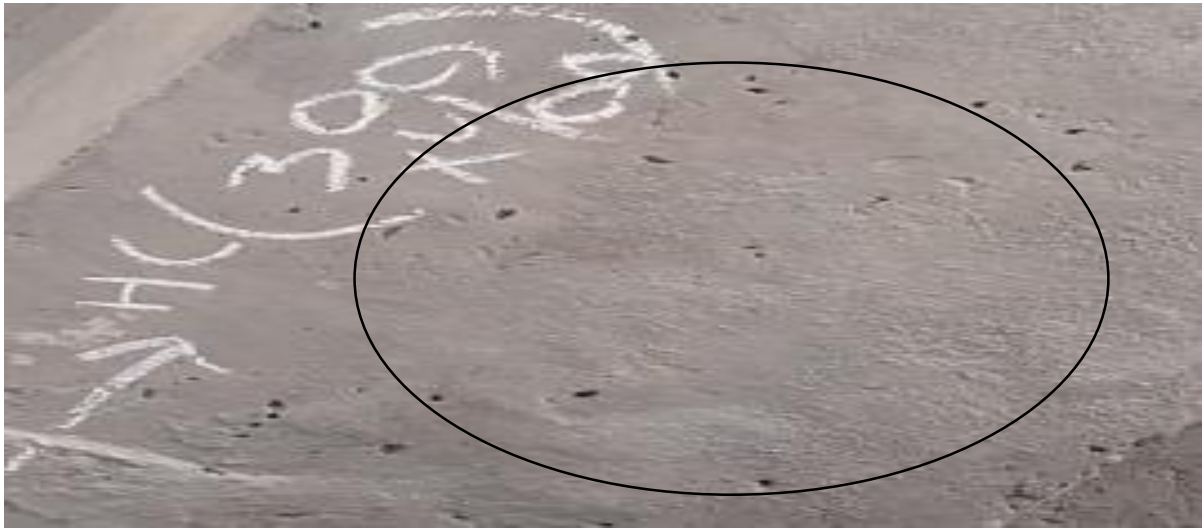
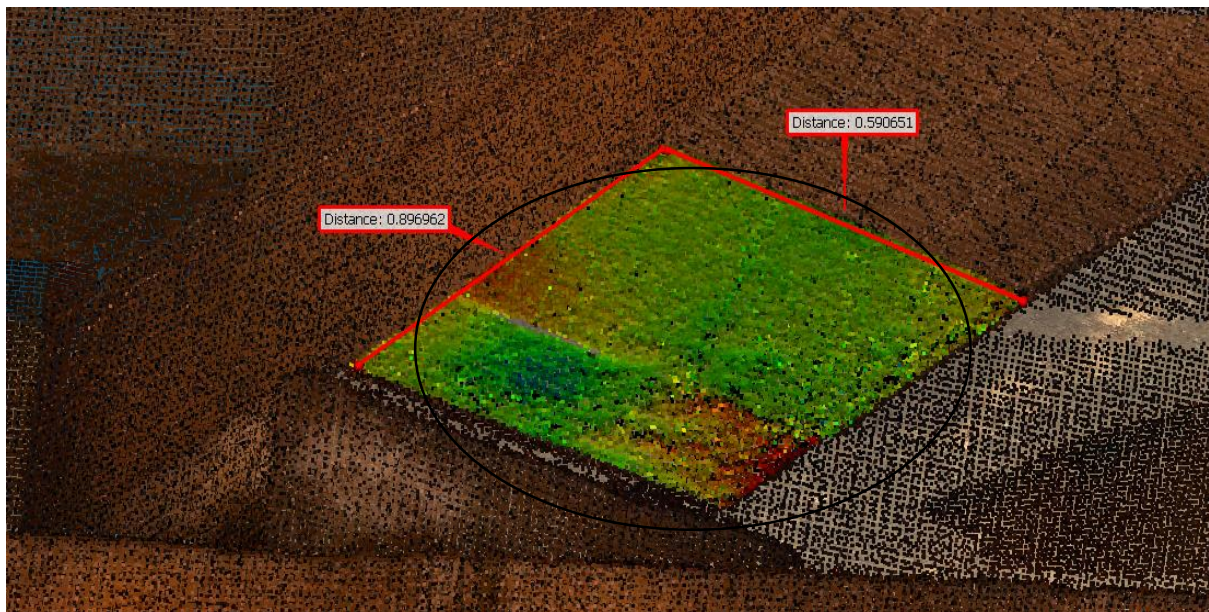
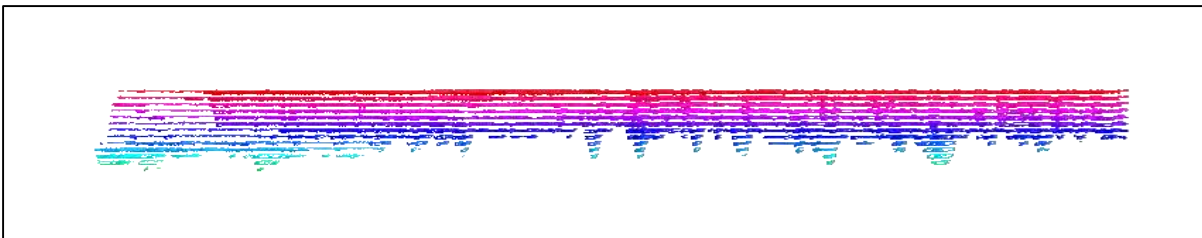
| Element Name | Observation | Location of Distress | Photo No. | Units | Distress Details | | | Area of Repair (Sq./RM T/m3) |
|---|---|---|---|---|---|---|---|---|
| Girder 2 | Honey Combing | | 1 | | 0.89 | 0.59 | | 0.5251 |

**1. Honey combing observed on LHS Abutment 1 Girder 2 , measuring 0.89 m in length and 0.59 m in width, covering an area of 0.5251 m<sup>2</sup>.**

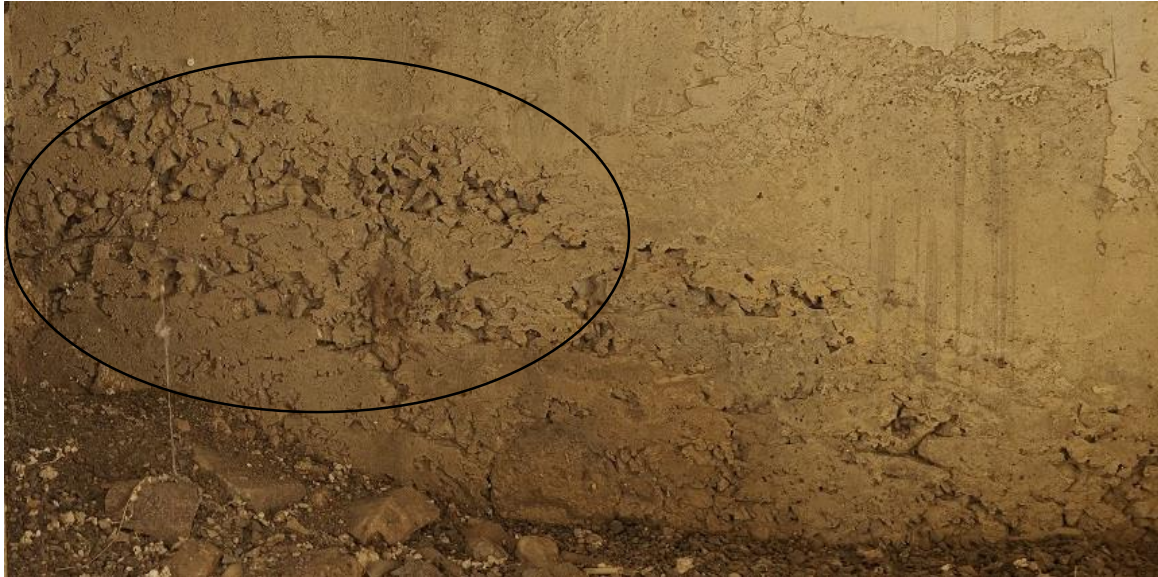
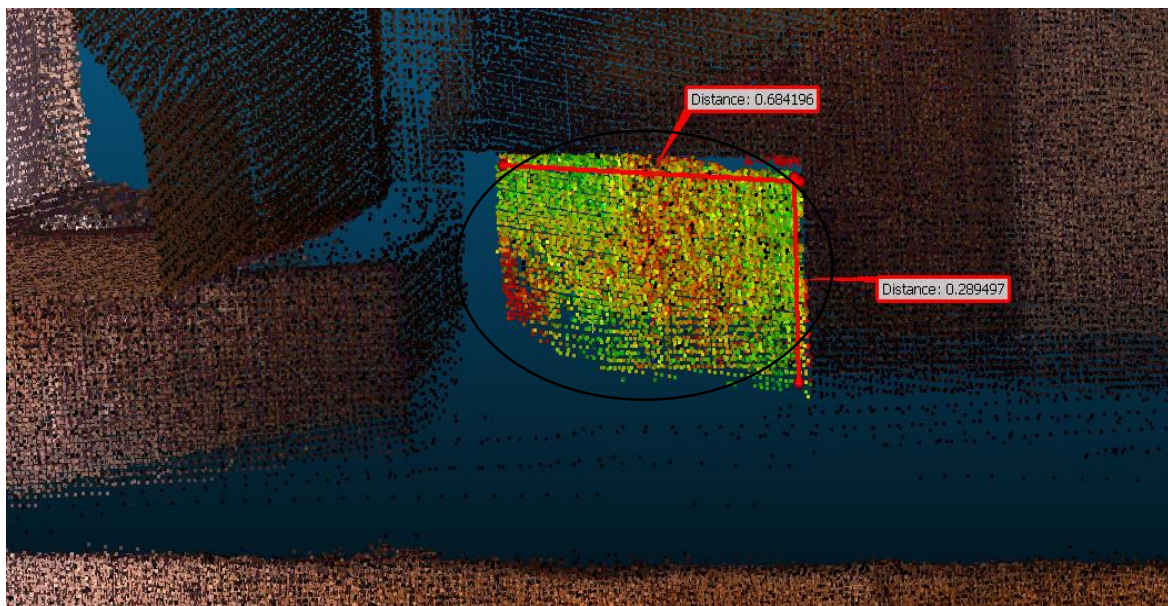
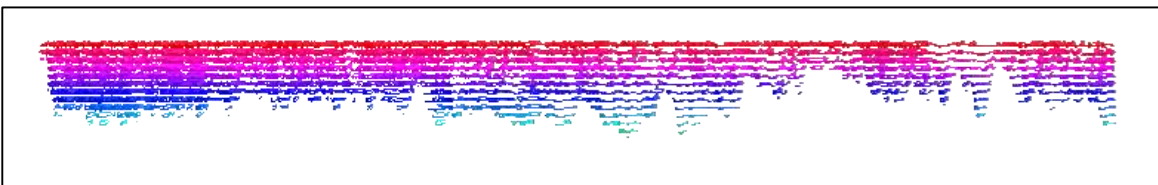
| Element Name | Observation | Location of Distress | Photo No. | Units | Distress Details | | | Area of Repair (Sq./RM T) |
|---|---|---|---|---|---|---|---|---|
| Dirt Wall | Scaling | | 2 | | 0.28 | 0.68 | | 0.1904 |

2. Scaling observed on dirt wall at RHS Abutment 2 Bearing 1, measuring 0.28 m in length and 0.68 m in width, covering an area of 0.1904 m<sup>2</sup>.

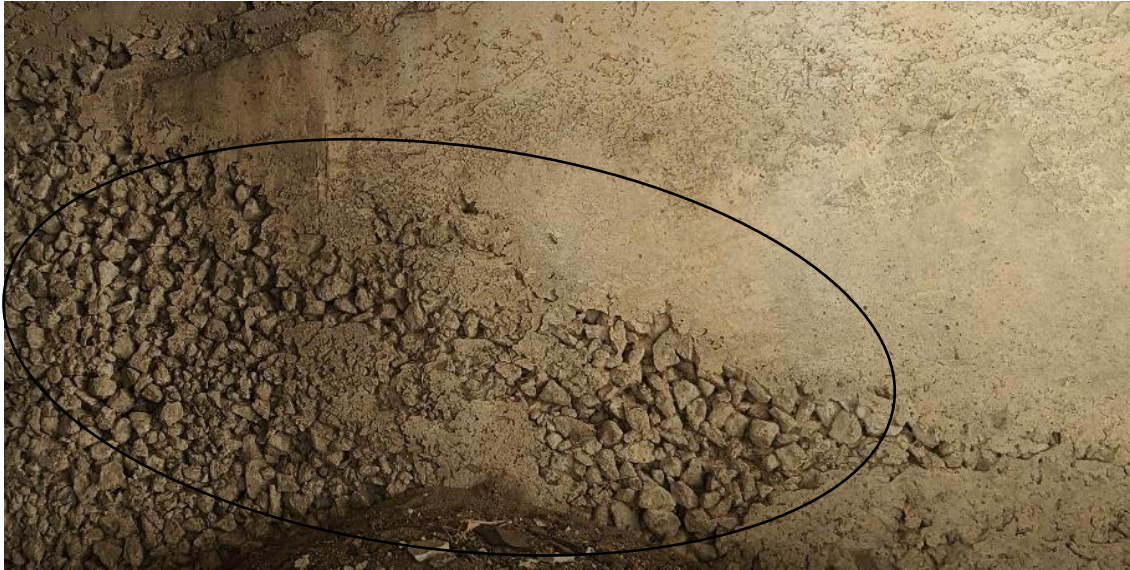
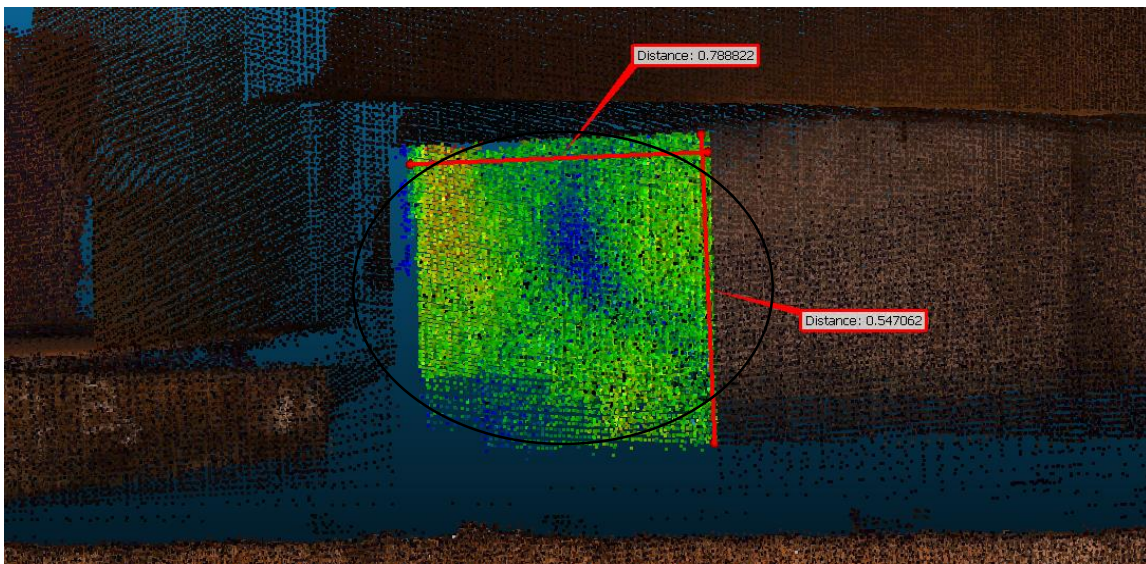
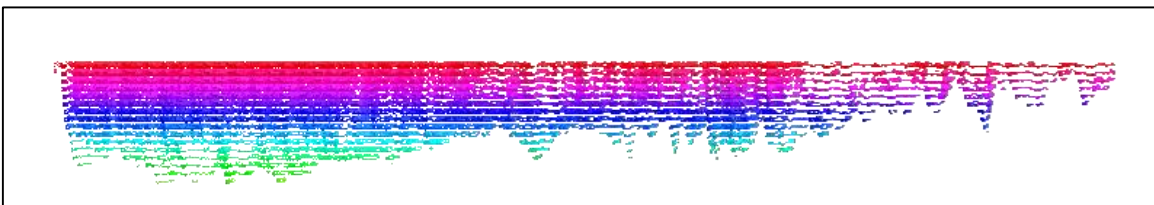
| Element Name | Observation | Location of Distress | Photo No. | Units | Distress Details | | | Area of Repair (Sq./RM T) |
|---|---|---|---|---|---|---|---|---|
| Dirt Wall | Honey Combing | | 3 | | 0.78 | 0.54 | | 0.4212 |

- 3. Honey Combing observed on dirt wall at RHS Abutment 2 Bearing 2, measuring 0.78 m in length and 0.54 m in width, covering an area of 0.4212 m<sup>2</sup>.**

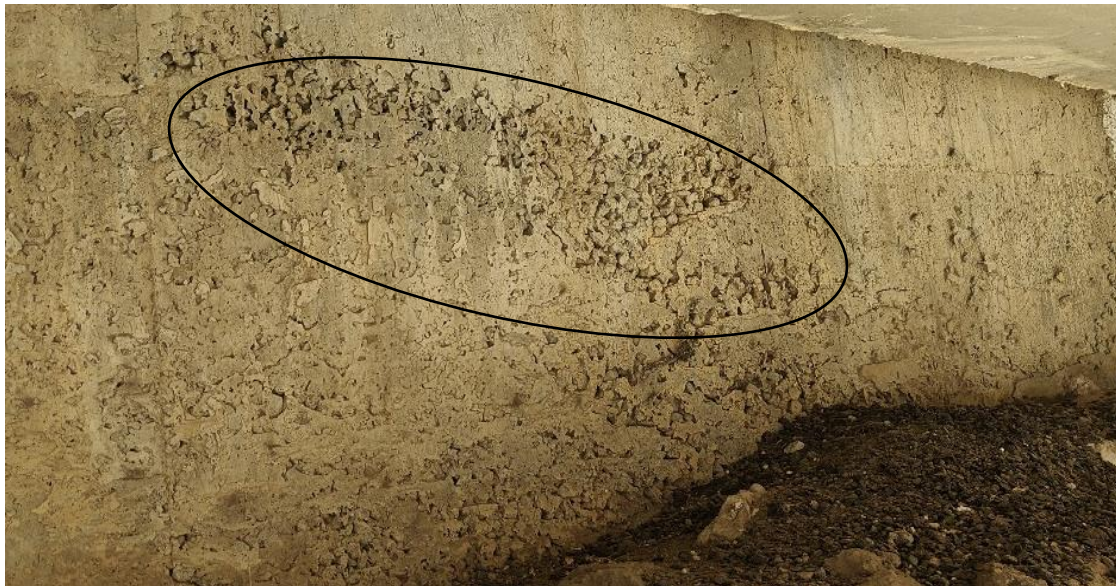
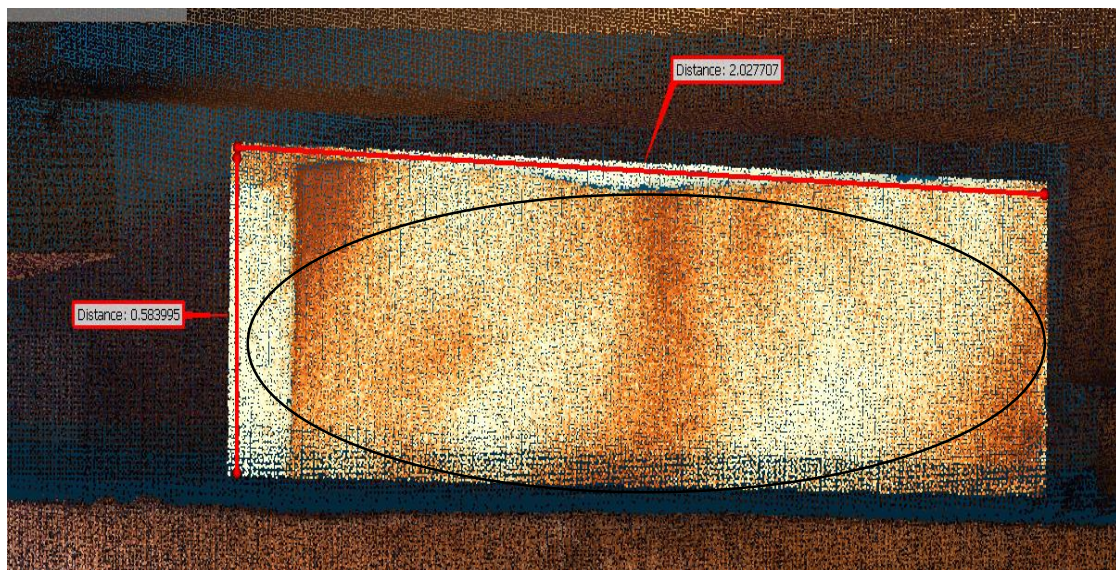
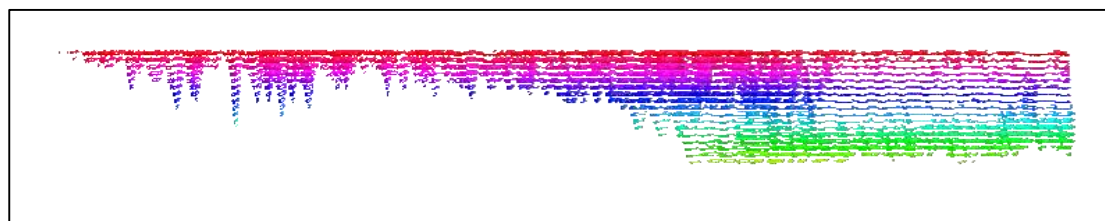
| Element Name | Observation | Location of Distress | Photo No. | Units | Distress Details | | | Area of Repair (Sq./RM T) |
|---|---|---|---|---|---|---|---|---|
| Dirt Wall | Scaling | | 4 | | 2.02 | 0.58 | | 1.1716 |

**4. Scaling observed on dirt wall between Abutment 2 Bearing 1–Bearing 2 , measuring 2.02 m in length and 0.58 m in width, covering an area of 1.1716 m<sup>2</sup>.**

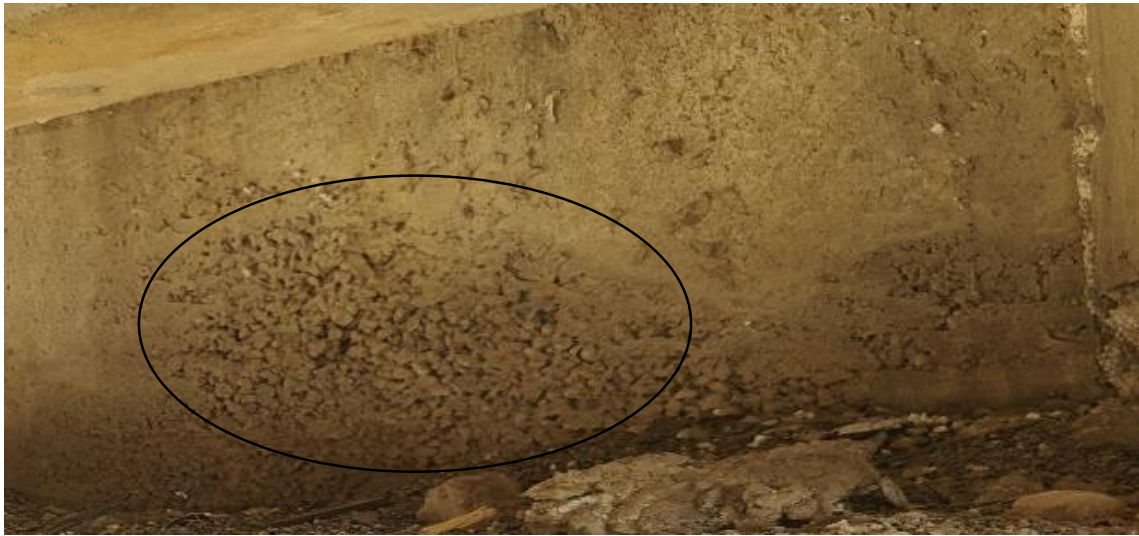
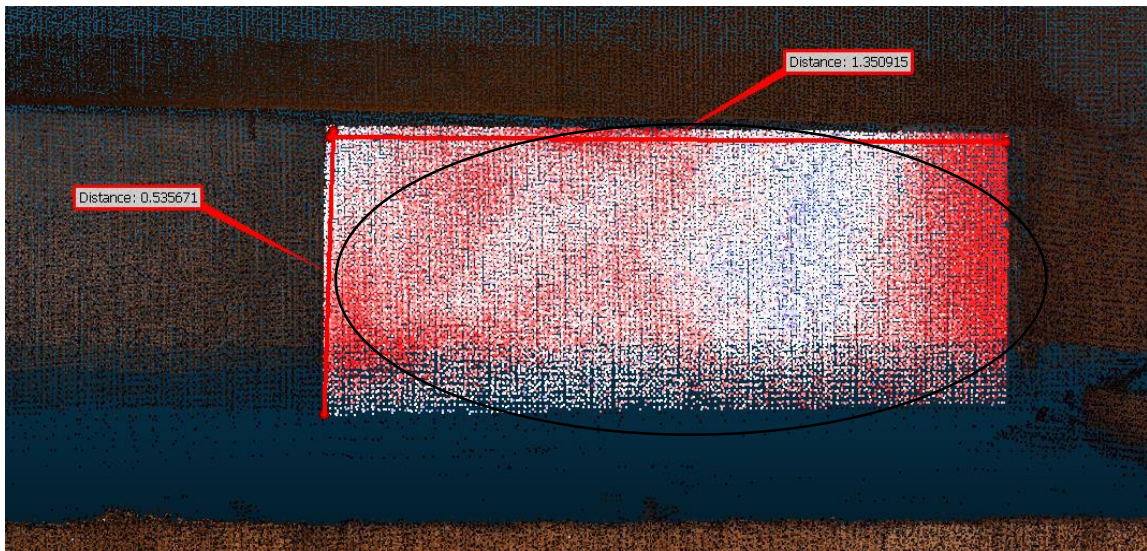
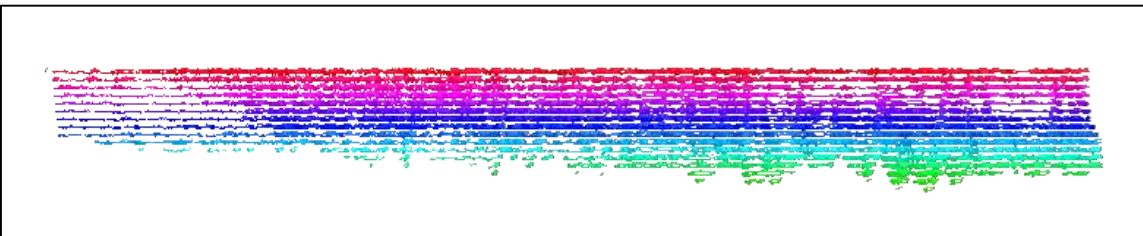
| Element Name | Observation | Location of Distress | Photo No. | Units | Distress Details | | | Area of Repair (Sq./RM T) |
|---|---|---|---|---|---|---|---|---|
| Dirt Wall | Honey Combing | | 5 | | 1.35 | 0.53 | | 0.1716 |

**5. Honey Combing observed on RHS Abutment 2 between Bearing 2–Bearing 3 (HC2), measuring 1.35 m in length and 0.53 m in width, covering an area of 0.7155 m<sup>2</sup>.**

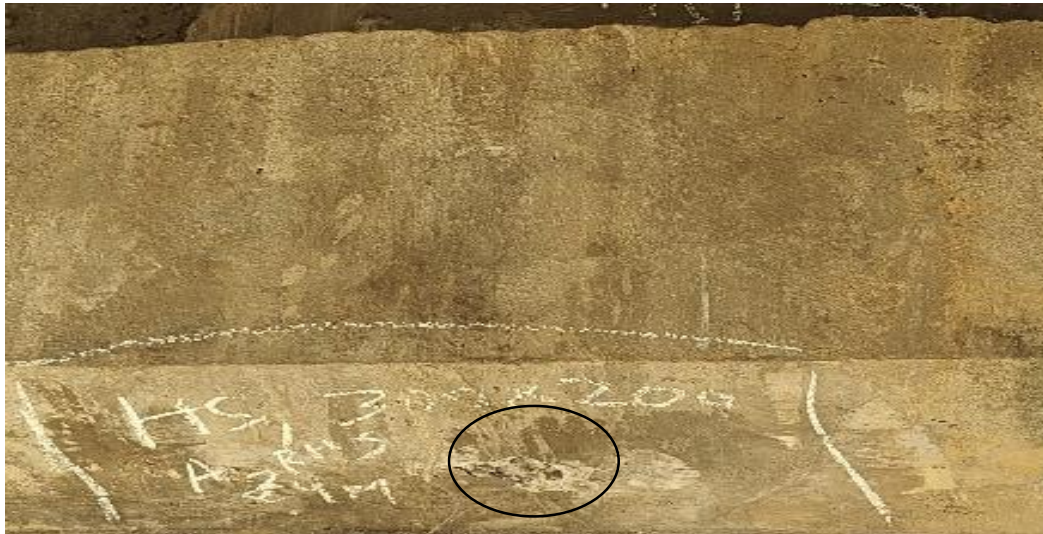
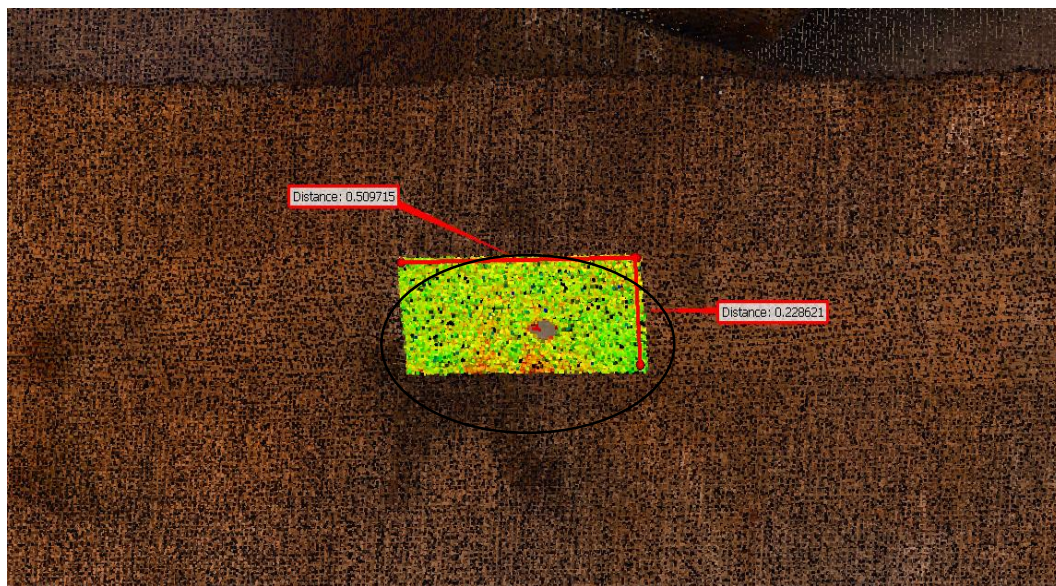
| Element Name | Observation | Location of Distress | Photo No. | Units | Distress Details | | | Area of Repair (Sq./RM T) |
|---|---|---|---|---|---|---|---|---|
| Abutment 2 | Hollow Section | | 6 | | 0.50 | 0.22 | 0.033 | 0.0036 |

**6. Hollow section observed at RHS Abutment 2, measuring 0.50 m in length and 0.22 m in width. Depth ranges from 0.018 m (min) to 0.043 m (max), with an average depth of 0.043 m. The calculated volume of the distress is 0.0036 m<sup>3</sup>.**

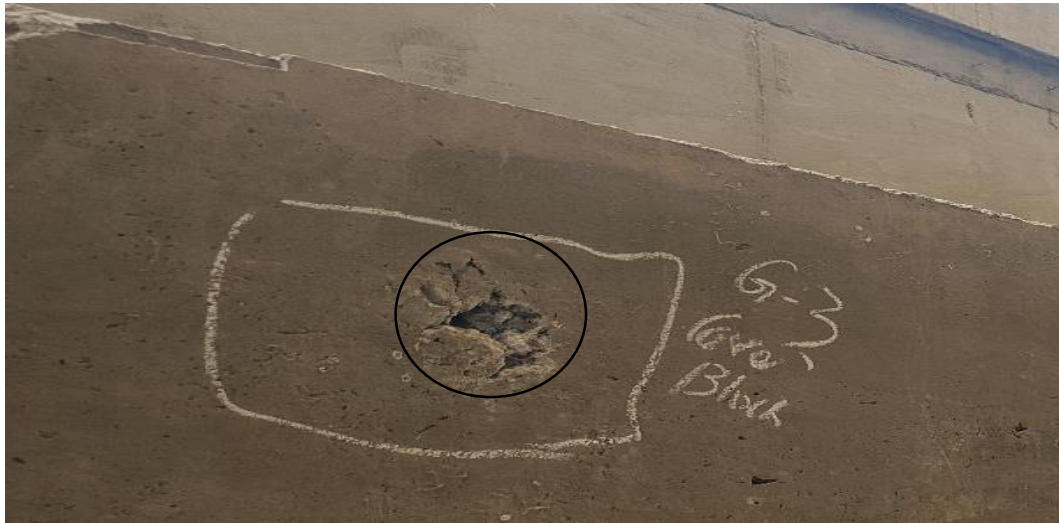
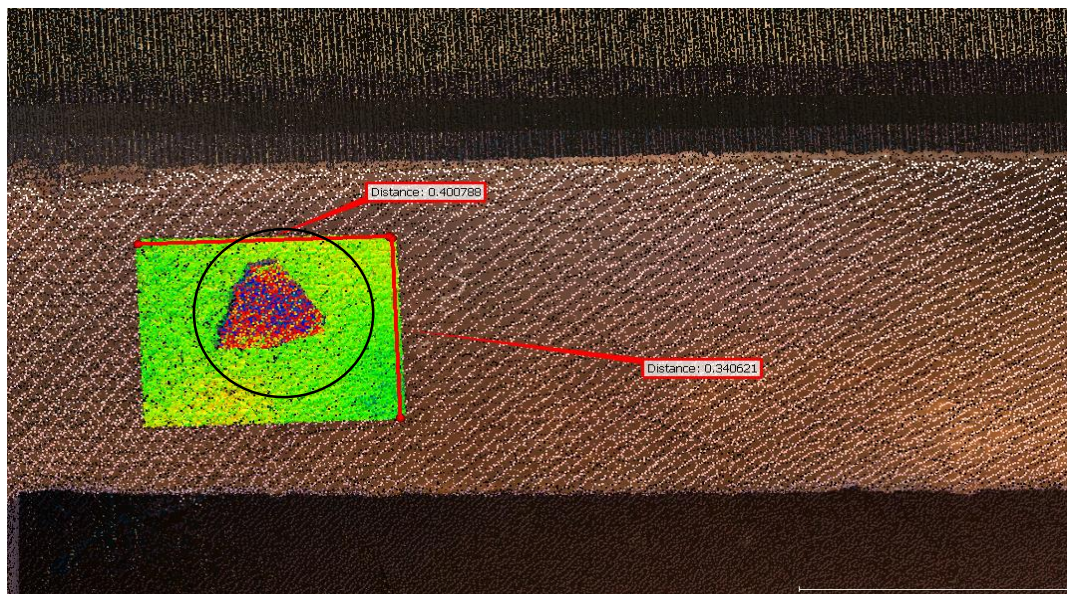
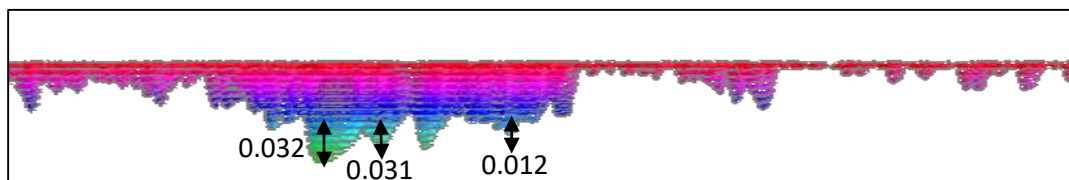
| Element Name | Observation | Location of Distress | Photo No. | Units | Distress Details | | | Area of Repair (Sq./RM T) |
|---|---|---|---|---|---|---|---|---|
| Girder 3 | Damage | | 7 | | 0.40 | 0.34 | 0.031 | 0.0042 |

**7. Damage observed at RHS Abutment 1 Girder 3, measuring 0.40 m in length and 0.34 m in width. Depth ranges from 0.012 m (min) to 0.032 m (max), with an average depth of 0.031 m. The calculated volume of the distress is 0.0042 m<sup>3</sup>.**
