# **LIDAR Inspection Report of Box Culvert ch.914+302**

**Bridge Chainage:** 914+302

- **Bridge No:** -
- **Chainage:** 914+302
- **Structure type:** Box Culvert

- **CKRP:** Chittorgarh to kota
- **State:** Rajasthan NH 27
- **Zone:** RJ-20

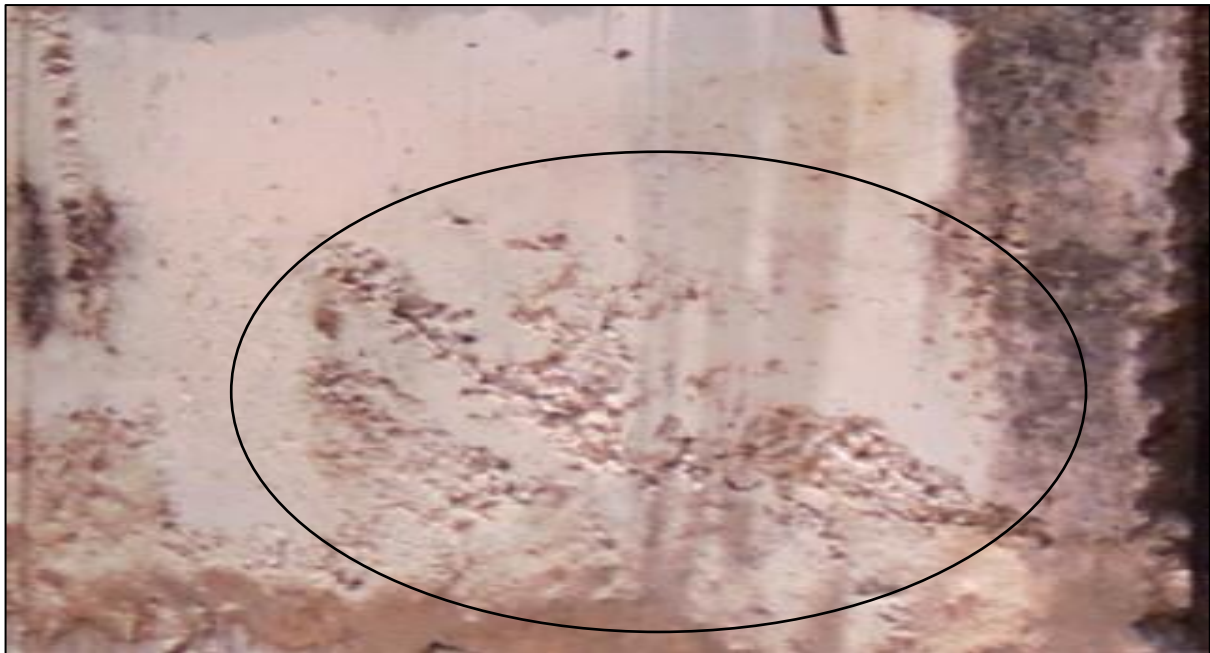
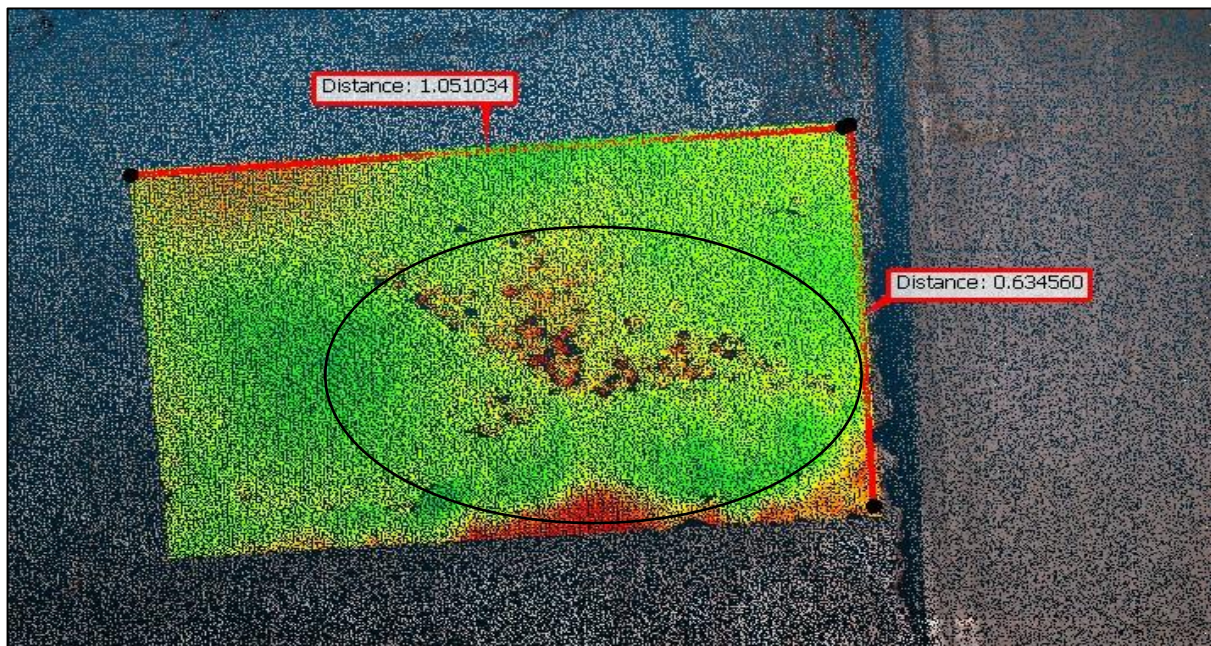
| Element Name | Observation | Location of Distress | Photo No. | Units | Distress Details | | | Area of Repair (Sq.m/R MT/m3) |
|---|---|---|---|---|---|---|---|---|
| Return Wall | Scalling | - | 1 | Sq m | 1.05 | 0.63 | - | 0.66 |

**1. Scaling observed on return wall RHS side, measuring 1.05 m in length and 0.63 m in width, covering an area of 0.66 m<sup>2</sup>.**

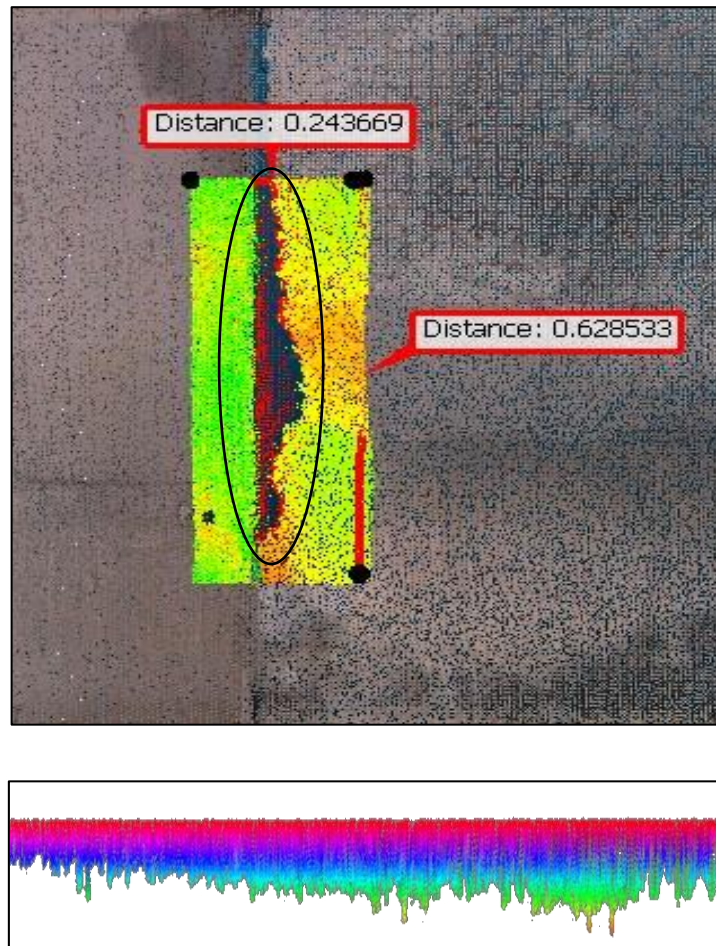
| Element Name | Observation | Location of Distress | Photo No. | Units | Distress Details | | | Area of Repair (Sq.m/R MT/m3) |
|---|---|---|---|---|---|---|---|---|
| Abutment | Damage | - | 2 | Sq m | 0.62 | 0.24 | - | 0.14 |

**2.Damage observed on Abutment corner LHS side, measuring 0.62 m in length and 0.24 m in width, covering an area of 0.14 m<sup>2</sup>.**
