# LIDAR Inspection Report of **Box Culvert** ch.914+757

**Bridge Chainage:** 914+757 (CKRP)

- **CKRP:** Chittorgarh to kota
- **State:** Rajasthan NH 27
- **Zone:** RJ-06

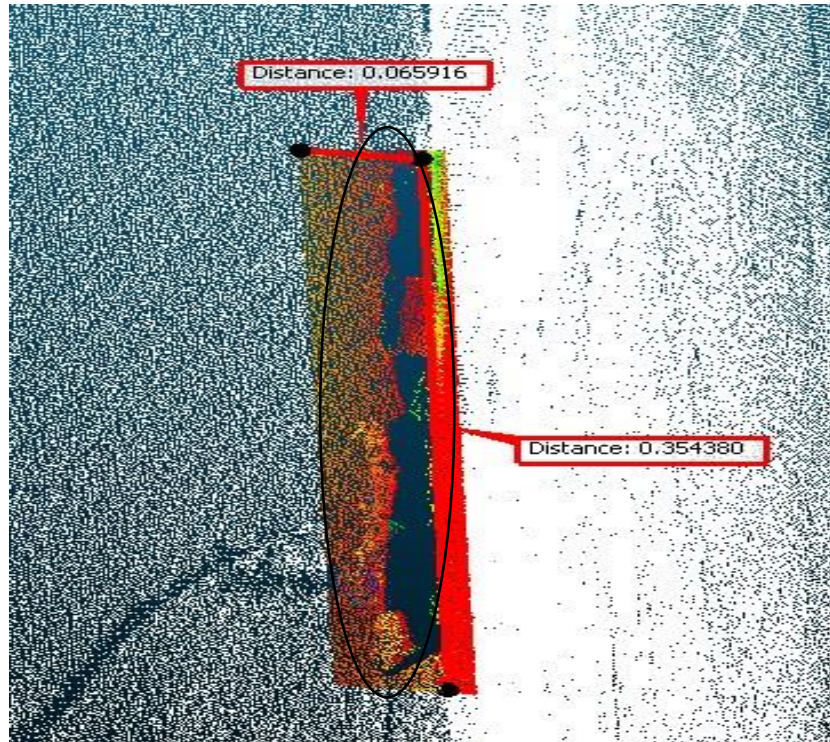
| Element Name | Observation | Location of Distress | Photo No. | Units | Distress Details | | | Area of Repair (Sq.m/ RMT/ m3) |
|---|---|---|---|---|---|---|---|---|
| Wing Wall | Damage | - | 1 | M | 0.06 | 0.35 | | 0.021 |

**1. Wing wall damage observed, measuring 0.06 m in length and 0.35 m in width, covering an area of 0.021 m<sup>2</sup>.**

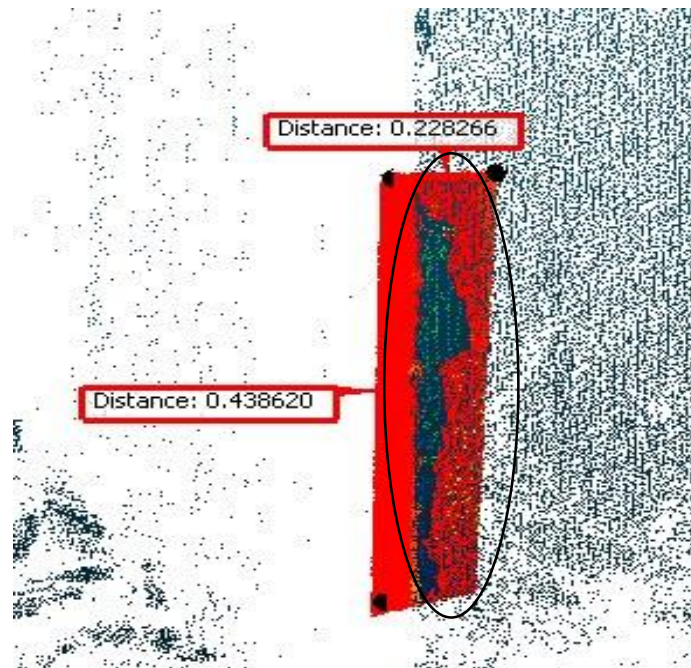
| Element Name | Observation | Location of Distress | Photo No. | Units | Distress Details | | | Area of Repair (Sq.m/ RMT/ m3) |
|---|---|---|---|---|---|---|---|---|
| Wing Wall | Damage | - | 2 | M | 0.22 | 0.43 | | 0.094 |

**2. Wing wall damage observed, measuring 0.22 m in length and 0.43 m in width, covering an area of 0.094 m<sup>2</sup>.**

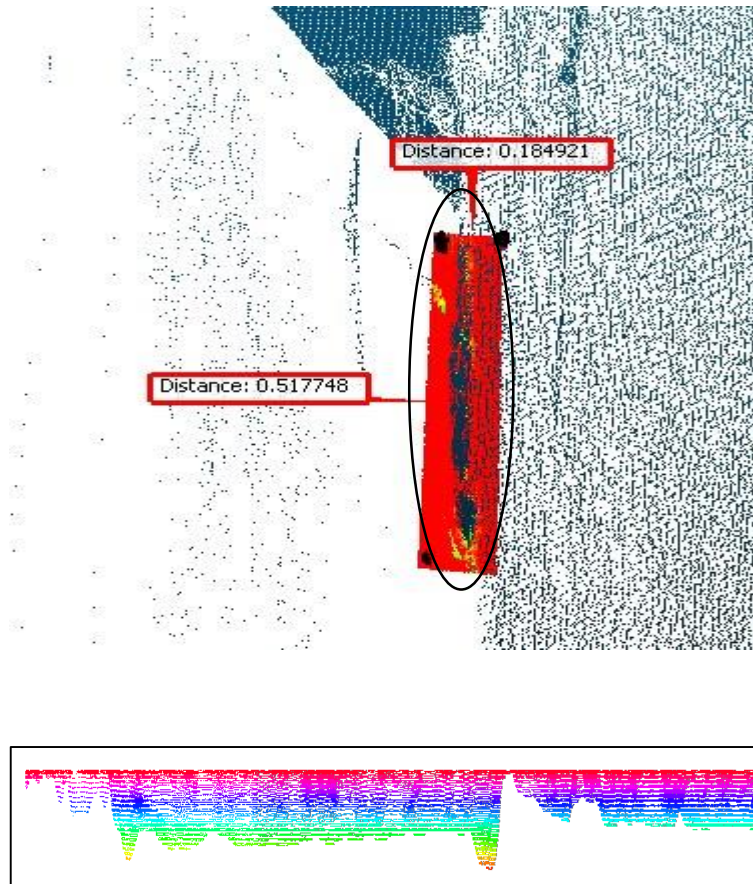
| Element Name | Observation | Location of Distress | Photo No. | Units | Distress Details | | | Area of Repair (Sq.m/ RMT/ m3) |
|---|---|---|---|---|---|---|---|---|
| Wing Wall | Damage | - | 3 | M | 0.16 | 0.51 | | 0.081 |

**3. Wing wall damage observed, measuring 0.16 m in length and 0.51 m in width, covering an area of 0.081 m<sup>2</sup>.**

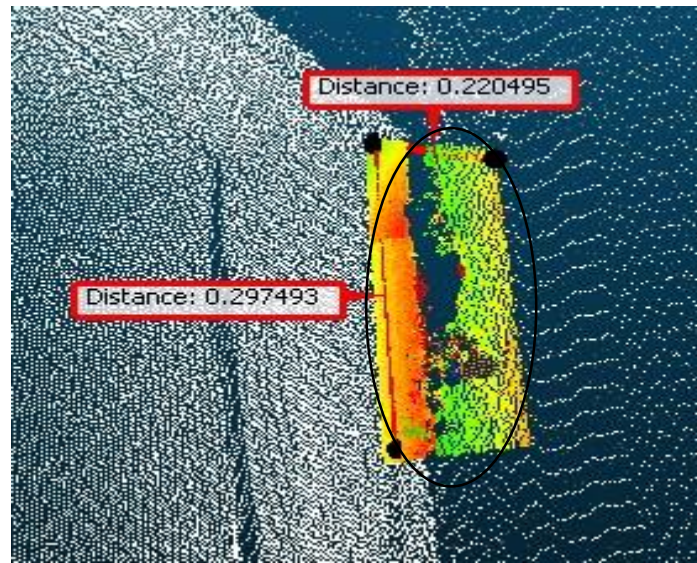
| Element Name | Observation | Location of Distress | Photo No. | Units | Distress Details | | | Area of Repair (Sq.m/ RMT/ m3) |
|---|---|---|---|---|---|---|---|---|
| Wing Wall | Damage | - | 4 | M | 0.22 | 0.29 | | 0.063 |

**4. Wing wall damage observed, measuring 0.22 m in length and 0.29 m in width, covering an area of 0.063 m<sup>2</sup>.**
